Water Management Inspection - Hamlet of Pelly Bay, August 15, 1997

Inspection Report

Pelly Bay
Unlicensed

15 August 1997

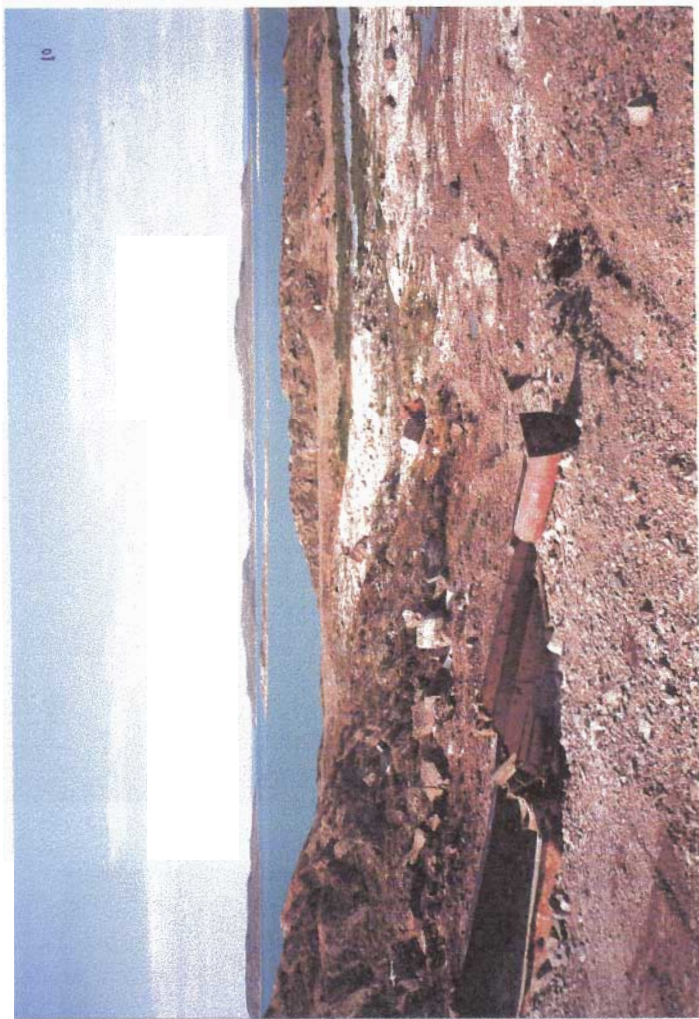
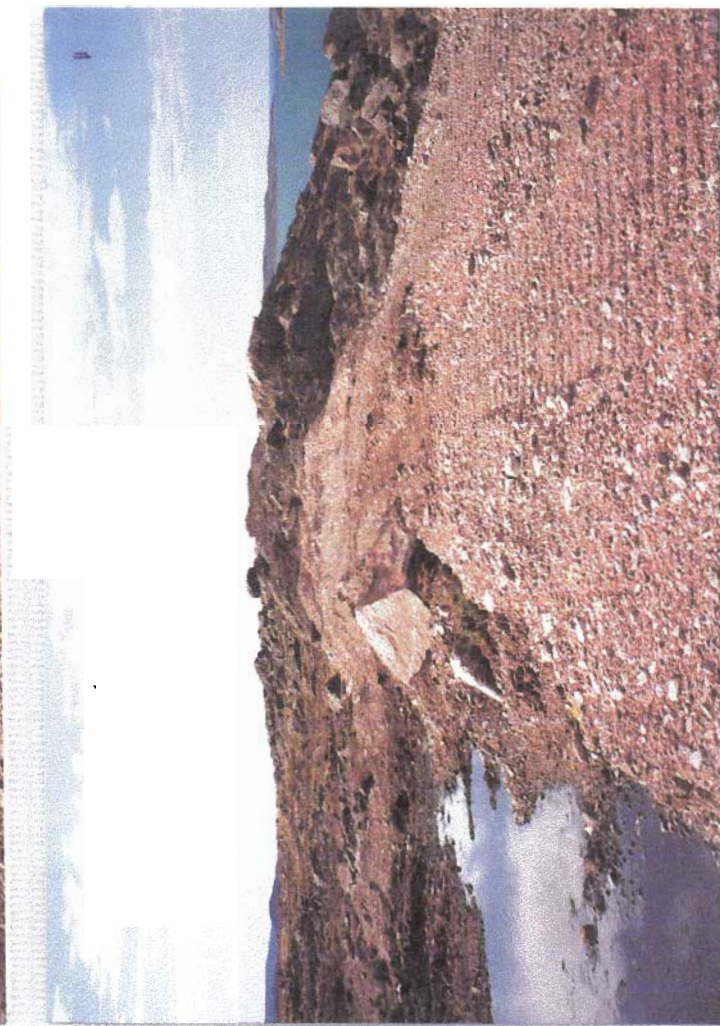
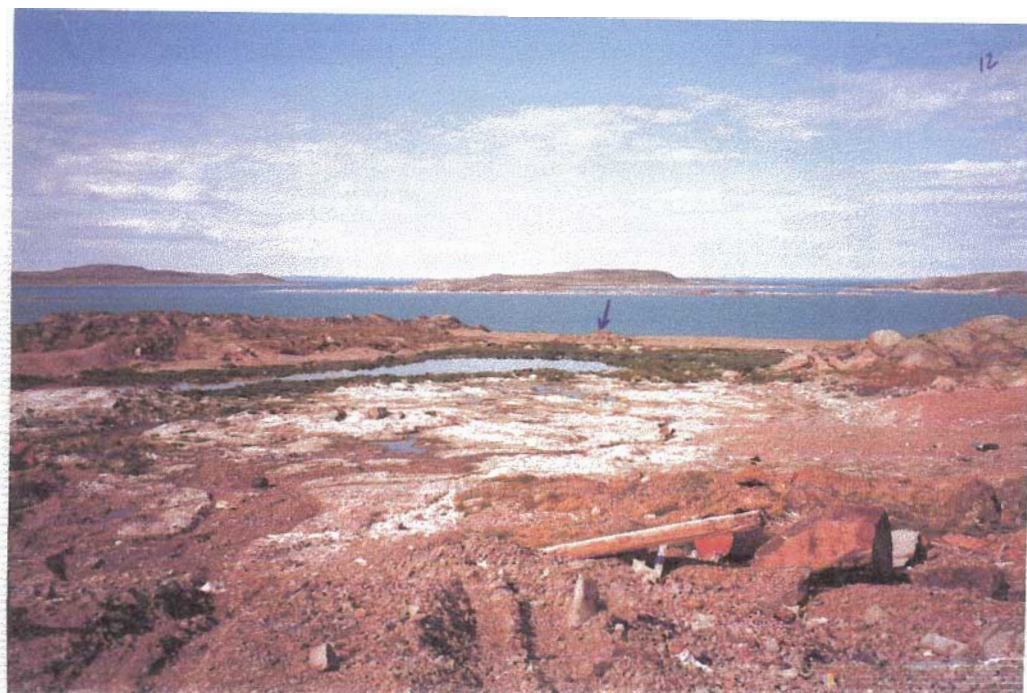
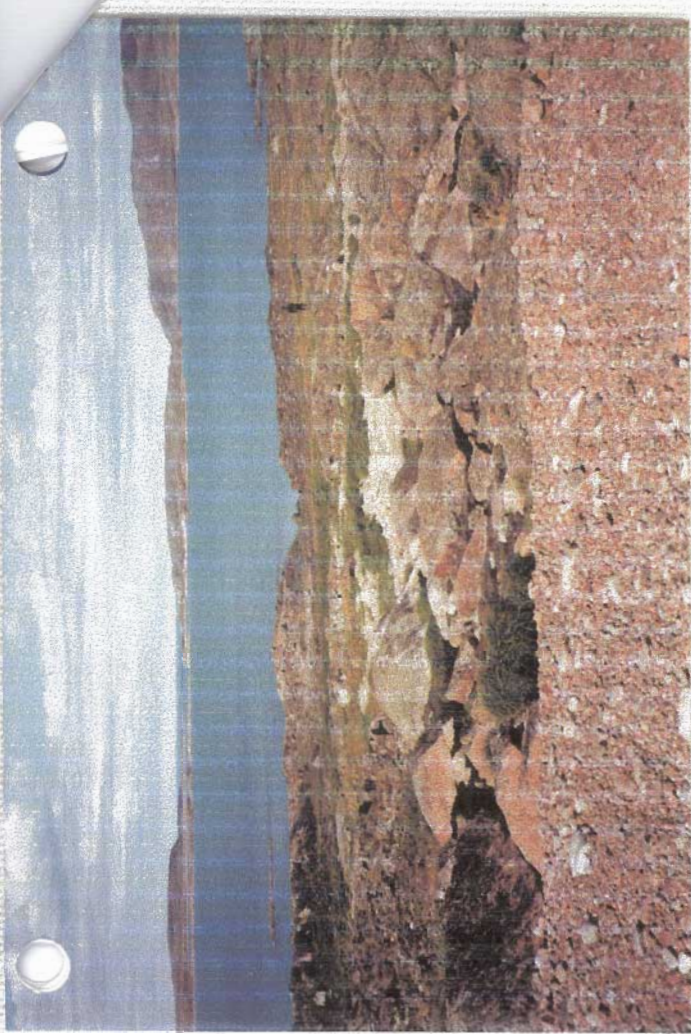
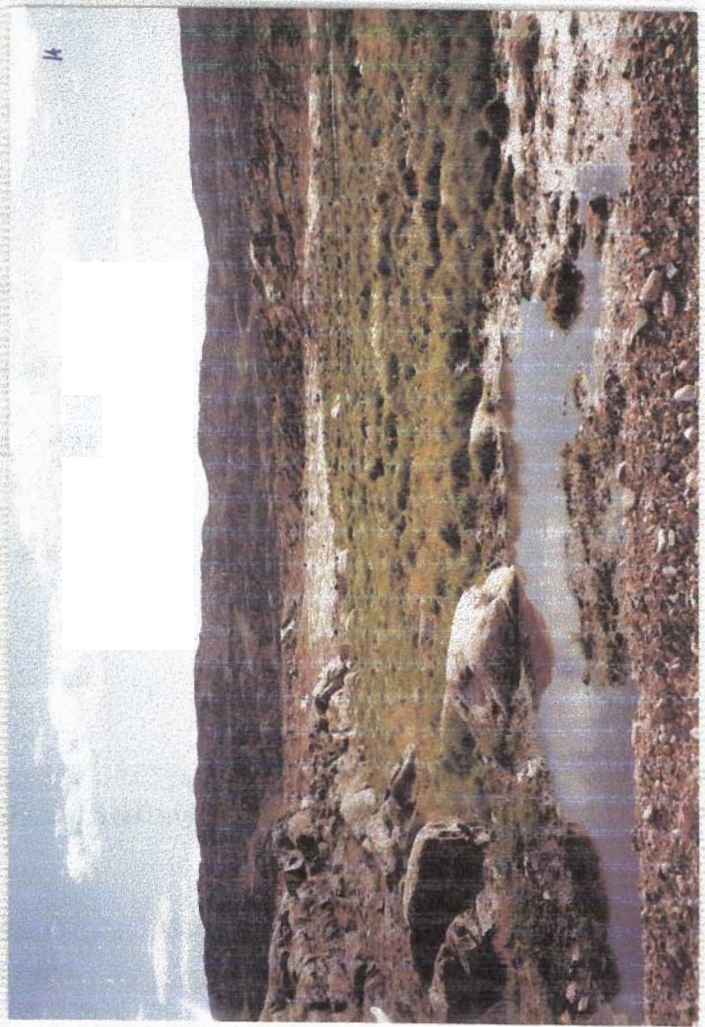
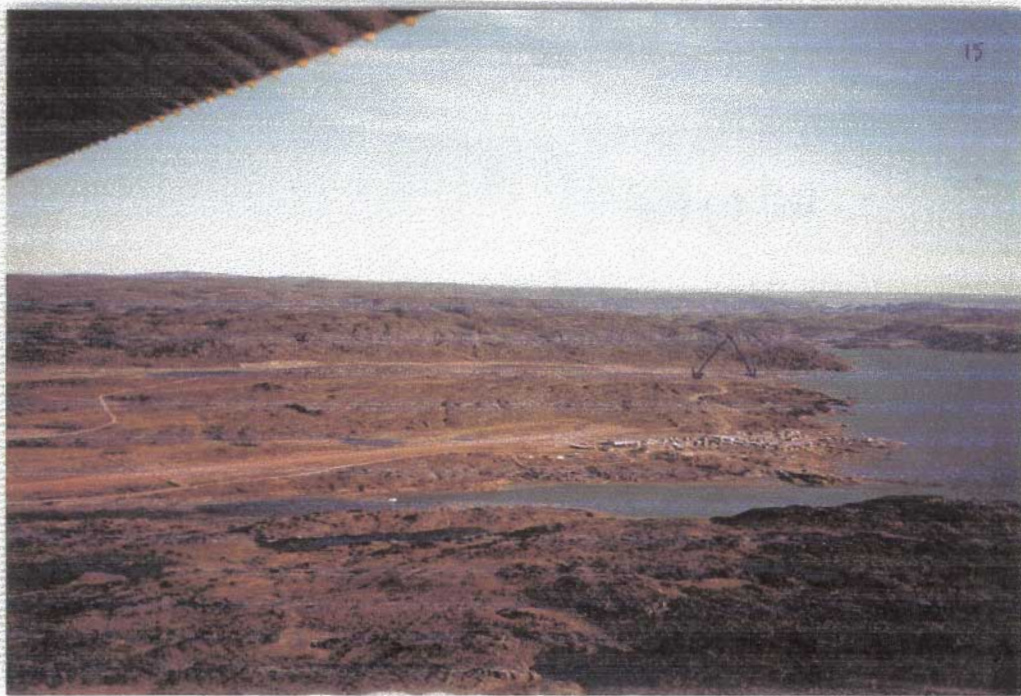
1. Truckfill station.
2. Aerial view. Arrow denotes location of truckfill station on river.
3. Creek where people go to collect water. Public Health had taken an interest in this source.
- 4-6. Waste disposal site. Accumulated garbage is due to Public Health's direction to the Hamlet not to burn the dump.
7. Trench to divert runoff water from entering the dump.
8. Waste oil - stacked and palletized.
9. Bulky metal disposal site.
- 10-14. Views of sewage disposal area. Note in 11+12 (arrow) an area of repair as lagoon washed out in June of last year. Photo 13 shows 'wetlands' area below lagoon. Photo 14 is reverse view.
15. Aerial view of community and waste disposal facilities (to show relative distances). Solid waste is on the left, sewage on the right.
