Kugaaruk Sewage Lagoon Study

Final Report

Prepared for:
Government of Nunavut
Community and Government
Services

Project No. 1101 26041

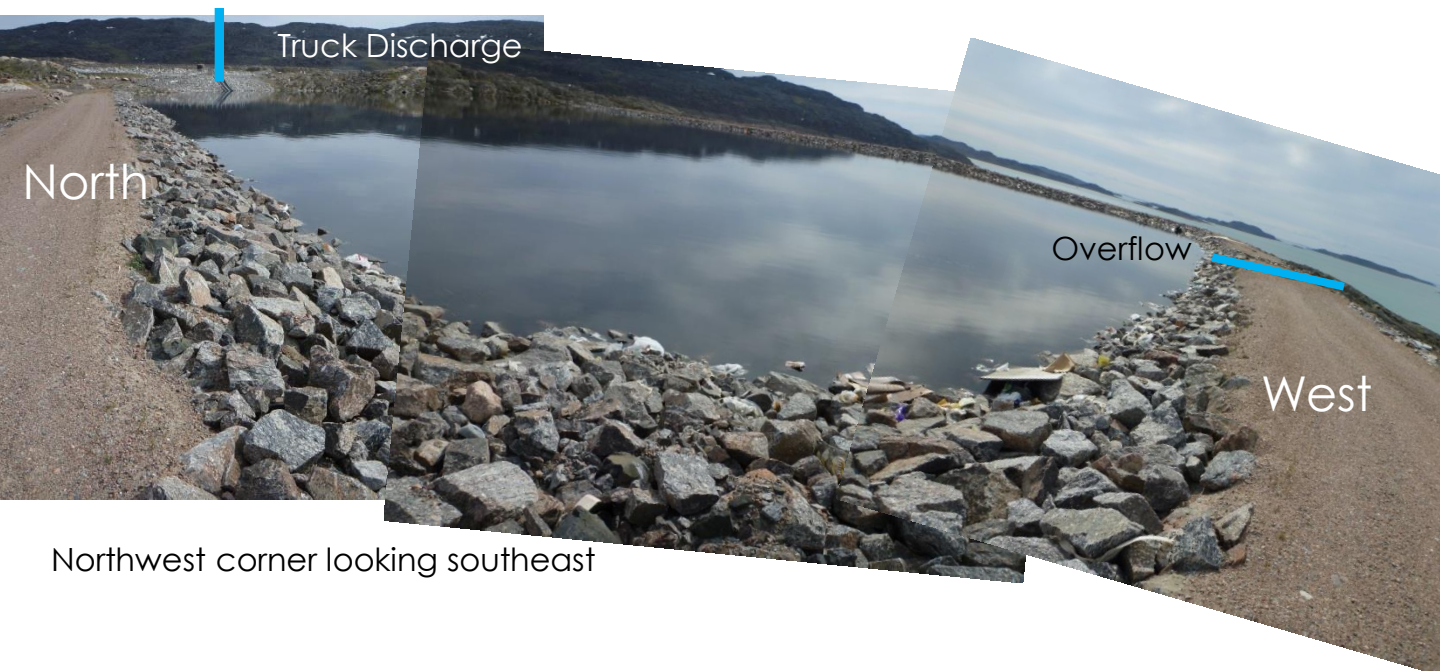
Northwest corner looking southeast

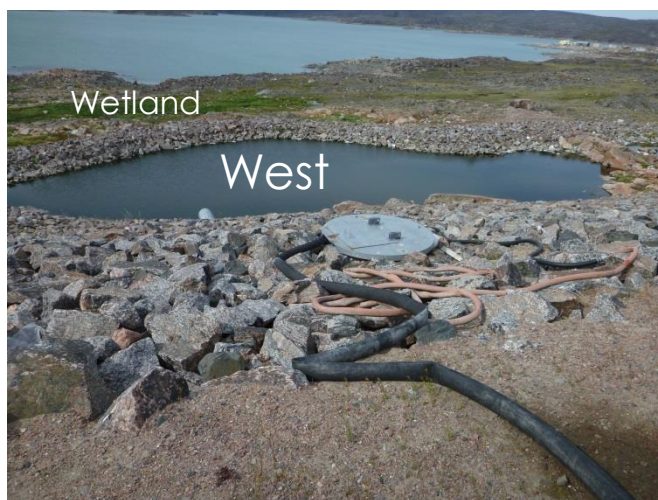
Discharge control manhole on west side flowing onto flow dispersion berm structure

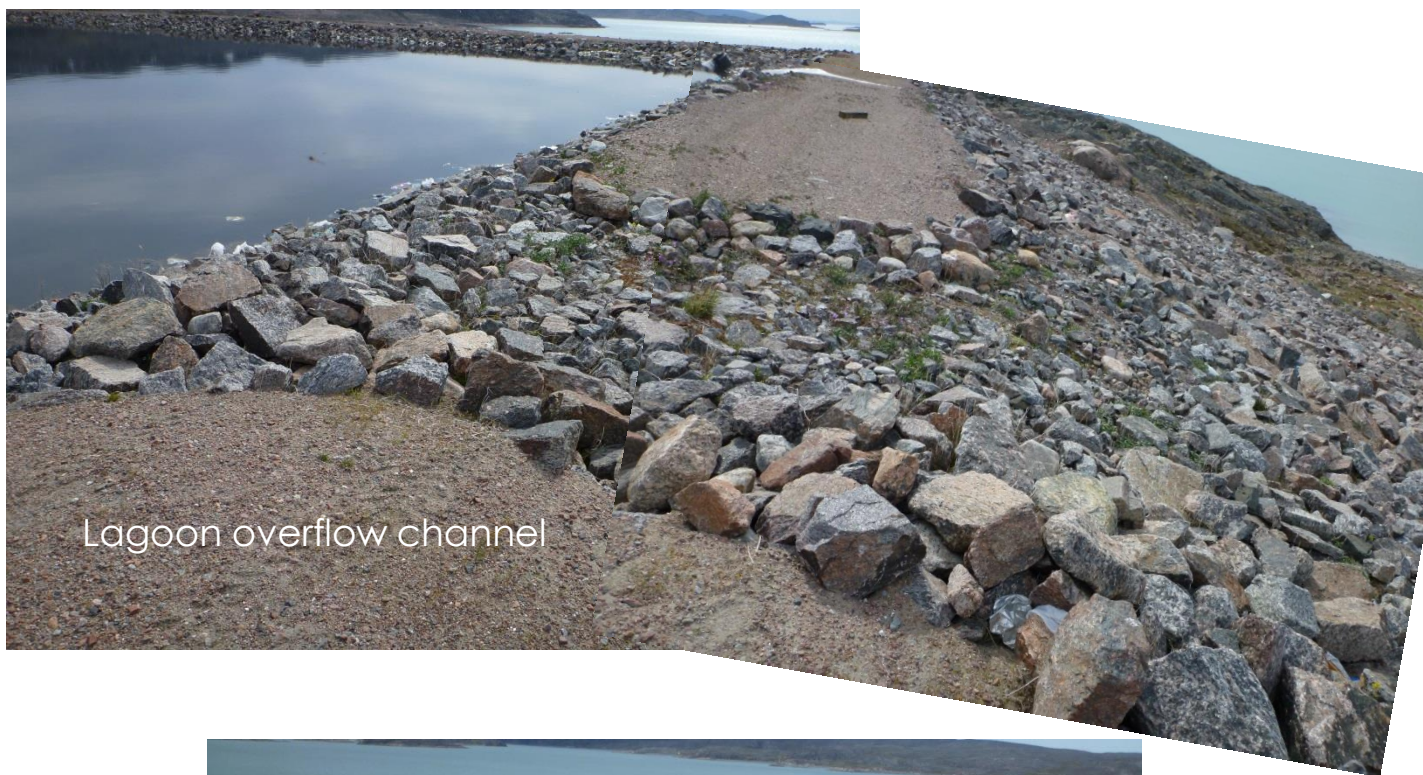
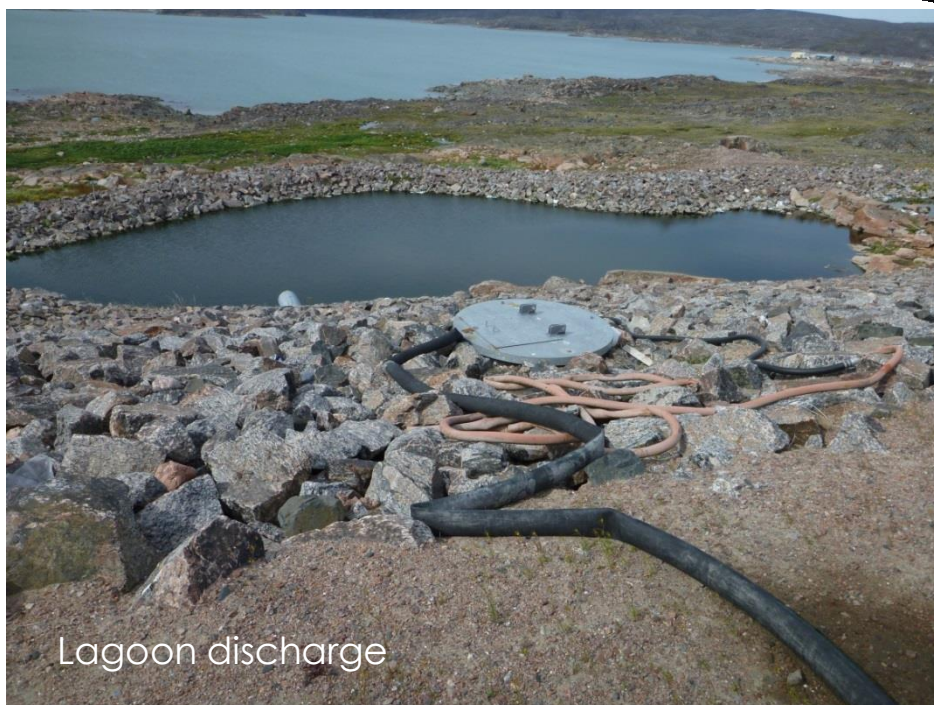
FIGURE 6. Overflow and Discharge

The discharge structure for the lagoon is a pipe on the west side of the lagoon which discharges into a flow dispersion structure and ultimately into a wetland (See **Figure 6**). An overflow structure is also located on the west berm beside the discharge structure.

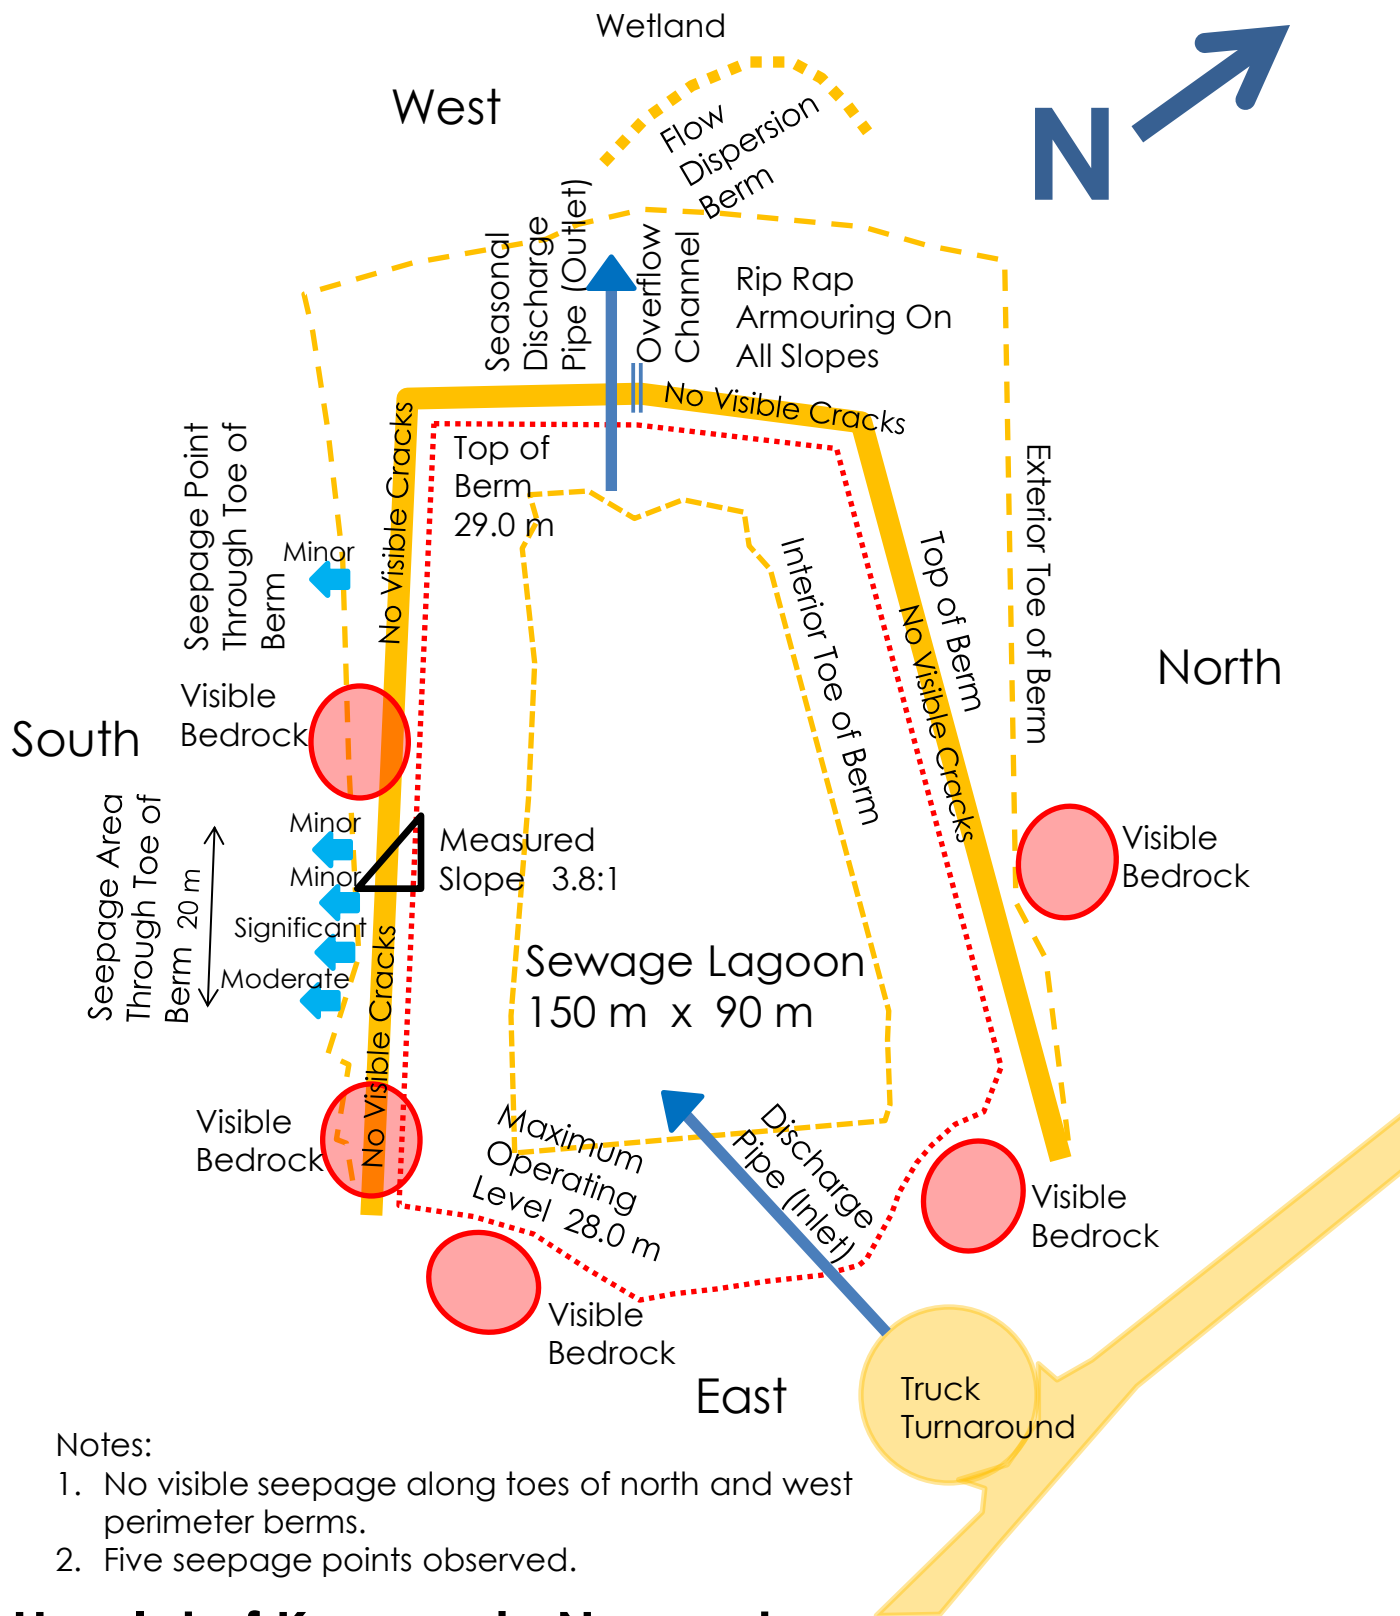
FIGURE 2. Site Photographs

A notable flow from the base of the lagoon on the south side was clearly visible. The flow originates from two general areas on the south berm, and from specific flow points in each area. The flow area in the south east corner has 4 distinct points of flow (**See Figure 2**), with varying degrees of flow that contribute to two channels of flow immediately downstream, that form one channel of flow. A single point of minor flow was observed in the south west corner, and this flow infiltrates into the ground within 20 metres of the toe of the berm.
