24 November 2010
YX00828

Dillon Consulting Limited
P.O. Box 1409,
4920 47th Street
Yellowknife, NT X1A 2P1

**Re: Dam Safety Review for the Kugaaruk Sewage Lagoon,
Kugaaruk, NU**

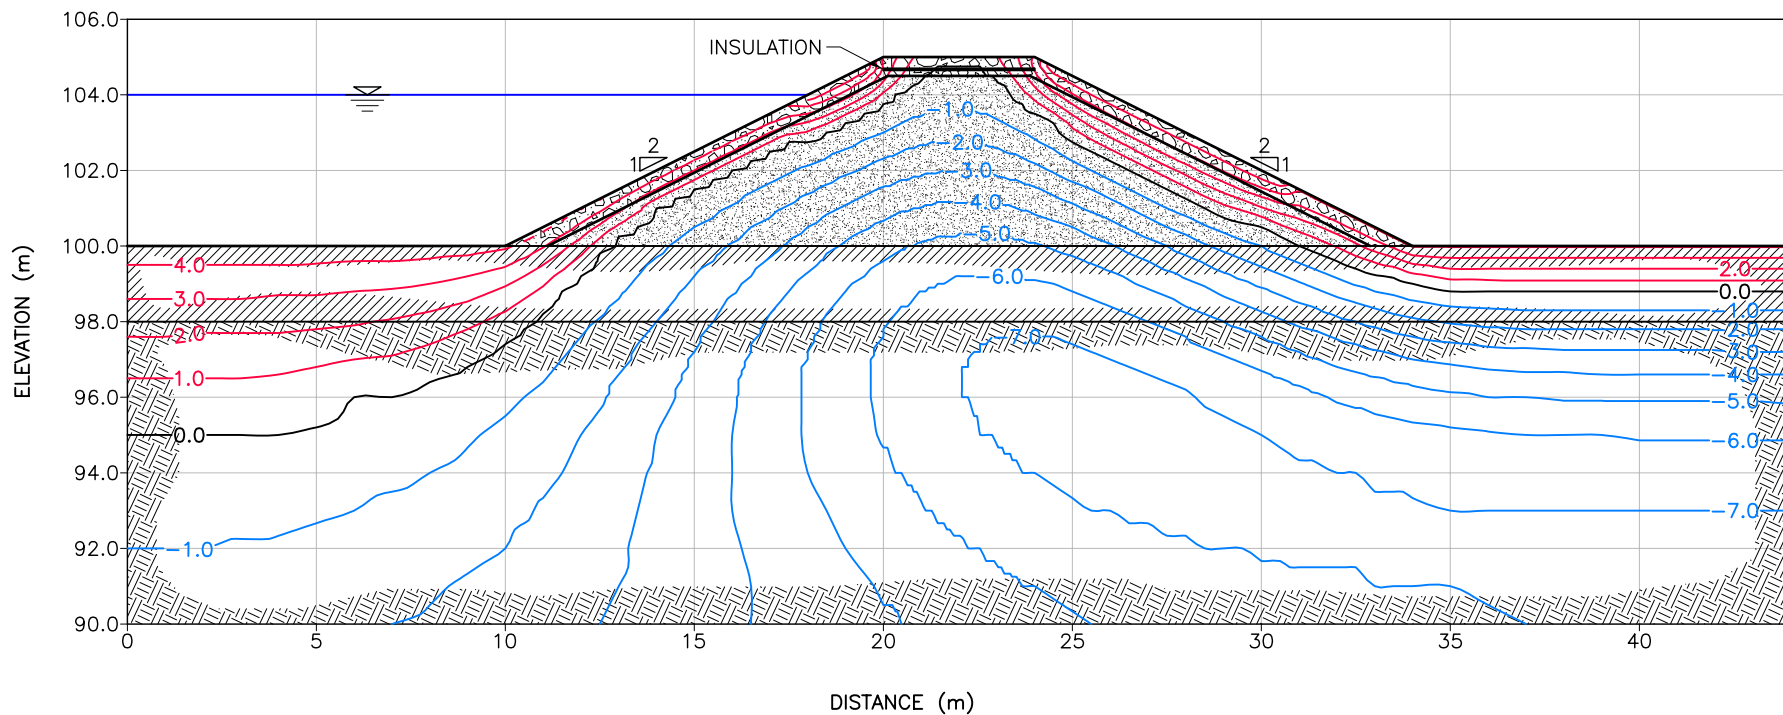
FIGURE 11

Figures 11 through 14 (Appendix B) shows that after five years of the operation, the thickness of the active layer at the crest of the dyke is decreased to about 0.5 m. No significant changes in the dyke temperature regime are observed from the fifth to thirtieth year of the dyke operation (dyke temperature remains in a range from -1 °C to -5 °C, considerably colder than after the first year of operation). It can be seen that the unfrozen zone thickness under the lagoon is increased up to 5 m, while the ground temperature at the base of the central part of the dyke is decreased down to -7 °C. These latter temperatures are the same both design options.

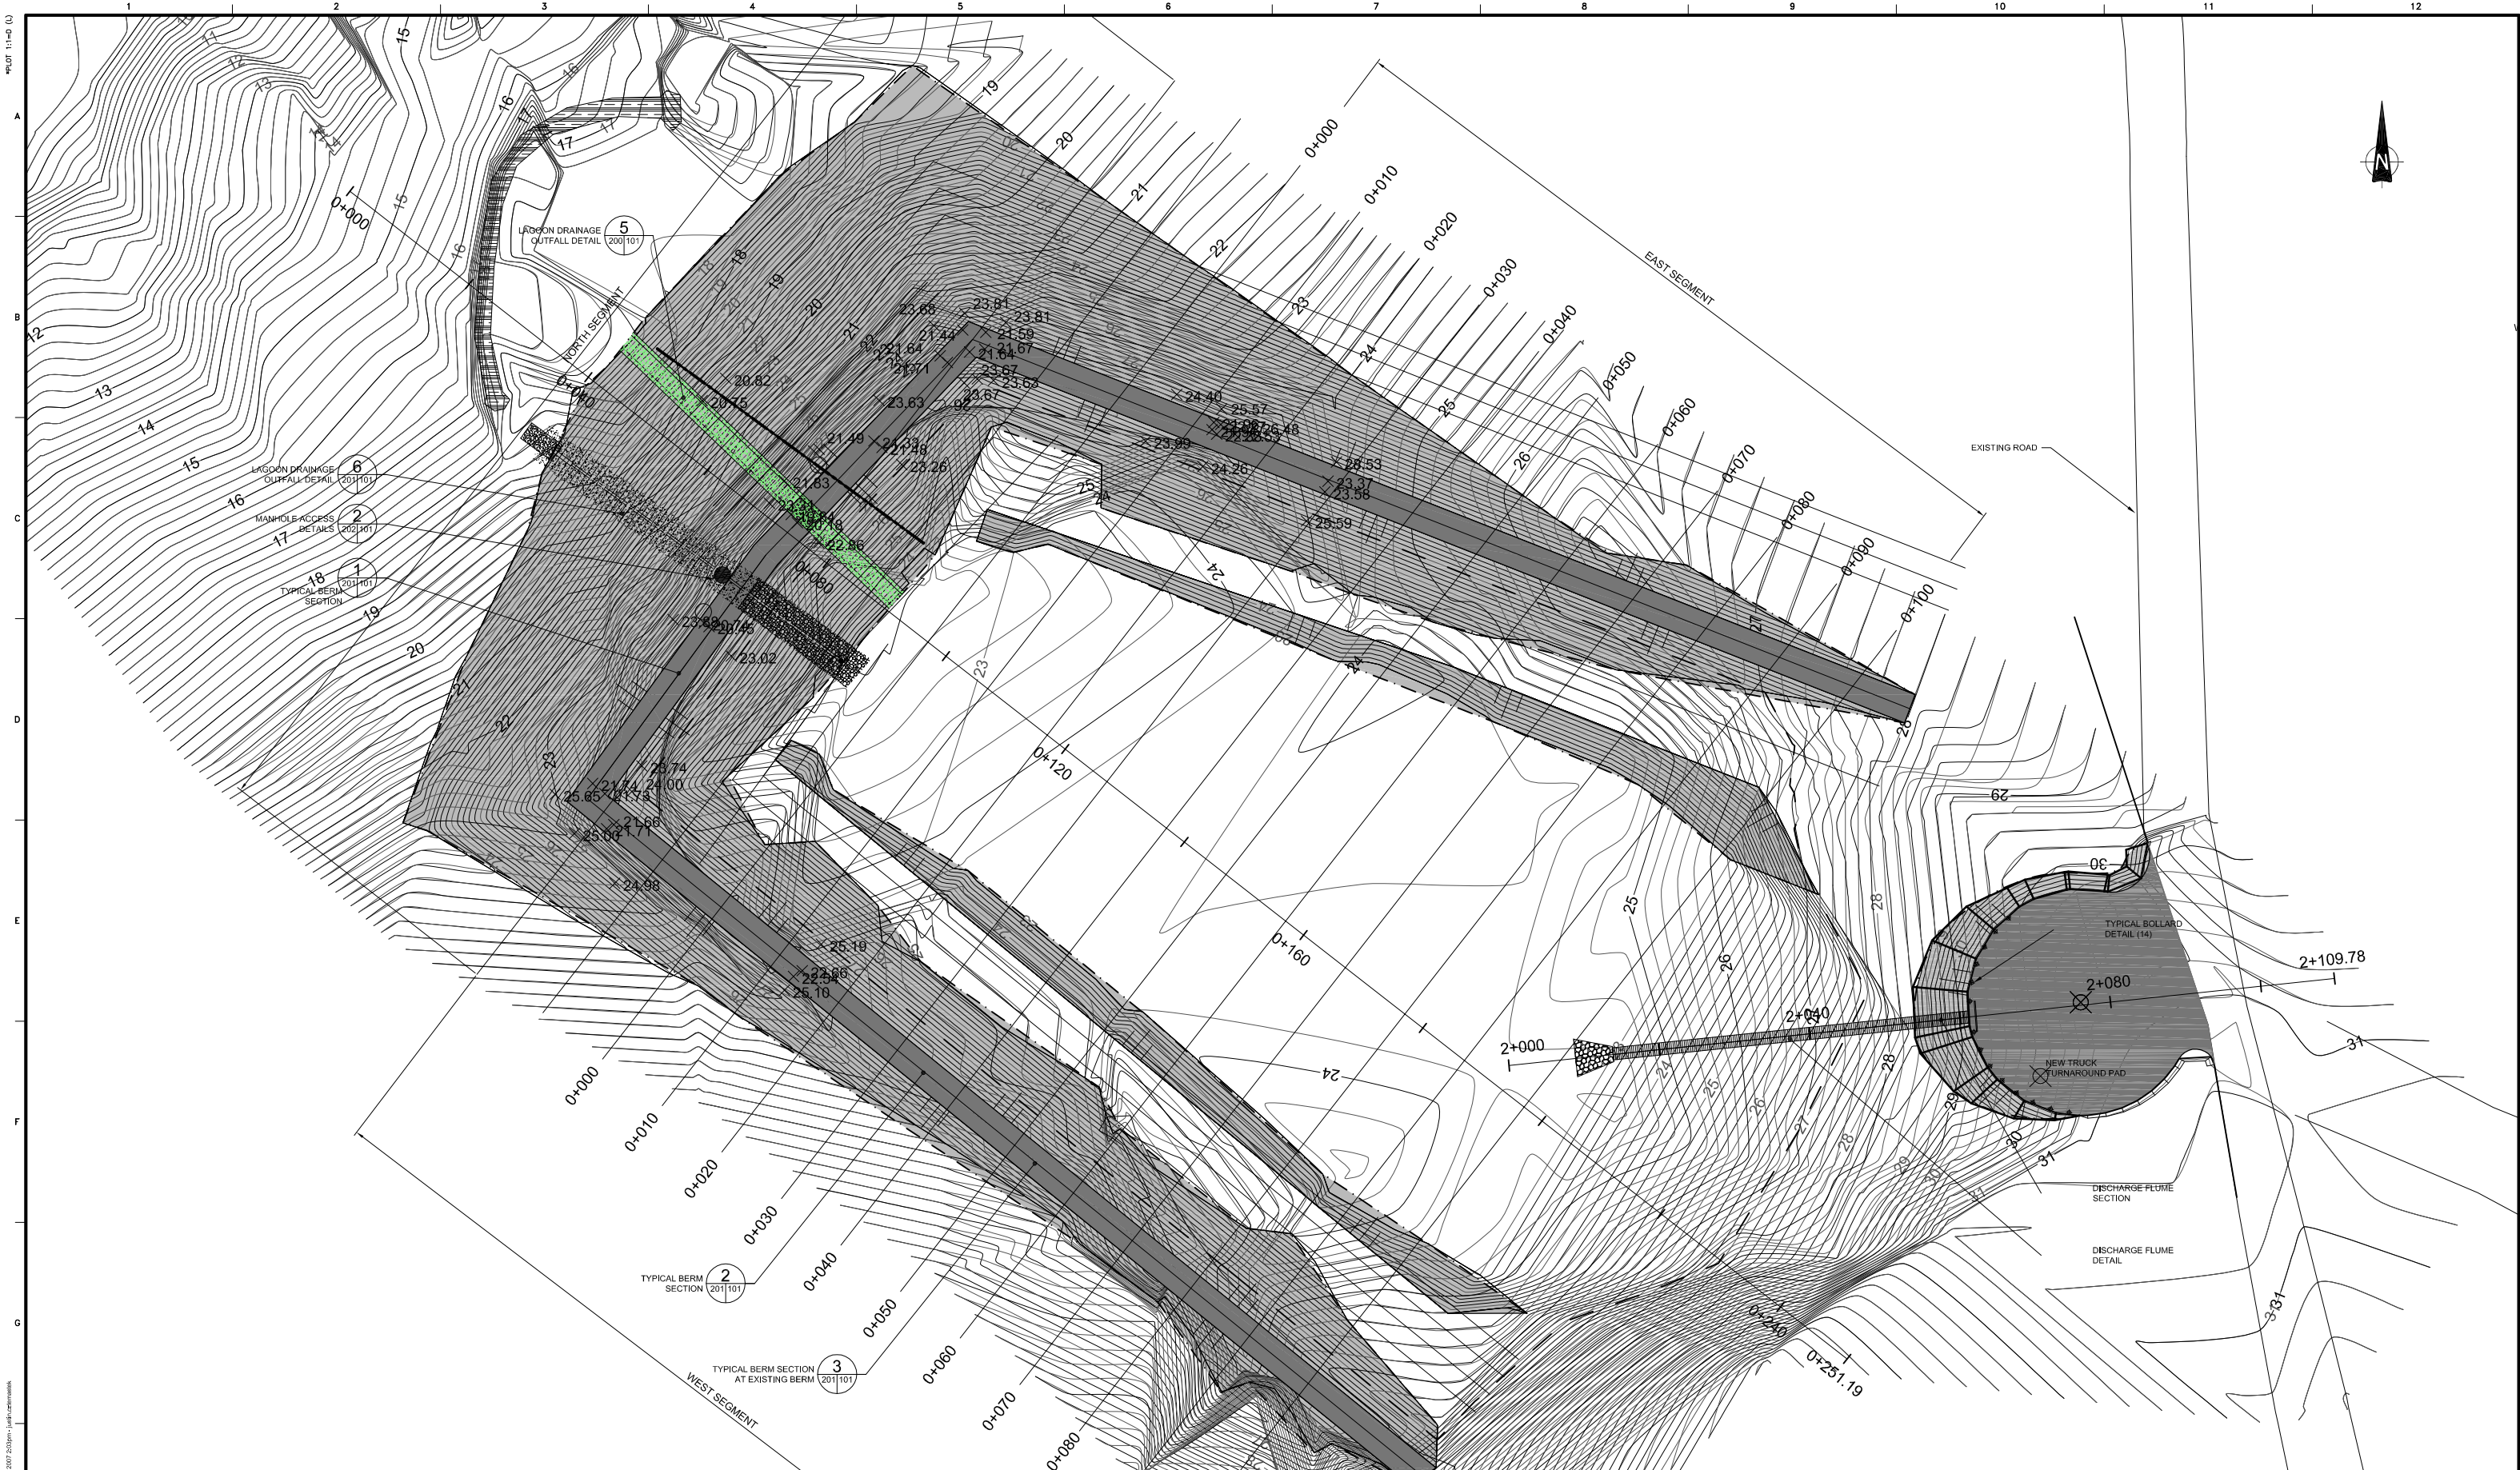
For reporting, description, and visualization purposes, the cut-off trench has been divided into three segments: northern, eastern, and western. Elevations of the cut-off trench alignment prior to the excavation are shown on Figure 2, Appendix A. Elevations of the levelling sand layer (the layer of sand between the exposed bedrock and the installed liner), placed on the trench bottom as well as backfill elevations are presented on Figure 3, Appendix A. It is noted that the actual elevations of the trench bottom are lower than those presented on Figure 3, because most of the observed surveying in the cut-off trench was done following placement of the levelling sand layer, about 0.2 m thick. All of the elevations presented on Figures 2 and 3 were provided by Kudlik personnel.

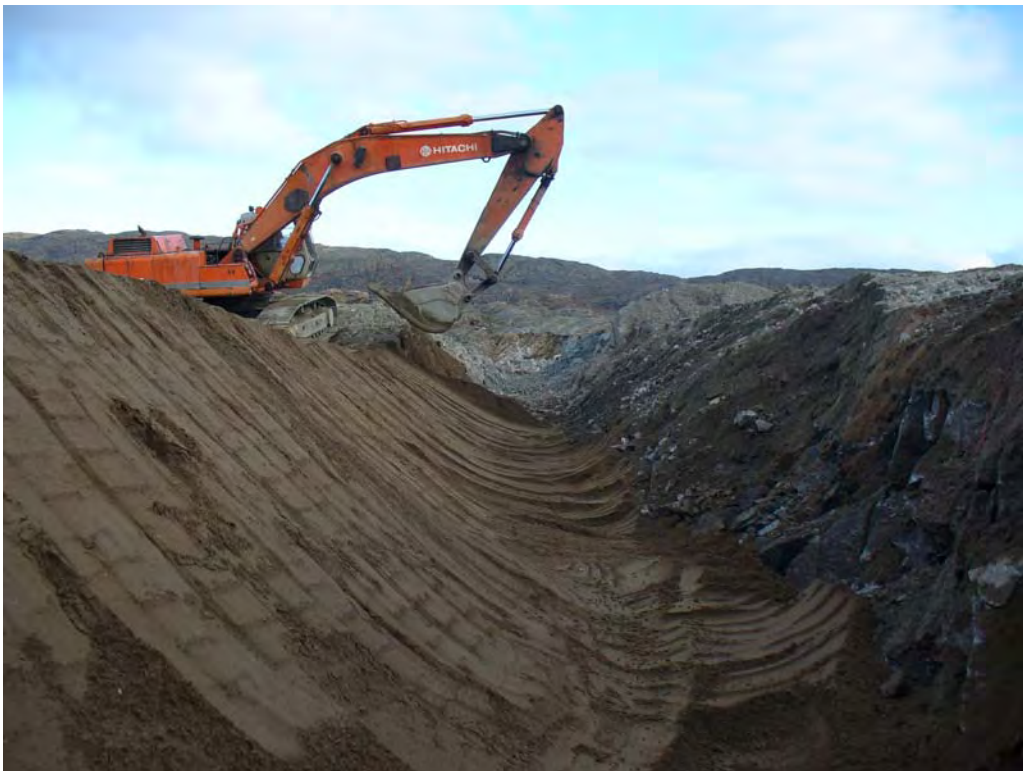
Photograph 4: Excavator placing sand material along trench bottom and slopes.

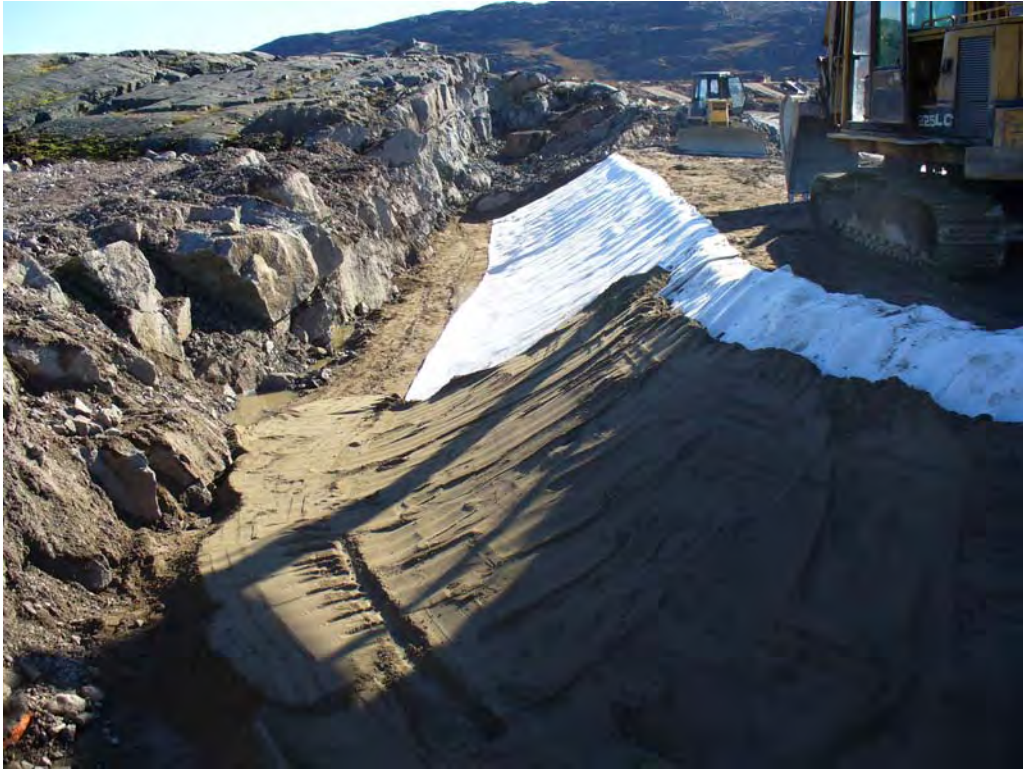
Photograph 5: Placement and backfilling of sand fill atop liner.
