Water Licence 8BC- EUR2131

2023 Annual Report

Eureka High Arctic Weather Station

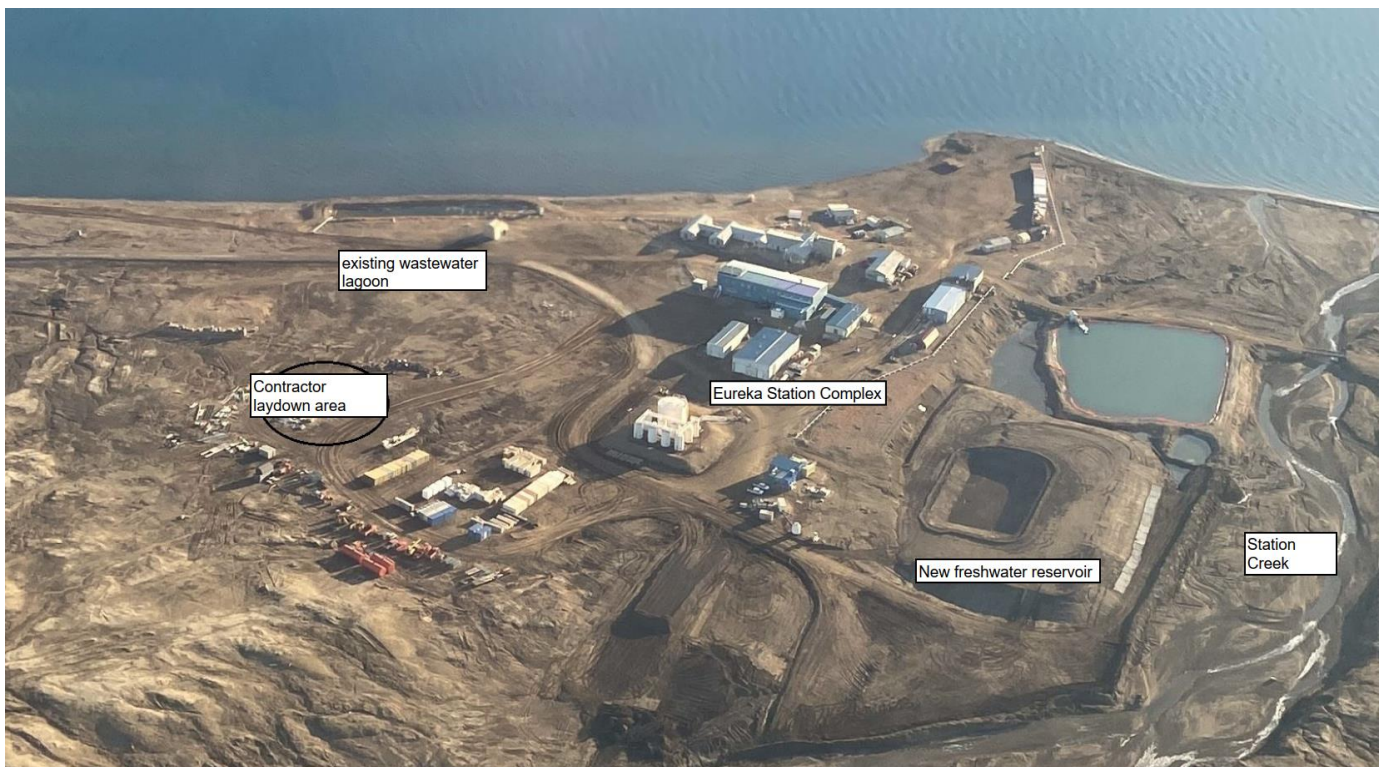
Figure 2 -Photograph of New Freshwater Reservoir

- Completing the earthworks construction of new water reservoir berms (See **Figure 2**).
 - Initiating the construction of a pad, a new Creek Pump house, and Transfer Pump house near Station Creek.

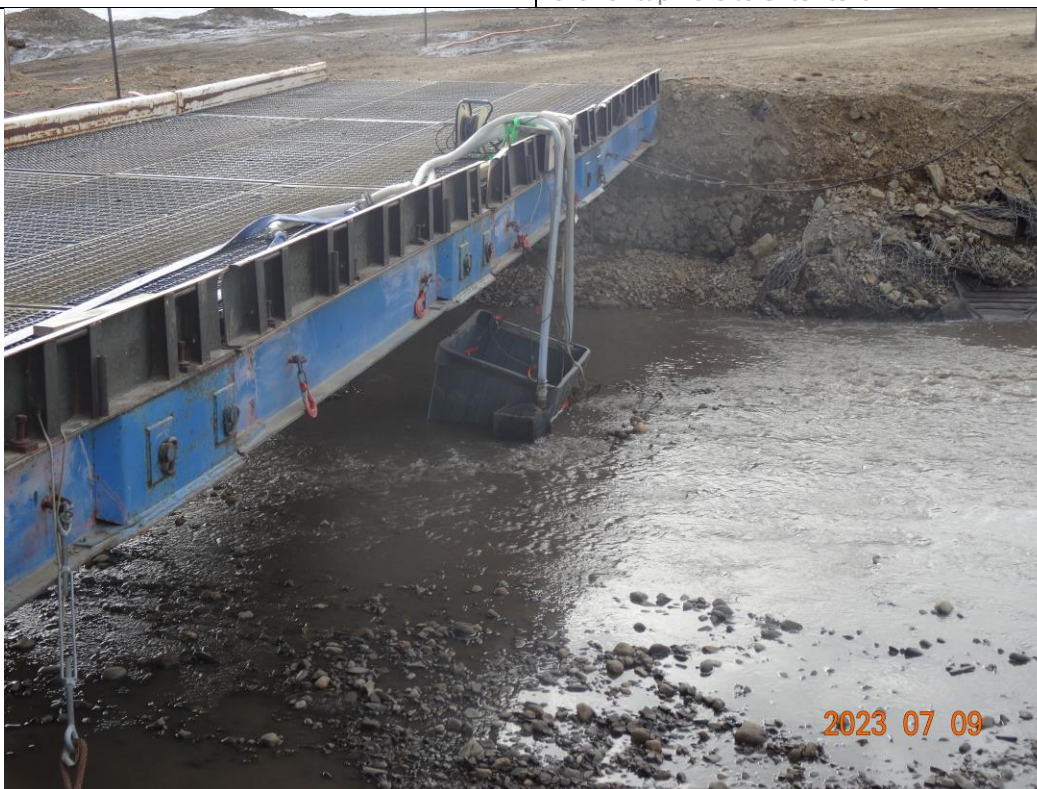
Photo No.
Photo #39

26. Eureka obtains its water for domestic purposes from a bridge at Station Creek. The water is pumped from Station Creek into the water reservoir using a submersible pump placed inside a milk crate covered with fine mesh in order to reduce the transfer of silt and potentially fish from the creek to the reservoir. (Photo #39 and #40)

Raw water intake at Station creek.

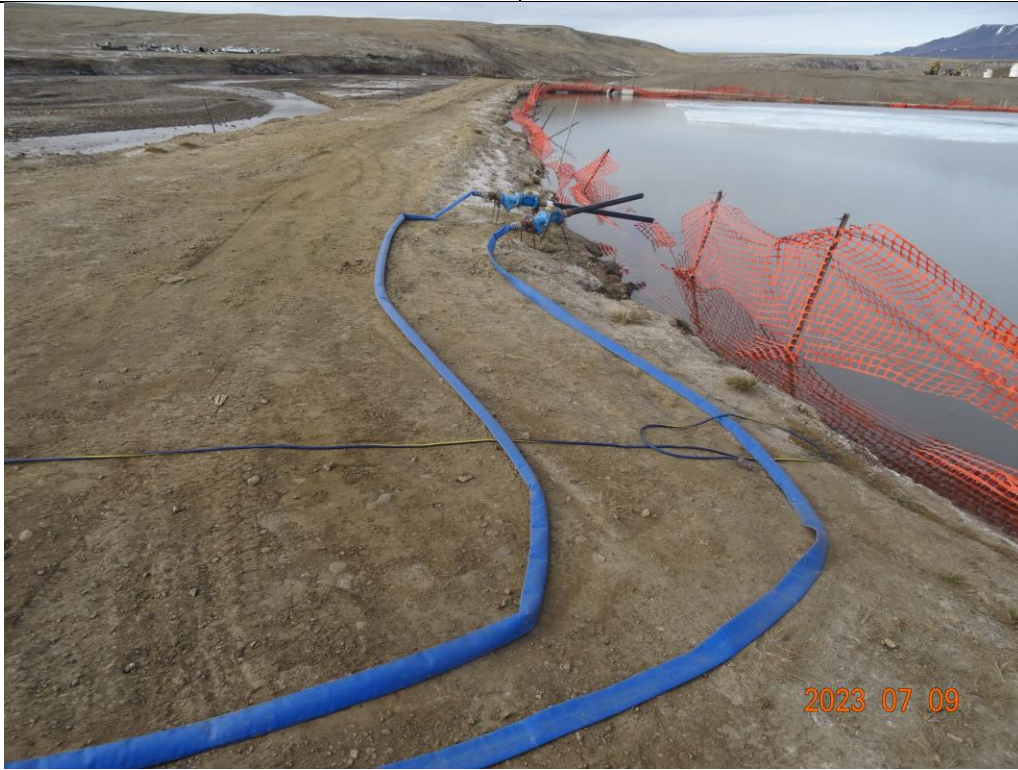
Photo No.
Photo #40

Raw water pumped from station creek to the water reservoir.

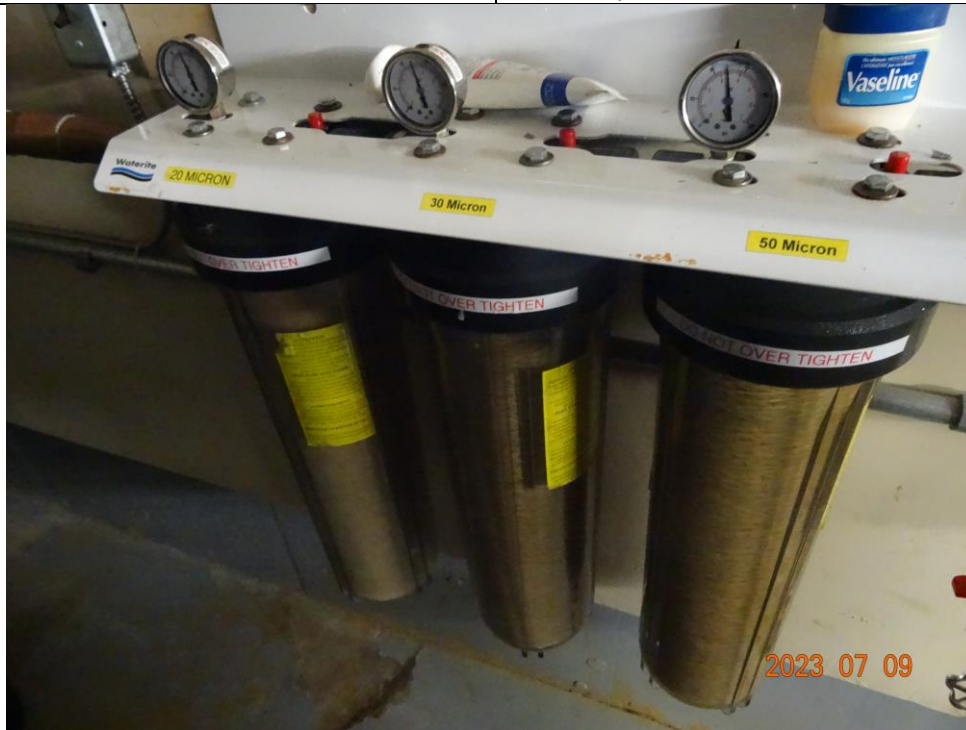
Photo No.
Photo #44

Various size micron filters are also used to help treat the water.
