## APPENDIX A2 SOUTH CAMP DIKE PHOTOGRAPHIC LOG

## **Bay-Goose Dike Photographic Log and Record of Inspection**

**2017 ANNUAL GEOTECHNICAL INSPECTION  
MEADOWBANK GOLD MINE, NUNAVUT**

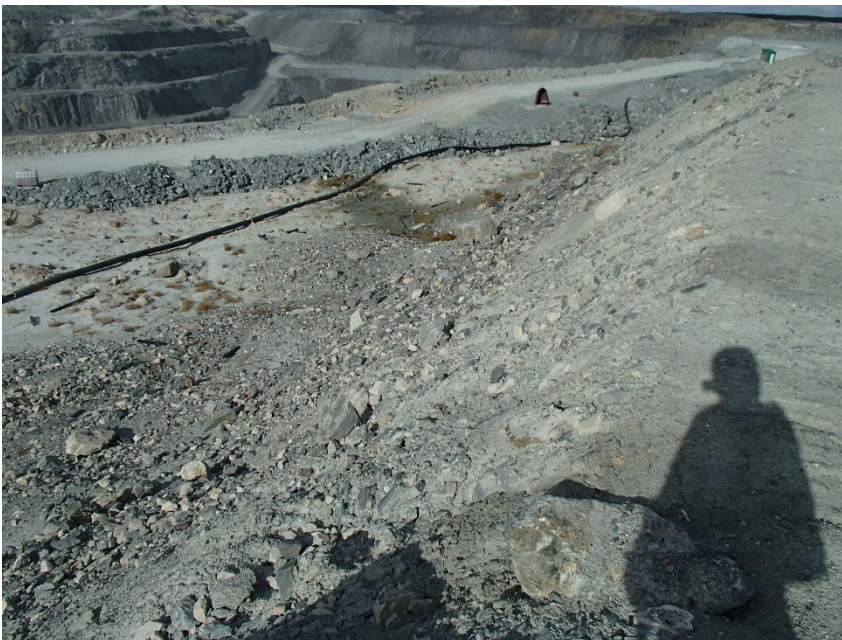
*Photograph A3-6 Bay Goose Dike*

| INSPECTION ITEM | OBSERVATIONS DATA | PHOTO | COMMENTS & OTHER DATA |
|---|---|---|---|
| | North Channel | 325, 329 | Monitored by stations 8 (30+420) and 9 (30+380). Water flowing was observed during the inspection. |

**Description:** From approximately Sta. 30+325 downstream, looking southwest at the North Channel.

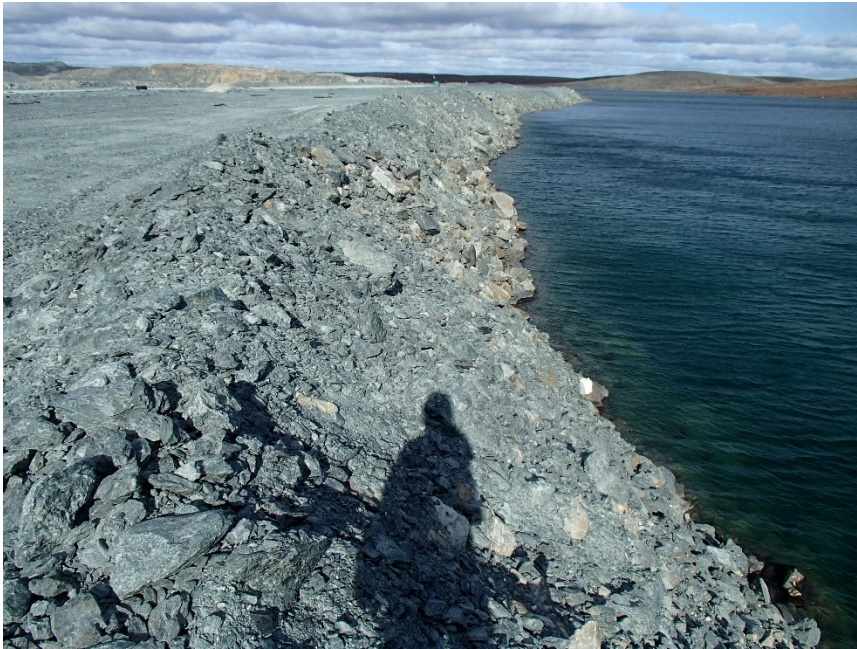
*Photograph A3-7 Bay Goose Dike*

**Description:** From Sta. 30+500, looking northeast at the crest and the upstream slope.

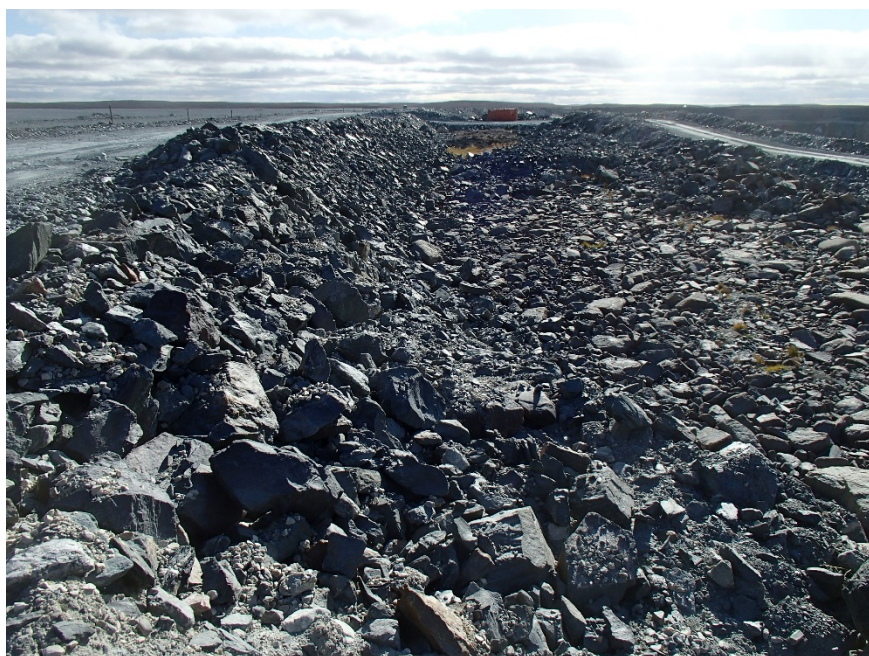
*Photograph A3-13 Bay Goose Dike*

**Description:** From approximately Sta. 30+680 on the crest, looking south at the downstream slope and toe.

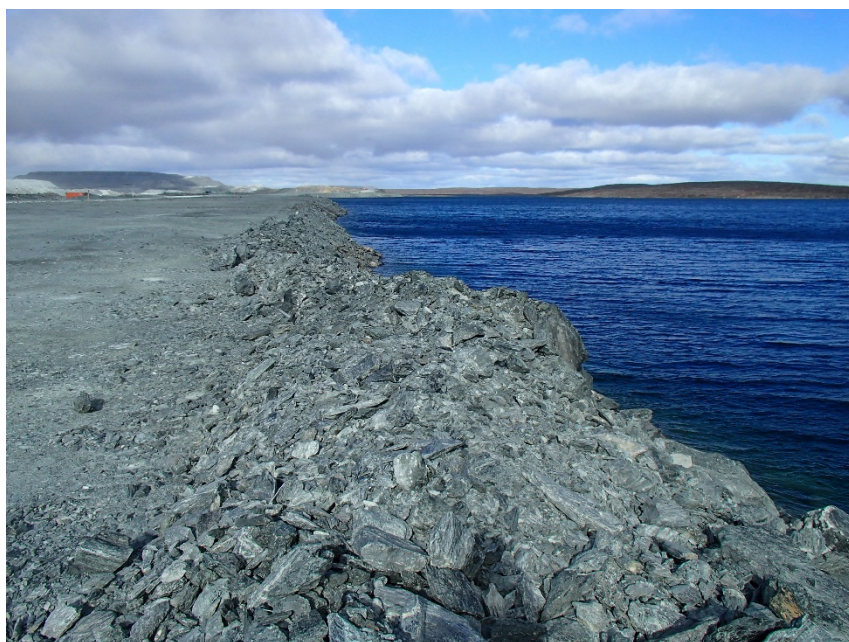
*Photograph A3-15 Bay Goose Dike*

**Description:** From approximately Sta. 31+130, looking north at the crest and upstream slope.

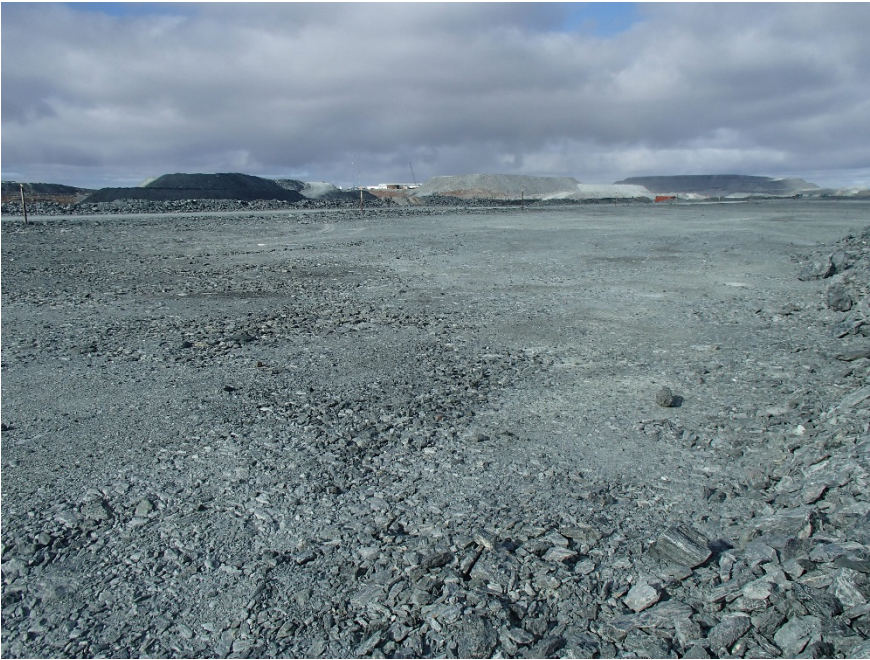
*Photograph A3-19 Bay Goose Dike*

**Description:** From approximately Sta. 31+130, looking north at the crest.
