2017 ANNUAL GEOTECHNICAL INSPECTION
MEADOWBANK GOLD MINE, NUNAVUT

APPENDIX A4 RECORD OF DAM INSPECTION

Client: AEM **By:** Yves Boulianne
Project: Meadowbank **Date:** September 8, 2017
Location: Vault Dike **Reviewed:** Yves Boulianne

APPENDIX A4 VAULT DIKE PHOTOGRAPHIC LOG

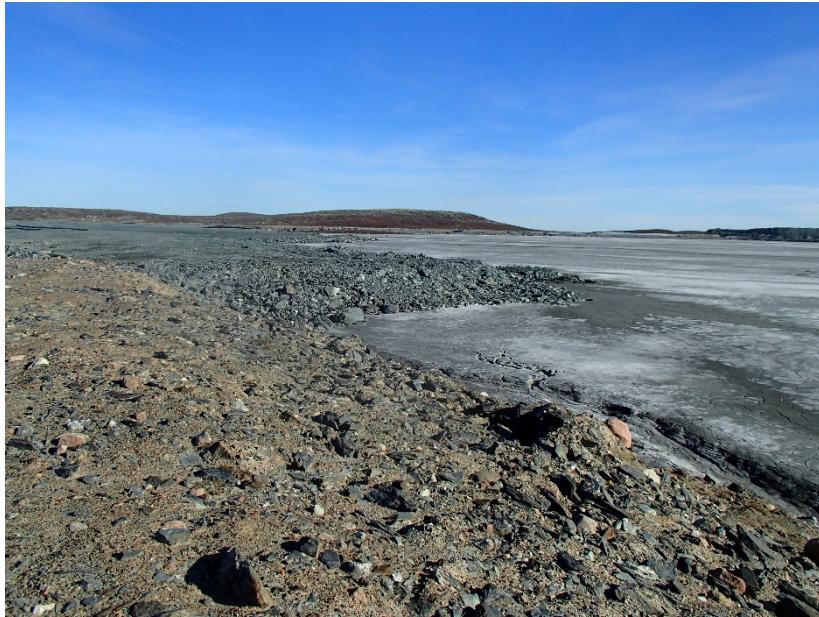
Photograph B1-5 Tailings Storage Facility

Description: From the western diversion ditch, looking northeast toward the North Cell.

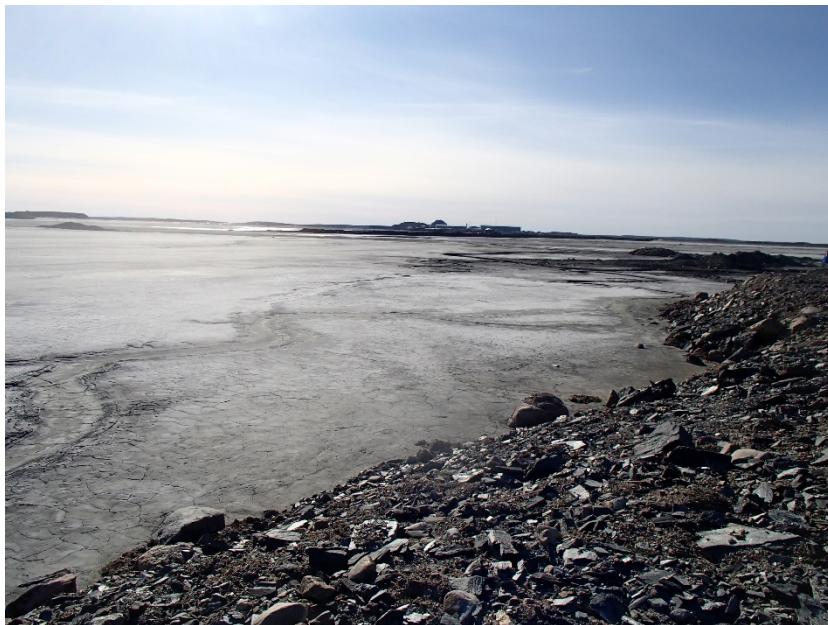
Photograph B1-7 Tailings Storage Facility

Description: From the western diversion ditch, looking southeast toward the North Cell.

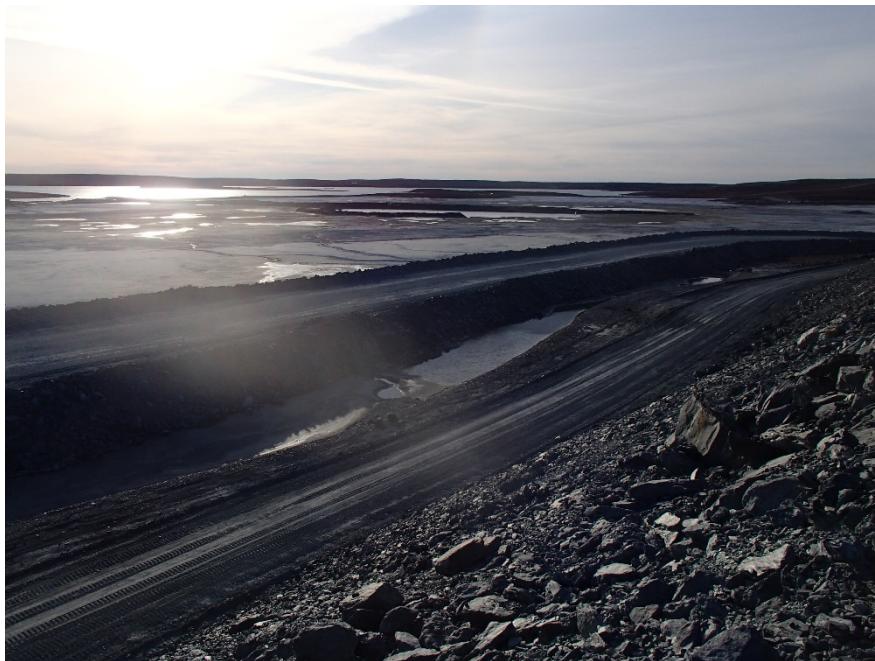
Photograph B1-9 Tailings Storage Facility

Description: From the RSF looking west at RF1 and the North Cell toward Saddle Dam 2. View of the 2016 North Cell capping.

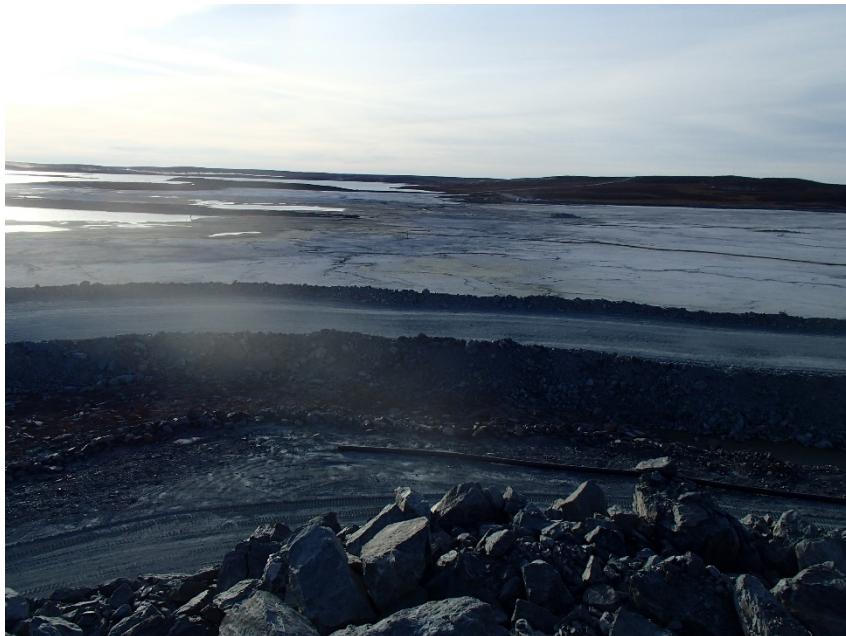
Photograph B1-11 Tailings Storage Facility

Description: From the RSF looking southwest at RF1 and the North Cell.

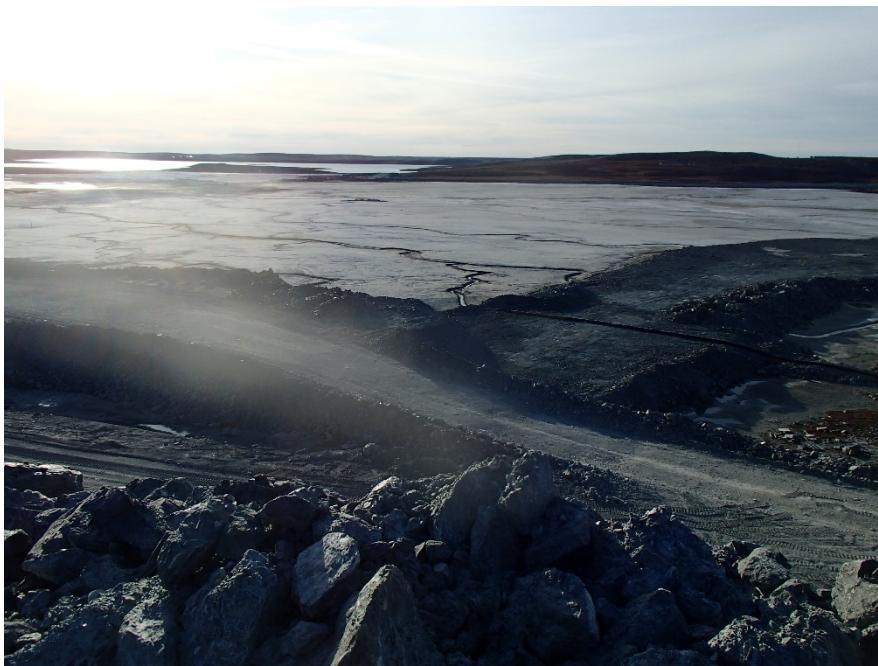
Photograph B1-13 Tailings Storage Facility

Description: From the RSF looking southwest at RF2 and the North Cell. View of the 2016 capping.

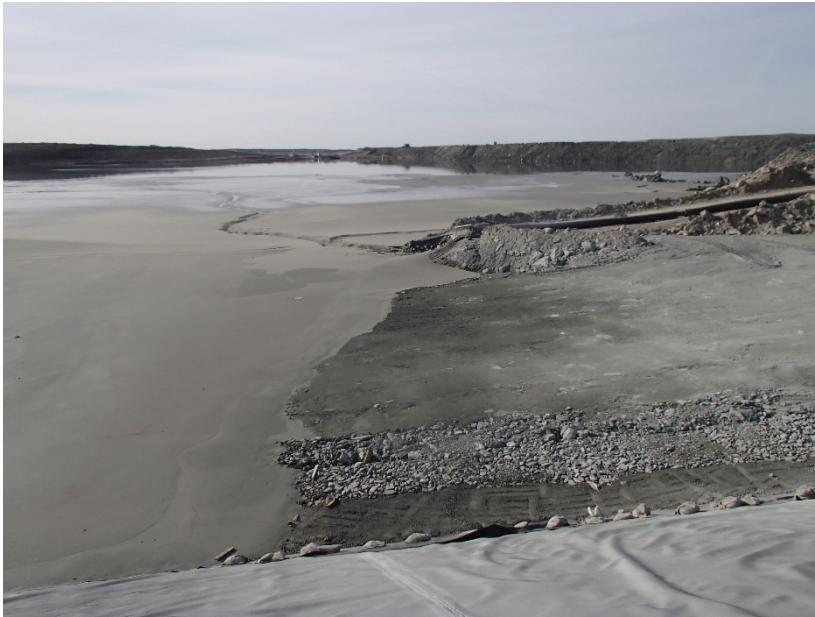
Photograph B1-15 Tailings Storage Facility

Description: From the northern abutment of Central Dike, looking west at the South Cell.

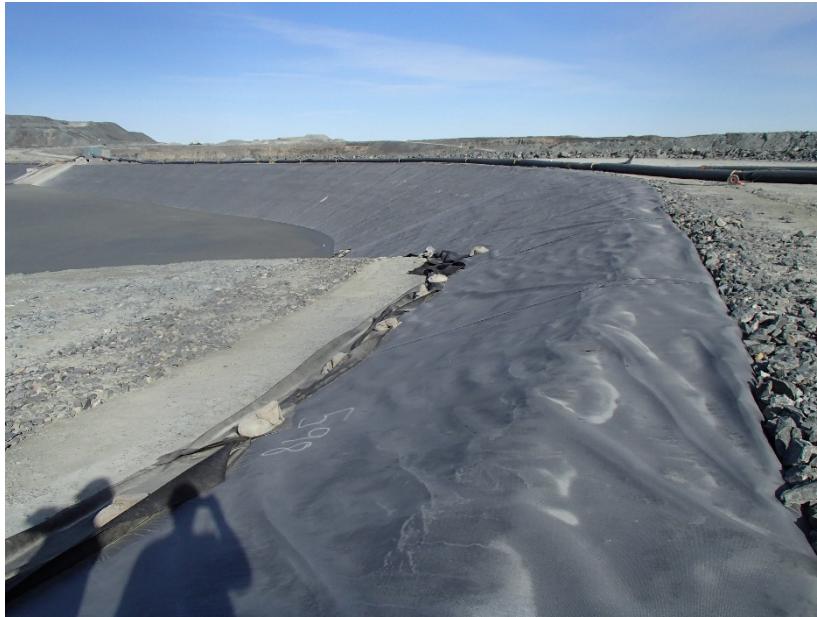
Photograph B1-19 Tailings Storage Facility

Description: From Central Dike looking north at Central Dike and the South Cell.
