## APPENDIX B5 SADDLE DAM 2 PHOTOGRAPHIC LOG

2017 ANNUAL GEOTECHNICAL INSPECTION  
MEADOWBANK GOLD MINE, NUNAVUT

## APPENDIX B6 RECORD OF DAM INSPECTION

**Client:** AEM **By:** Yves Boulianne  
**Project:** Meadowbank **Date:** September 13, 2017  
**Location:** Saddle Dam 4 **Reviewed:** Yves Boulianne

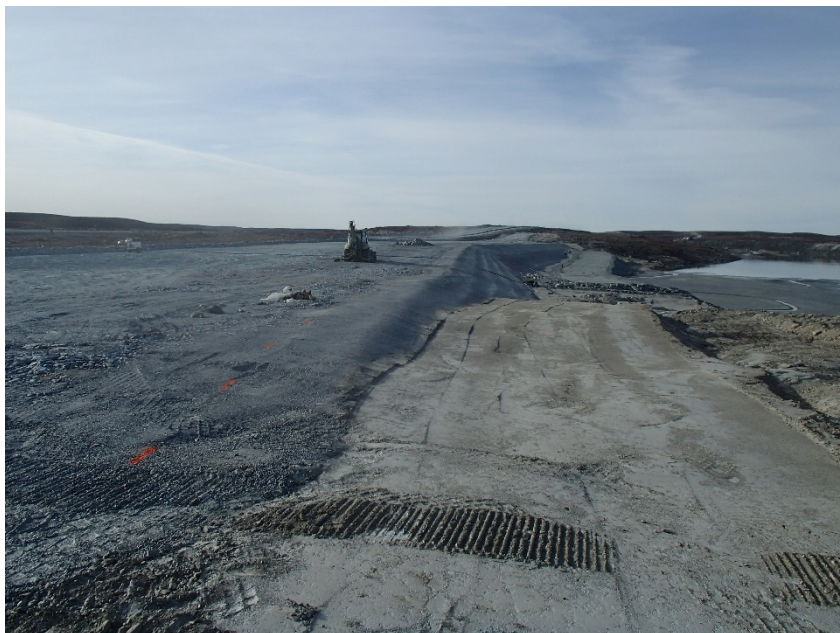
*Photograph B6-1 Saddle Dam 4*

**Description:** From 40+200 approximately, looking northwest at the upstream slope.

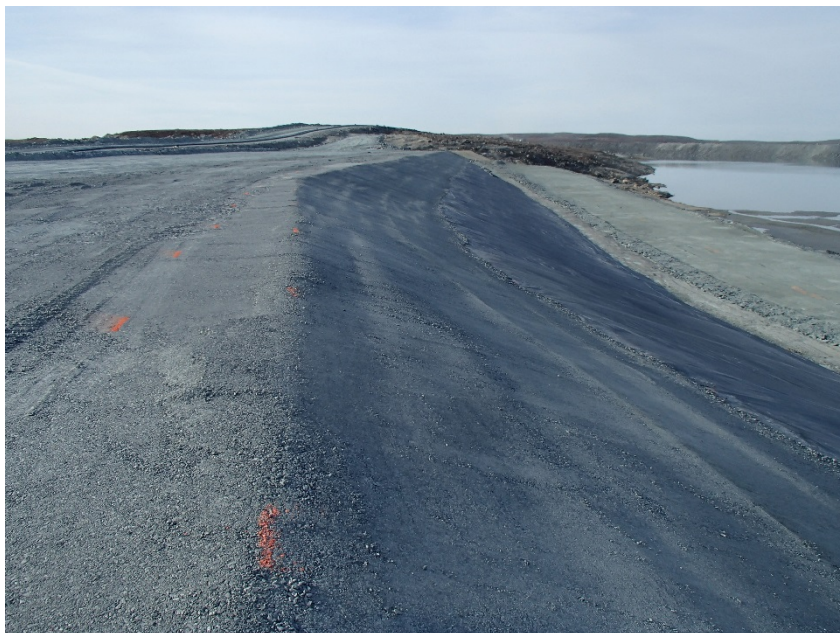
*Photograph B6-3 Saddle Dam 4*

**Description:** From 40+250 approximately, looking northwest at the crest and the upstream slope.

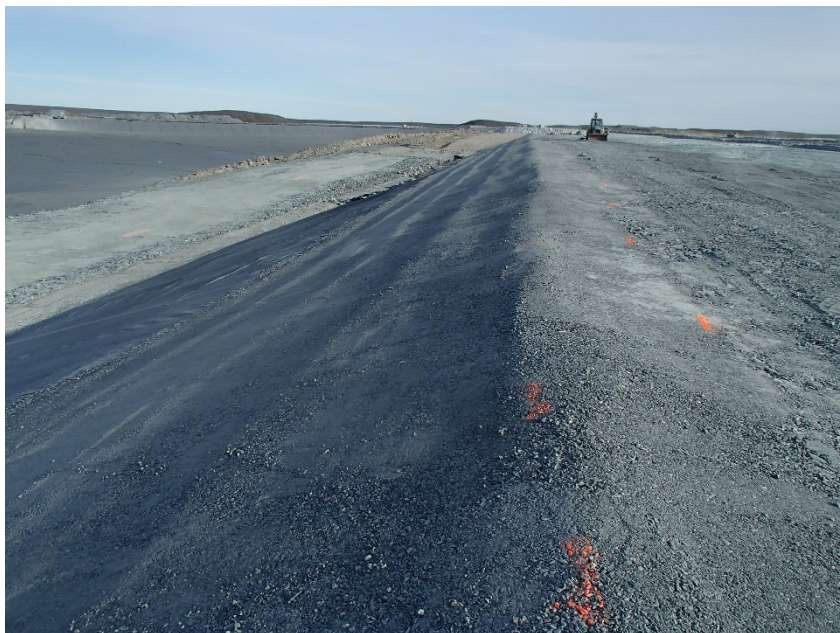
*Photograph B6-5 Saddle Dam 4*

**Description:** From 40+250 approximately, looking southeast at the crest and the upstream slope.

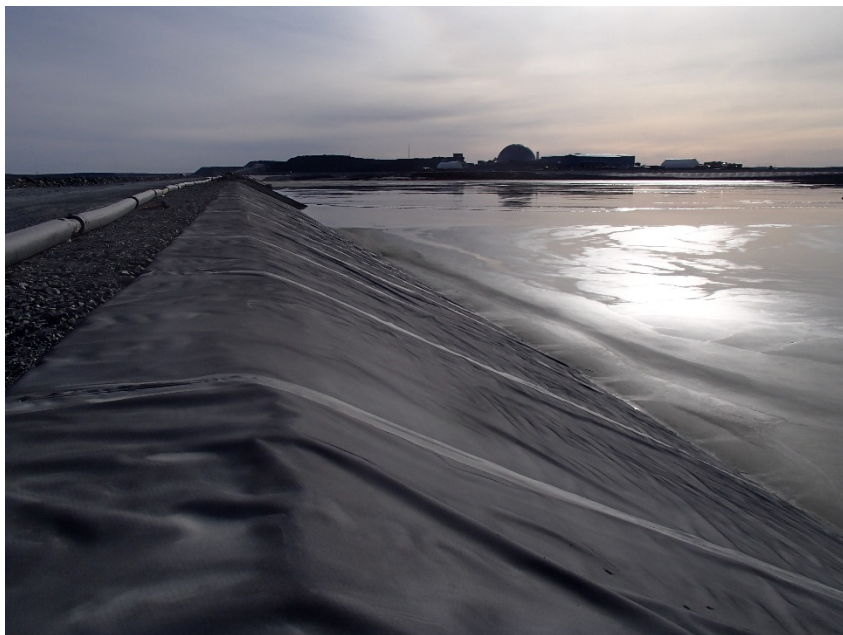
*Photograph B7-1 Central Dike and Saddle Dam 5*

**Description:** From approximately Sta. 0+325 looking southwest. View of the upstream slope of Central Dike.

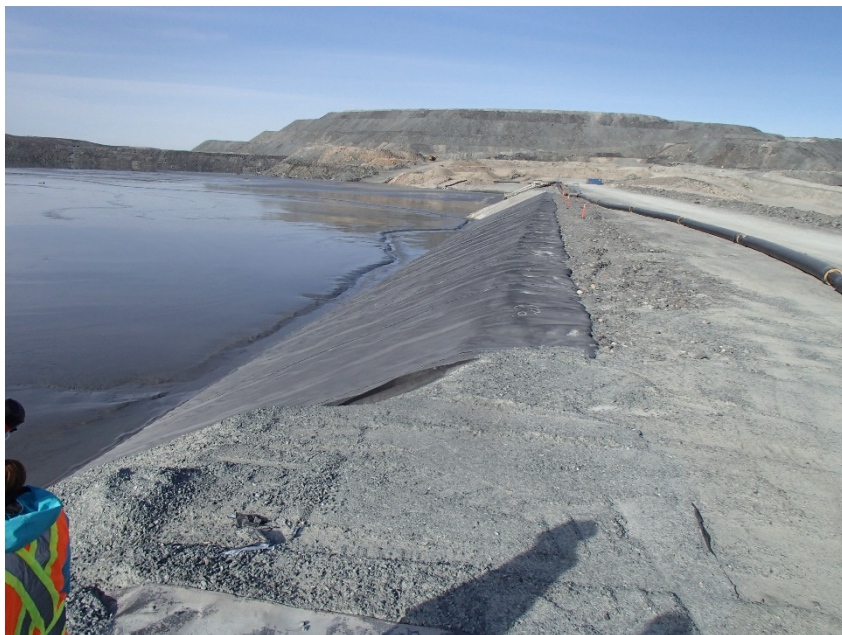
*Photograph B7-5 Central Dike and Saddle Dam 5*

**Description:** From approximately Sta. 0+525 looking northwest at the upstream slope. Adequate tailings beach against the south section of the structure.

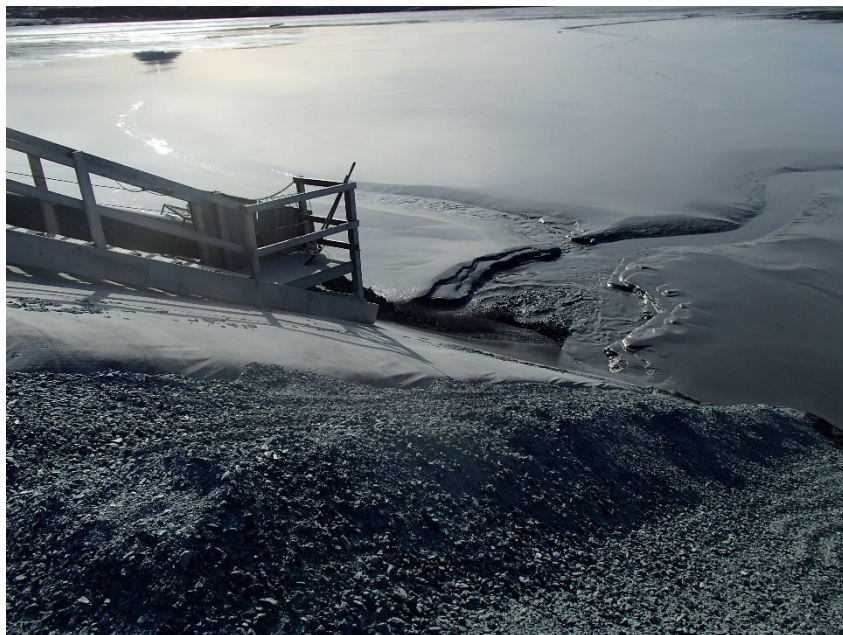
*Photograph B7-7 Central Dike and Saddle Dam 5*

**Description:** From approximately Sta. 0+525 looking at the deposition finger. The LLDPE liner is well protected and the tailing beach against the structure is adequate.

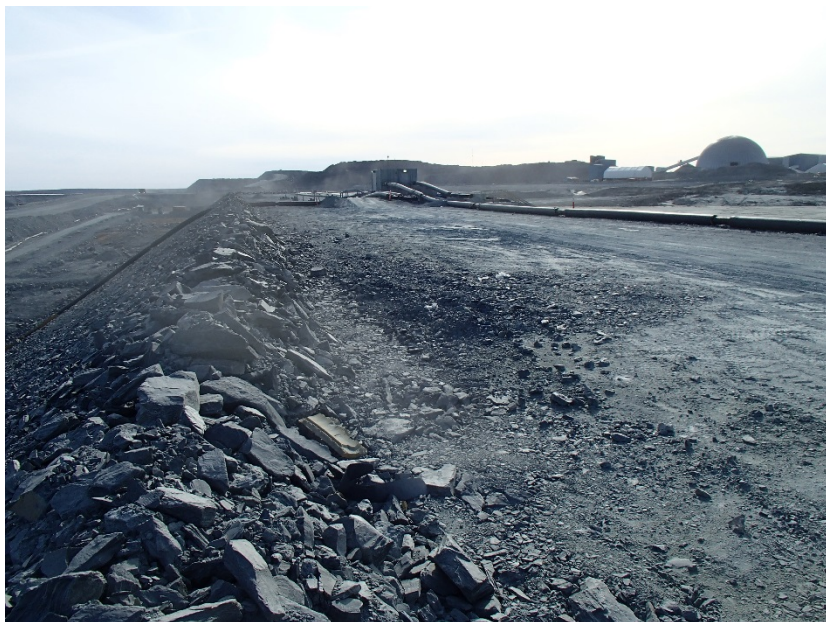
*Photograph B7-11 Central Dike and Saddle Dam 5*

**Description:** From approximately Sta. 0+720 looking south at the crest.

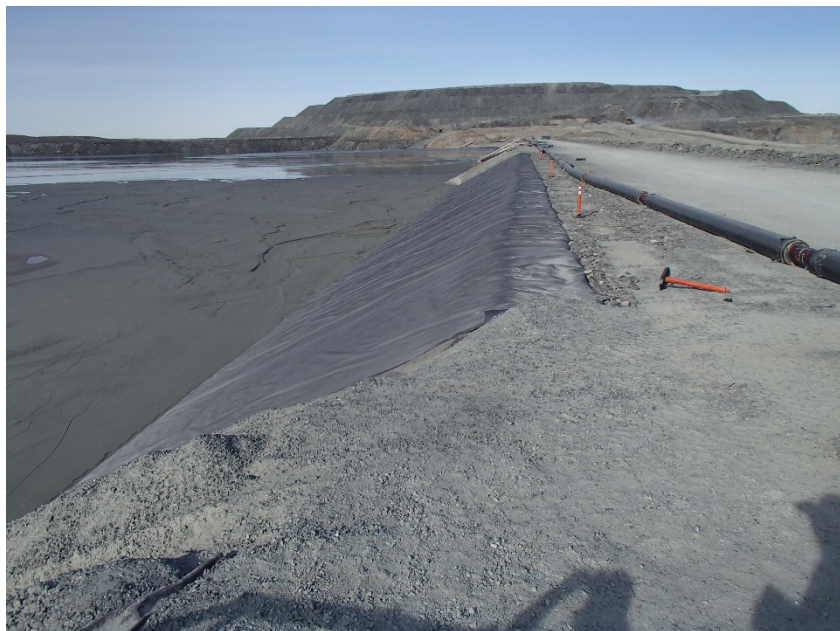
*Photograph B7-13 Central Dike and Saddle Dam 5*

**Description:** From approximately Sta. 0+800 on the crest, looking northwest at the upstream slope.

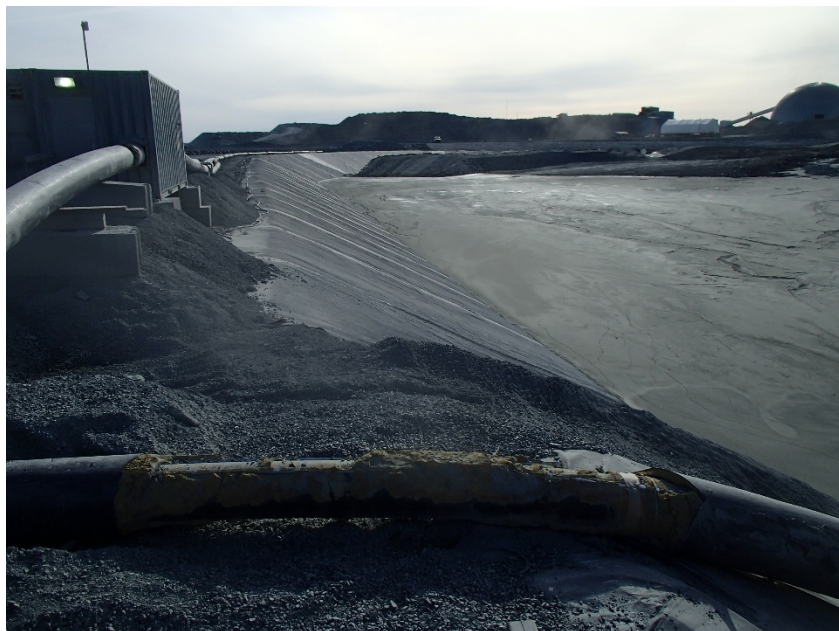
*Photograph B7-15 Central Dike and Saddle Dam 5*

**Description:** From approximately Sta. 0+800 on the crest, looking south at the upstream slope and a tailings deposition finger
