2017 ANNUAL GEOTECHNICAL INSPECTION
MEADOWBANK GOLD MINE, NUNAVUT

APPENDIX C3

TSF North Cell Instrumentation Data

**MDRB # 22
P3 – STORMWATER DIKE
UPDATE**

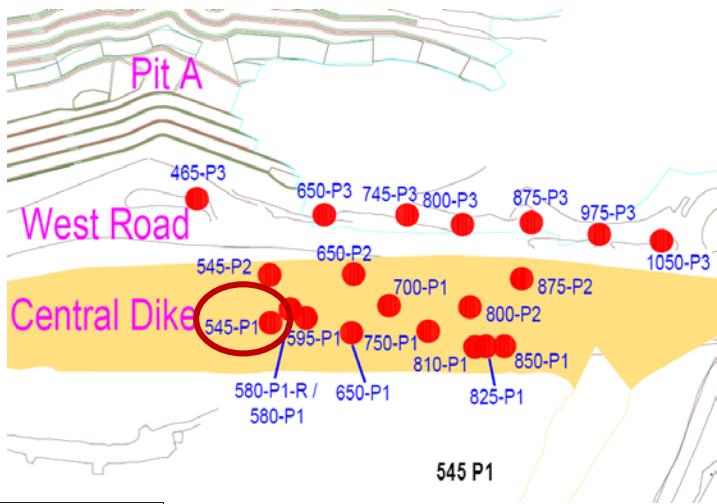
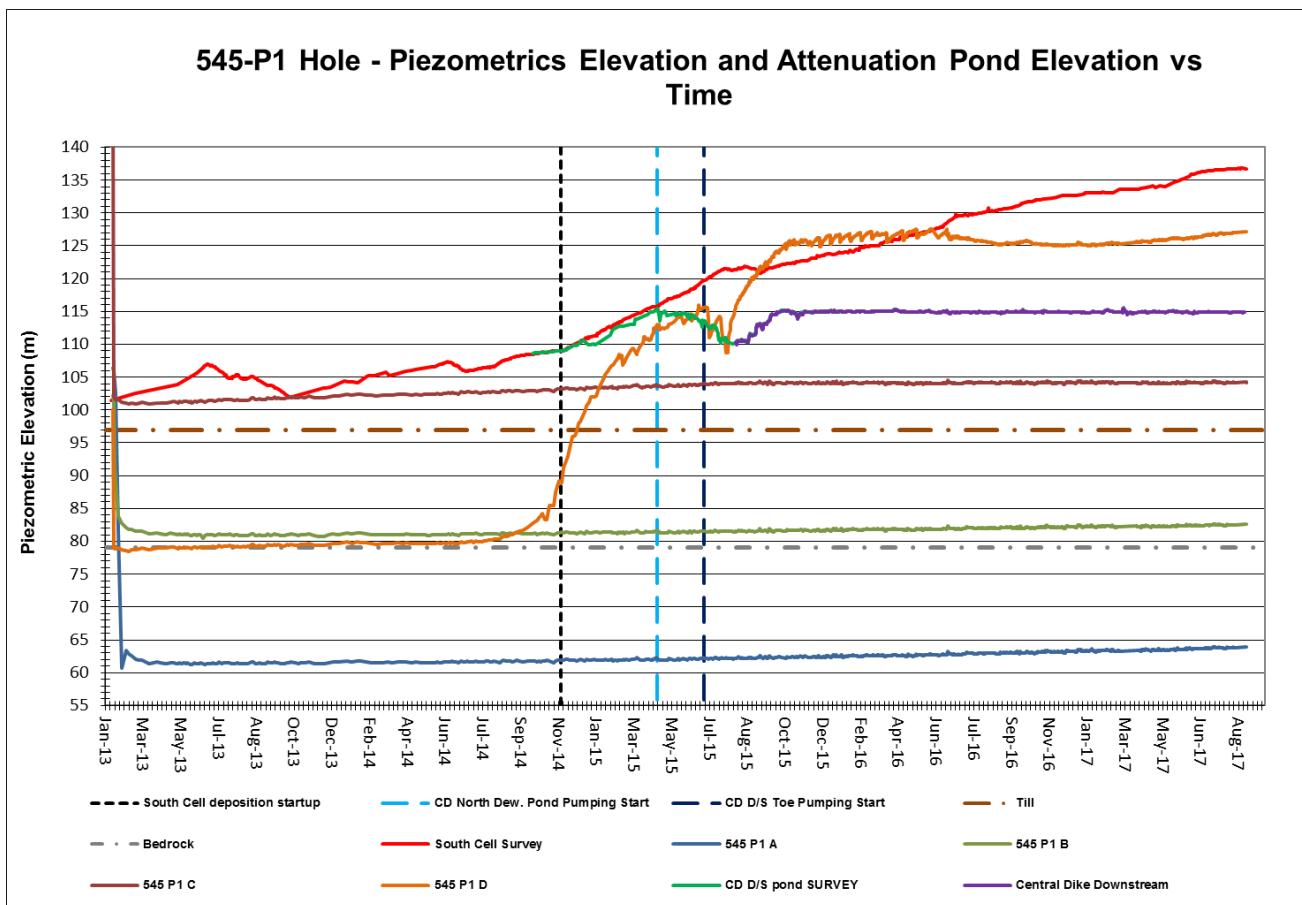
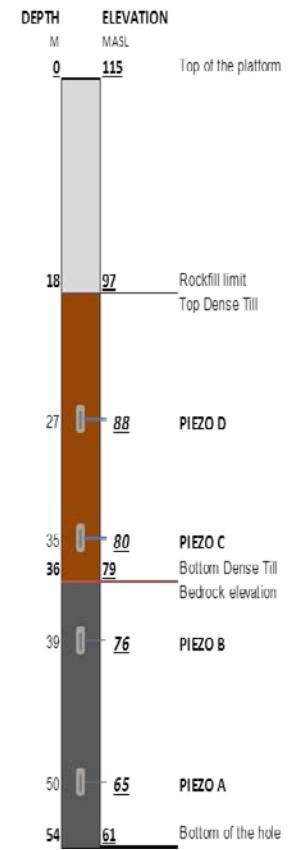
PIEZOMETER 545-P1

- Piezometer D still constant, no change since August 2015
- Piezometer A is recording suction since its installation
- Identification of the piezo on the field is confusing.
Interpretation of the readings must be done with precaution.

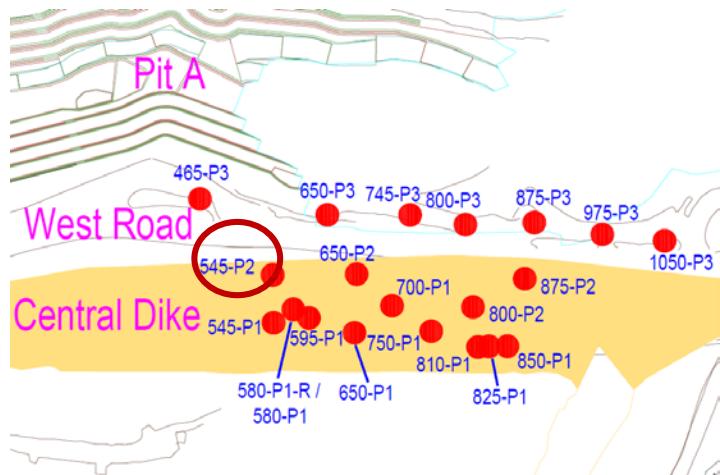
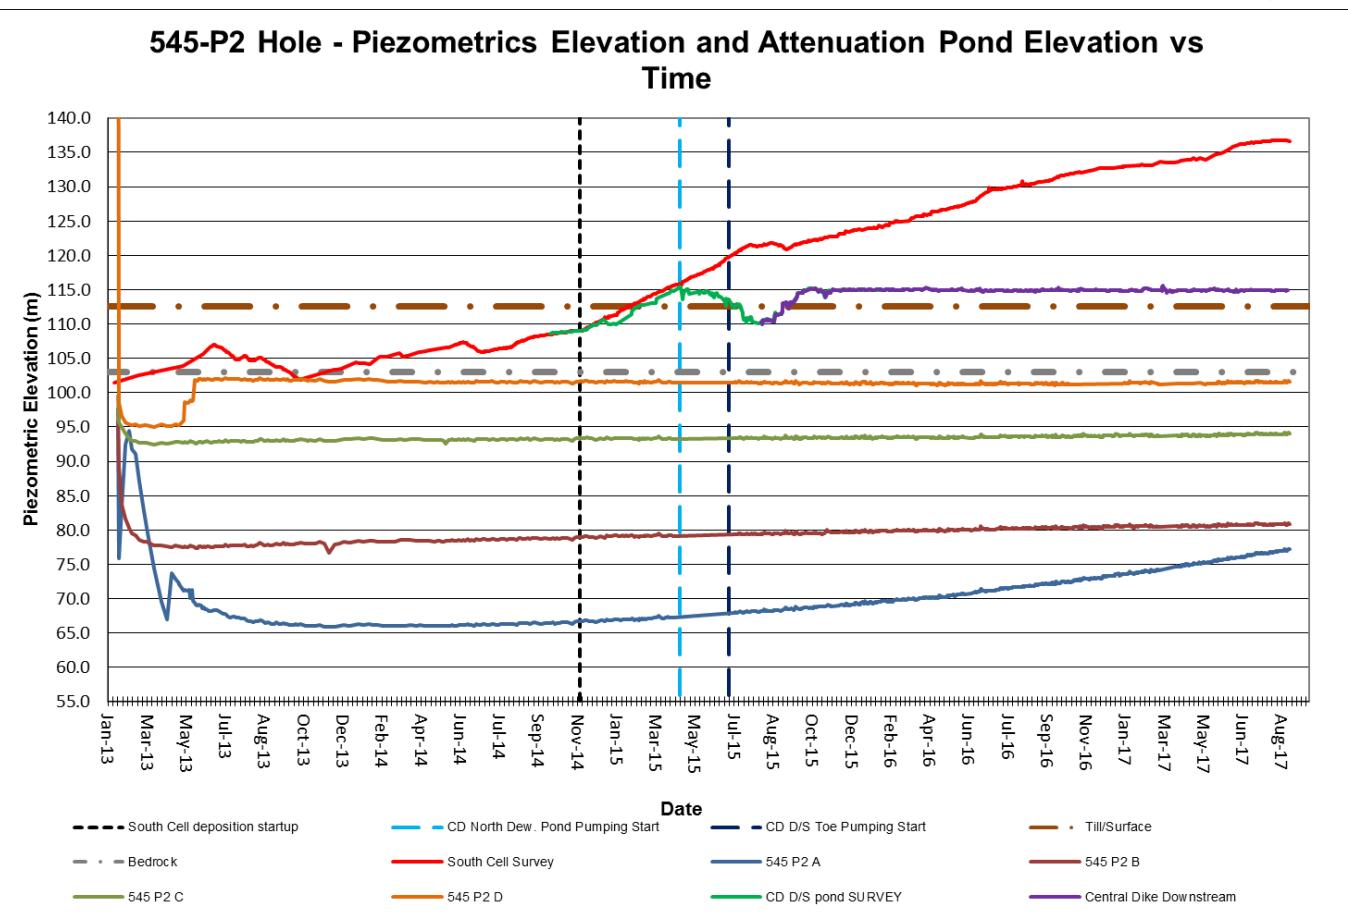
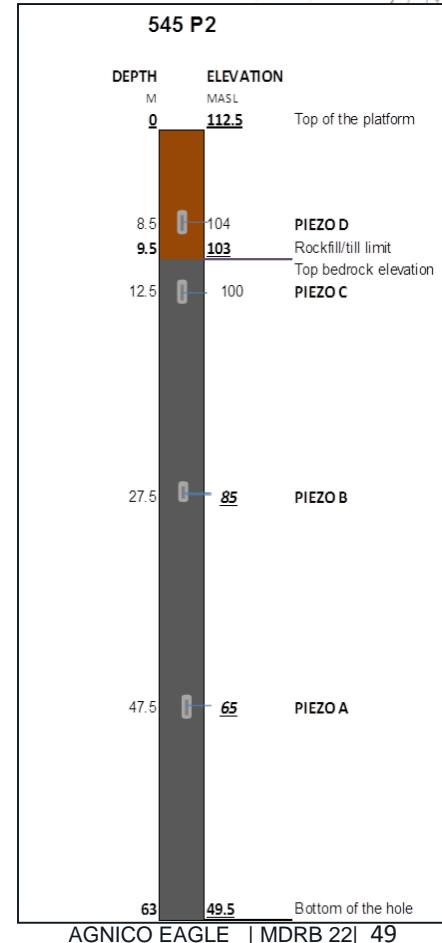
PIEZOMETER 545-P2

- Piezometer A reading is increasing with South Cell level
- Other piezometers are recording suction

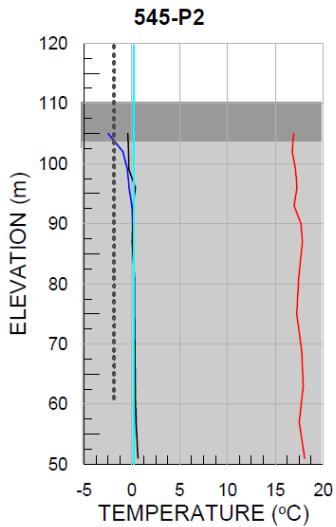
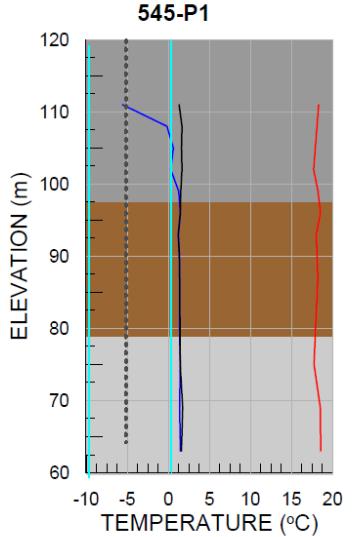
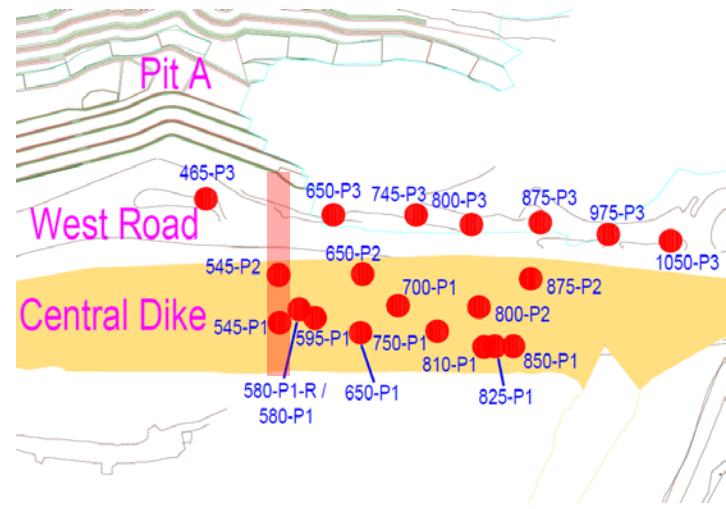
THERMISTOR READINGS FROM AUGUST 2015 - 2016

Max temperature in 2015-2016 was more around 2°C

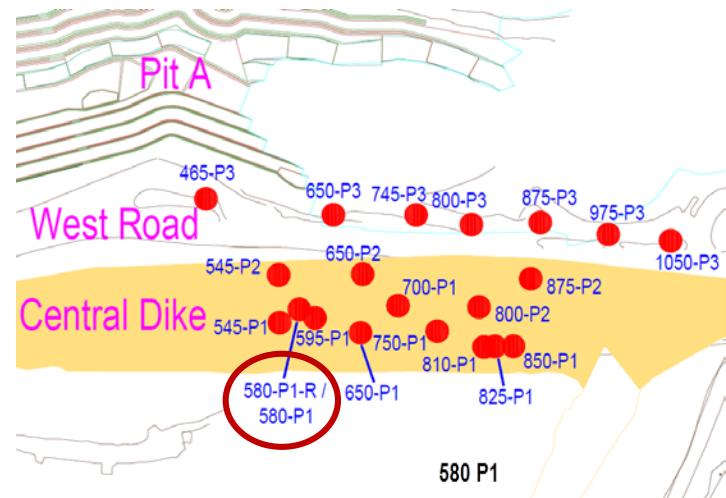
580-P1

- Piezometer and thermistance readings are not functional since July 2016
- Replacement hole 580-P1R drilled during 2017 campaign

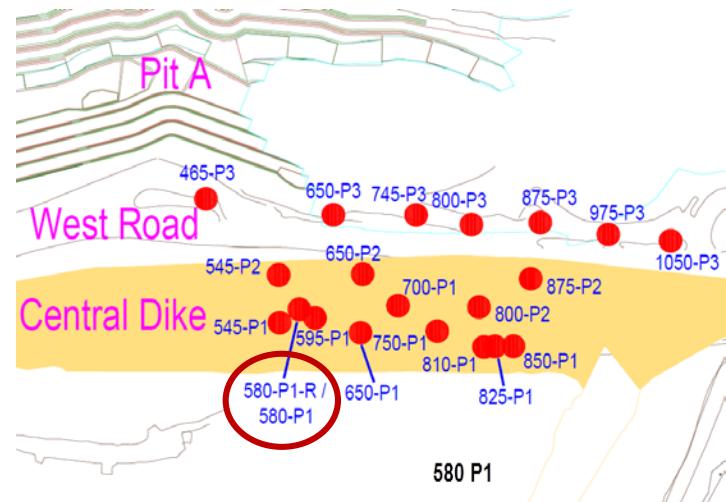
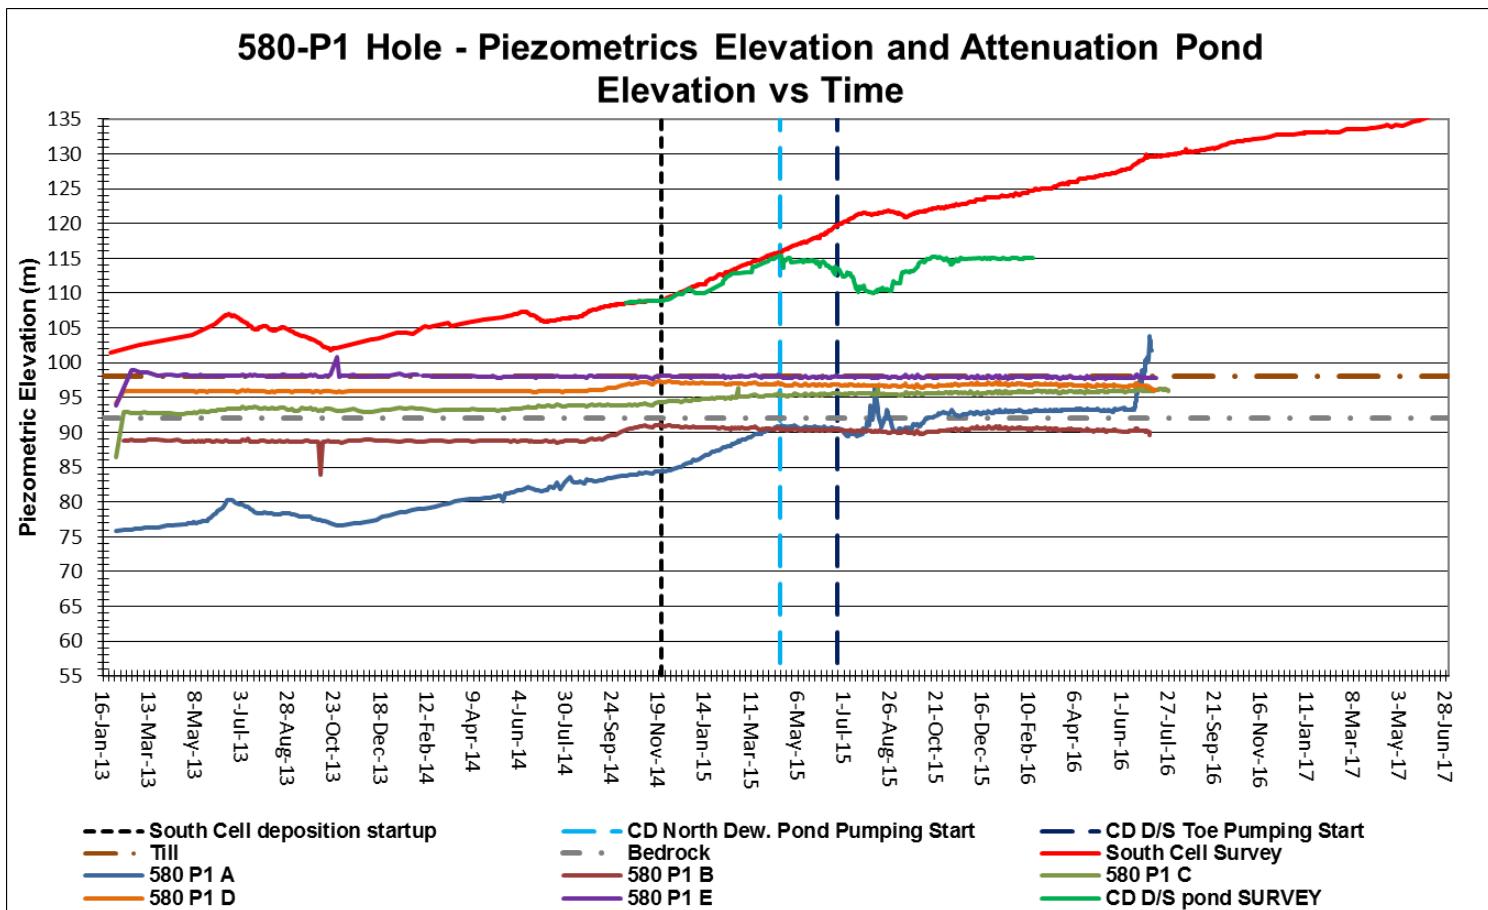
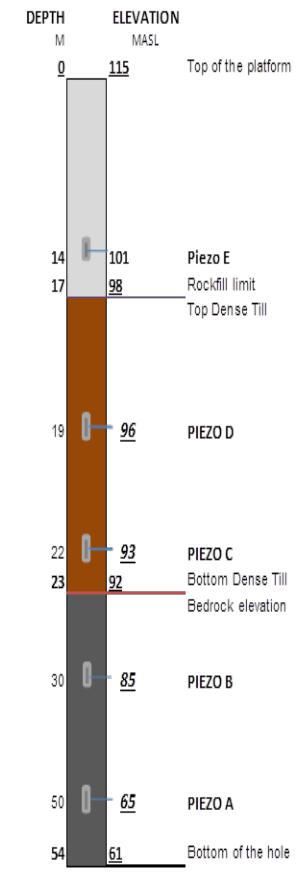
580-P1

- Piezometer and thermistor readings are not functional since July 2016
- Replacement hole 580-P1R drilled during 2017 campaign

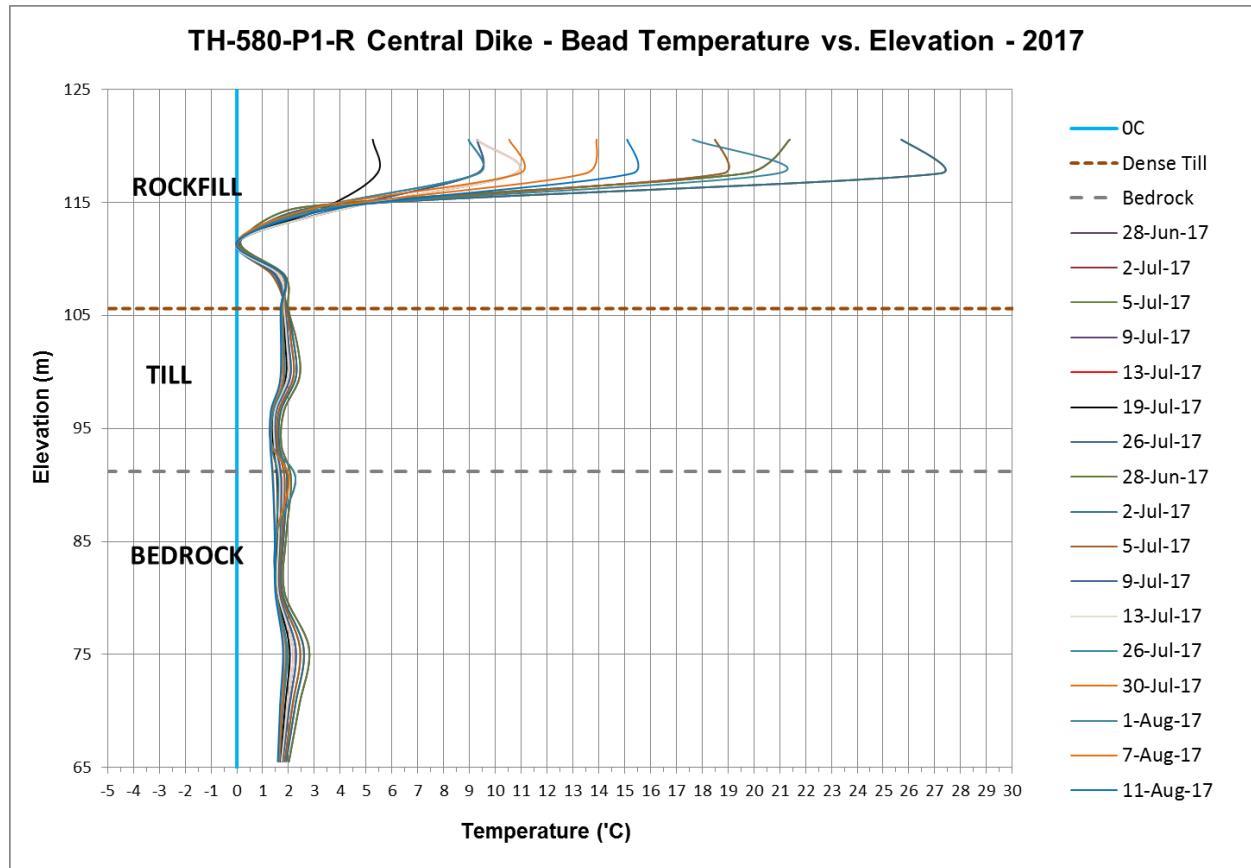
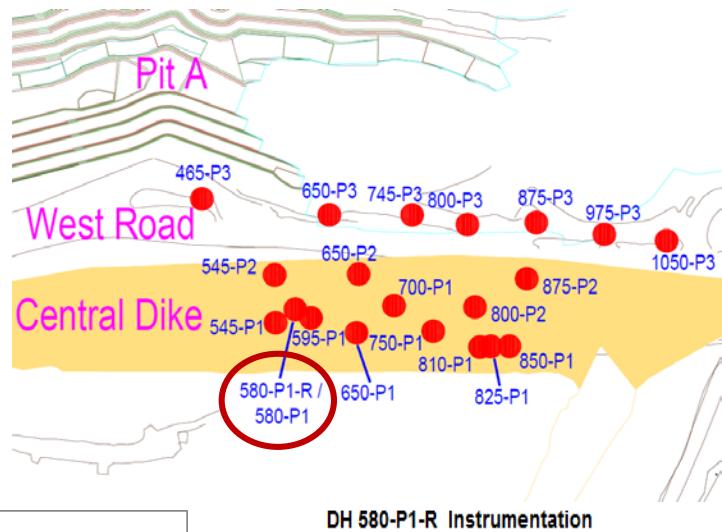
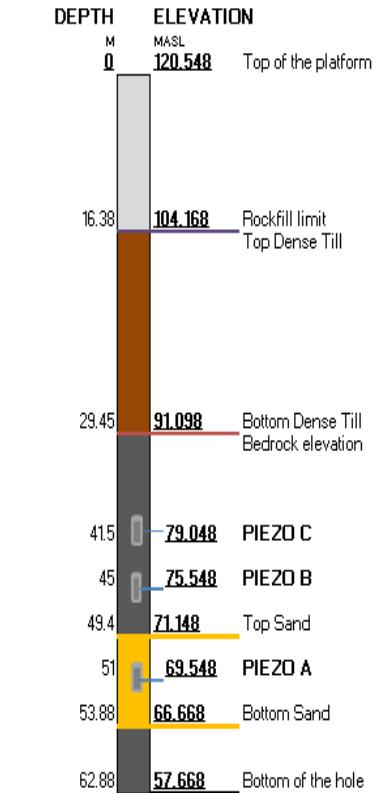
THERMISTOR 580-P1R

- ↗ Stabilisation in progress
- ↗ Temperature readings above 0°C
- ↗ Similar temperature readings range than 580-P1

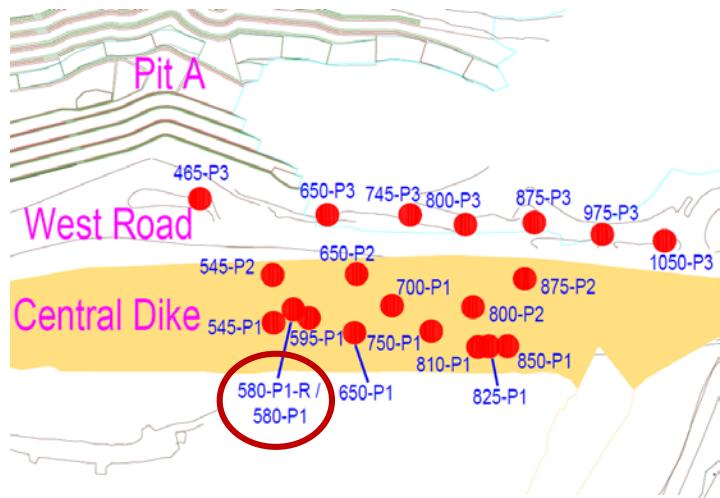
PIEZOMETER 580-P1R

- Piezo A is located in a sand layer and pressure readings are following the D/S pond regime
- Decrease in piezometric elevation ongoing for Piezo B
- Small data GAP

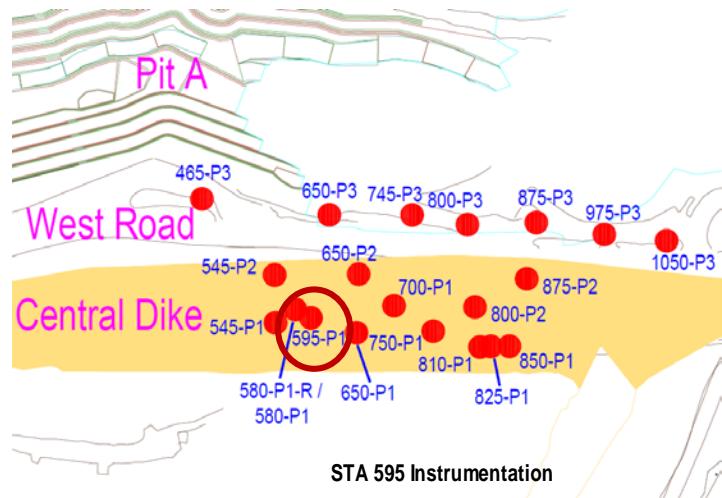
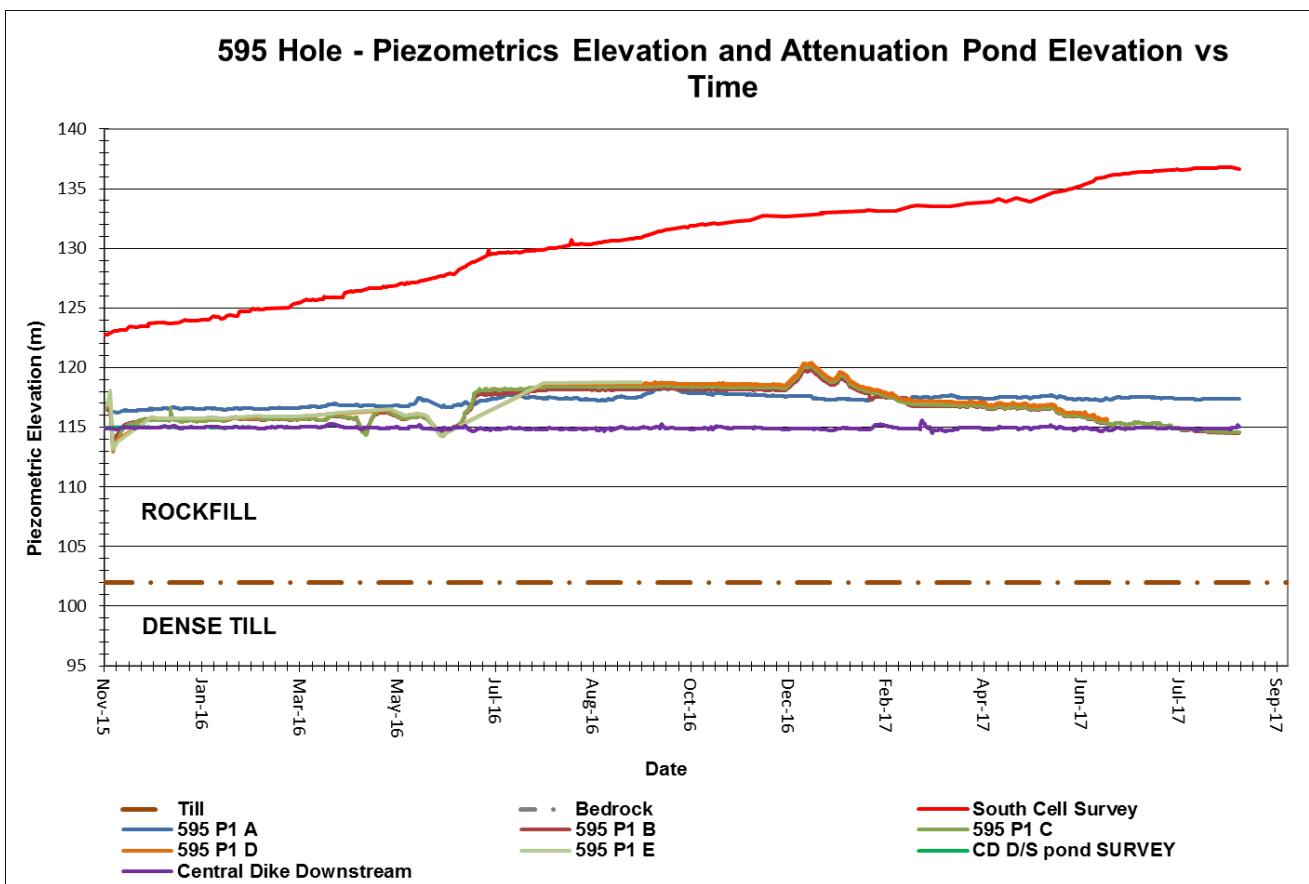
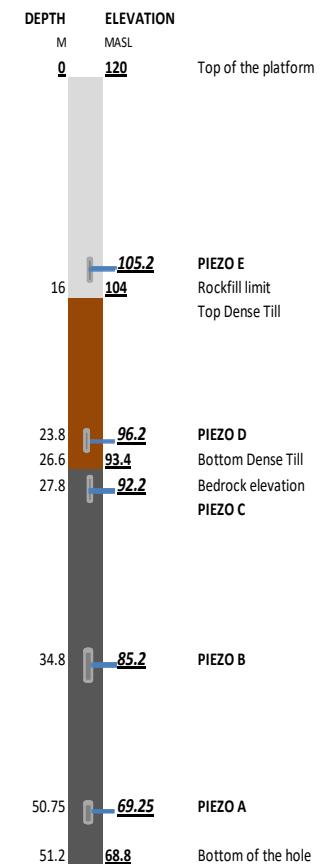
PIEZOMETER 595-P1

- Piezometric readings are fluctuating around D/S pond elevation since the installation.
- Piezo C to E was installed in casing**

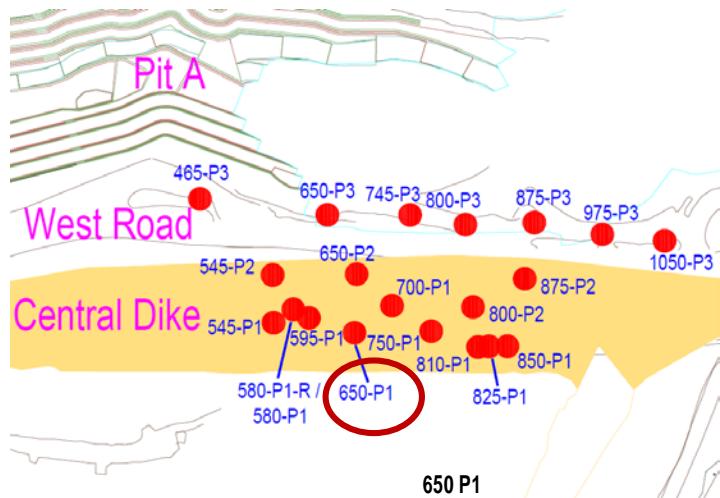
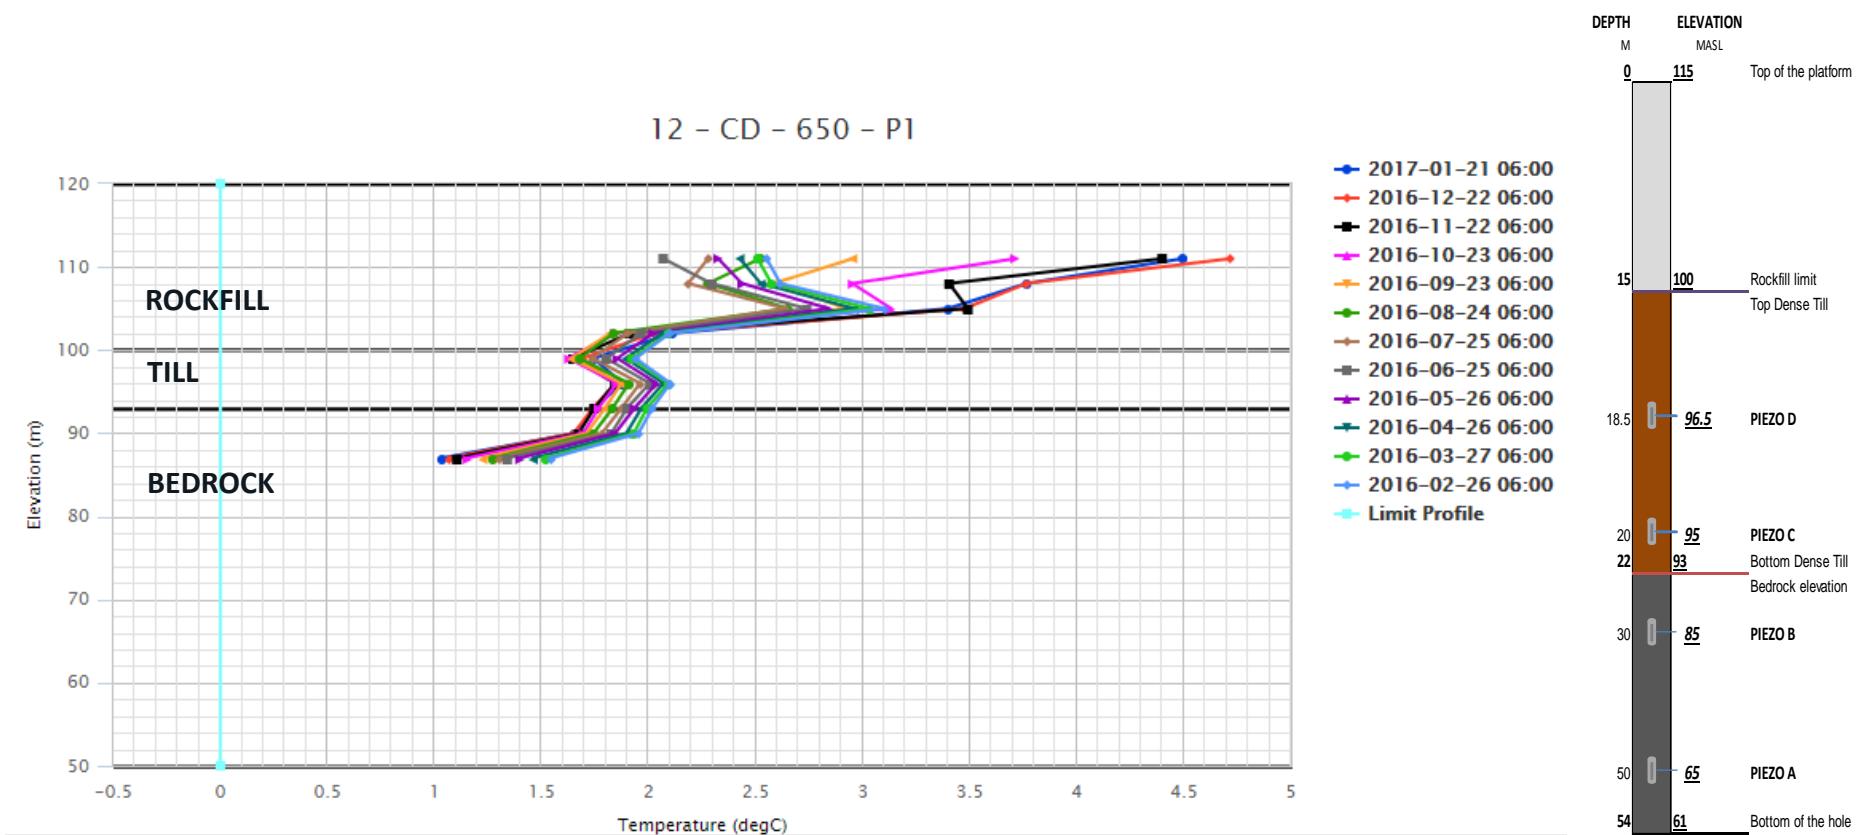
THERMISTOR 650-P1

- ↗ Thermistance reading not functional since January 2017
- ↗ Beads 10 to 12 are not functioning since August 2016
- ↗ Temperature of the bedrock/till units were in between 1.0 and 2.1°C.

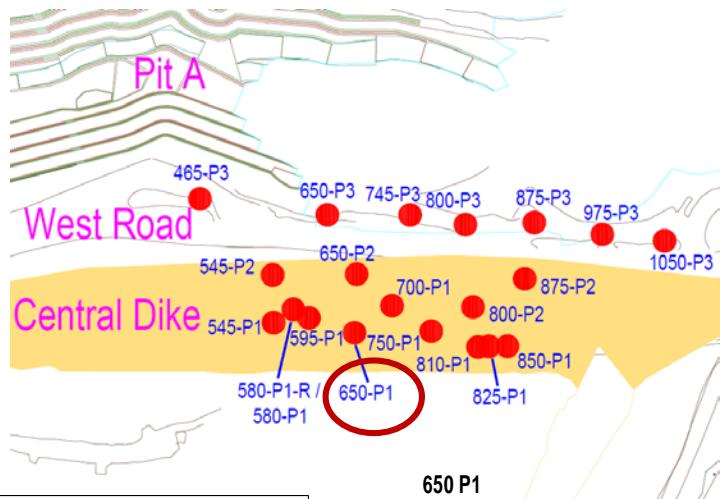
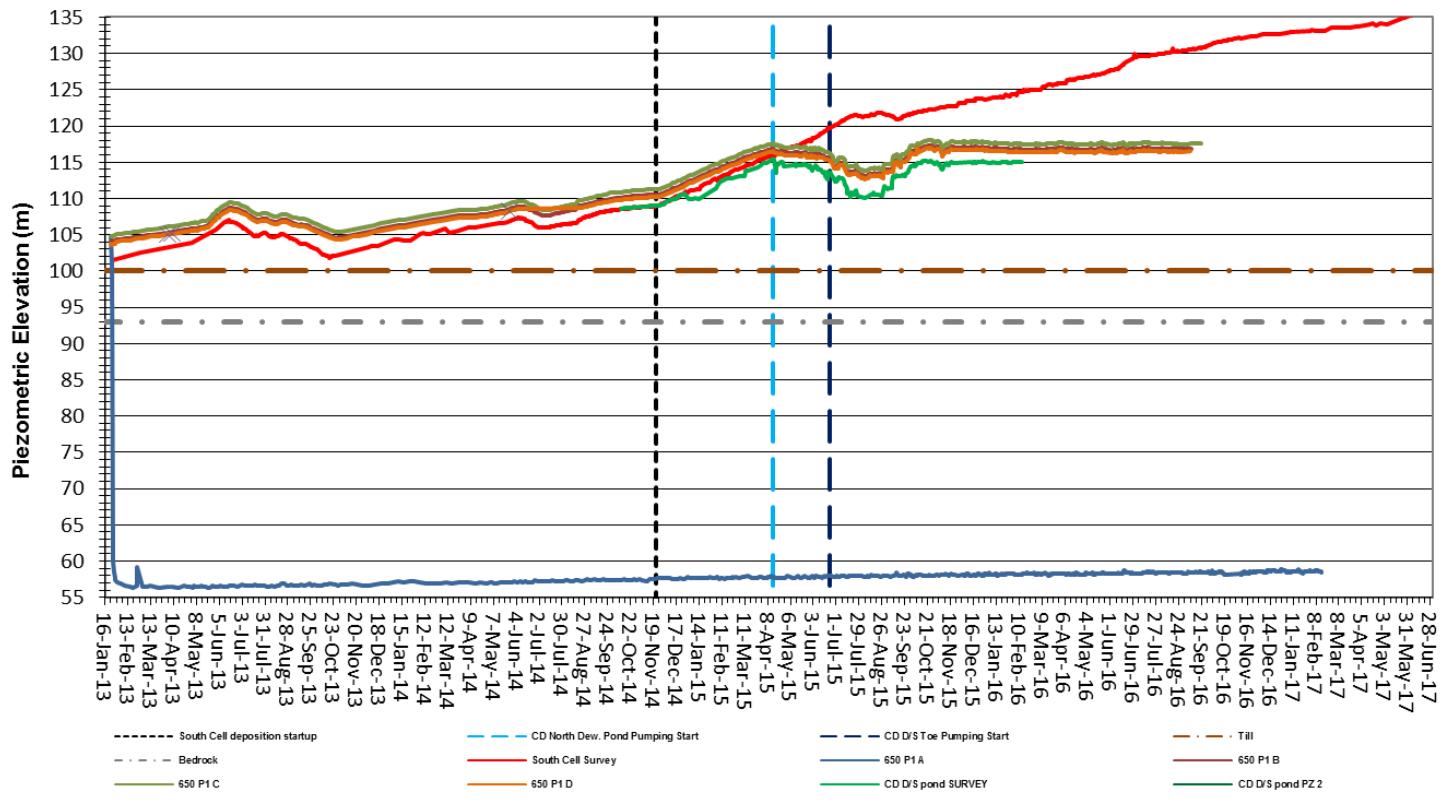
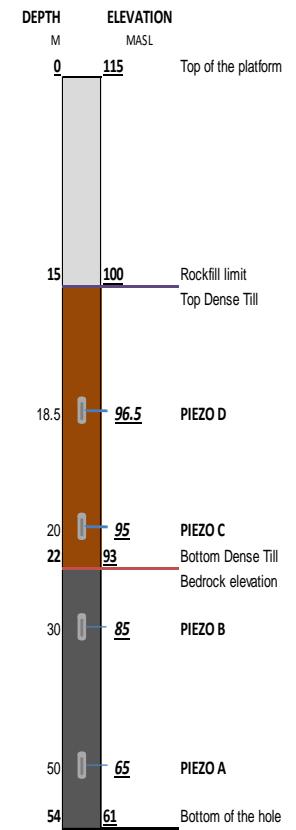
650-P1

- ↗ Piezometer reading not functional since February 2017
- ↗ Piezo A was in suction and piezo B to D were following D/S pond regime with readings around 117m.

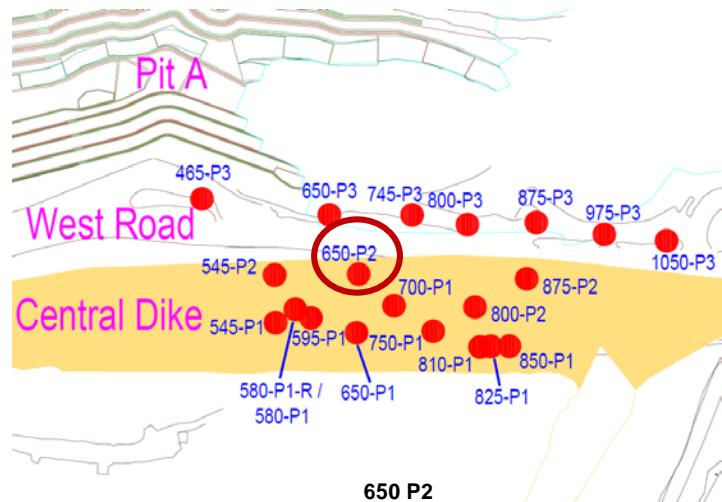
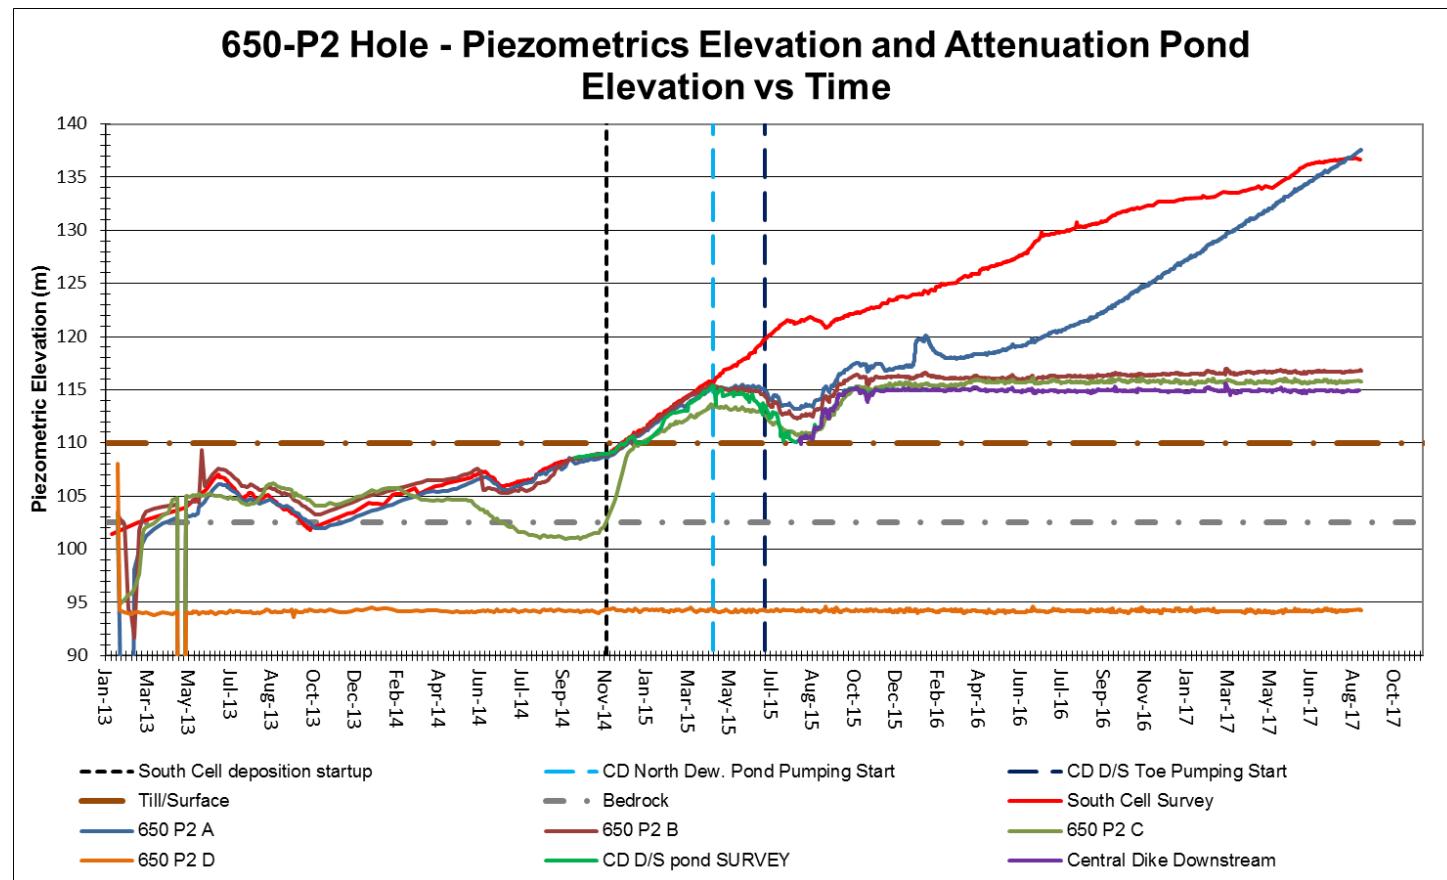
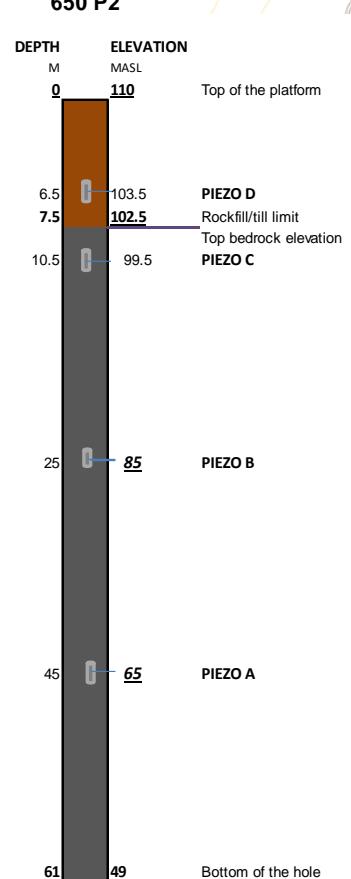
PIEZOMETER 650-P2

- Piezometer A in bedrock continue its rise and is now over the elevation of the South Cell
- Piezo B-C are following the piezometric regime of the D/S pond
- Piezo D is in suction

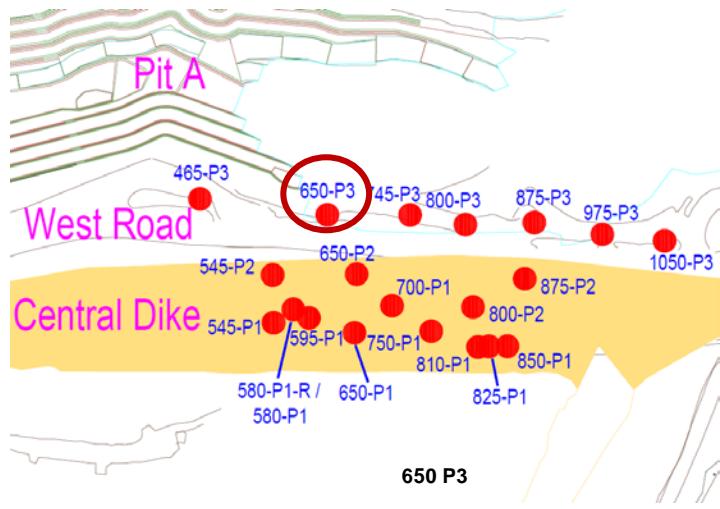
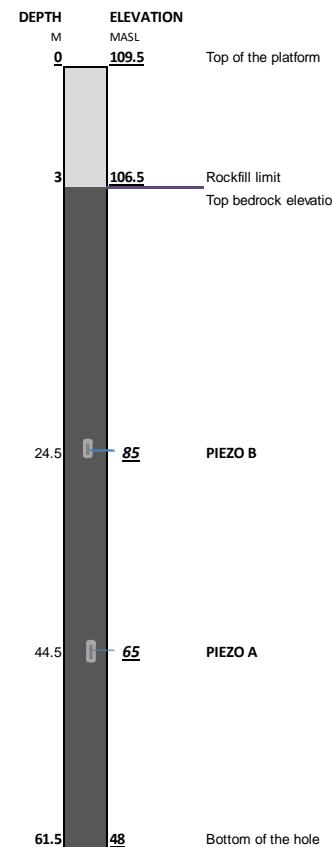
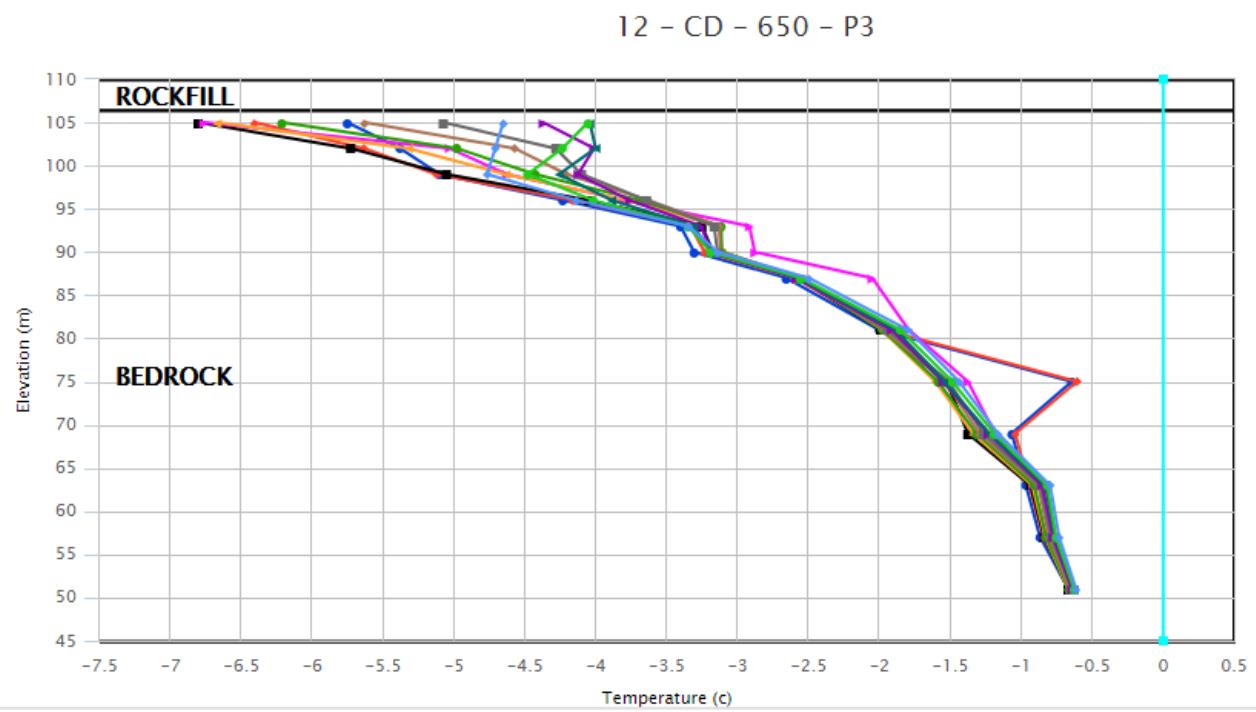
THERMISTOR 650-P3

- ↗ Bedrock Below 0° C at 650-P3
- ↗ Temperature spike at El. 75 m is related to capacitance effect on this specific bead.

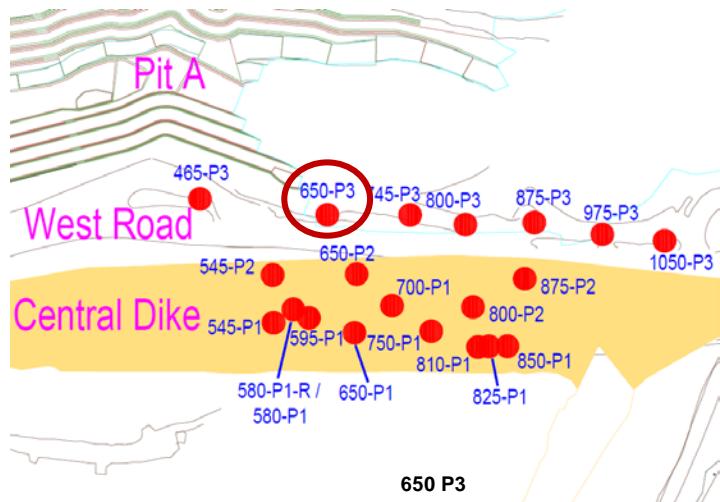
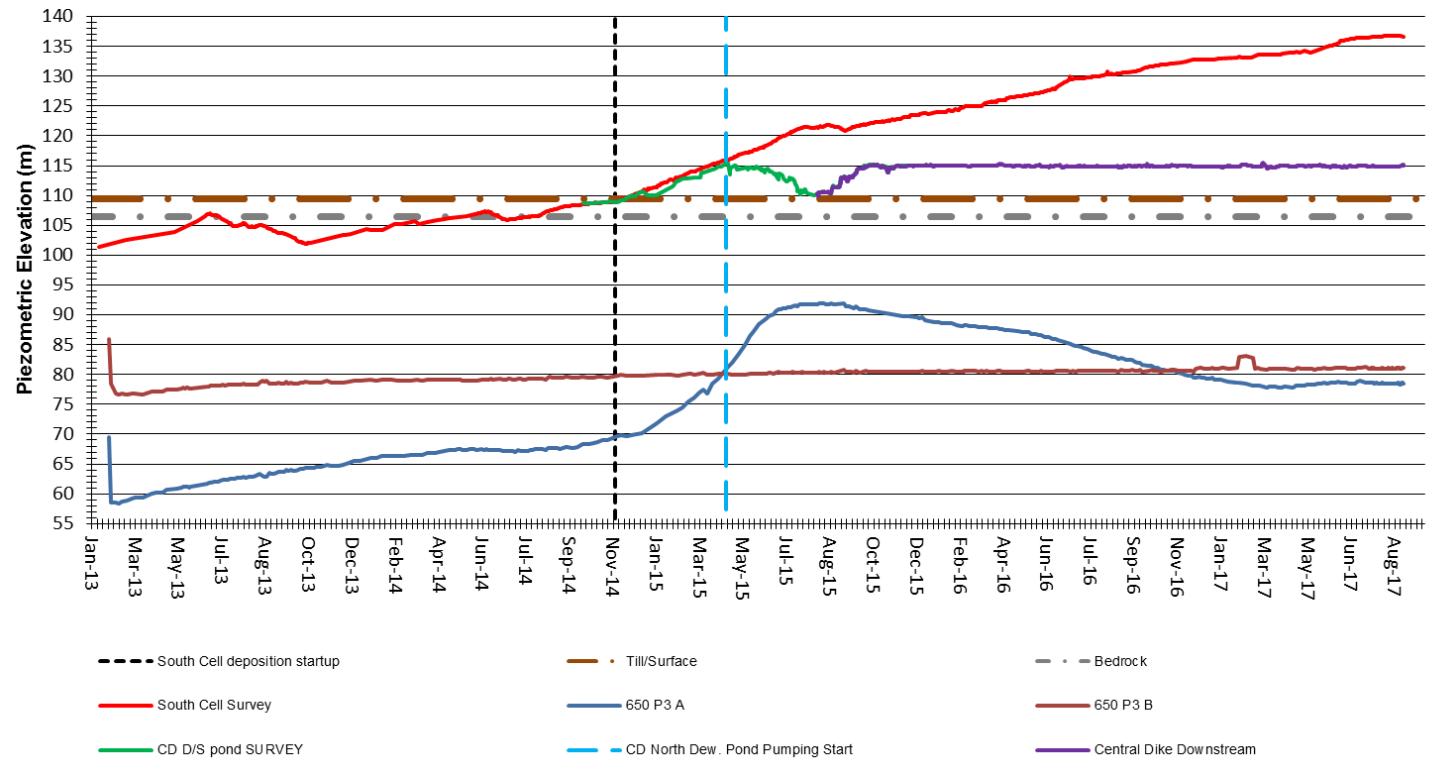
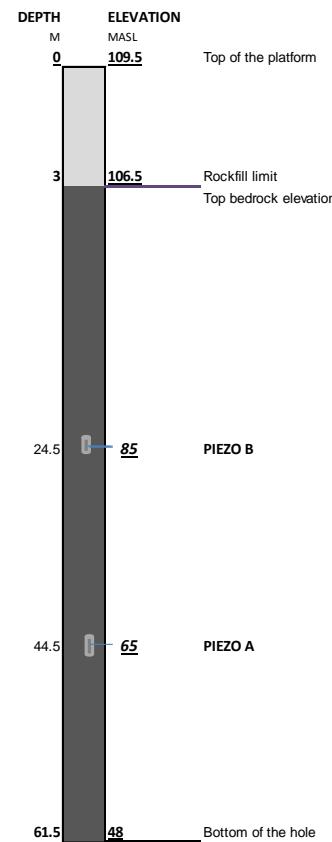
PIEZOMETERS 650-P3

Frozen Piezometers

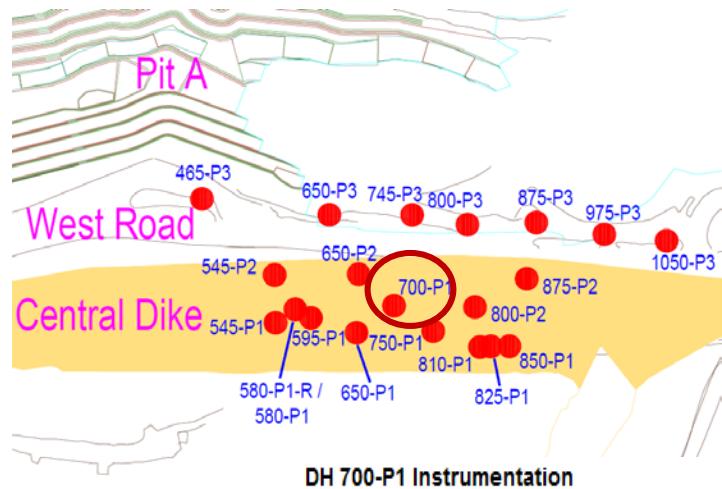
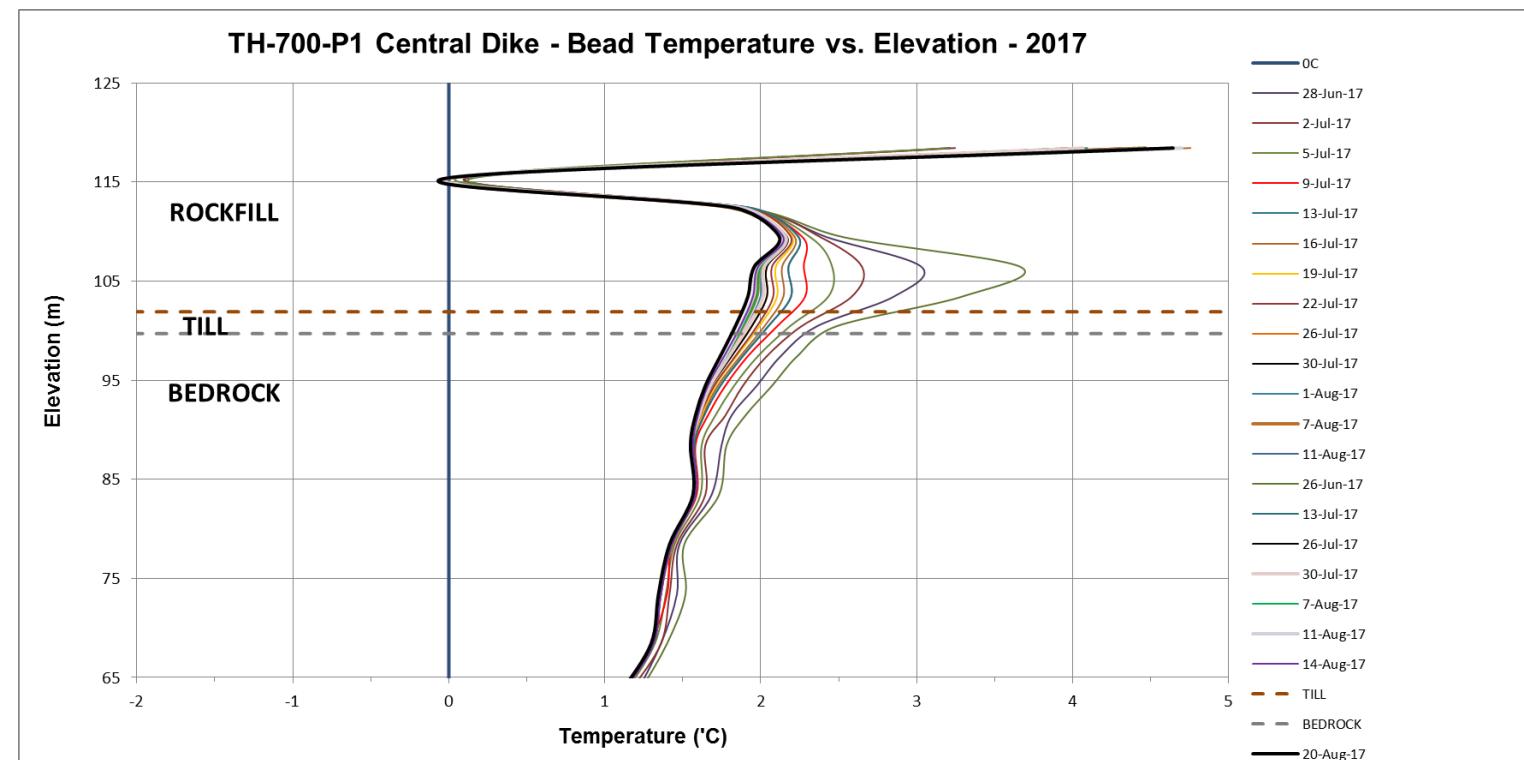
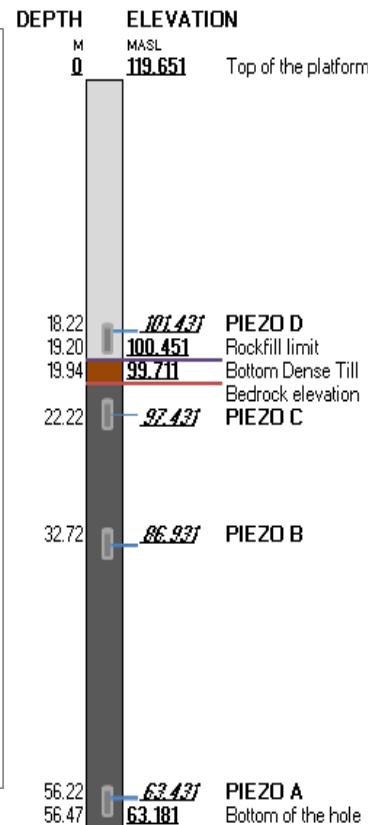
THERMISTOR 700-P1

- ↗ New instrument installed in 2017
- ↗ Stabilisation of temperature ongoing
- ↗ Till and bedrock temperature readings above 0°C
