2017 ANNUAL GEOTECHNICAL INSPECTION
MEADOWBANK GOLD MINE, NUNAVUT

APPENDIX C3

TSF North Cell Instrumentation Data

**MDRB # 22
P3 – STORMWATER DIKE
UPDATE**

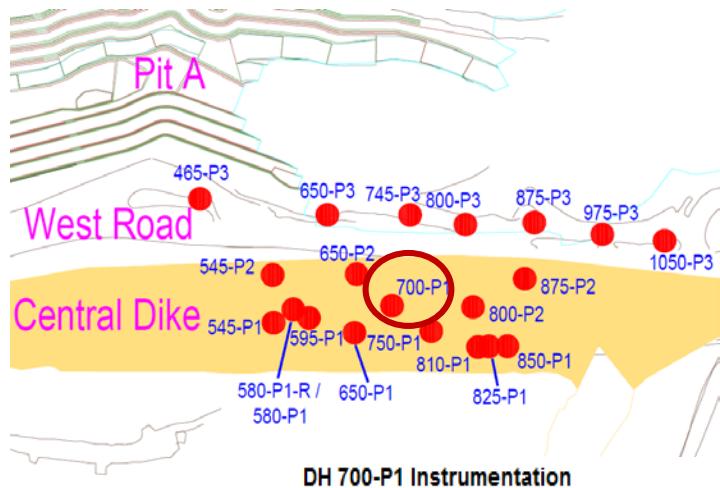
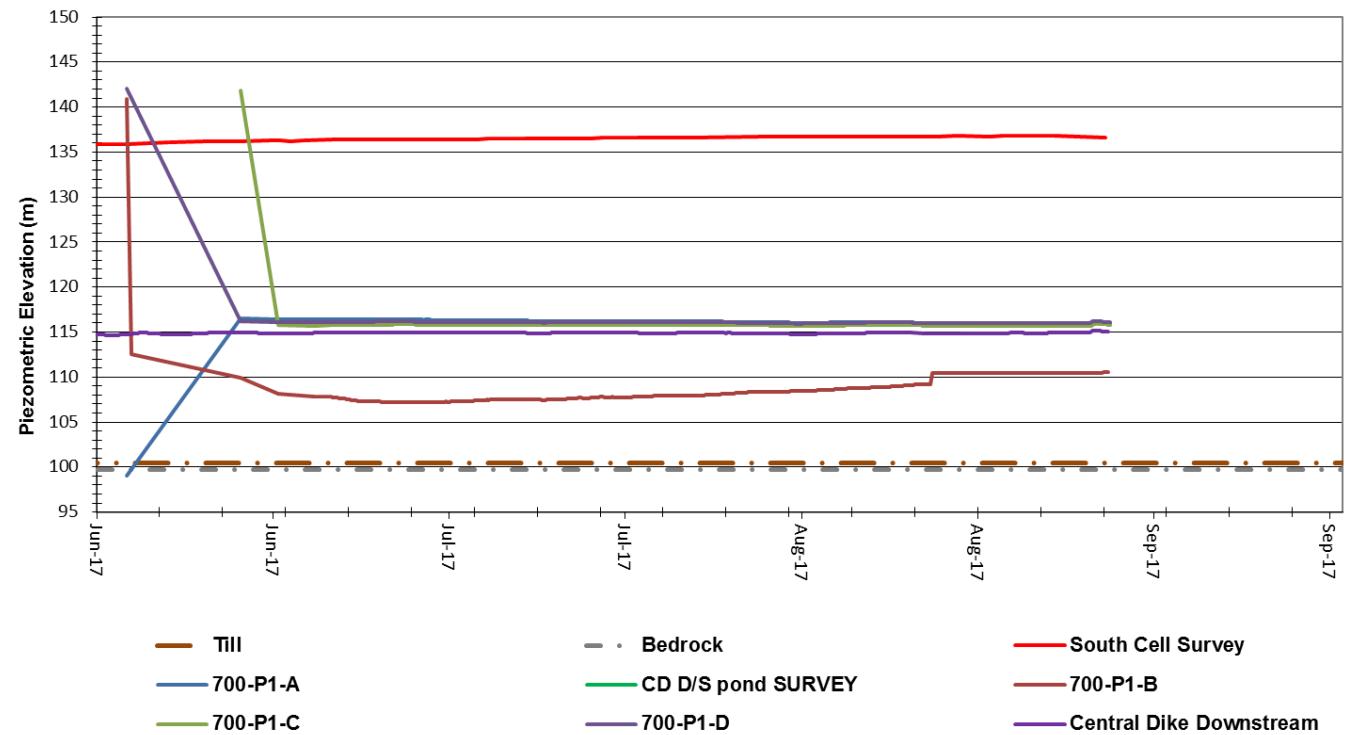
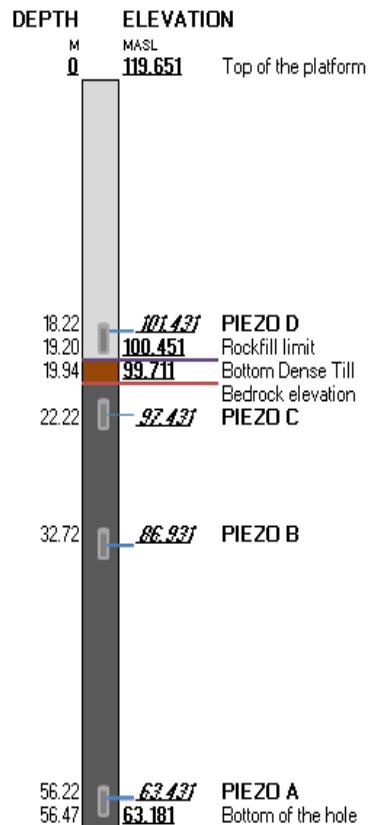
PIEZOMETER 700-P1

- ↗ New instrument installed in 2017
- ↗ Stabilization of temperature ongoing
- ↗ Reading automatization occurred on the date of the small bump observed on the piezo B
- ↗ Piezo A.C and D are showing reading similar to the D/S pond.

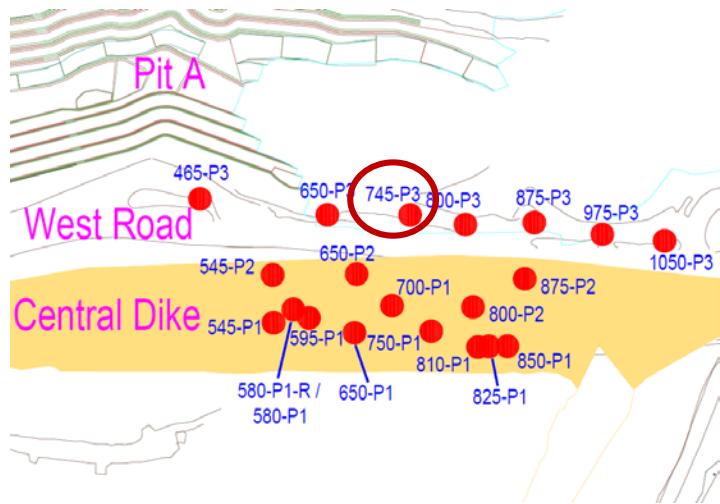
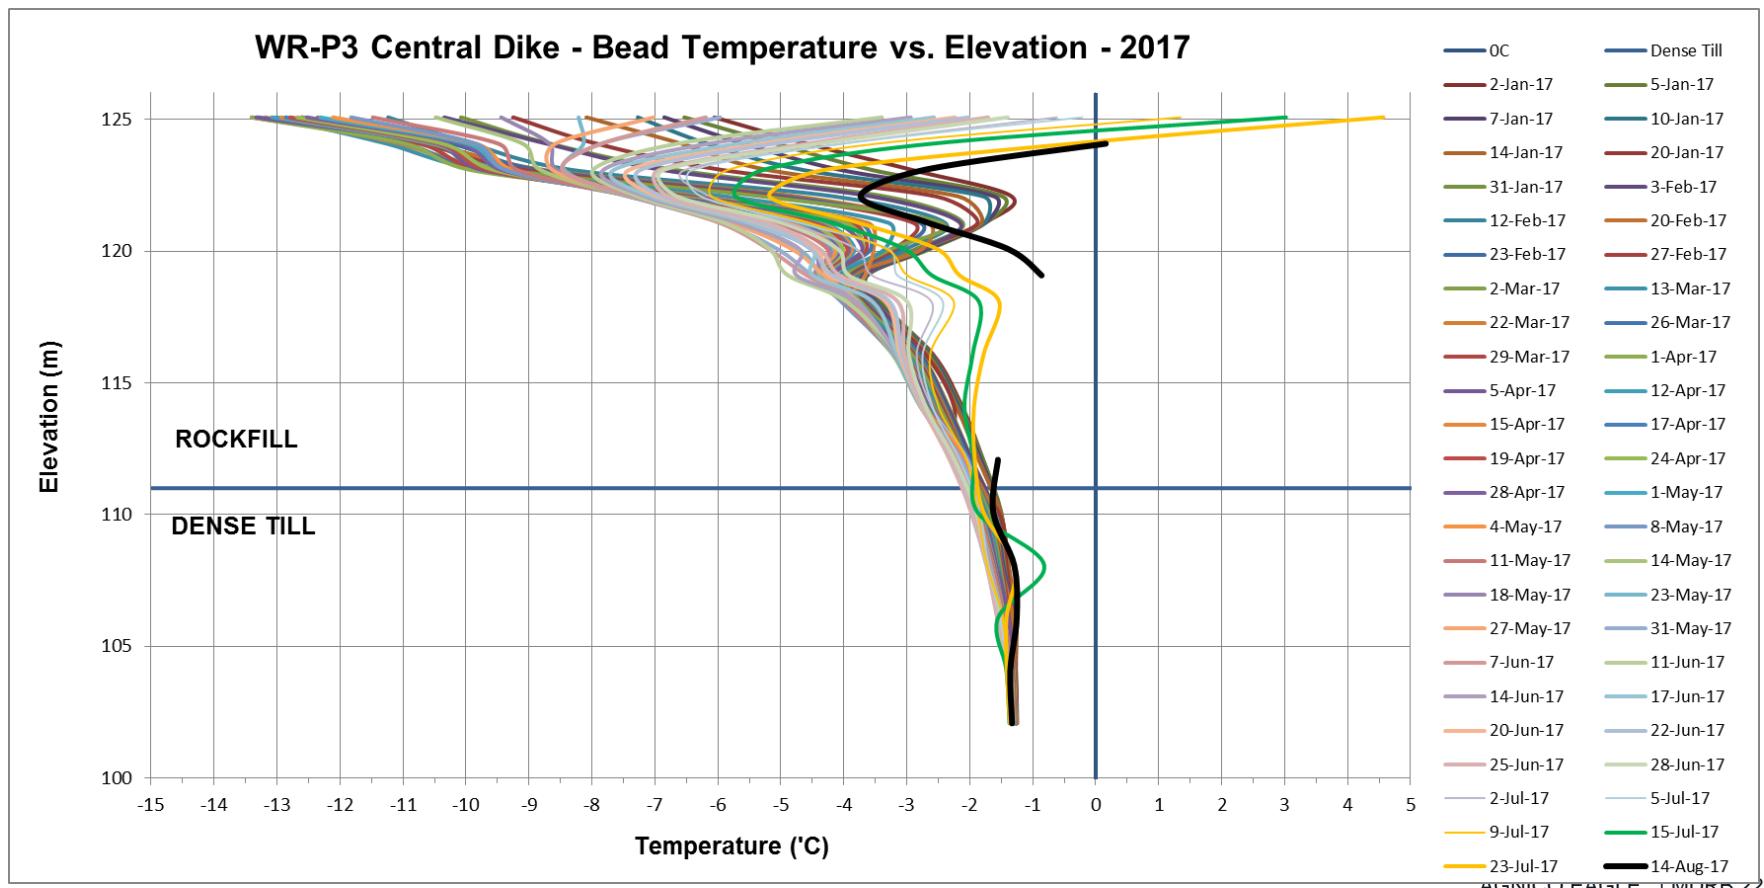
THERMISTOR 745-P3

- Thermistor installed to monitor freeze back of the West Road. This thermistor do not reach bedrock
- Rockfill and till below 0° C at 745-P3
- Frozen limit of the northern section of the P3 line

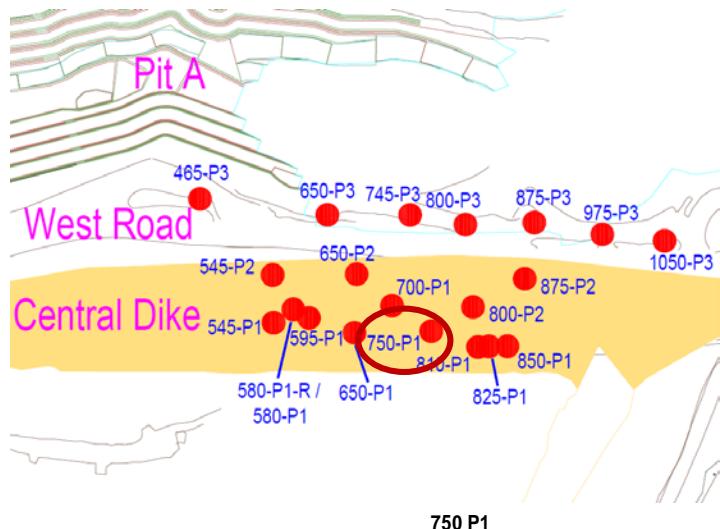
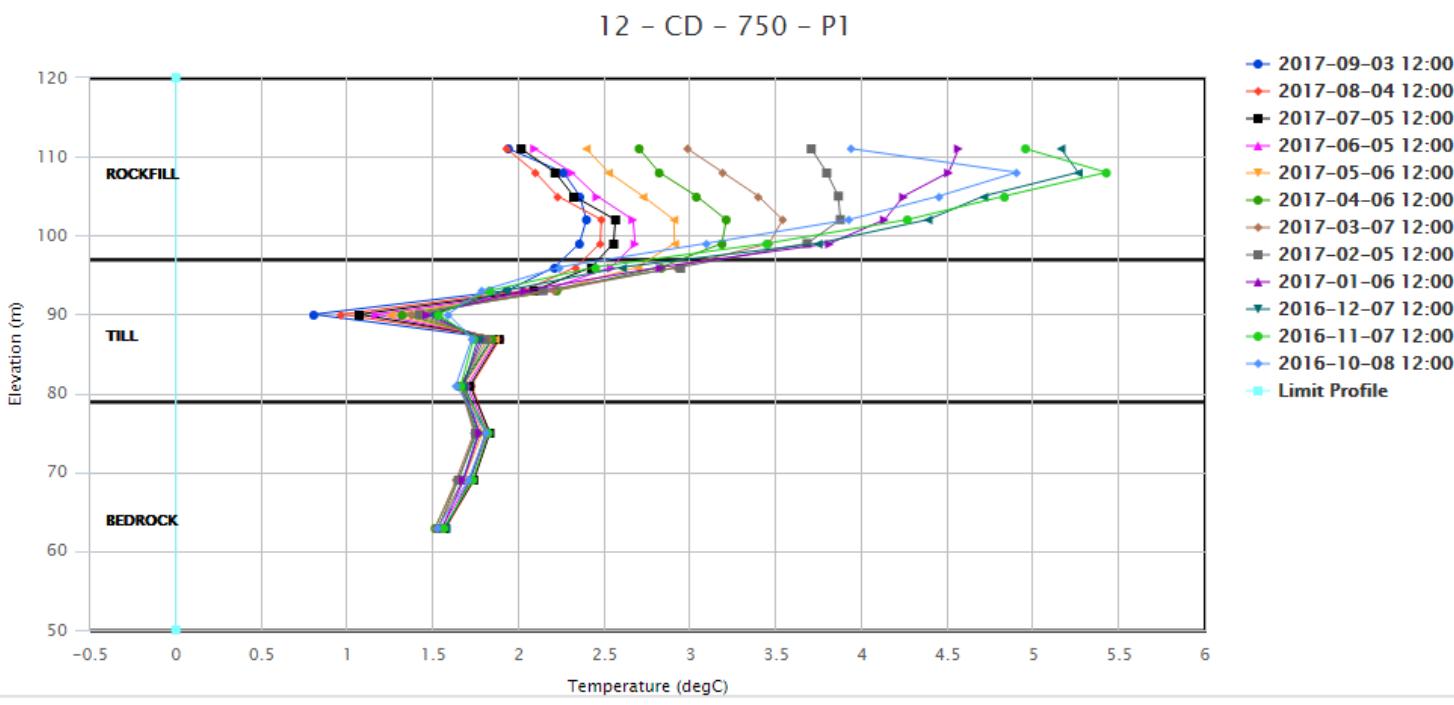
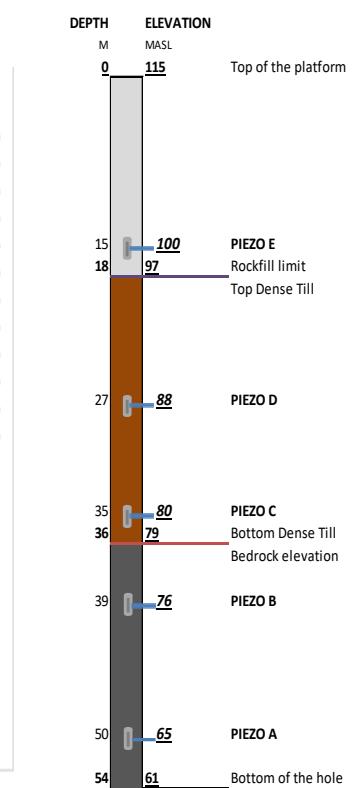
THERMISTOR 750-P1

→ Cooling trend in till layer. The bead located at elevation 90m is in average 1°C cooler than in 2016.

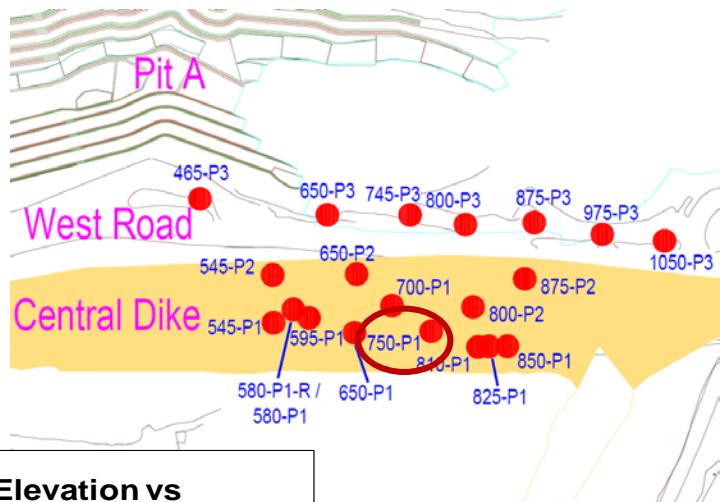
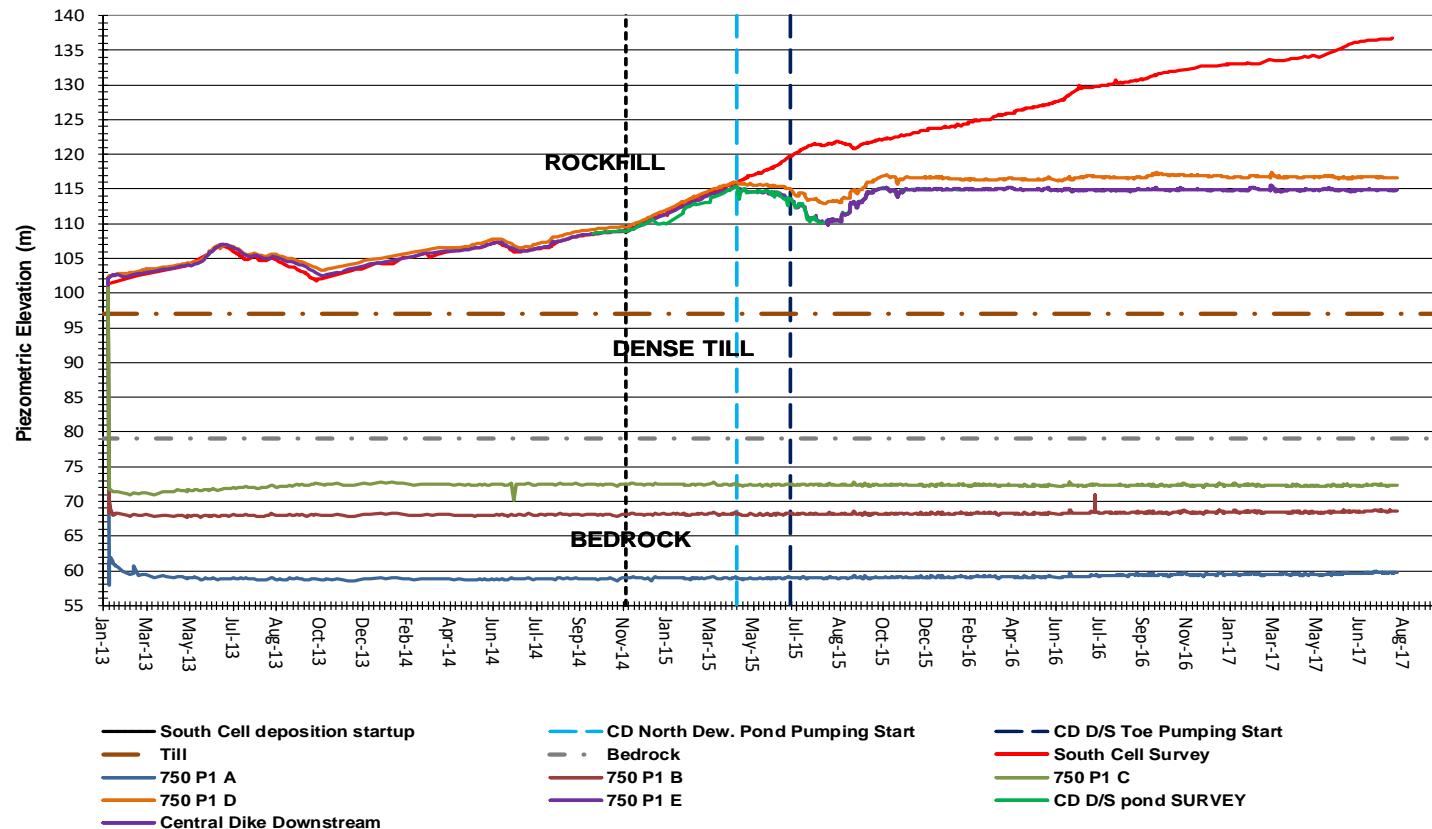
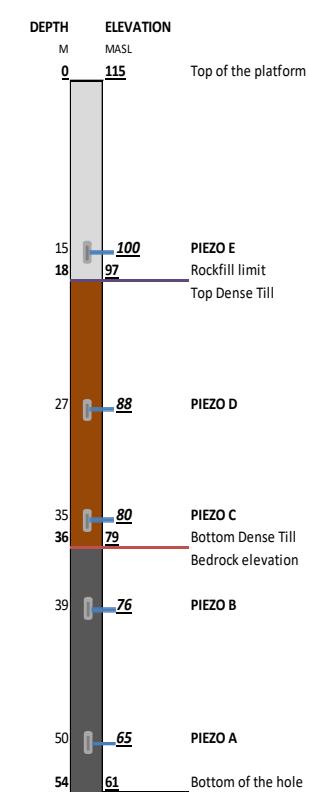
PIEZOMETER 750-P1

- Piezo A, B and C are in suction
- Piezo D is have a direct reaction to any variation in elevation observe in the D/S pond.

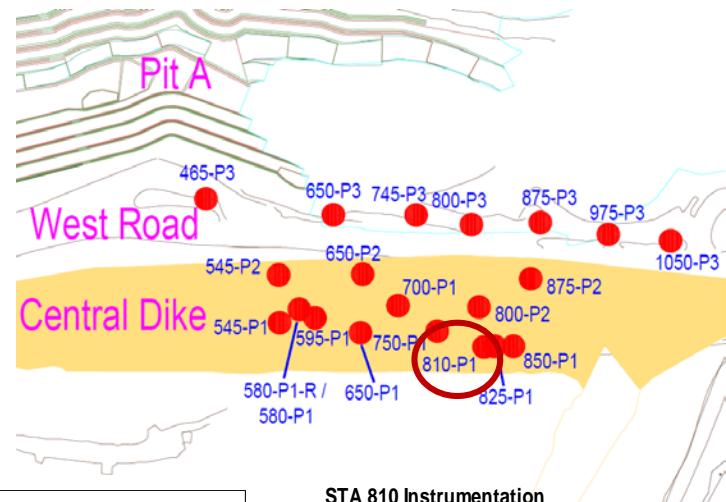
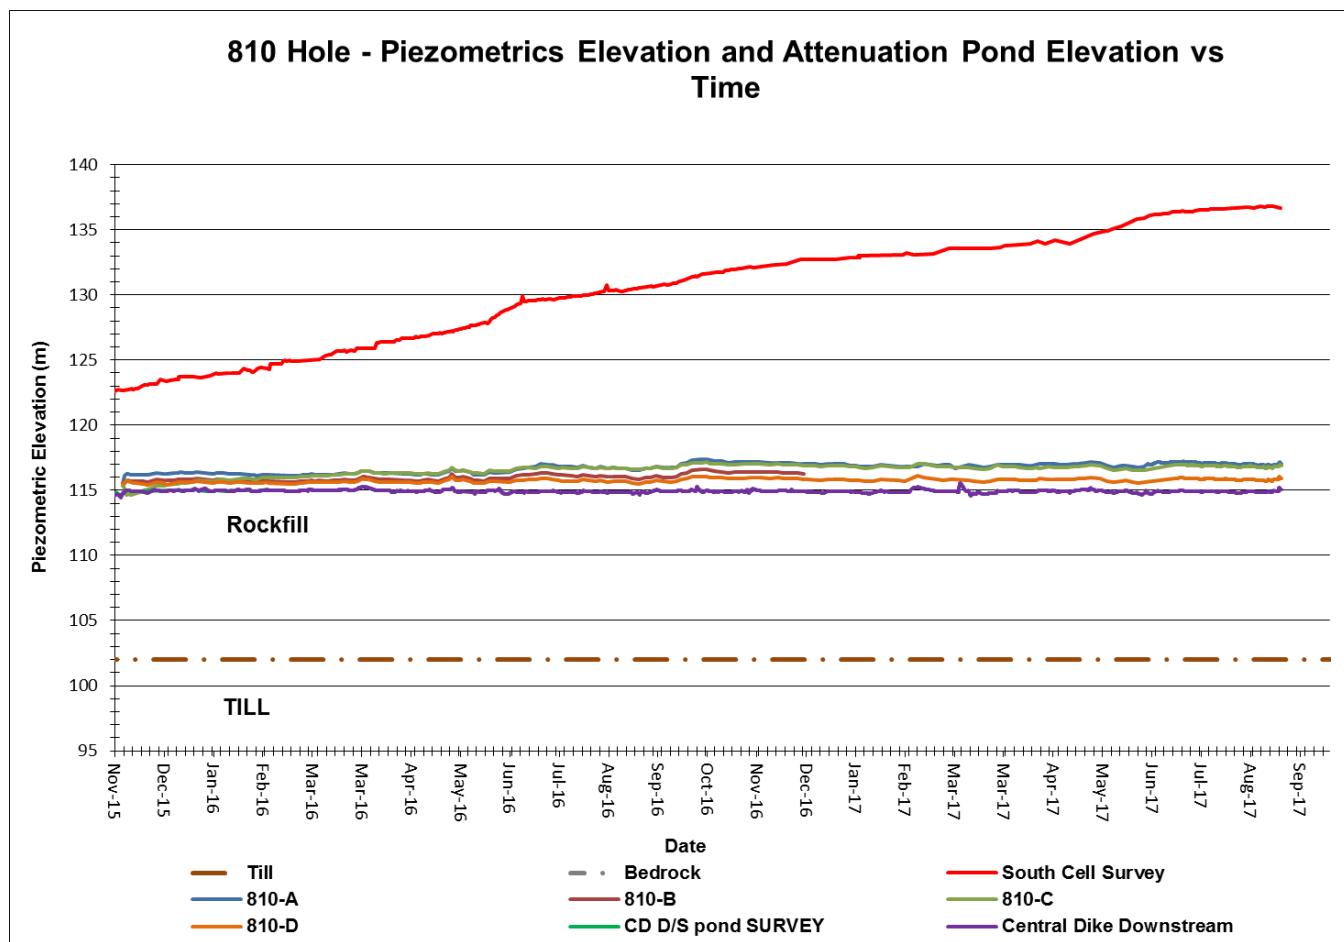
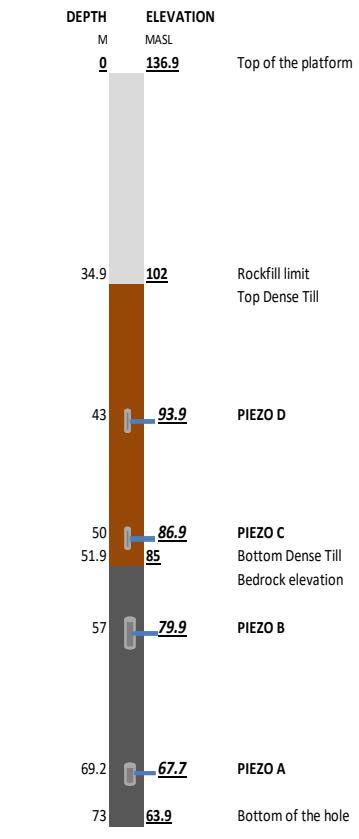
PIEZOMETER 810-P1

- Piezo B stop working in January 2017
- Piezo A, C & D are following the elevation change of the D/S pond

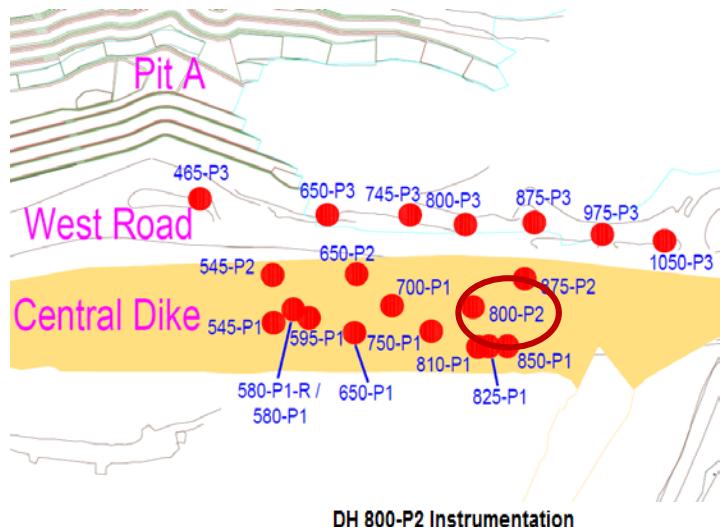
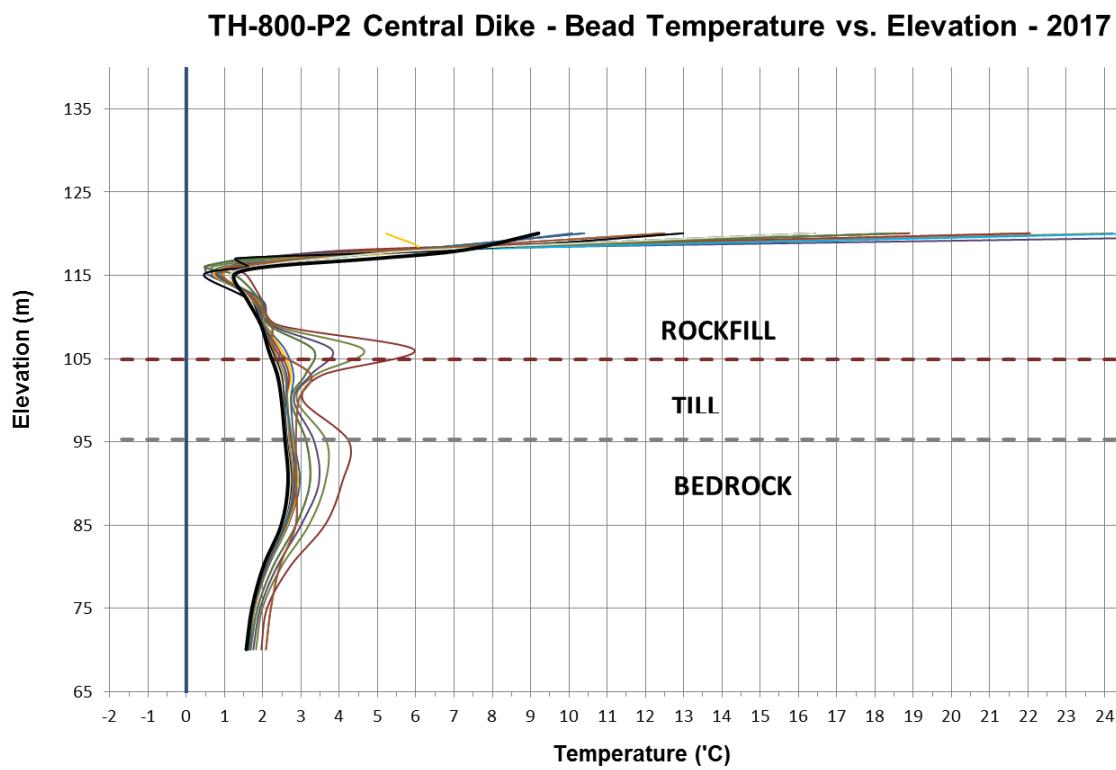
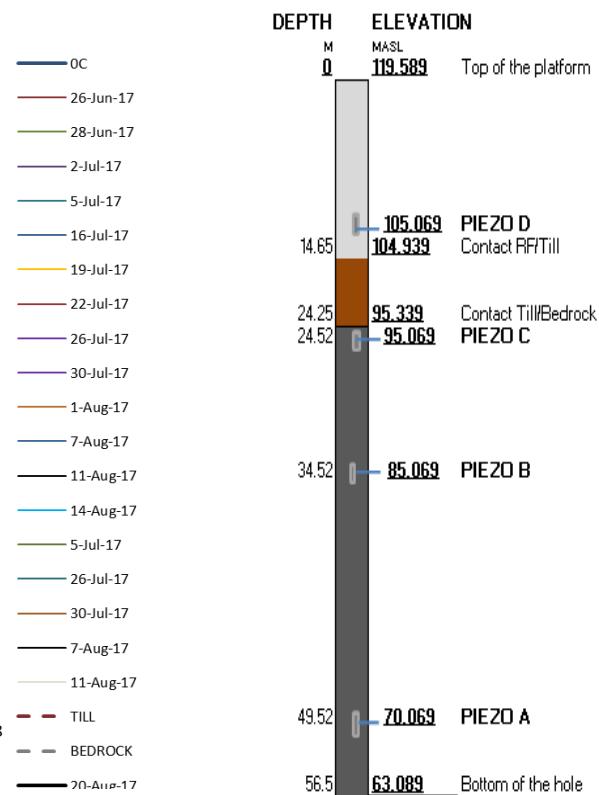
THERMISTOR 800-P2

- ↗ New instrument installed in 2017
- ↗ Stabilisation of temperature ongoing
- ↗ Temperature above 0 °C

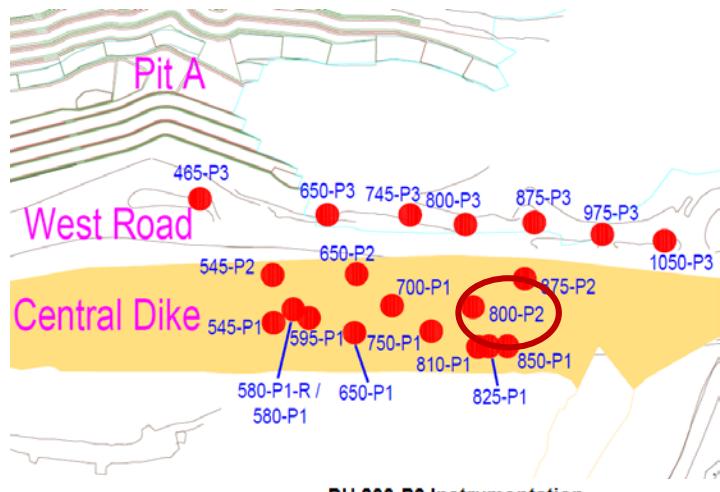
PIEZOMETER 800-P2

- ↗ New instrument installed in 2017
- ↗ Stabilisation ongoing
- ↗ Piezo A, B and C are showing pressure readings similar to the elevation of the D/S pond.

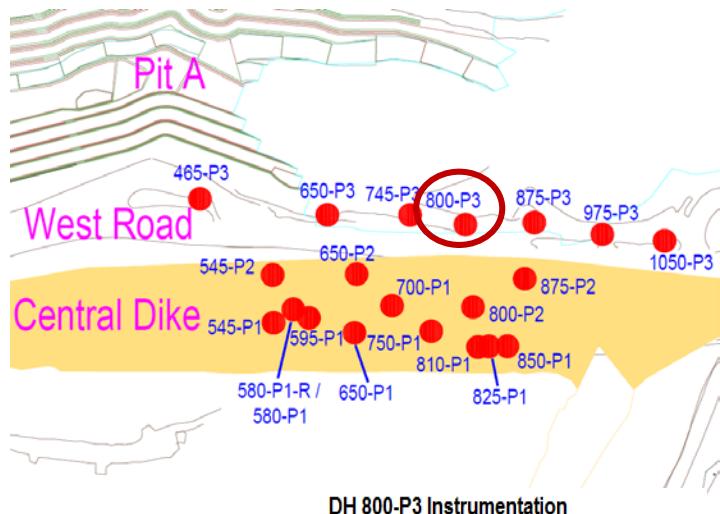
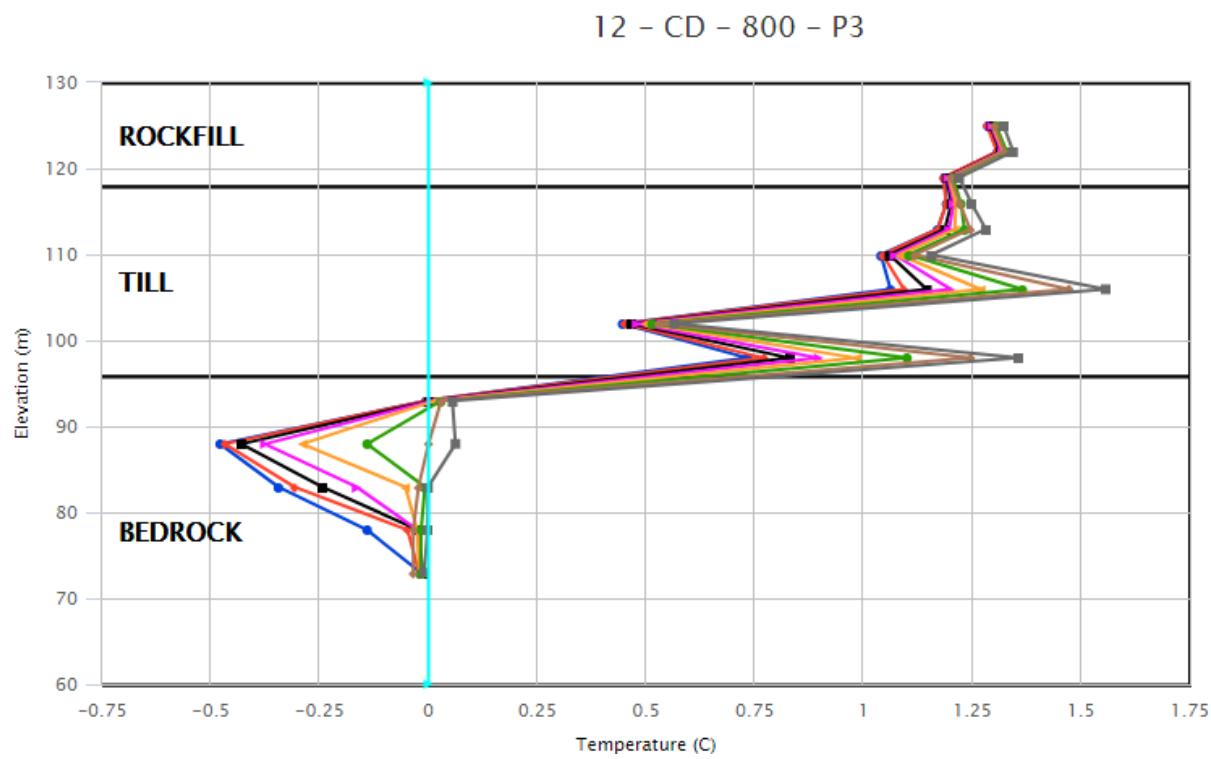
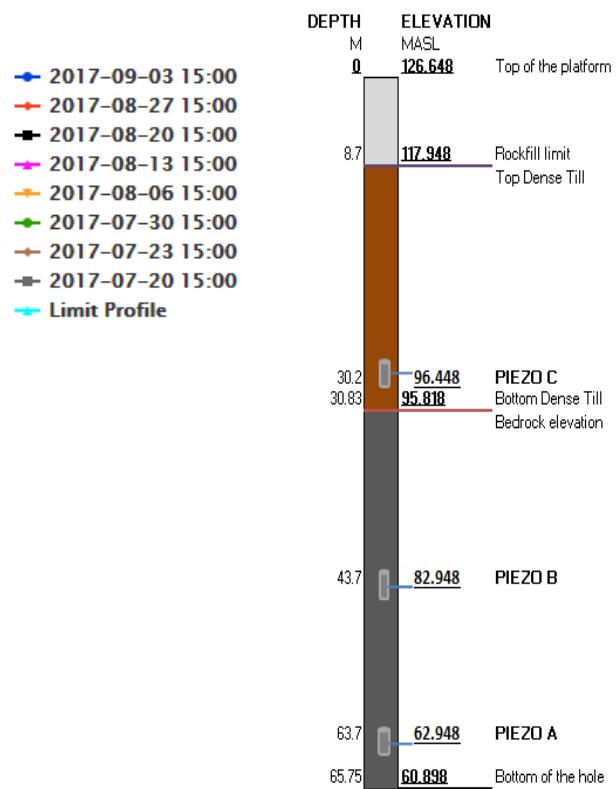
THERMISTOR 800-P3

- ↗ New instrument installed in 2017
- ↗ Stabilisation in progress
- ↗ Temperature under 0° C below El. 93 m

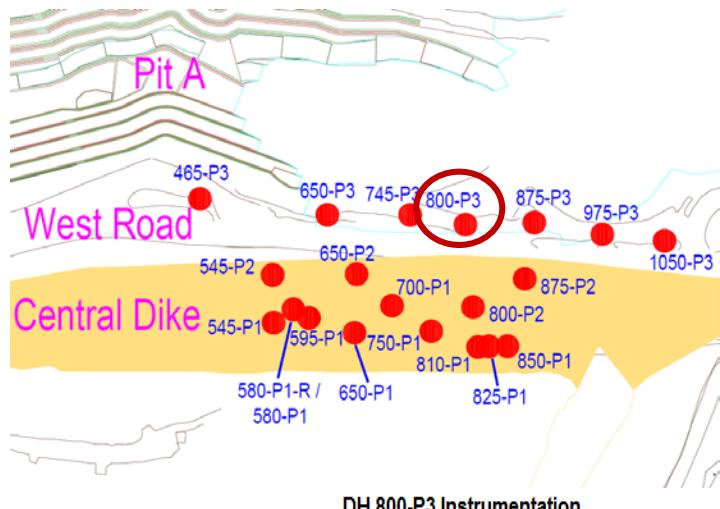
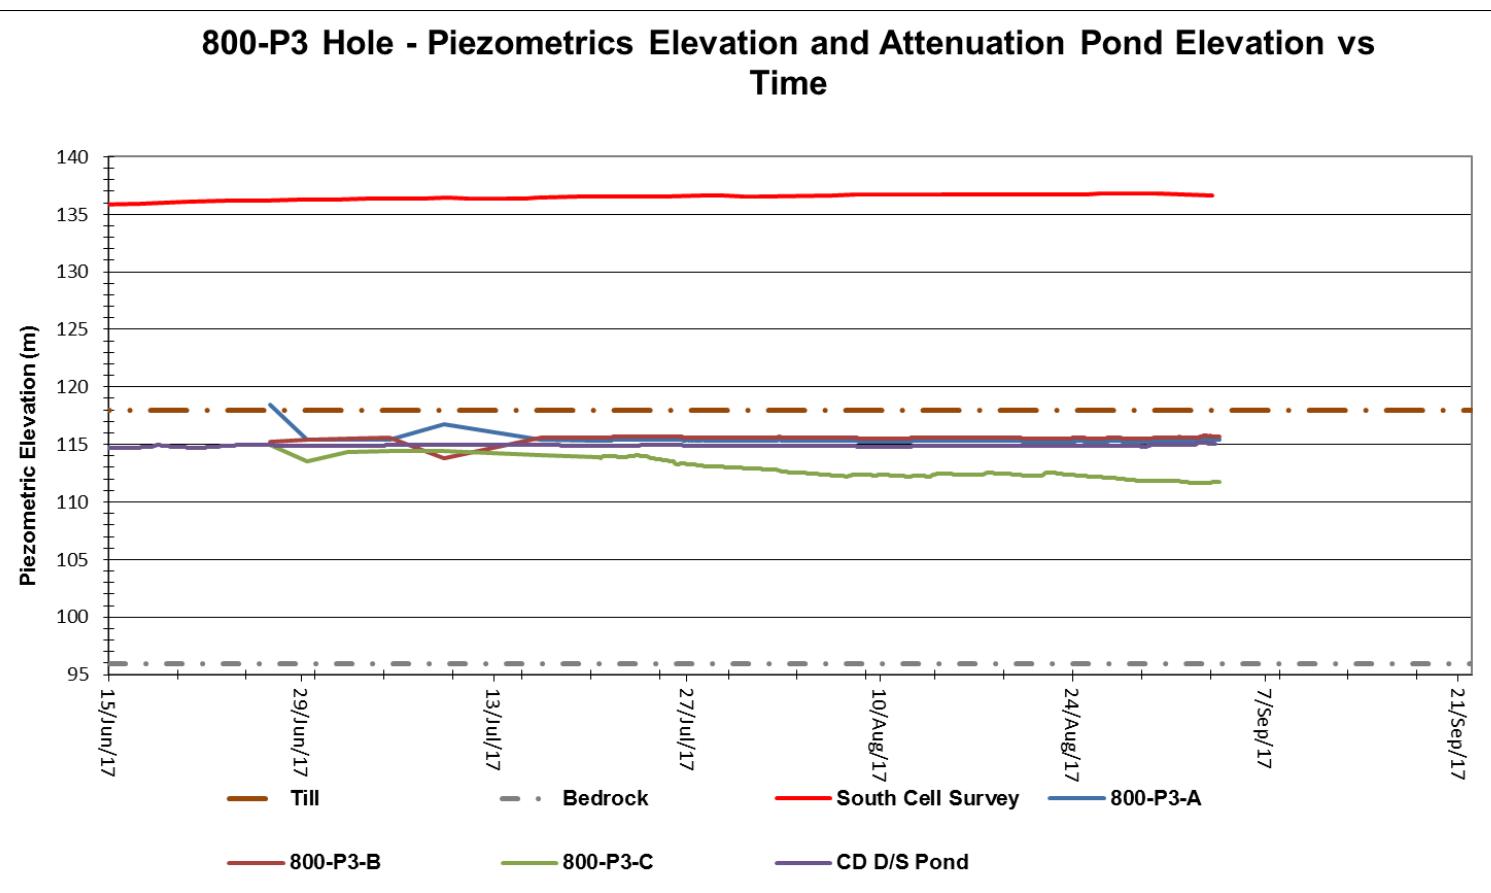
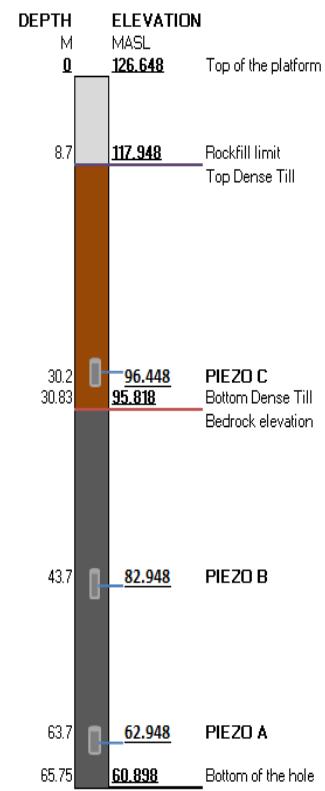
PIEZOMETERS 800-P3

- ↗ New instrument installed in 2017
- ↗ Stabilization in progress
- ↗ Piezo A & B readings are similar to the D/S pond elevation readings
- ↗ Piezo C readings is slowly decreasing

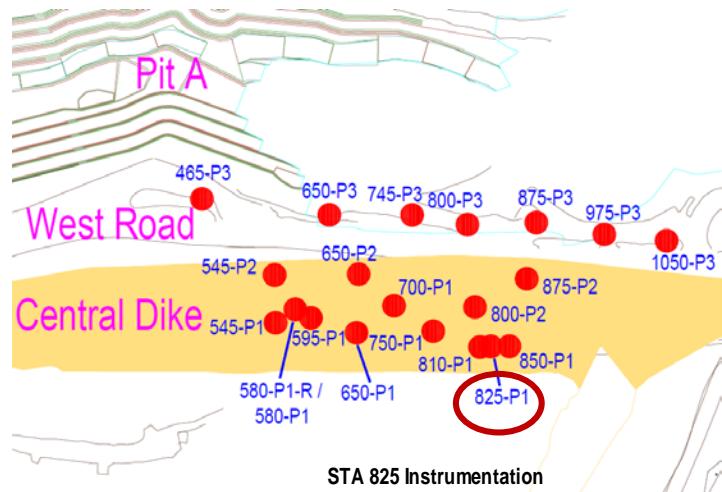
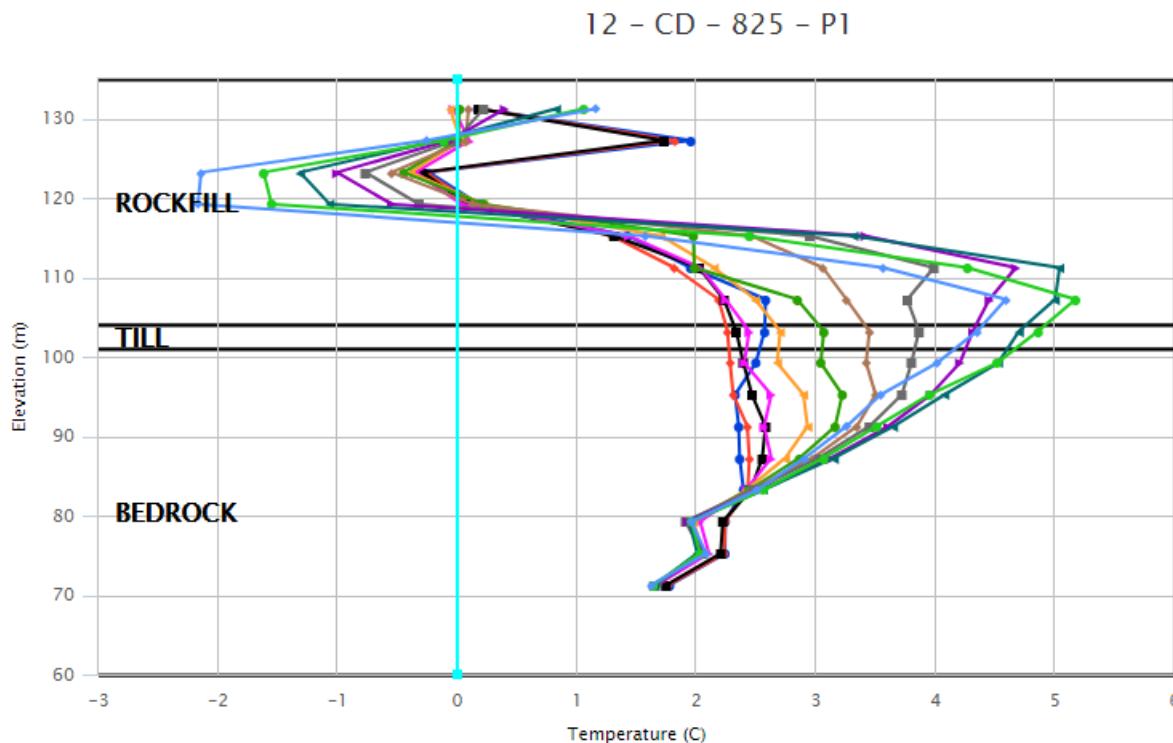
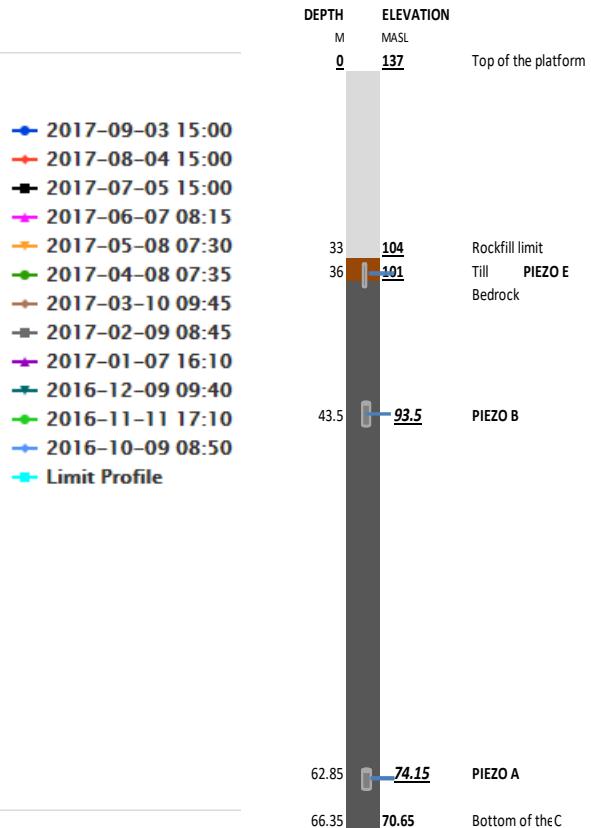
THERMISTOR 825-P1

- ↗ Temperature variation over the year inside the bedrock/till units is higher than in the previous year:
- ↗ 2016: [1.5, 3.2]
- ↗ 2017: [1.6, 4.5]
- ↗ Generally warmer readings recorded over the last year.

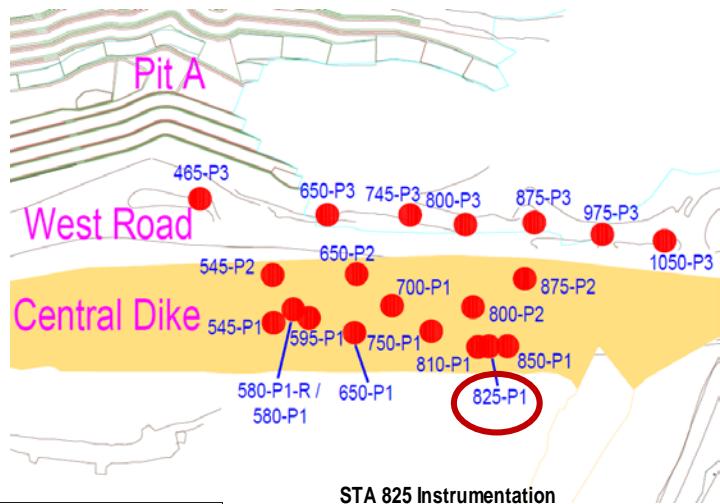
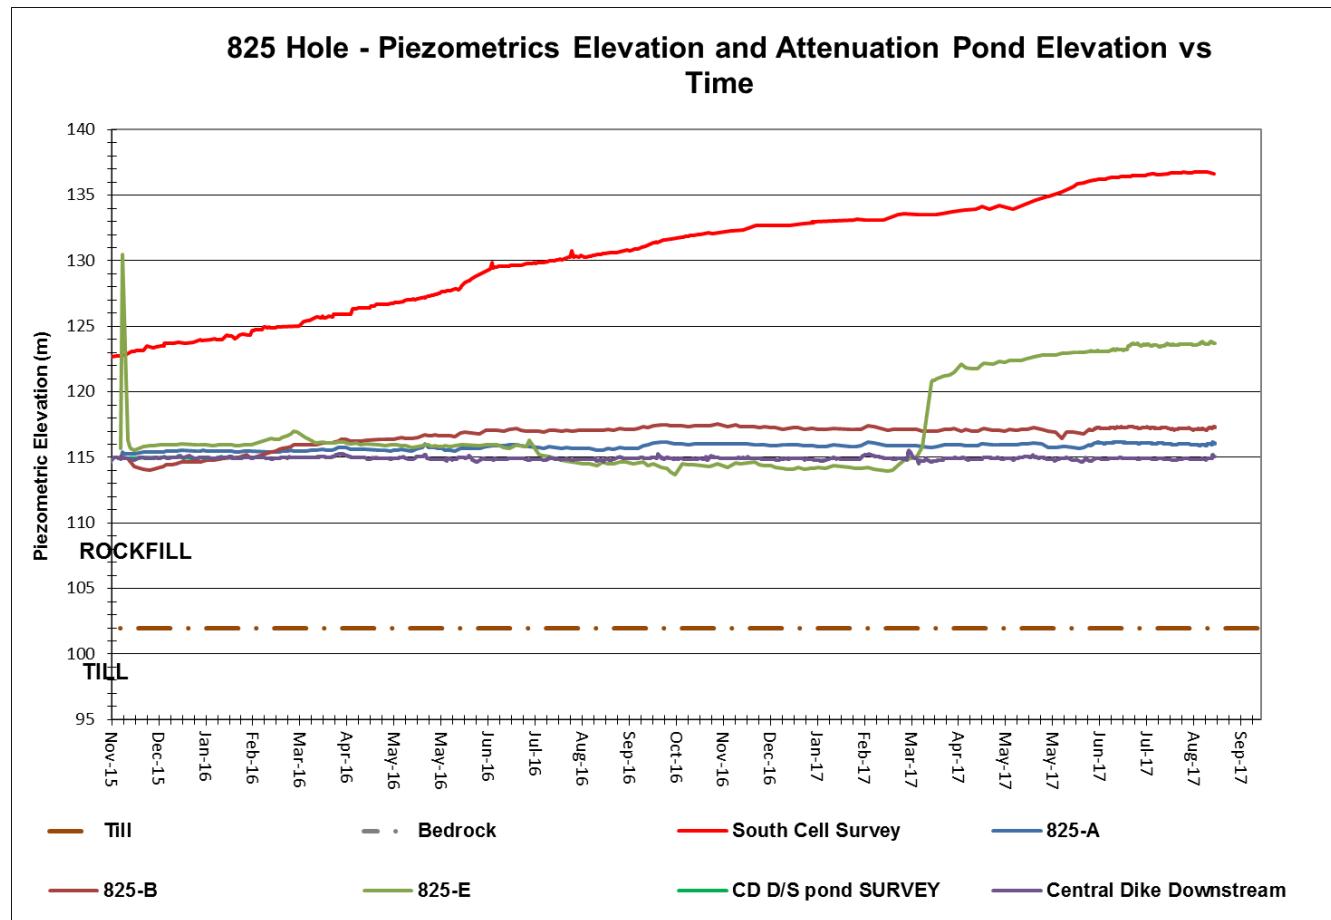
PIEZOMETER 825-P1

- Increased in piezometric elevation of Piezo E since April 2017. Seem to be connected now with South Cell.
- Piezo A and B showing readings similar to the D/S pond and are reacting directly with elevation change.

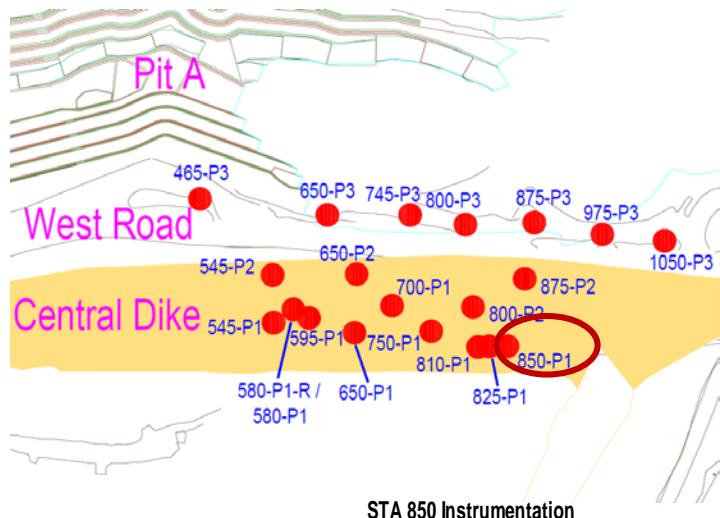
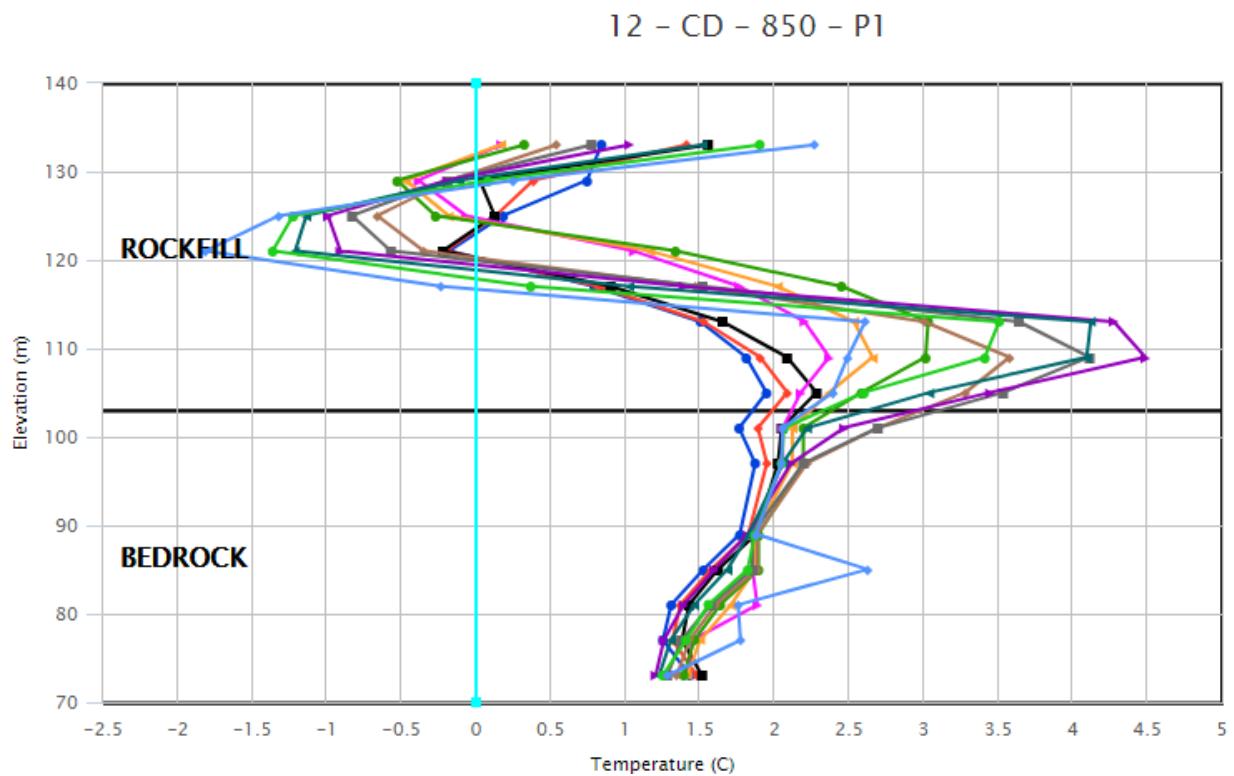
THERMISTOR 850-P1

- Temperature above 0° C in bedrock at 850-P1
- Similar profile than in 2016

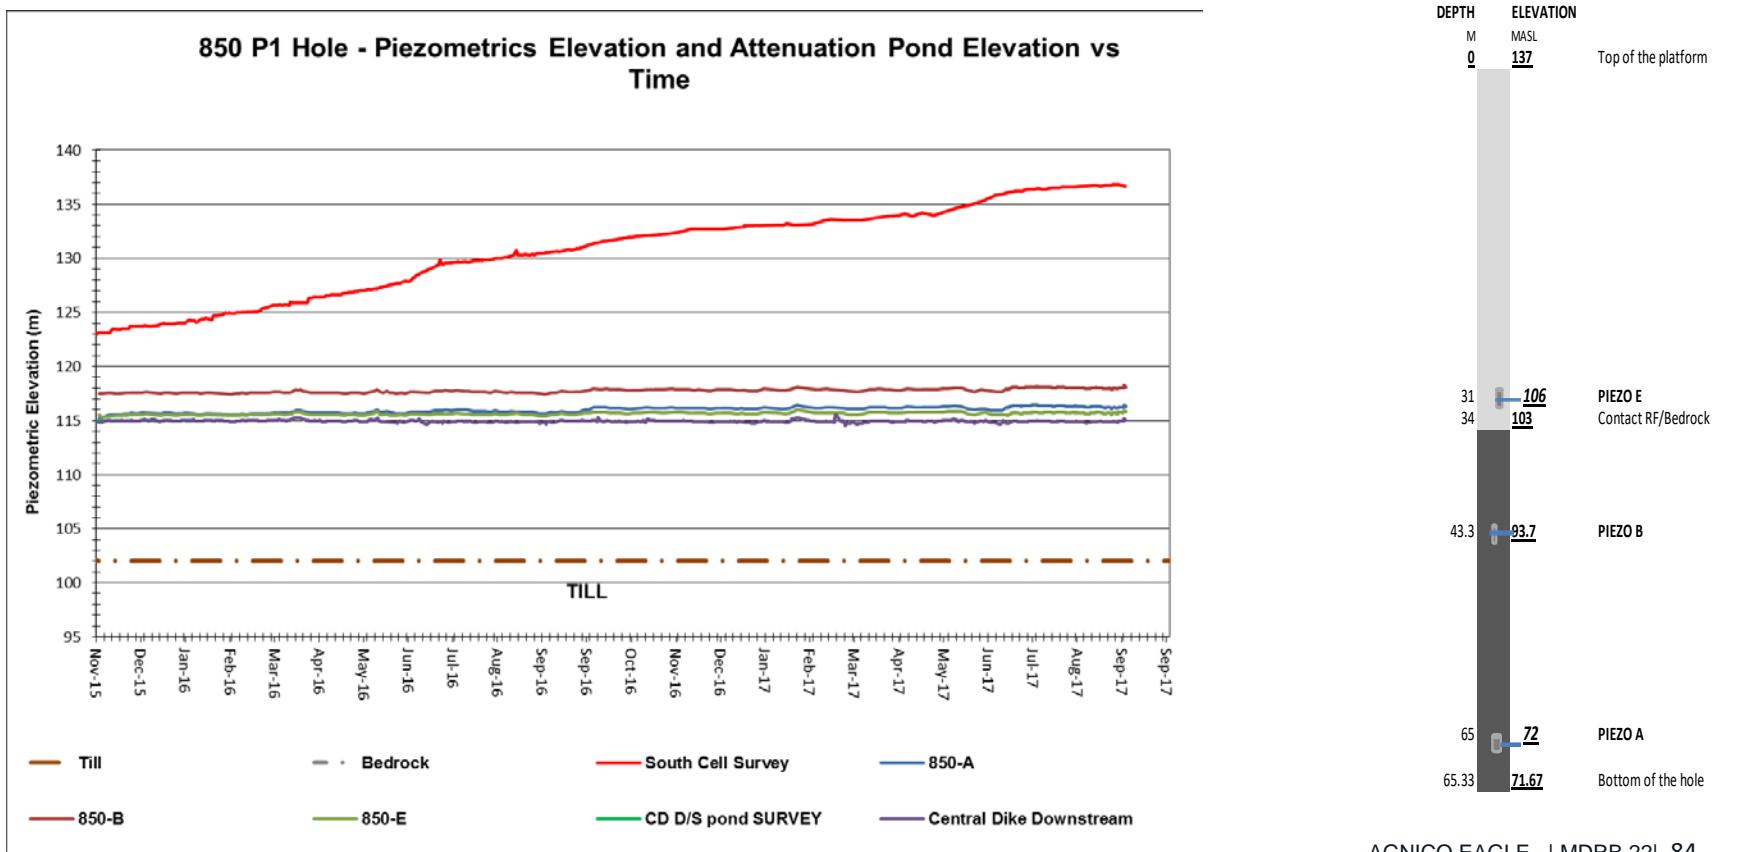
PIEZOMETER 850-P1

- ↗ All piezometer are following the trend of the D/S pond regime
- ↗ However piezo B is one of the highest in the piezometer readings that have stable reading (117.5m)
