2017 ANNUAL GEOTECHNICAL INSPECTION
MEADOWBANK GOLD MINE, NUNAVUT

APPENDIX C3

TSF North Cell Instrumentation Data

**MDRB # 22
P3 – STORMWATER DIKE
UPDATE**

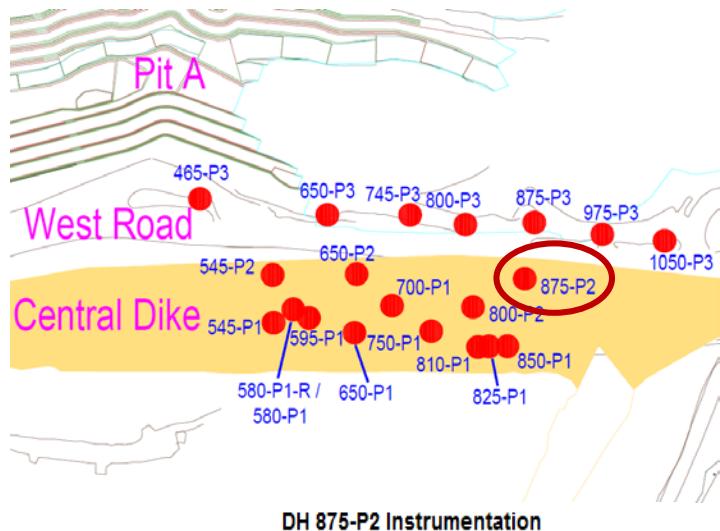
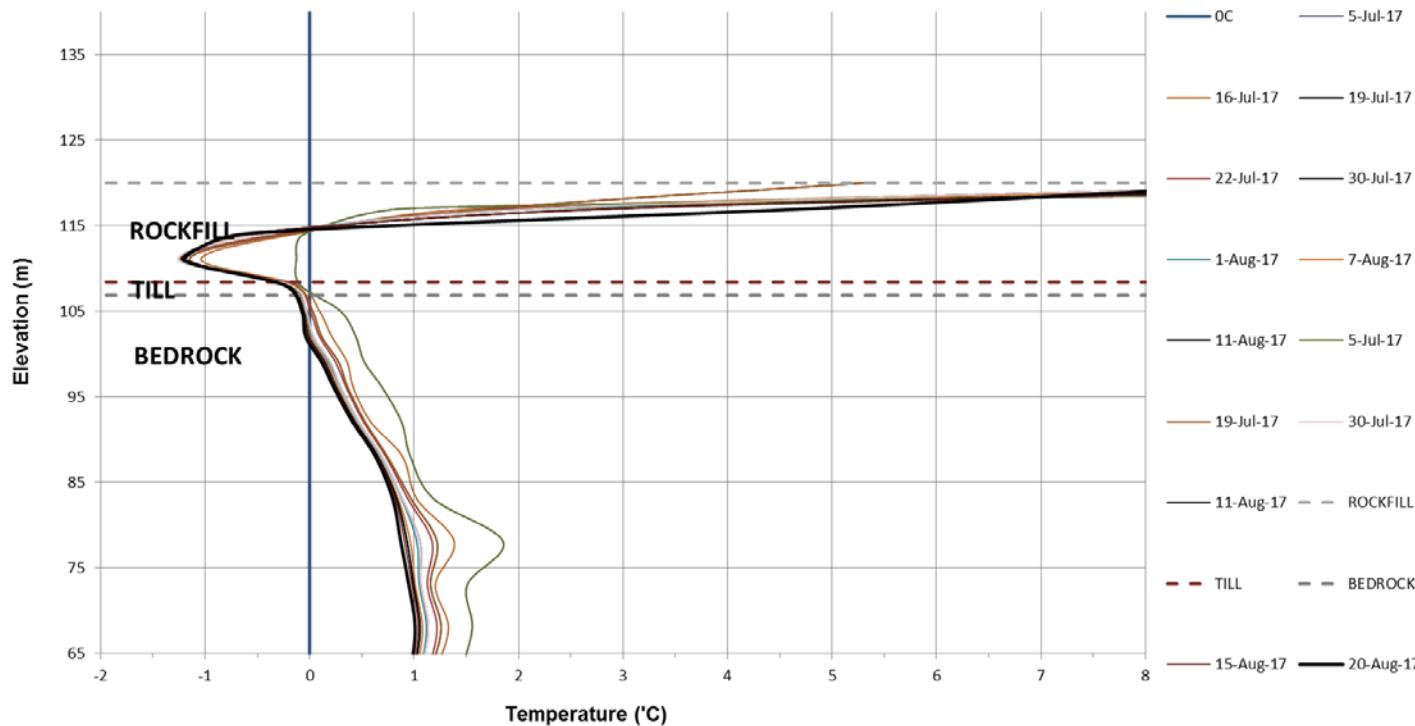
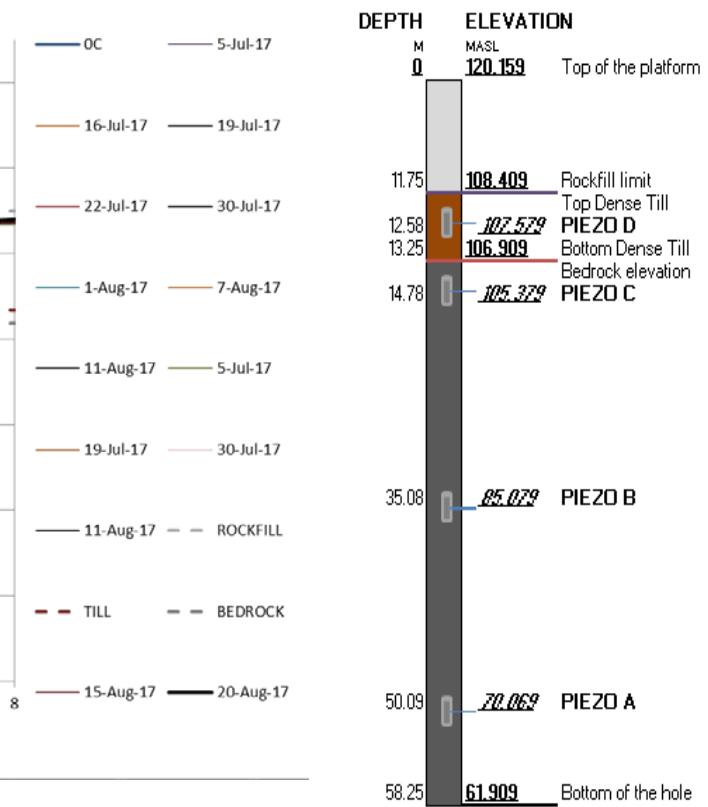
THERMISTOR 875-P2

- ↗ New thermistor installed in 2017
- ↗ Stabilisation of temperature ongoing
- ↗ Bedrock temperature above 0° C

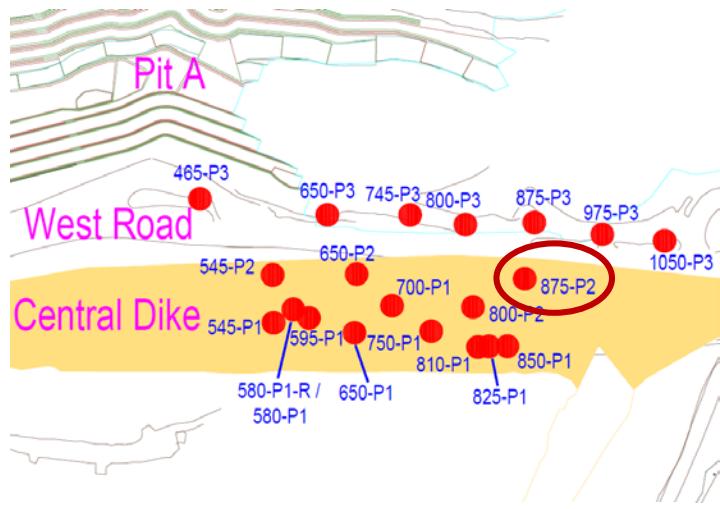
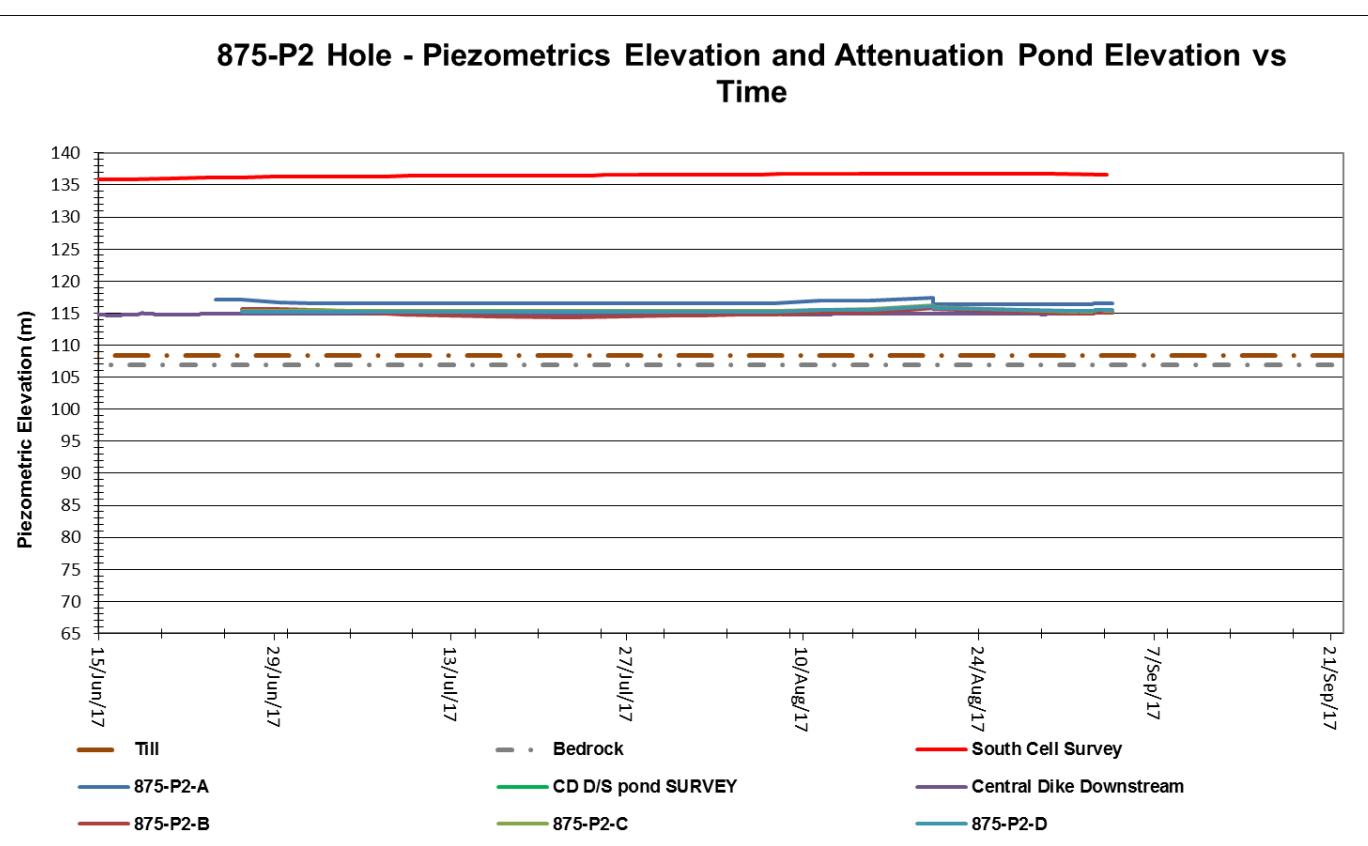
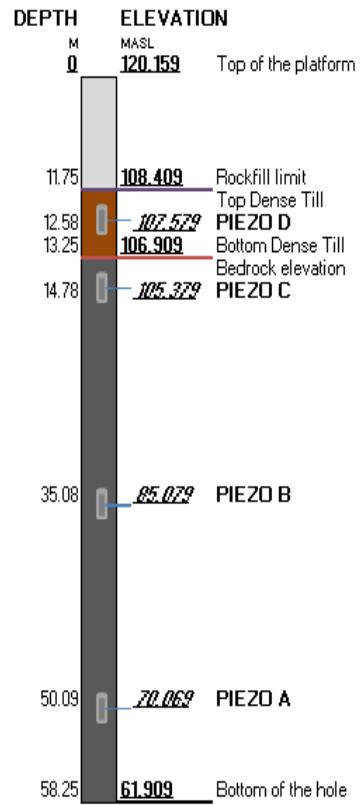
PIEZOMETER 875-P2

- >All piezometer are following the trend of the D/S pond regime
- Small glitch in the data was observed when automatization of the system was completed

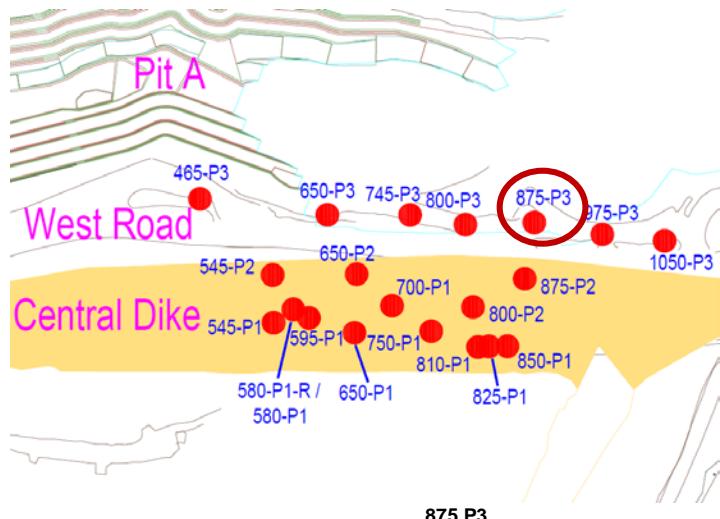
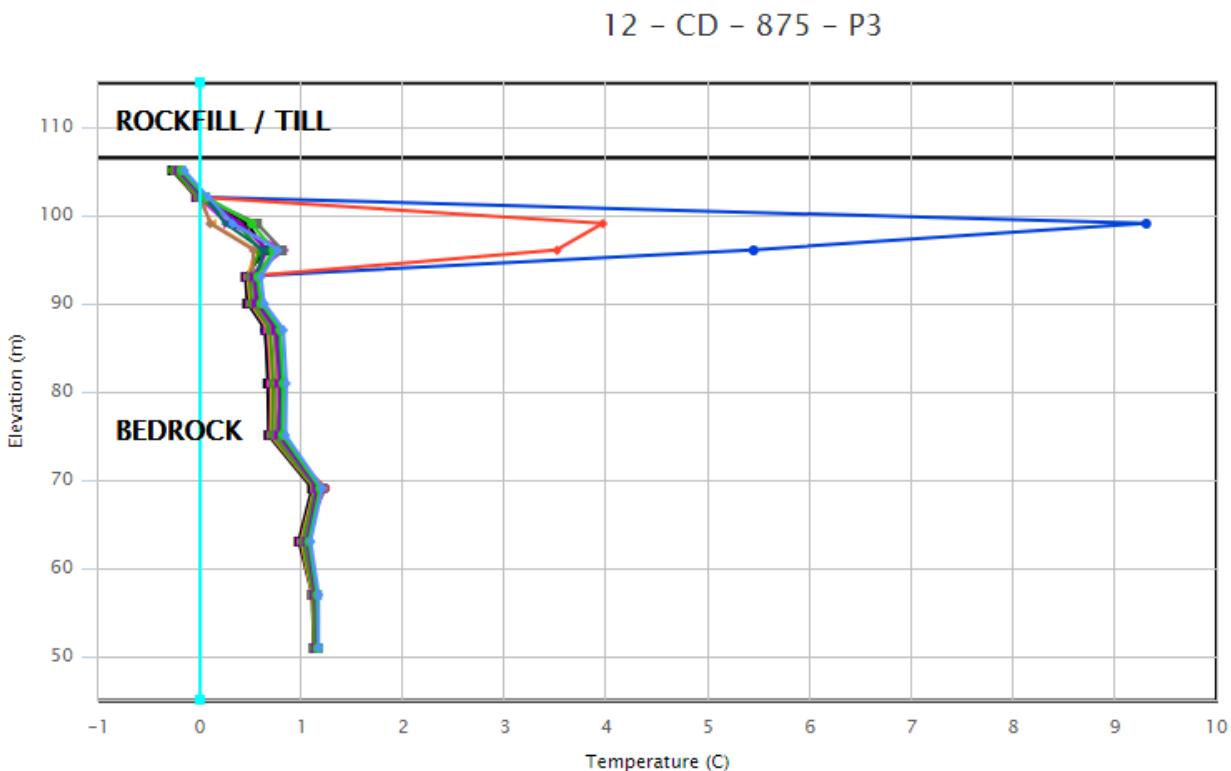
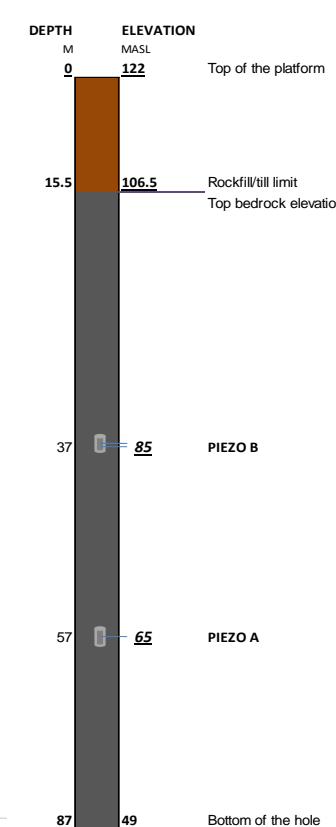
THERMISTOR 875-P3

- Temperature above 0° C in bedrock at 875-P3
- Temperature spike at El.96 m and 99 m are related to capacitance effect.

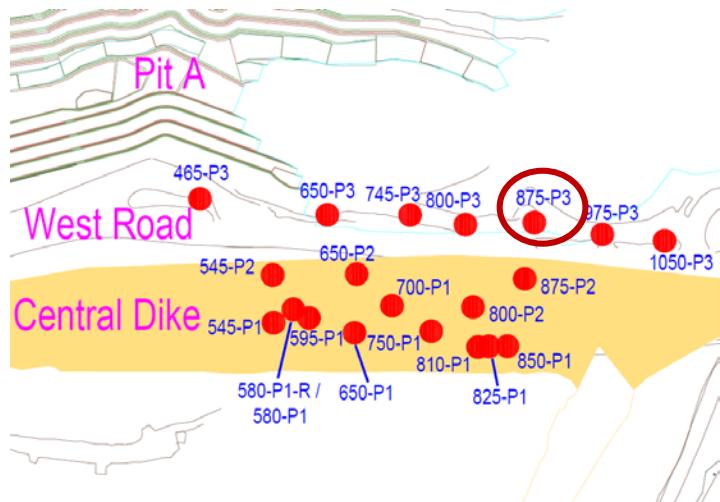
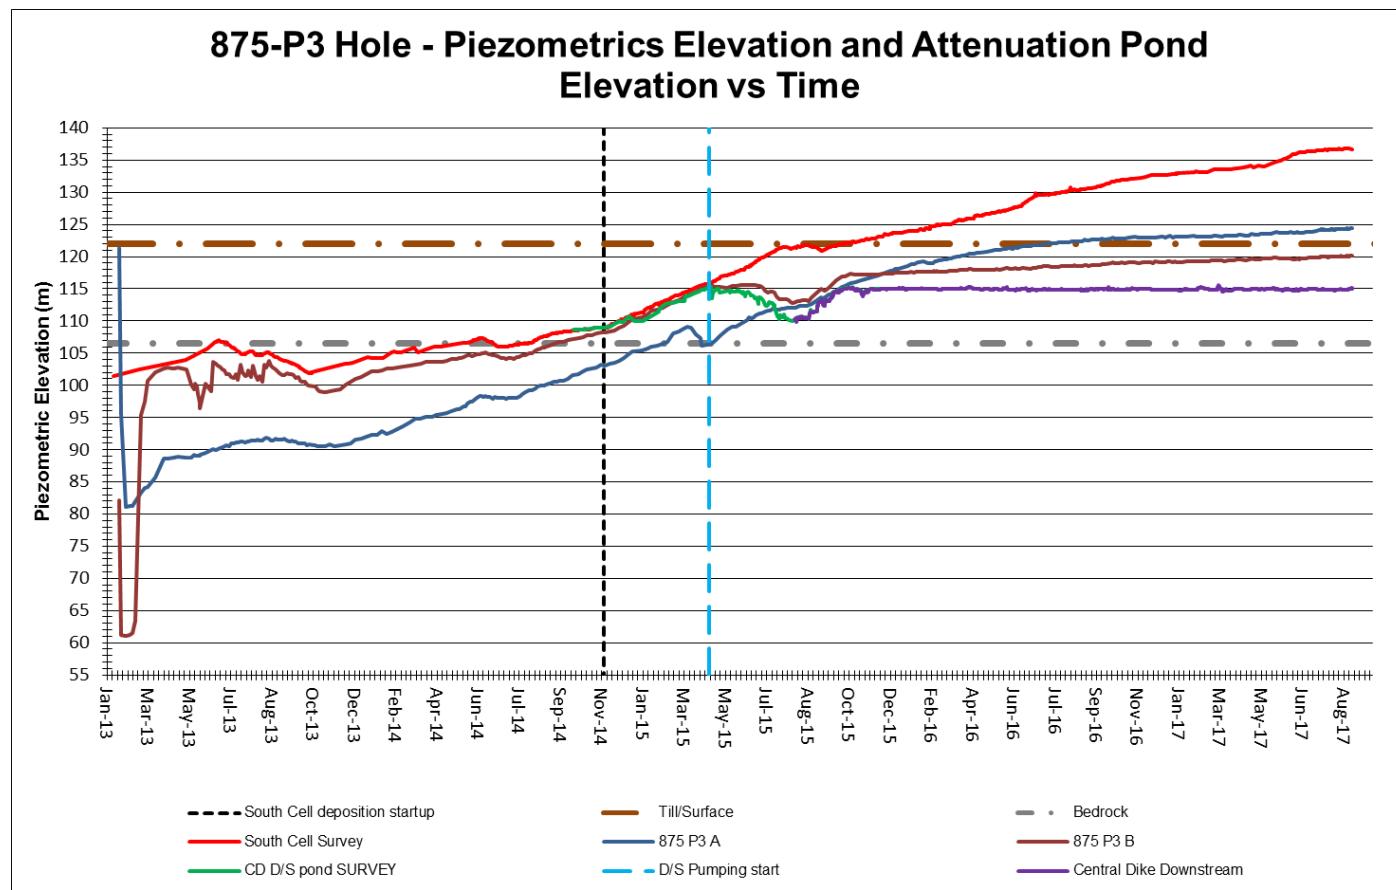
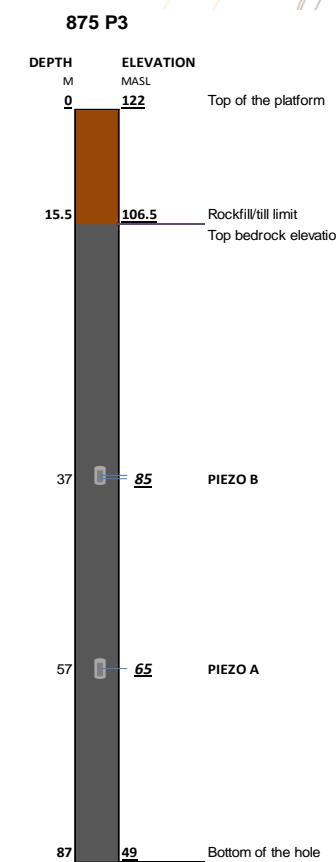
PIEZOMETER 875-P3

- Piezometer at 875-P3 are in bedrock and are impacted by increase in South Cell head

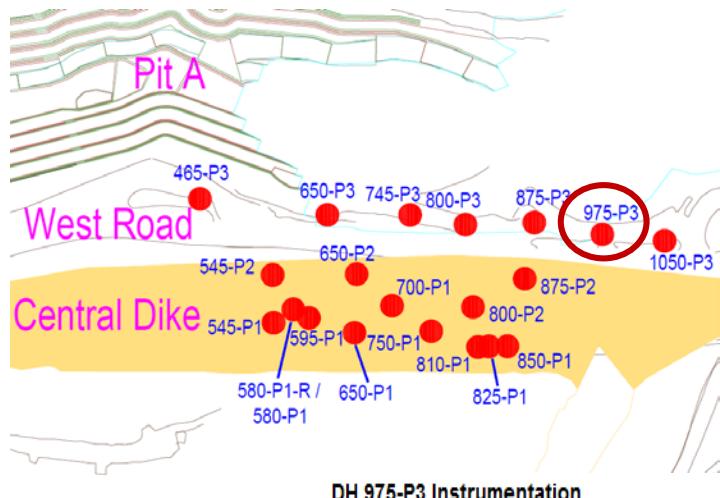
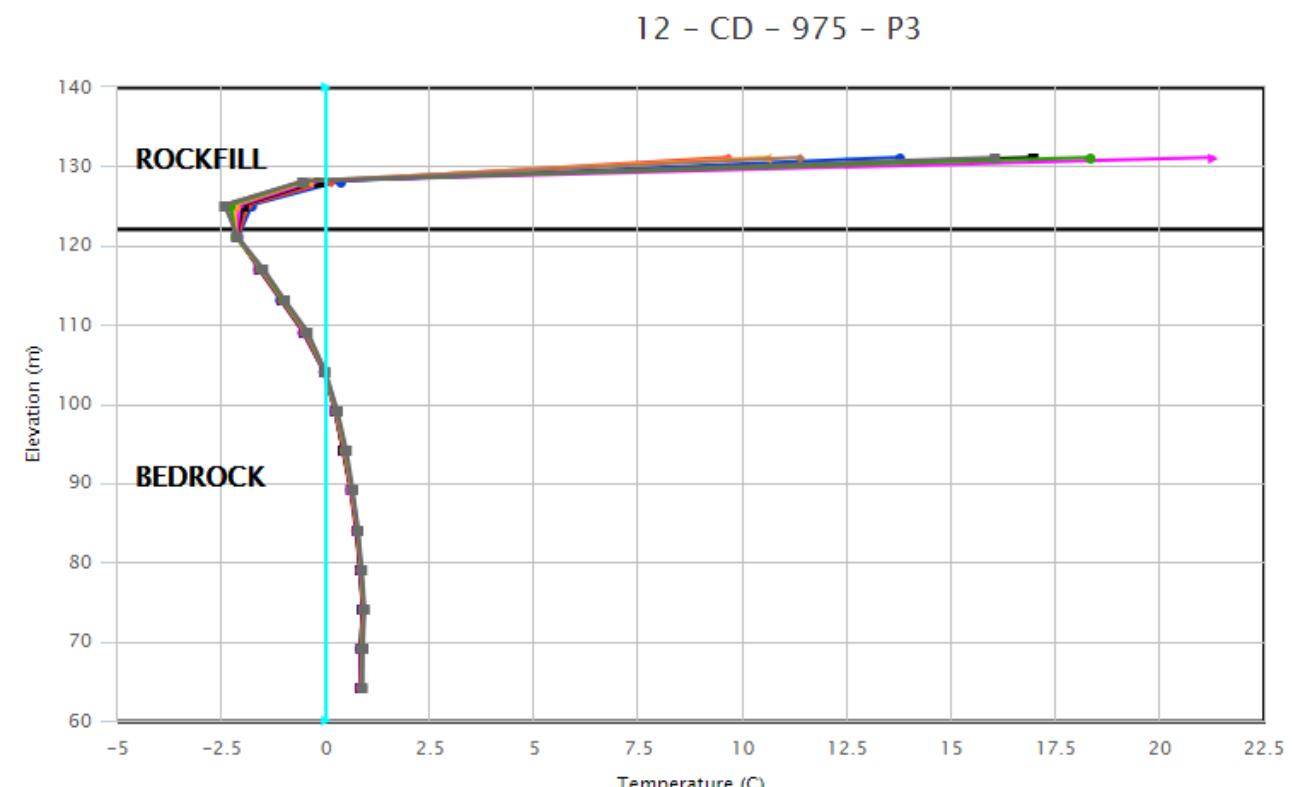
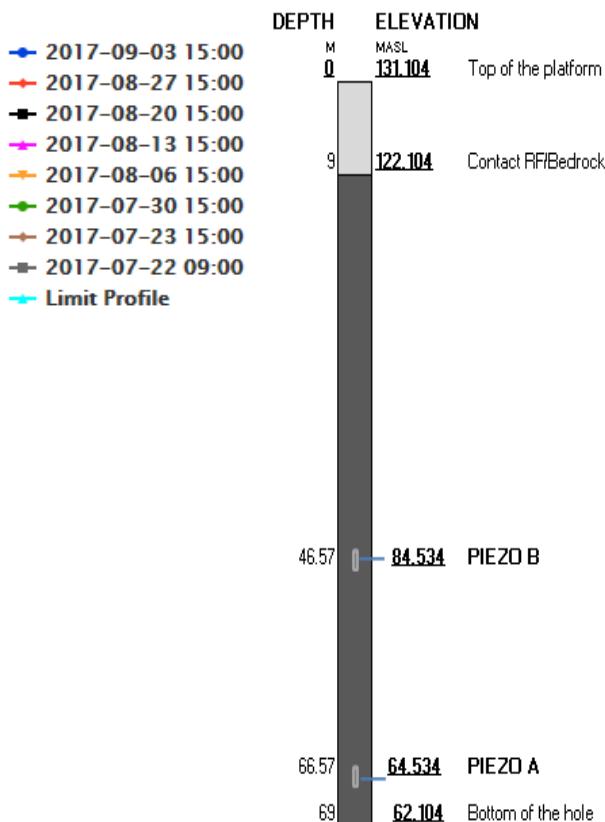
THERMISTOR 975-P3

- ↗ New instrument installed in 2017
- ↗ Stabilization of the thermistor mostly done
- ↗ Temperature above 0° C in bedrock below El. 105 m

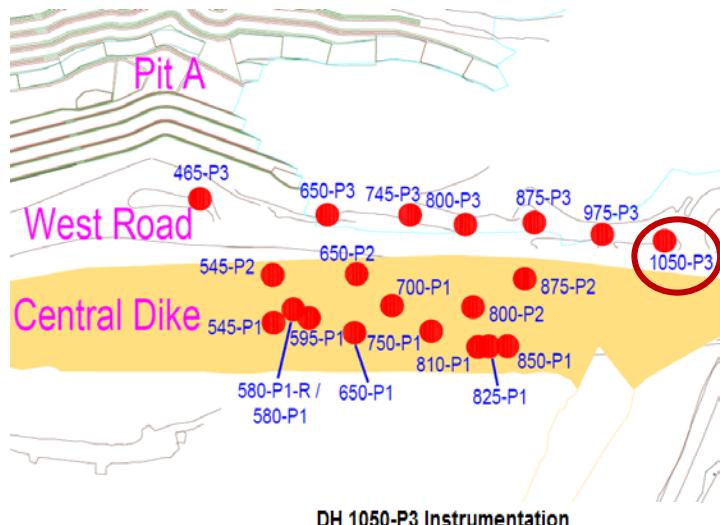
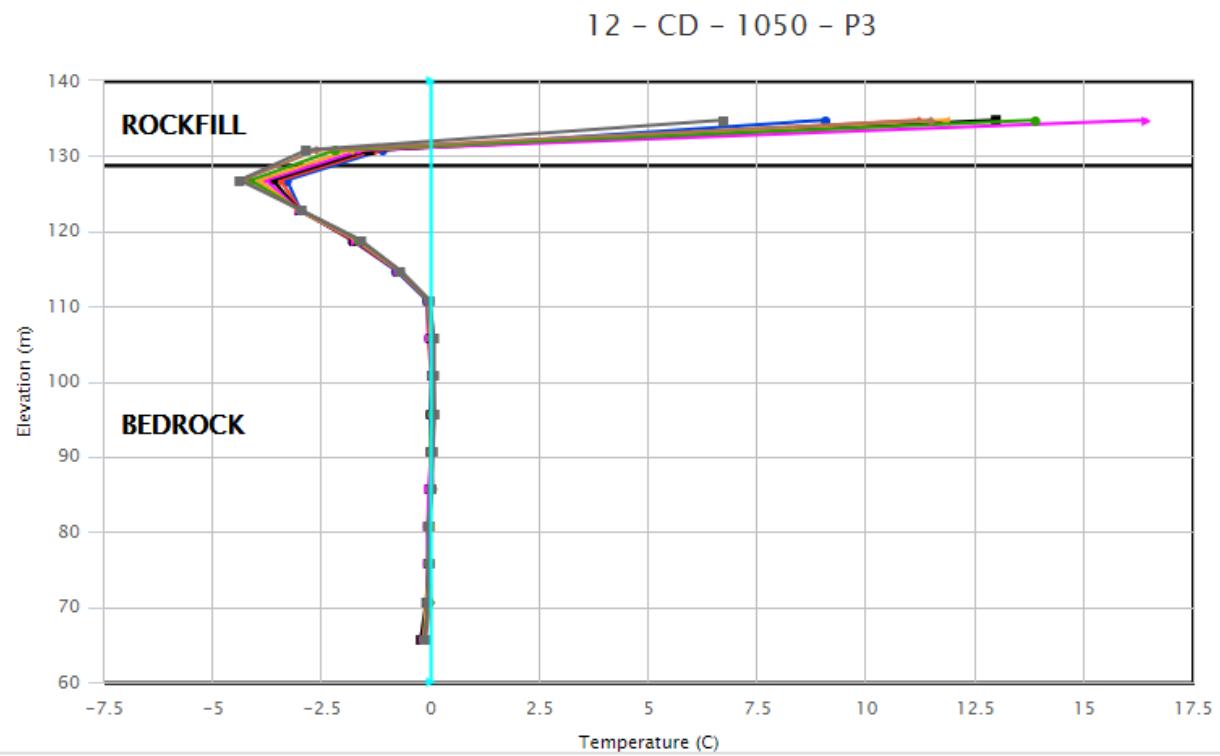
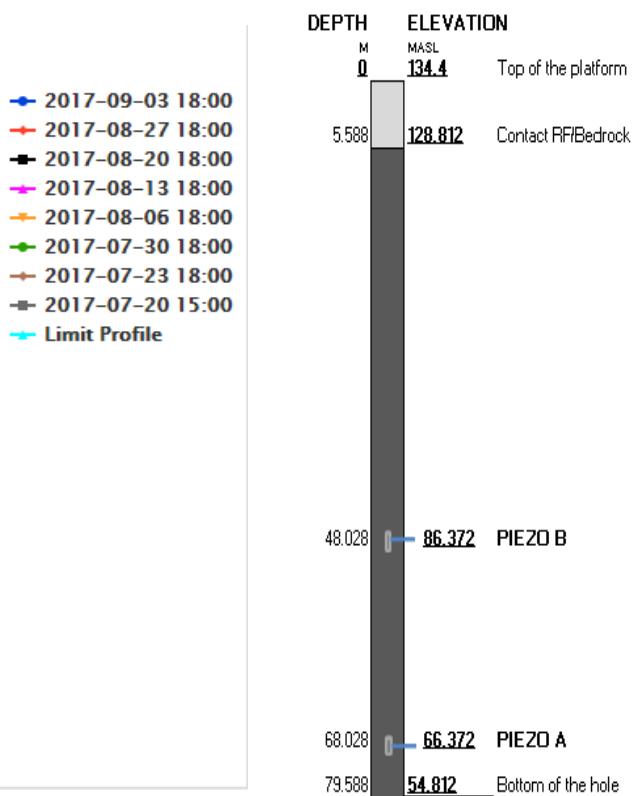
THERMISTOR 1050-P3

↗ Temperature at 0° C in bedrock

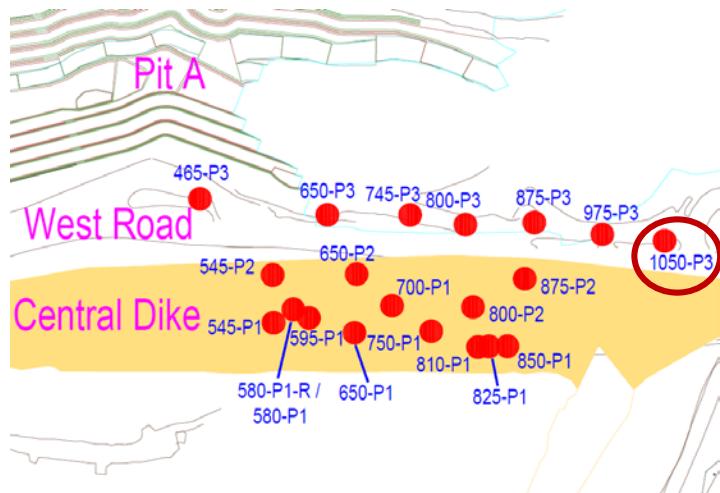
PIEZOMETER 1050-P3

- ↗ Piezometers temperature just below the freezing point
- ↗ Piezometers are following the trend of the D/S pond elevation.

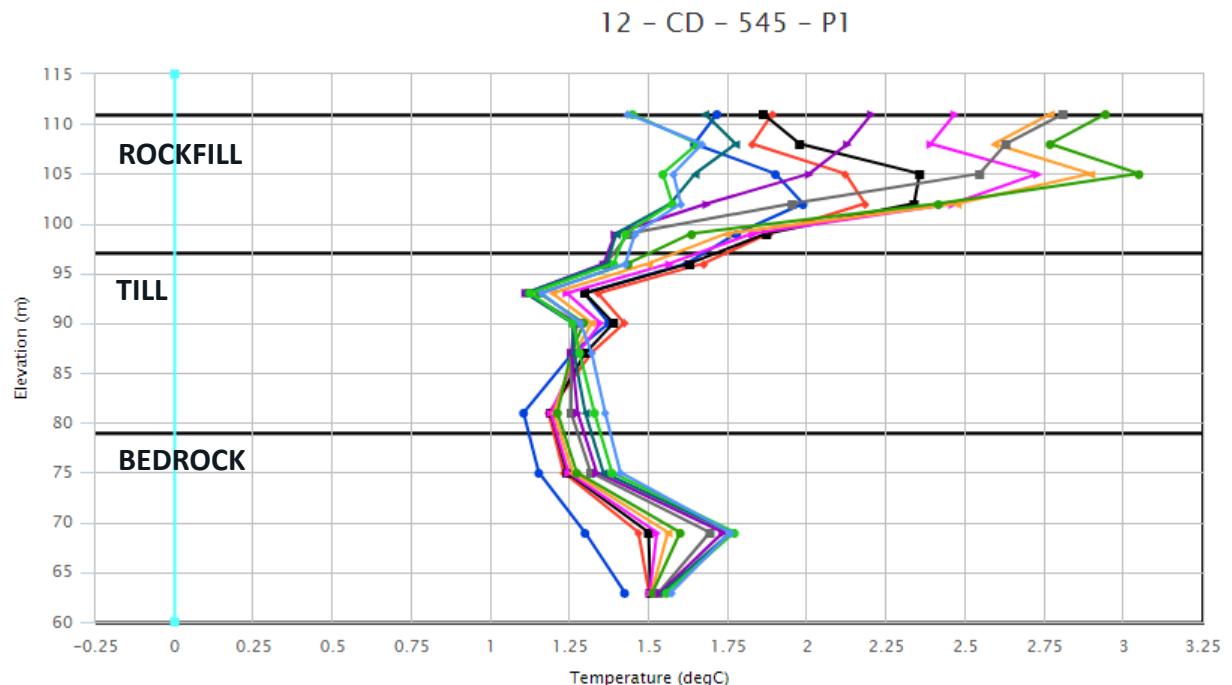
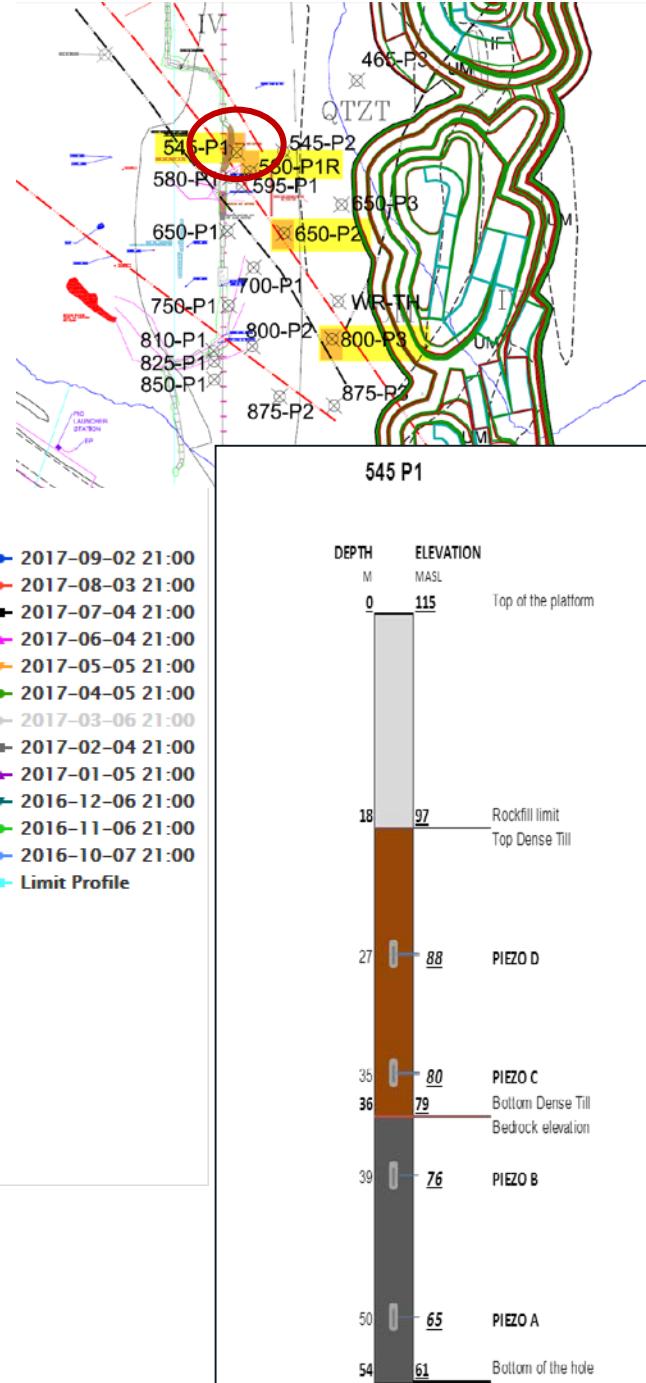
THERMISTOR 545-P1

- 545-P1 thermistor is showing the same temperature profile than last year. Warmer peak observed at elevation 70m since the installation.
- Temperature in the bedrock/till unit is in between 1.1 and 1.75° C.

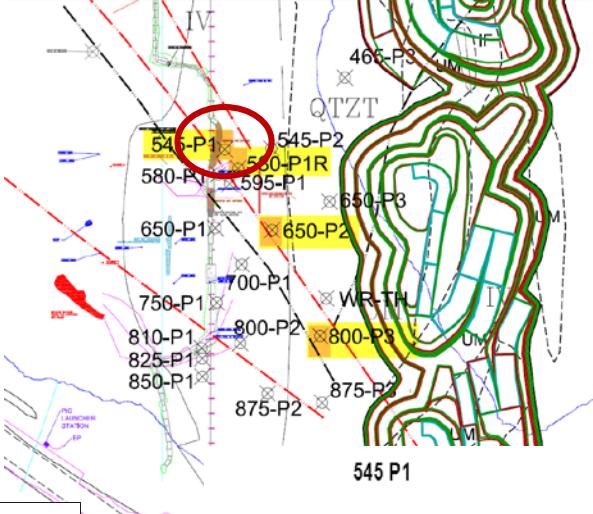
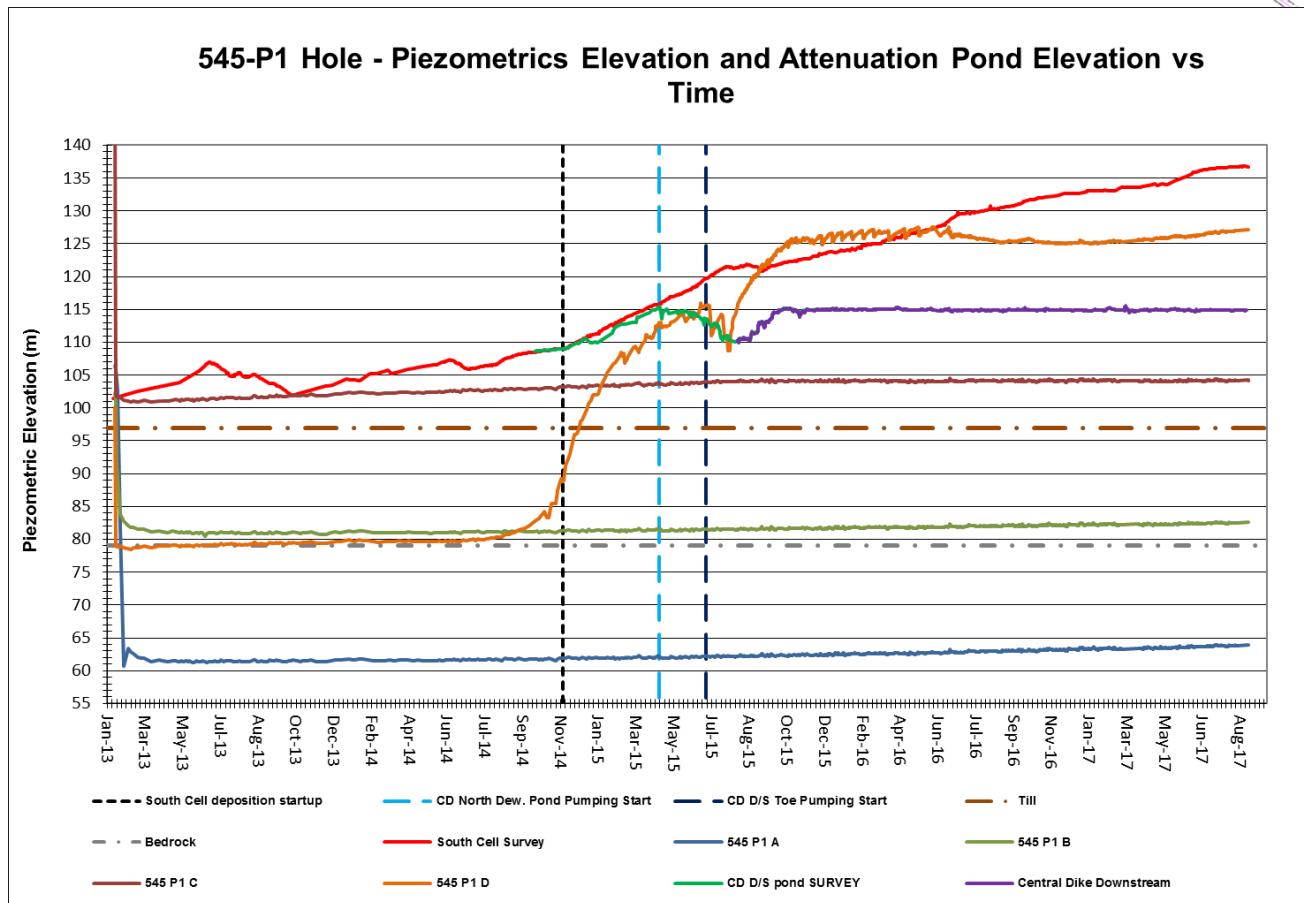
PIEZOMETER 545-P1

- Piezometer D still constant, no change since August 2015
- Piezometer A is recording suction since its installation
- Identification of the piezo on the field is confusing.
Interpretation of the readings must be done with precaution.

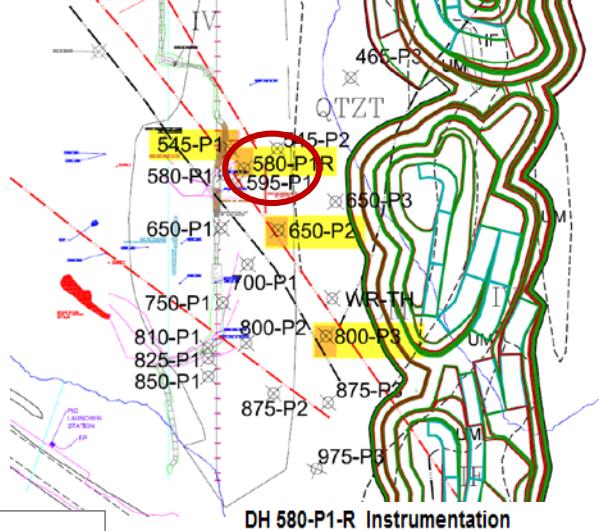
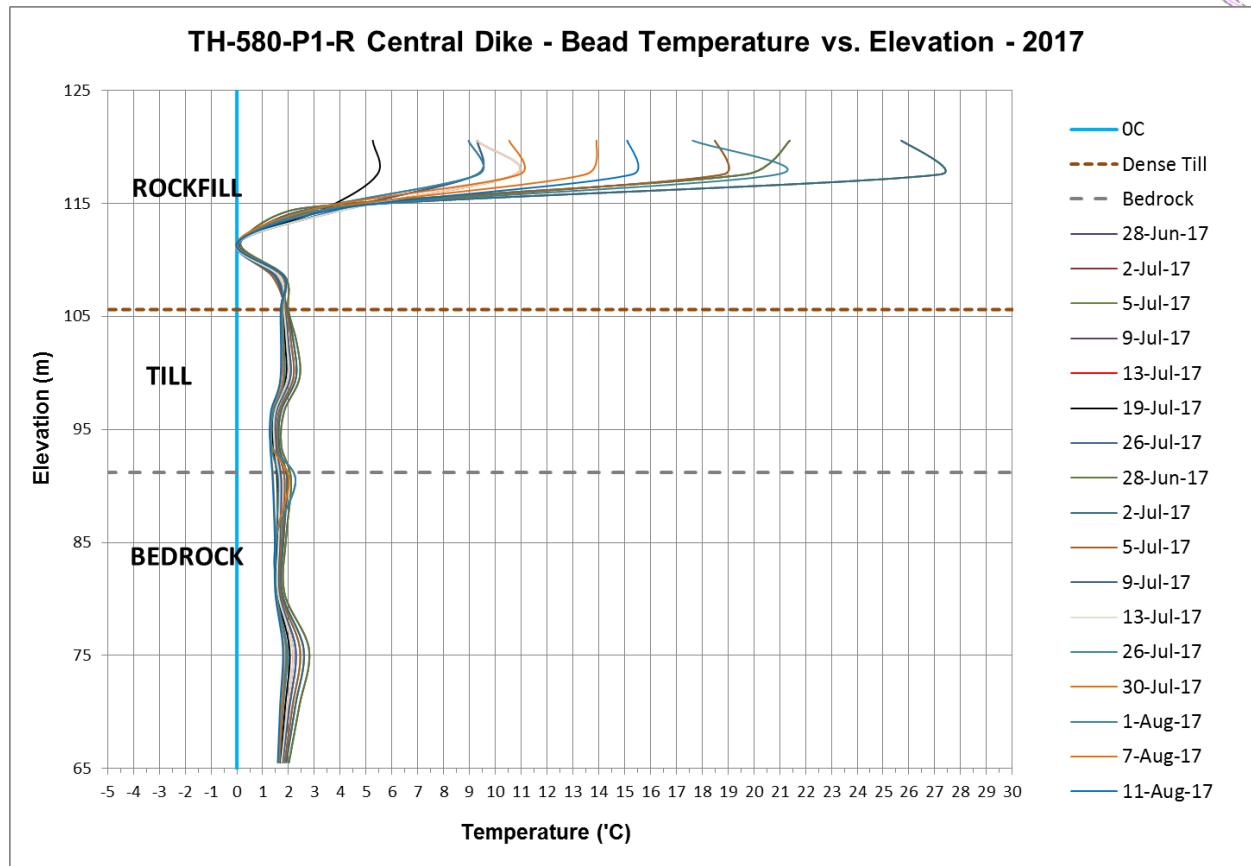
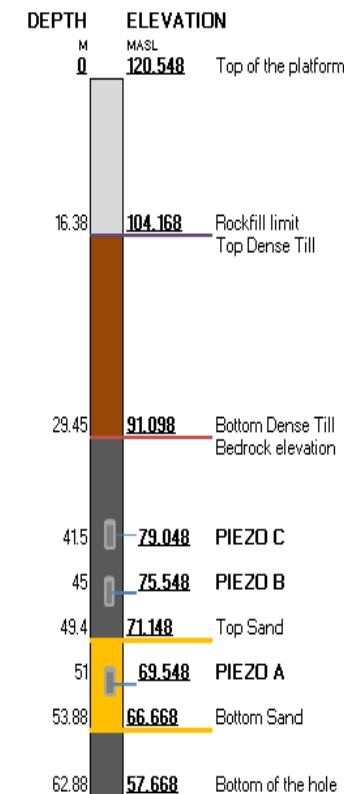
THERMISTOR 580-P1R

- ↗ Stabilisation in progress
- ↗ Temperature readings above 0°C
- ↗ Similar temperature readings range than 580-P1

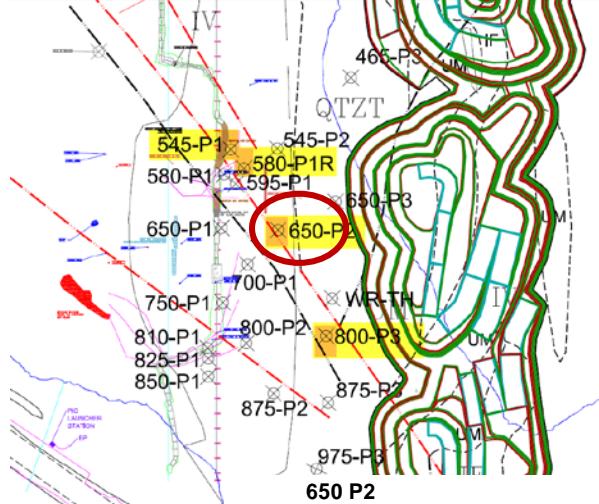
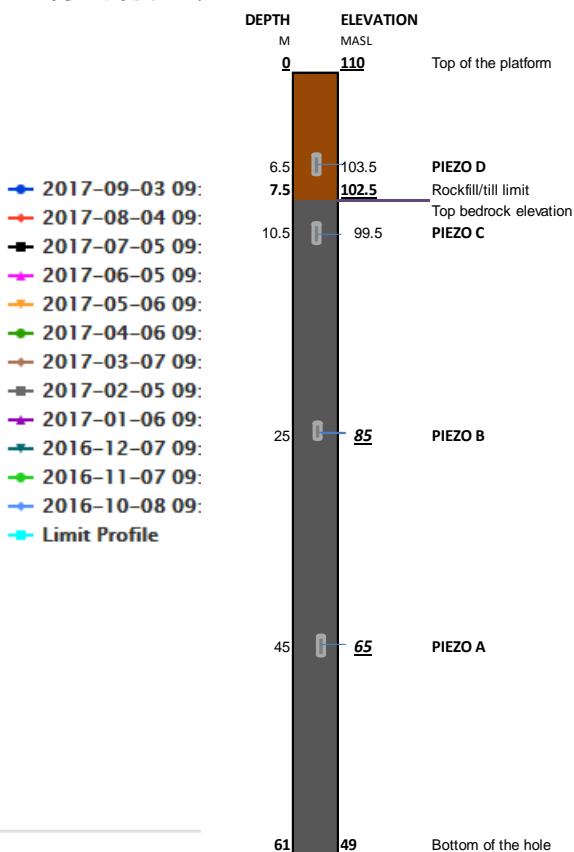
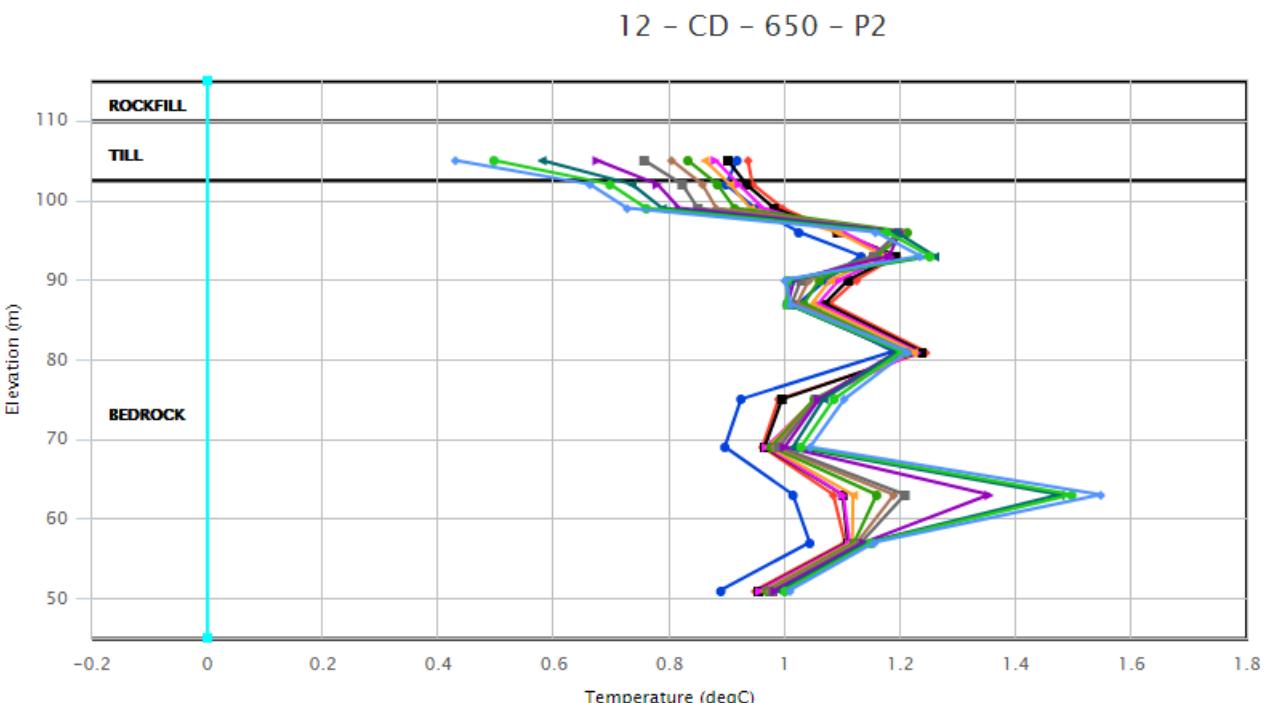
THERMISTOR 650-P2

- Cooling trend observed below El. 80 similar to 2016 readings.

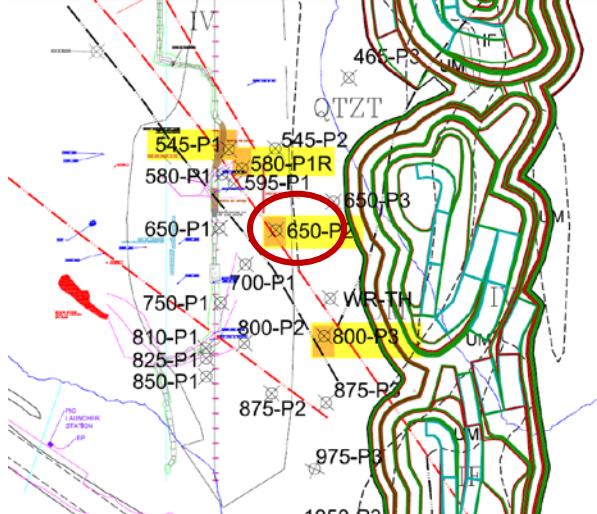
PIEZOMETER 650-P2

- Piezometer A in bedrock continue its rise and is now over the elevation of the South Cell
- Piezo B-C are following the piezometric regime of the D/S pond
- Piezo D is in suction

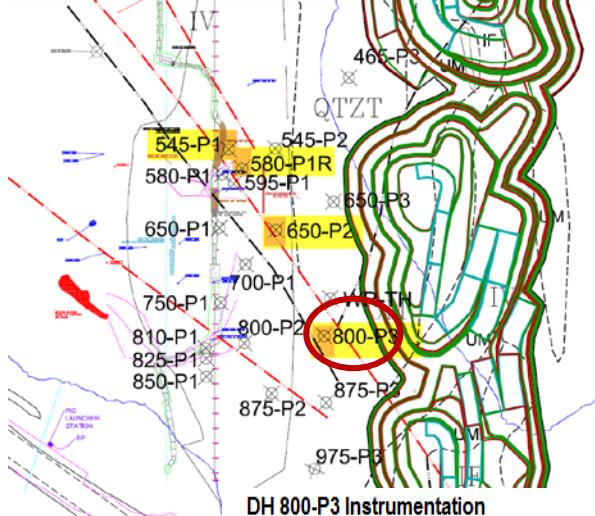
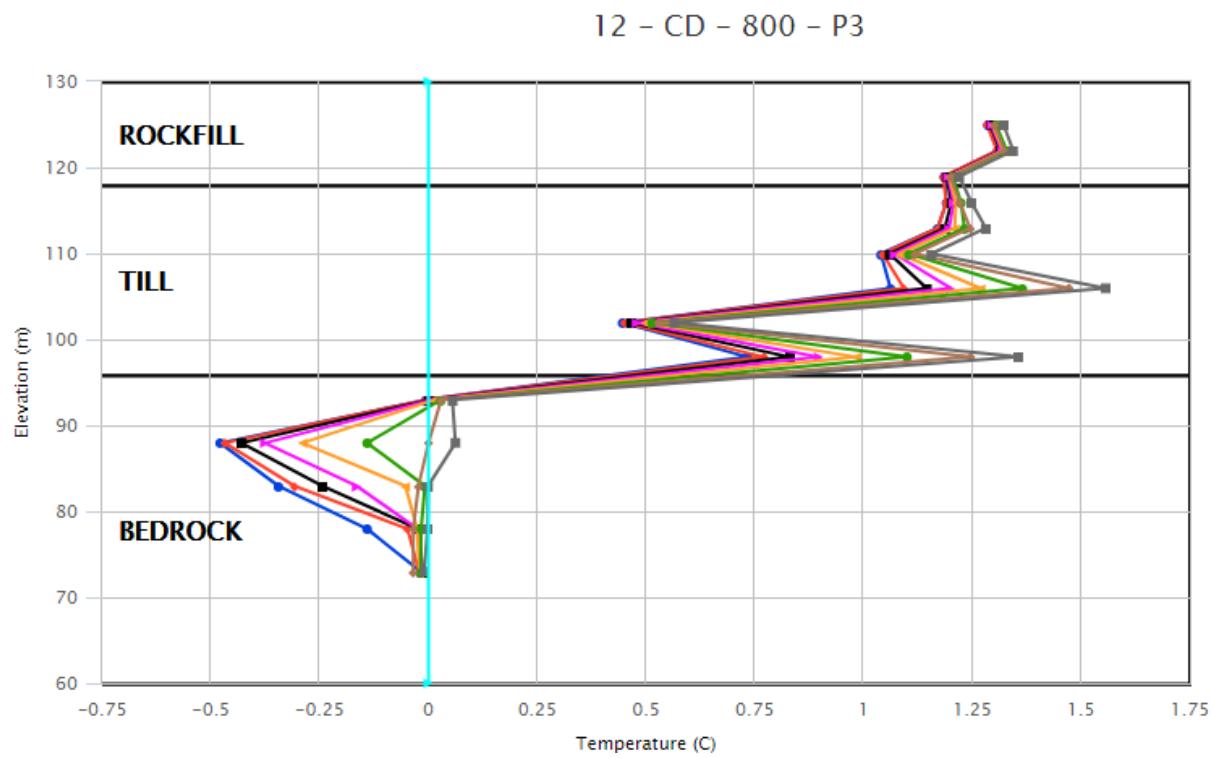
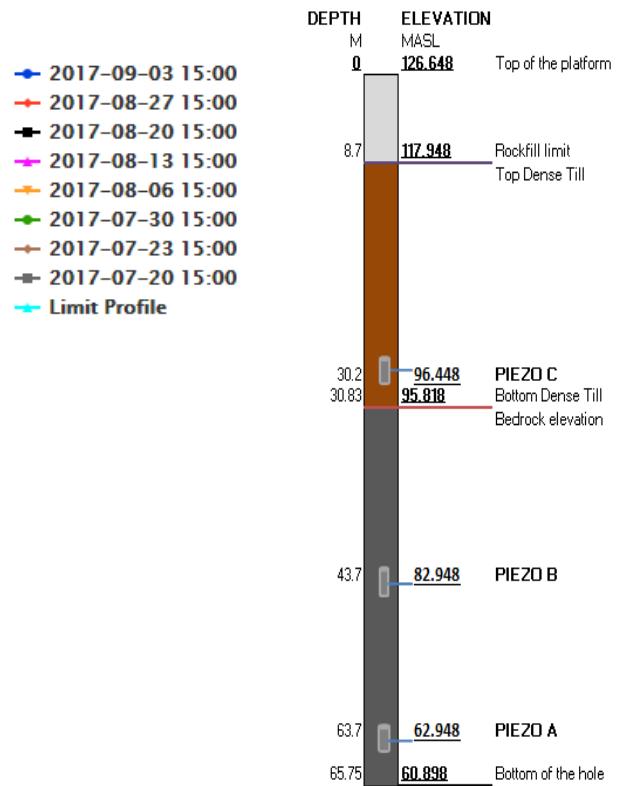
THERMISTOR 800-P3

- ↗ New instrument installed in 2017
- ↗ Stabilisation in progress
- ↗ Temperature under 0° C below El. 93 m

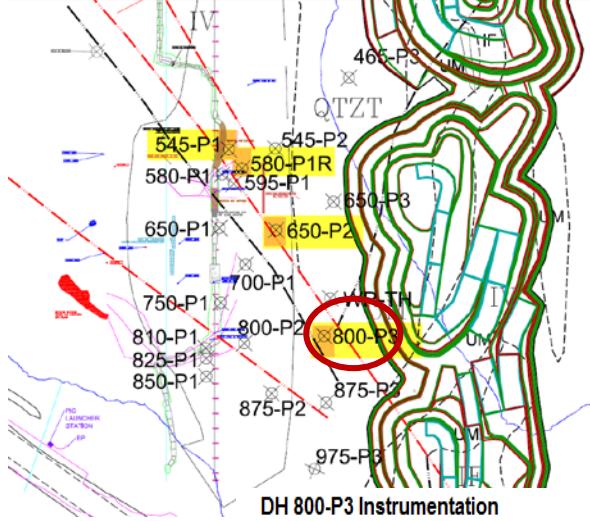
PIEZOMETERS 800-P3

- ↗ New instrument installed in 2017
- ↗ Stabilization in progress
- ↗ Piezo A & B readings are similar to the D/S pond elevation readings
- ↗ Piezo C readings is slowly decreasing

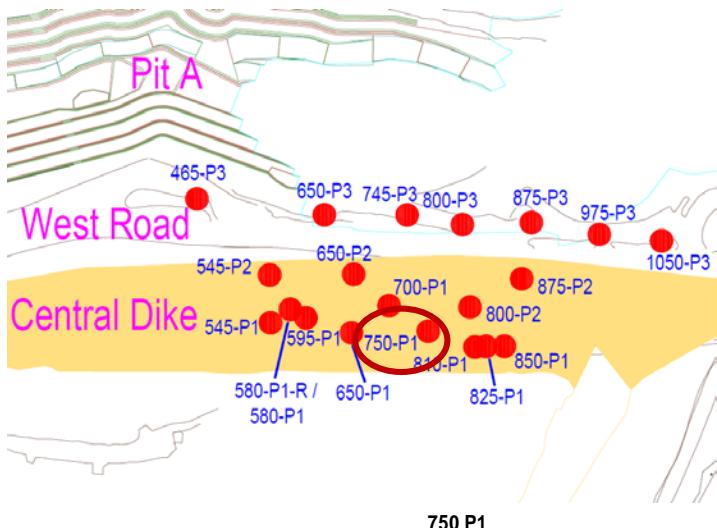
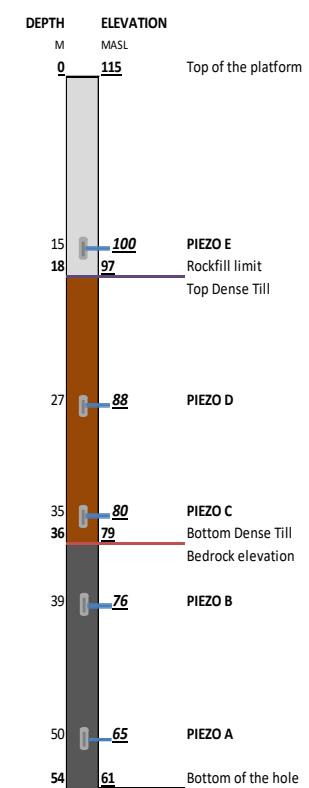
THERMISTOR 750-P1

→ Cooling trend in till layer. The bead located at elevation 90m is in average 1°C cooler than in 2016.

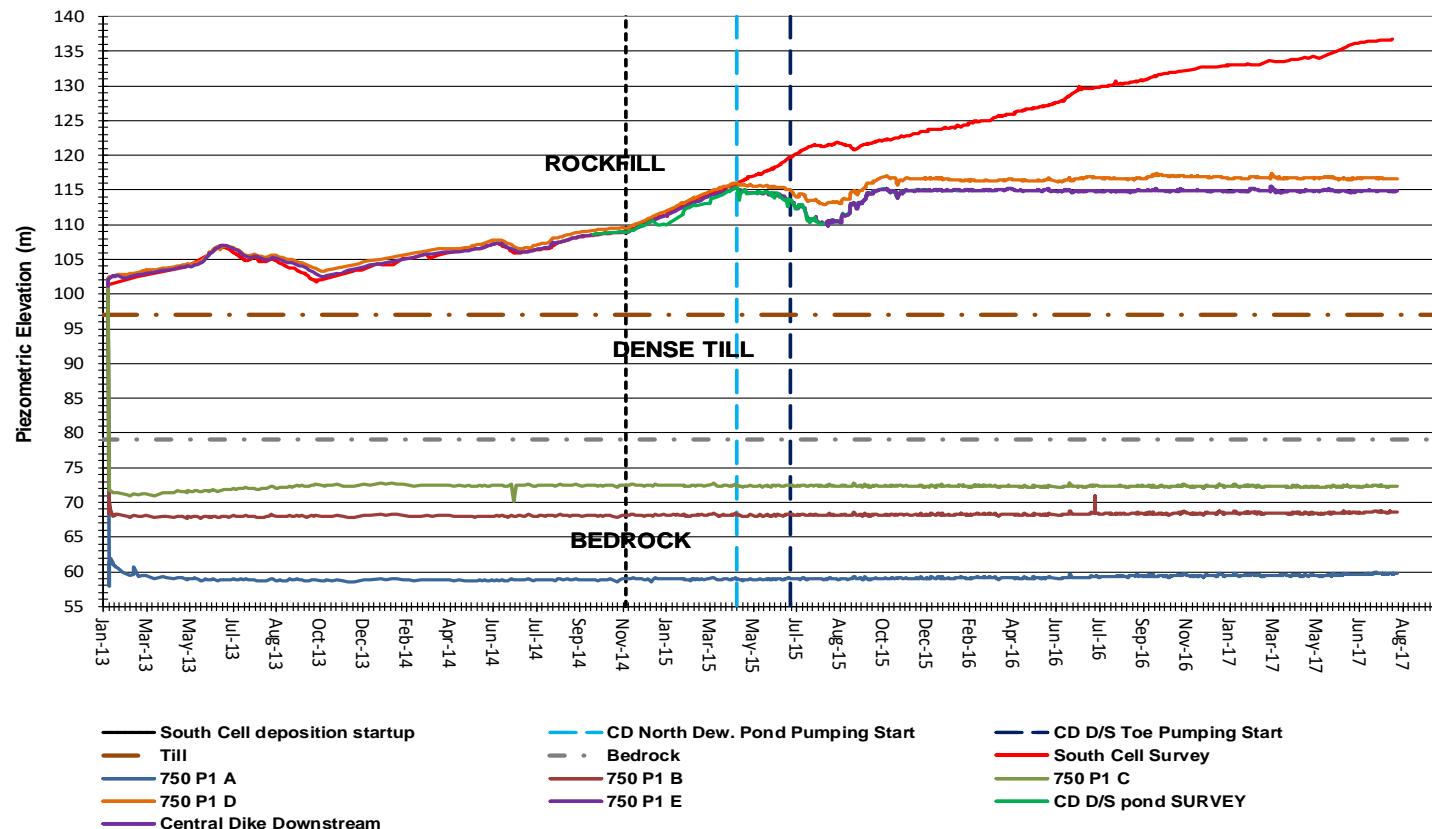
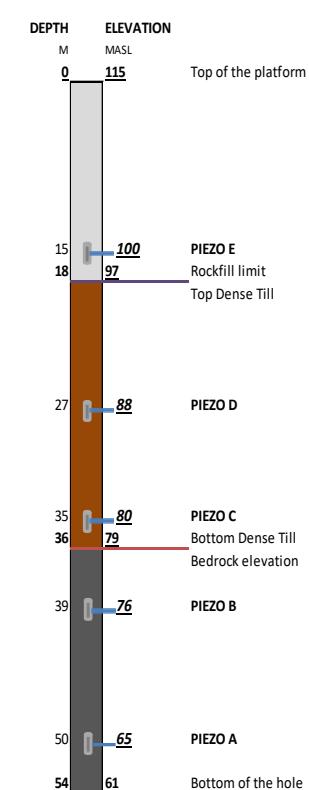
750-P1 Hole - Piezometrics Elevation and Attenuation Pond Elevation vs Time

- Piezo A, B and C are in suction
- Piezo D is have a direct reaction to any variation in elevation observe in the D/S pond.
