2017 ANNUAL GEOTECHNICAL INSPECTION
MEADOWBANK GOLD MINE, NUNAVUT

APPENDIX C3

TSF North Cell Instrumentation Data

**MDRB # 22
P3 – STORMWATER DIKE
UPDATE**

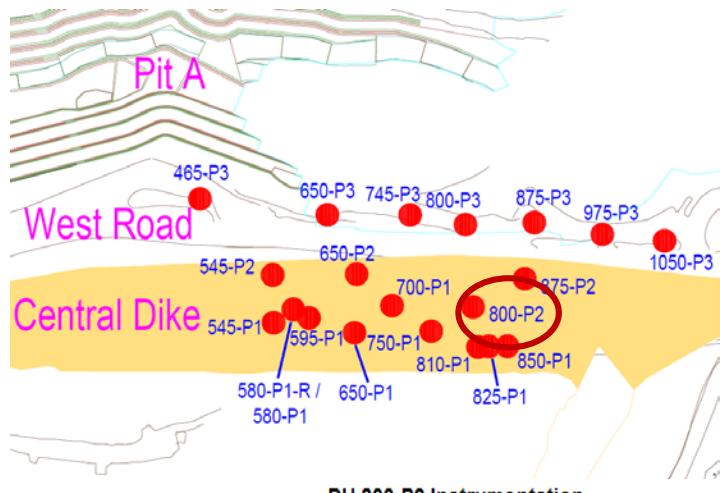
PIEZOMETER 800-P2

- ↗ New instrument installed in 2017
- ↗ Stabilisation ongoing
- ↗ Piezo A, B and C are showing pressure readings similar to the elevation of the D/S pond.

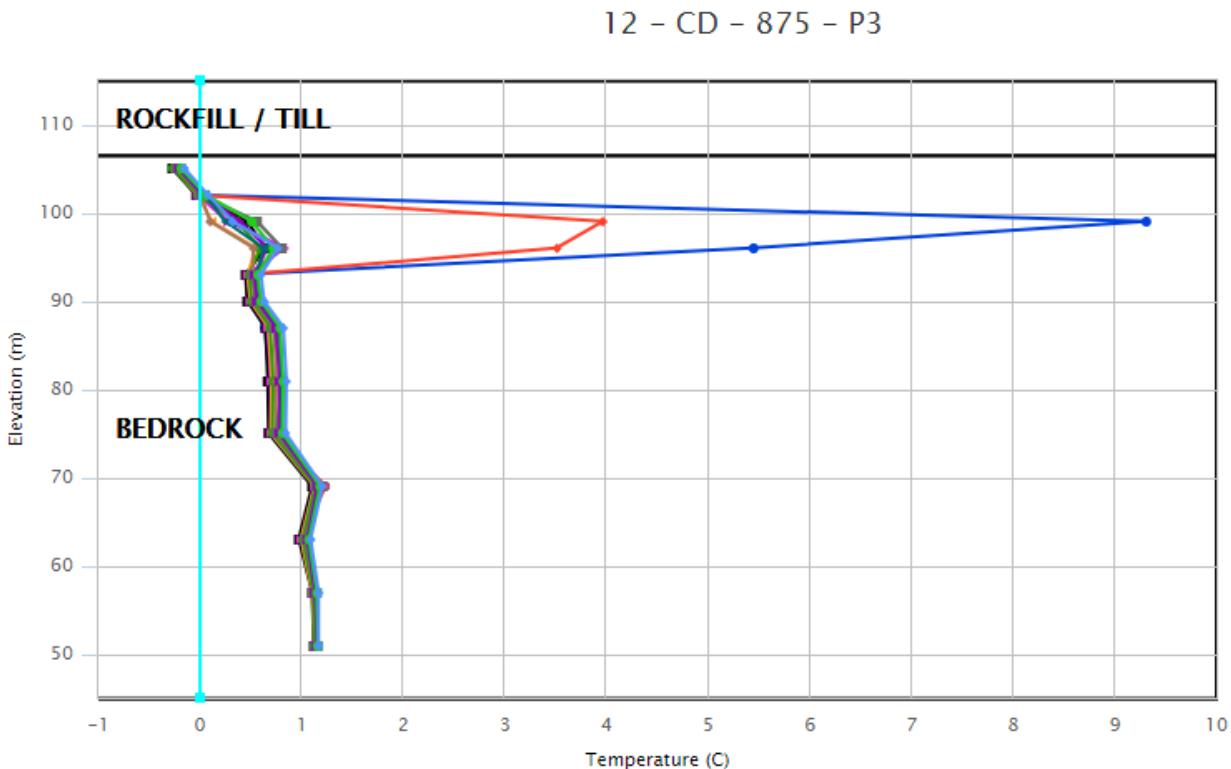
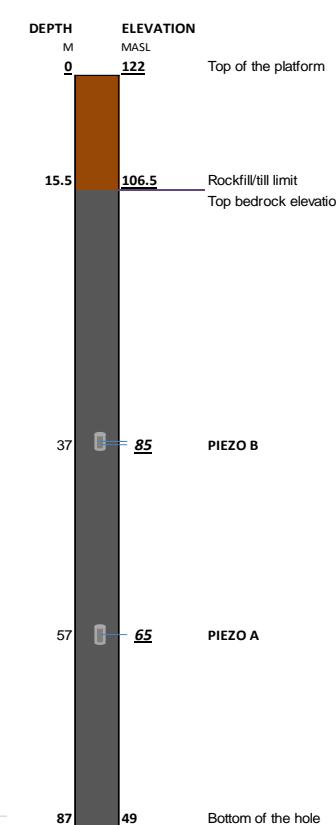
THERMISTOR 875-P3

- Temperature above 0° C in bedrock at 875-P3
- Temperature spike at El.96 m and 99 m are related to capacitance effect.

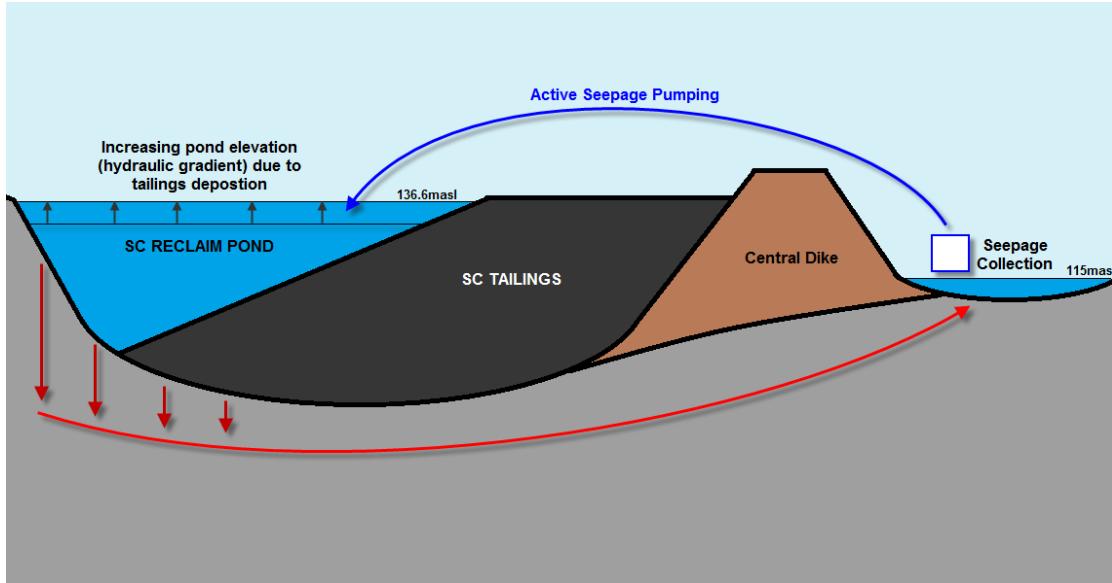
Original D/S Pond Setup

- ↗ Pump water back to South Cell keeping D/S Pond at El. 115m

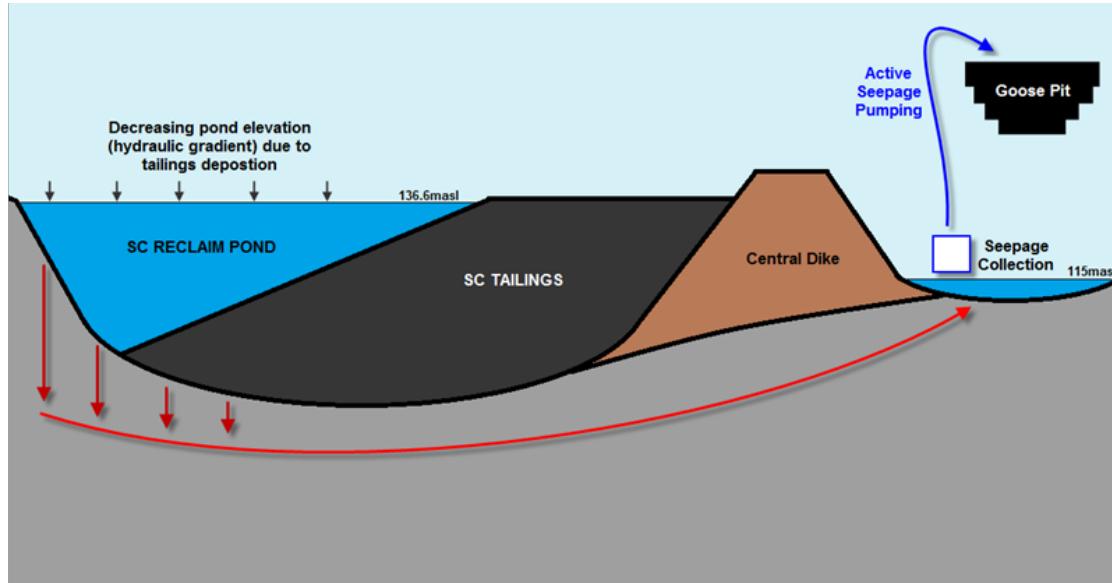
Modified D/S Pond Setup

- ↗ Addition of a line from D/S Pond to Goose pit
- ↗ Water is transferred while keeping D/S Pond at El. 115 m
- ↗ Transfer 350 000 m³ of water is initiated

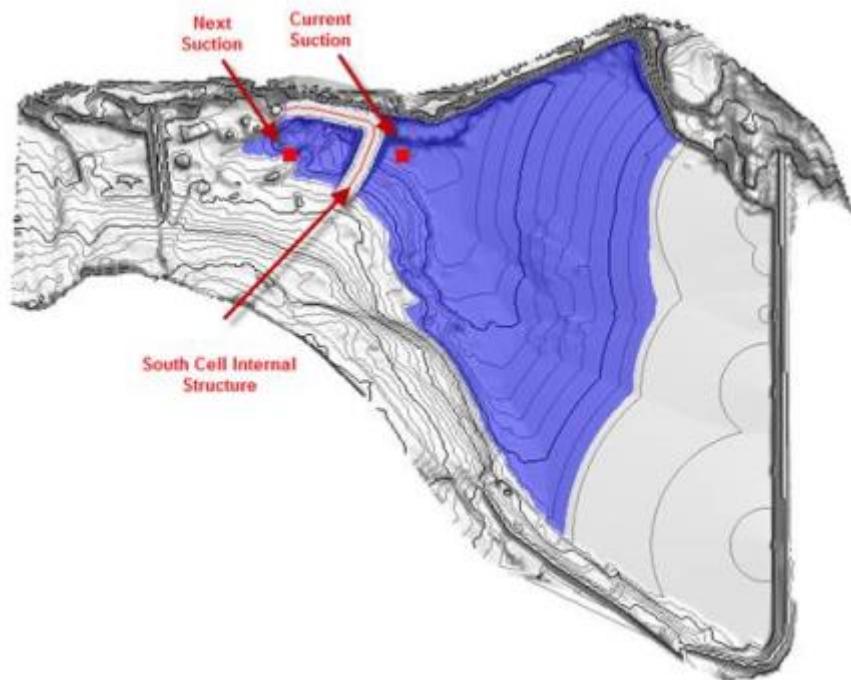
SOUTH CELL INTERNAL STRUCTURE

Objective is to secure operation of the South Cell TSF during the winter 2018 by building a permeable rock fill structure in front of the reclaim area.

- ↗ Slurry beach getting too close to the reclaim suction and reclaim water quality issues at the mill;
- ↗ Water elevation going higher than freeboard elevation (which would require goose transfers to fix);
- ↗ Increases TSF capacity.

Crest elevation:	138 m
Crest width:	30 m
Max structure height:	8 m
Volume of rock fill:	62,000 m ³
Type of material:	Soapstone
Trench bottom elevation:	136 m
Construction time:	Oct 2017

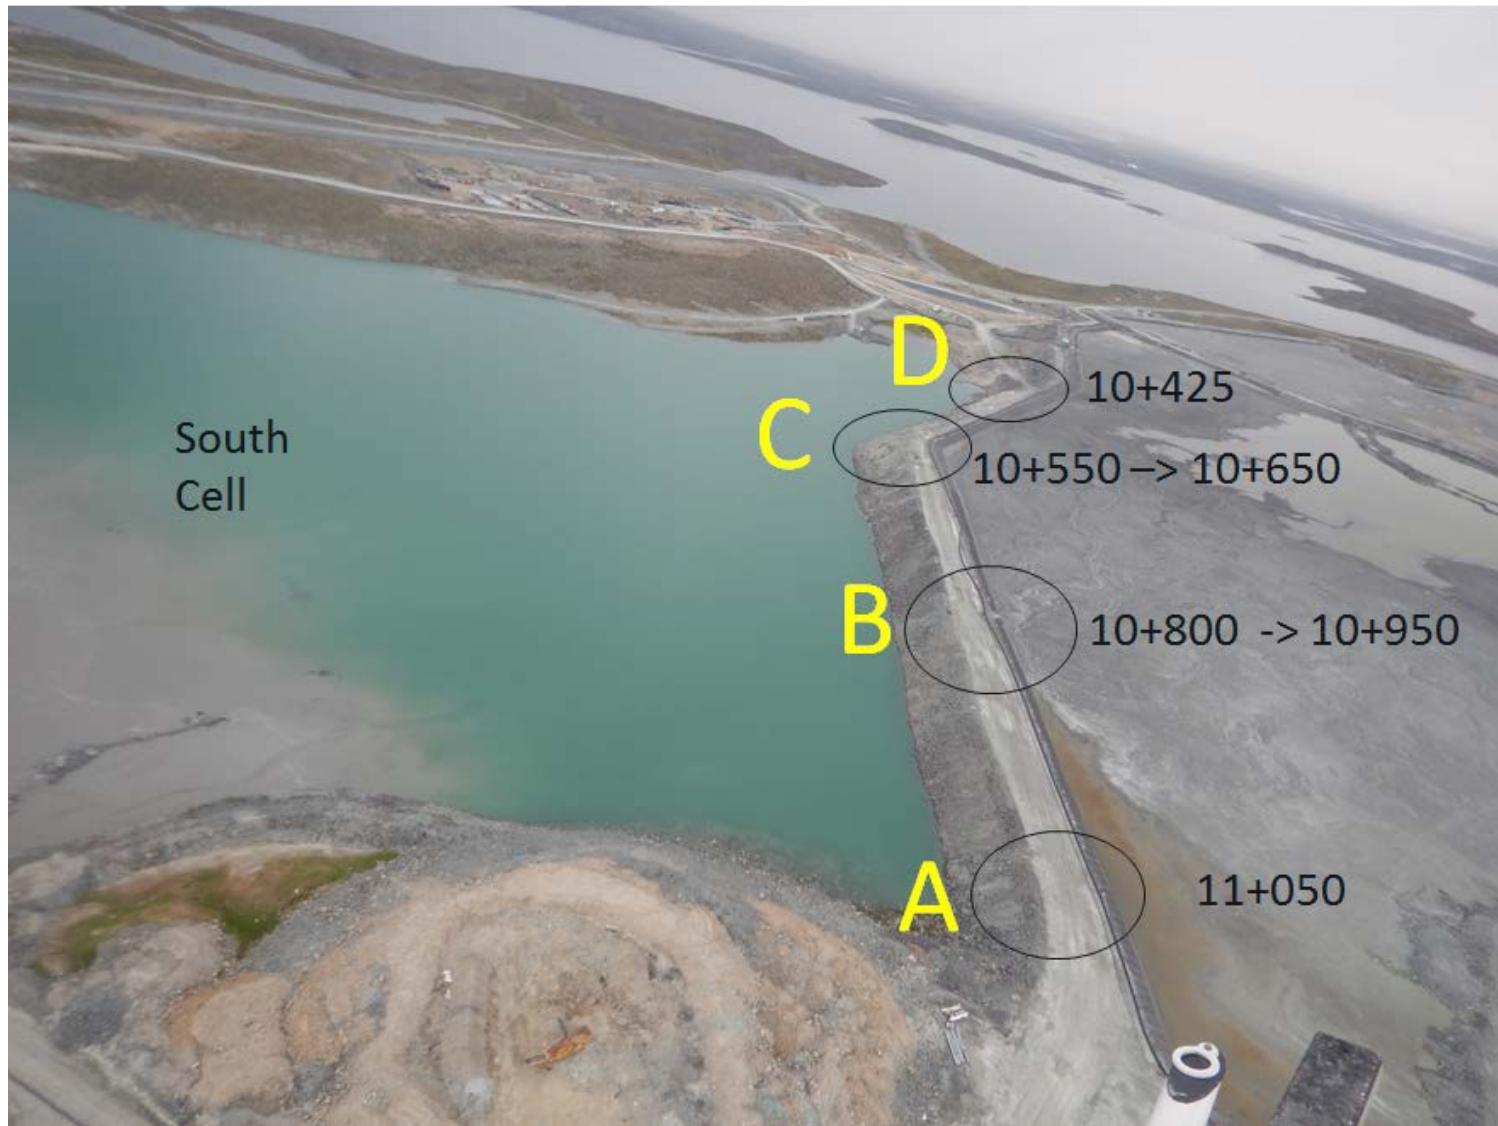
MOVEMENT ZONES - 2017

- ↗ Observed initially on July 5th 2017
- ↗ Depression present in previous year but deeper and larger amplitude this year
- ↗ Cracks were not present before

- ↗ Cracks crossing the crest at 40° from CL
 - Did not progressed much during summer
- ↗ Longitudinal cracks along the crest
 - Constantly opened to up to 5cm wide
