**2017 ANNUAL GEOTECHNICAL INSPECTION
MEADOWBANK GOLD MINE, NUNAVUT**

APPENDIX D

All-Weather Private Road (AWPR)

Inspection of the Facilities Along the All-Weather Private Road

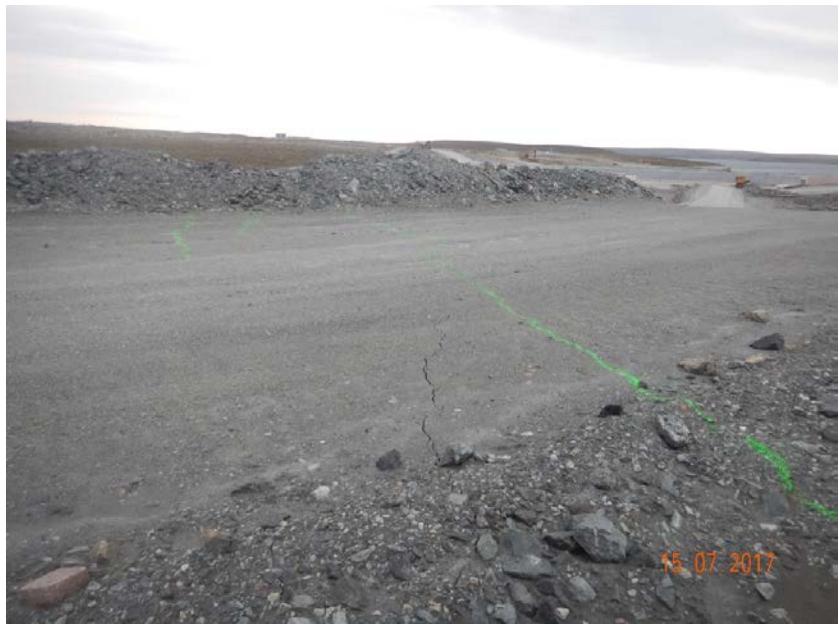
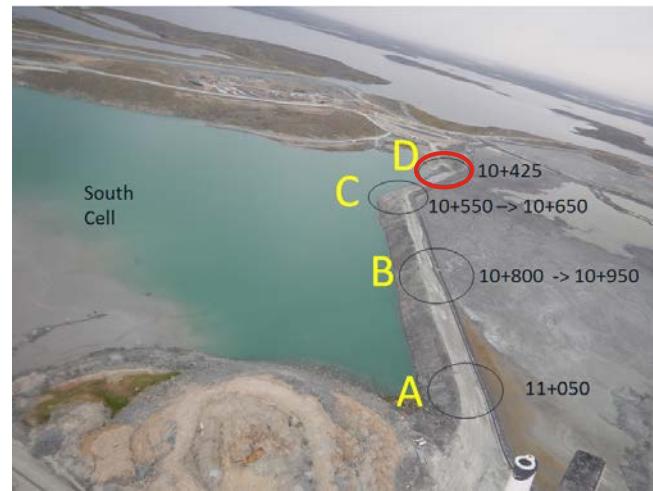
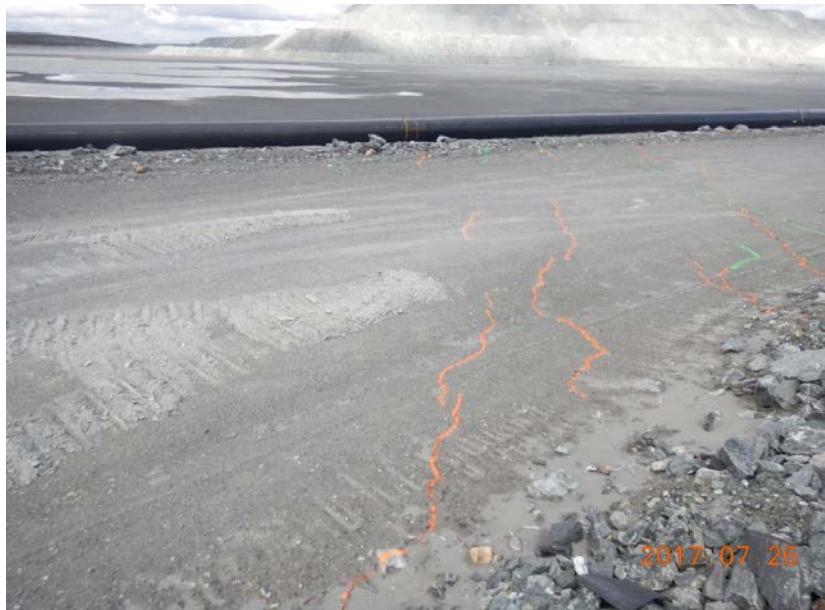
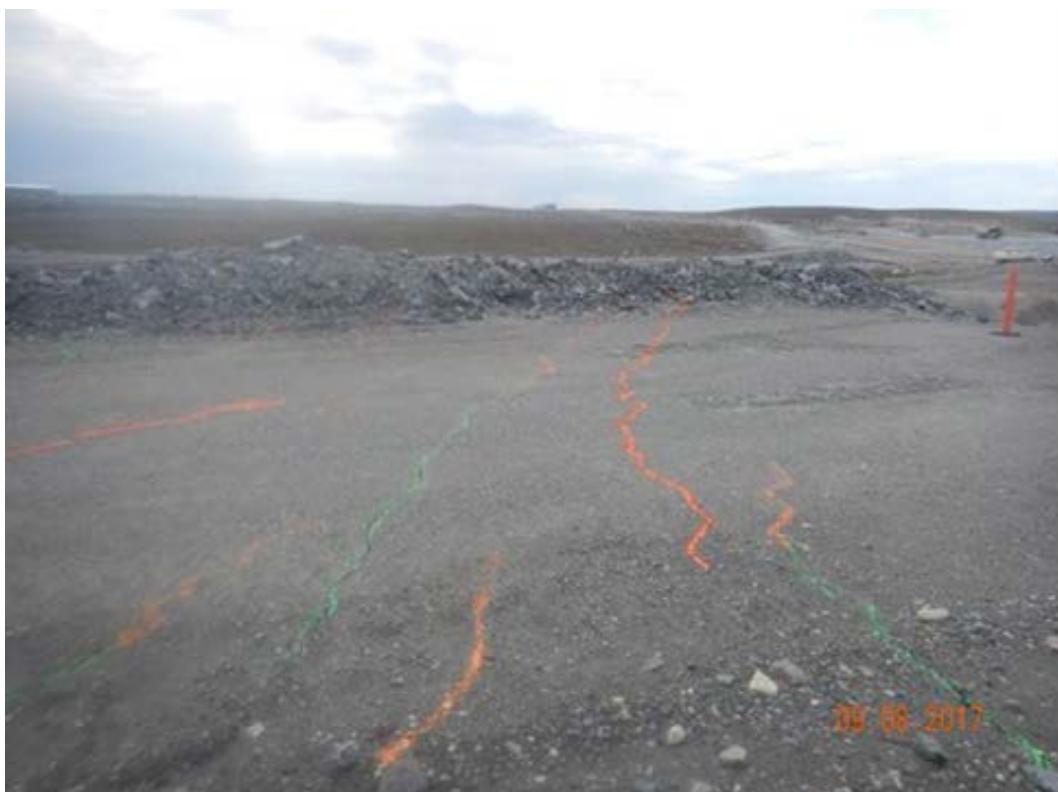
PICTURE OF MOVEMENT – 10+425

- ↗ The new cracks found at 10+425 and 11+050 happened when the South Cell water elevation reached the toe of the structure in these areas, same process as last year.
 - The observed cracks in those zones are smaller in amplitude compared to last year observation from 10+500 to 10+750
- ↗ The instrumentation data still shows movement but in a stabilizing trend since freshet as confirmed by the visual inspection. Creep is expected to continue to be visible until the crest of the structure freezes.
- ↗ Tailings in the North Cell are frozen for 18m.
- ↗ The structure is still in yellow tarp level and the situation is considered moving towards stability.
- ↗ Monitoring of the prisms will continue on a reduced frequency.
- ↗ Frequent visual inspection of the structure are planned for freshet 2018.
- ↗ New cracks will be filled with bentonite before temperature falls below 0°C.

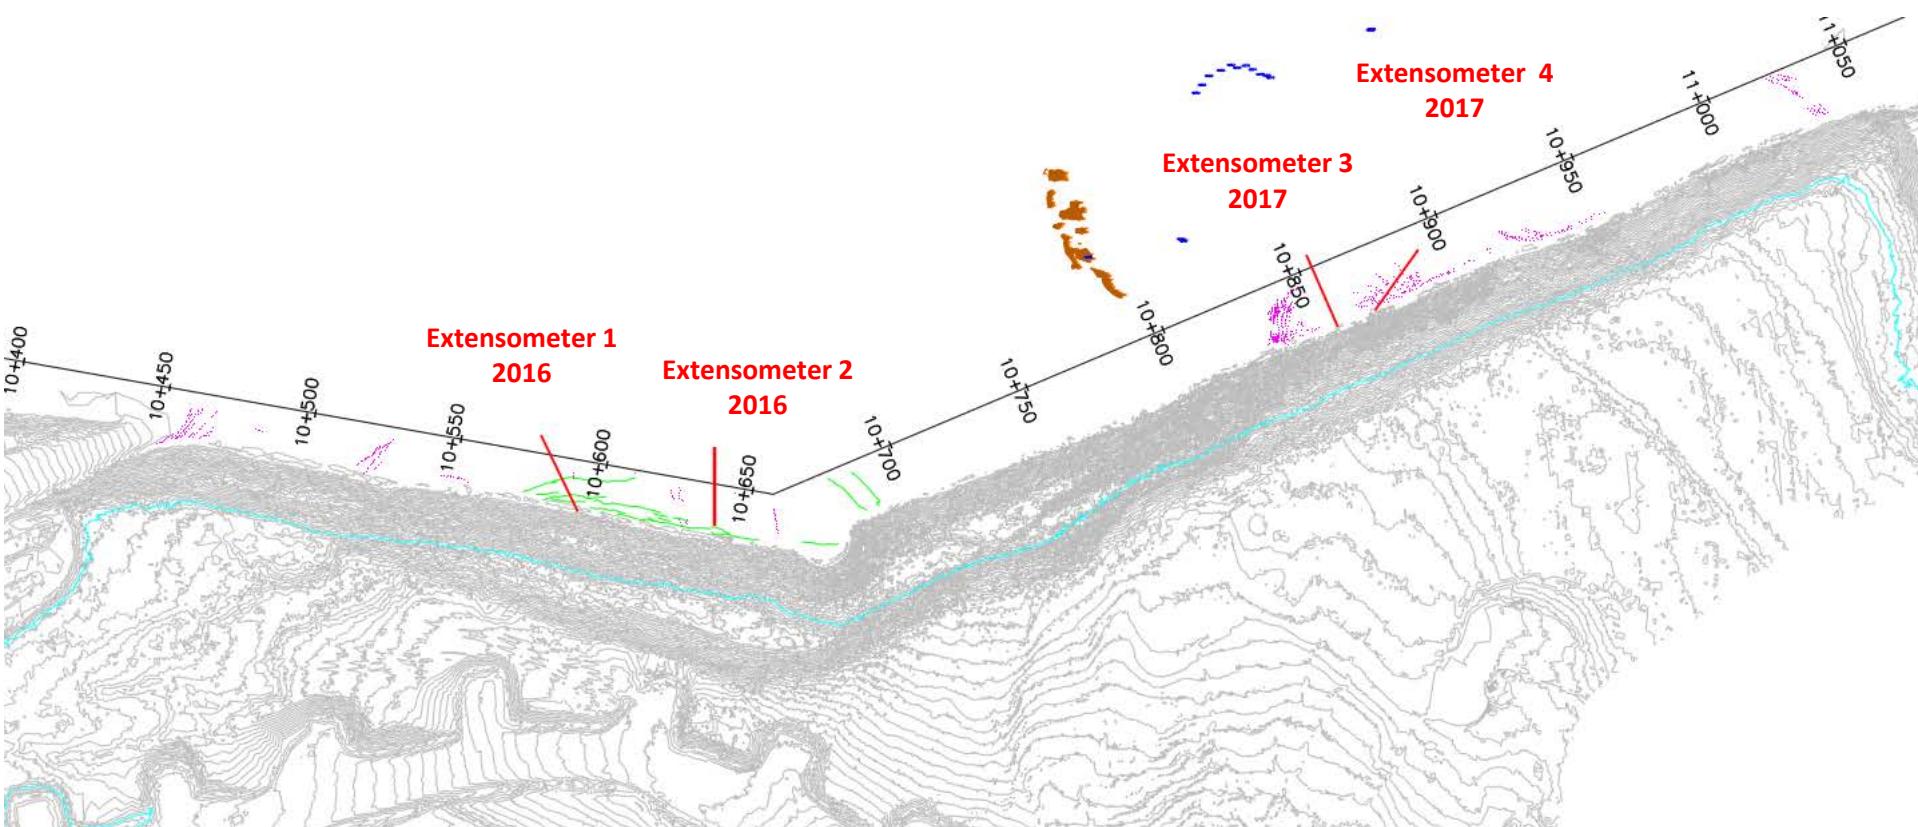
HOMEMADE EXTENSOMETERS (4X)

- ↗ No movements were recorded on any of the 4 extensometers installed in 2017

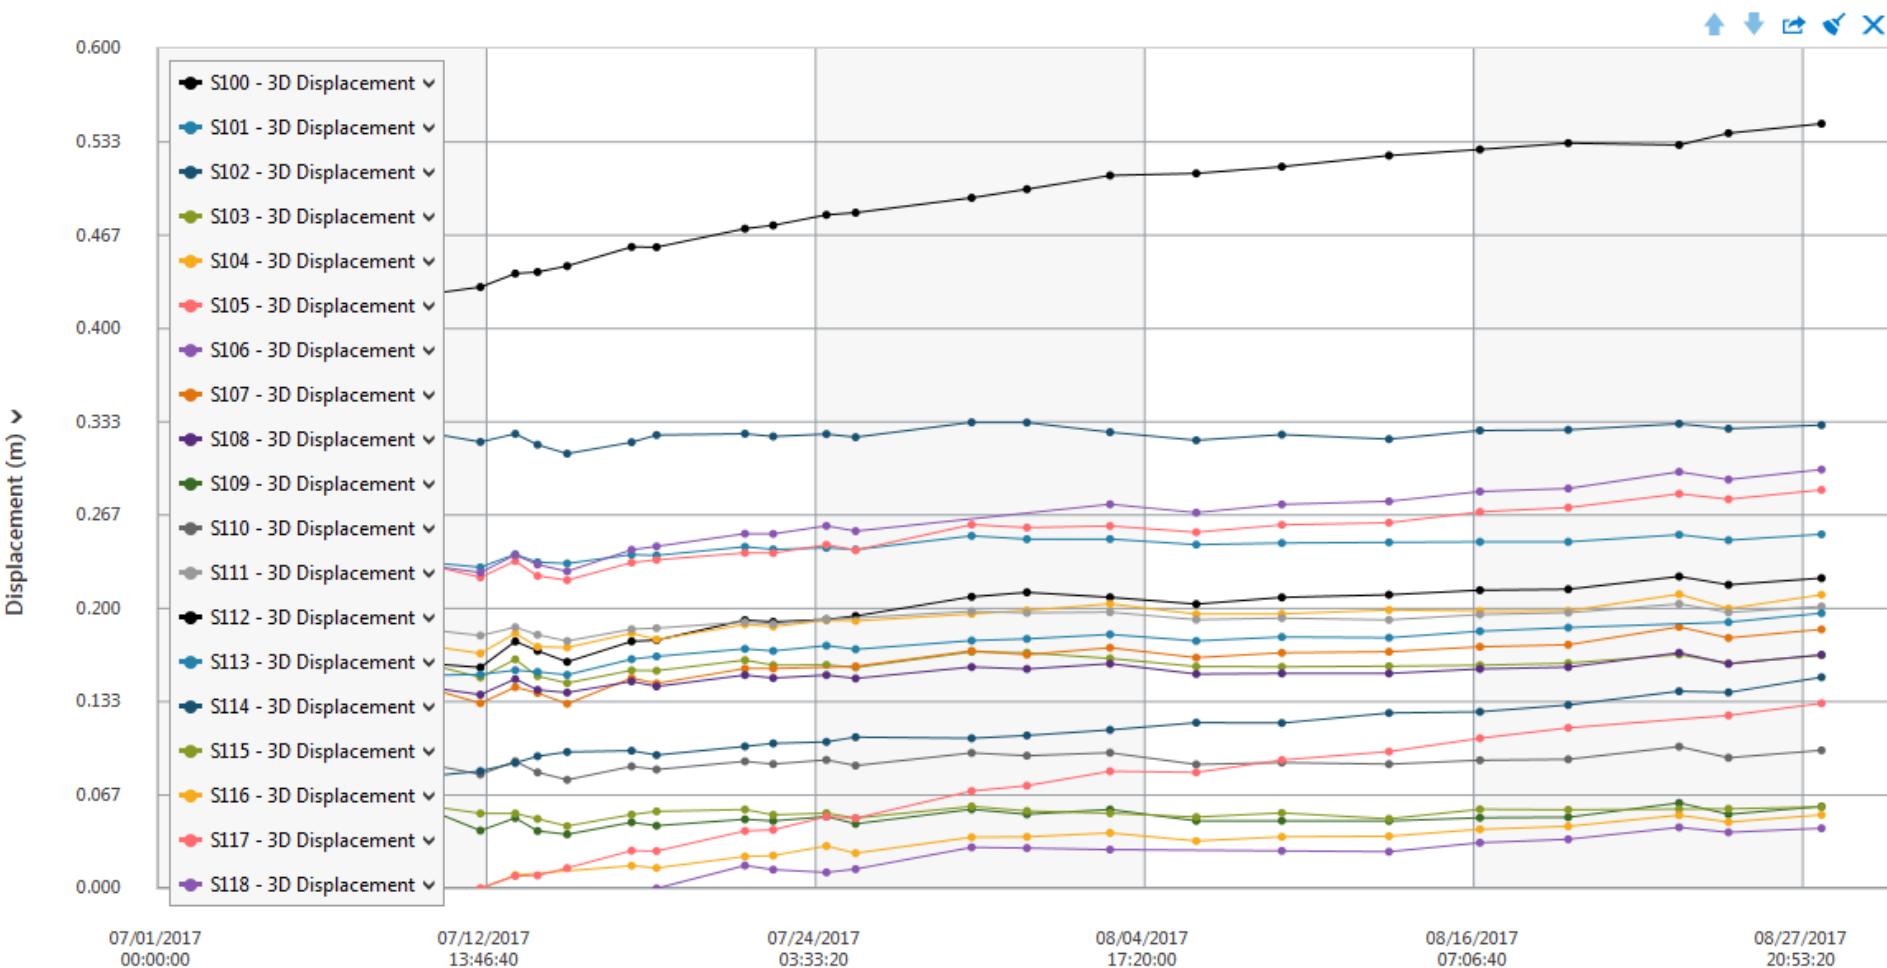
3D velocity since May 2017

Still displacement but lower amplitude than considering thawing period

Max movement for the post-freshet period is ~5-6 cm
