Sanikiluaq Wind Project

Site Visit Report

Document Name:	Sanikiluaq Wind Project Site Visit Report (October 14, 2021)		
Document Number:	SAN-PDG-RP-002

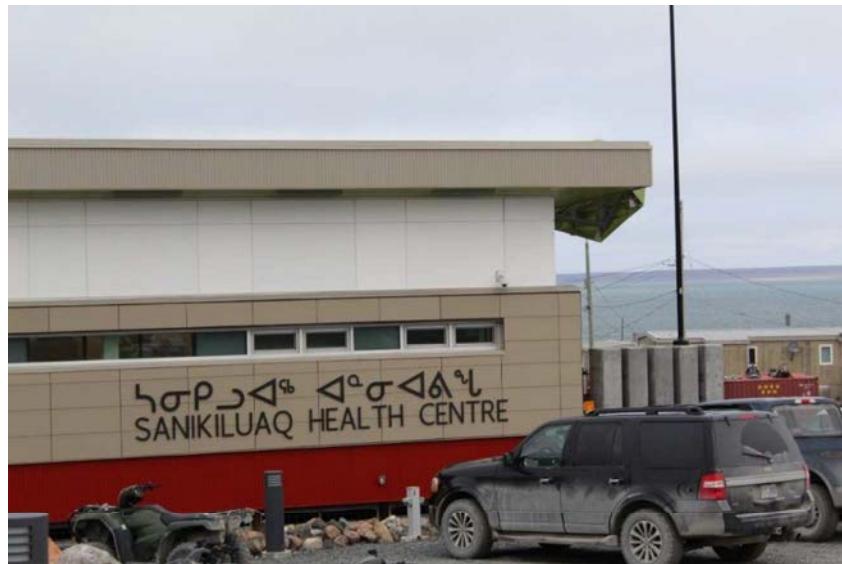
Figure 3: Sanikiluaq Health Centre

- There are two temporary work camps in the community for the time being. They are being used for the ongoing construction activities relating to the health centre and the new housing association office.
- There is a new health centre in the community that is large in comparison to the population. It was based on the design for the new Kinnigait Health Centre. The facility is well equipped to provide emergency medical care to the project with the option for medevac for more serious incidents.

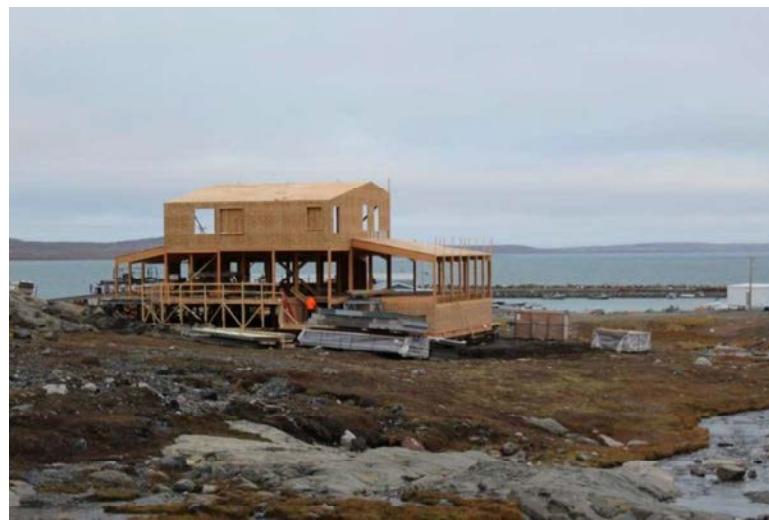
Figure 5: Arctic Eider Society Building Under Construction

- There is a new Arctic Eider Society building currently under construction. The Hunters and Trappers Organization (HTO) will share in this space. The team held discussions with some of the people working on the construction and discussed some of the equipment that was located at the project site (see Section 4.0). It is planned that this facility will be a net-zero facility and there exist opportunities for the Arctic Eider Society and HTO to collaborate with, and directly benefit from, construction of the wind project.

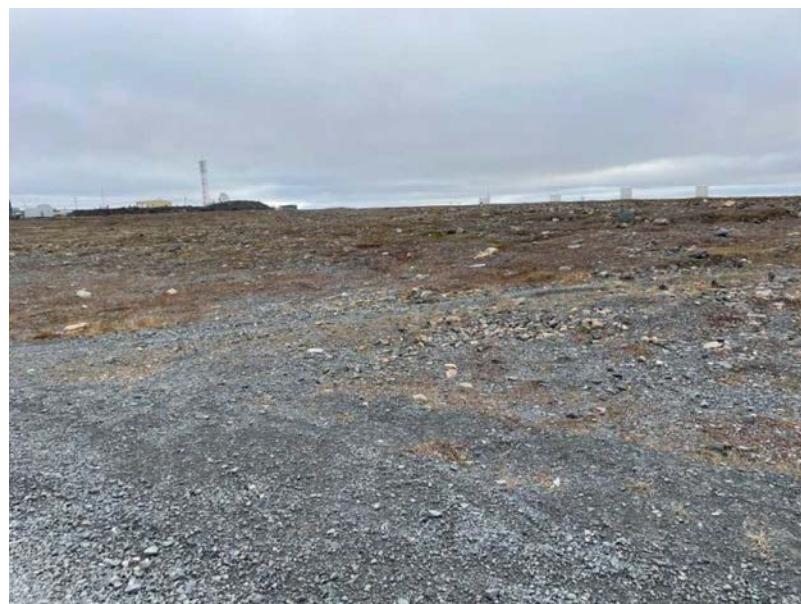
Figure 6: Magnetic Observatory Behind the QEC Plant

- There is a new housing association office being constructed near the QEC plant. The team had introductory discussions with some of the personnel working on the construction. The construction team for this office imported a considerable amount of cement due to the lack of a batch plant in the hamlet. This cement was located near the new building footprint.
- There is a magnetic observatory next to the QEC plant. Information indicates that there is very sensitive equipment contained in the buildings.

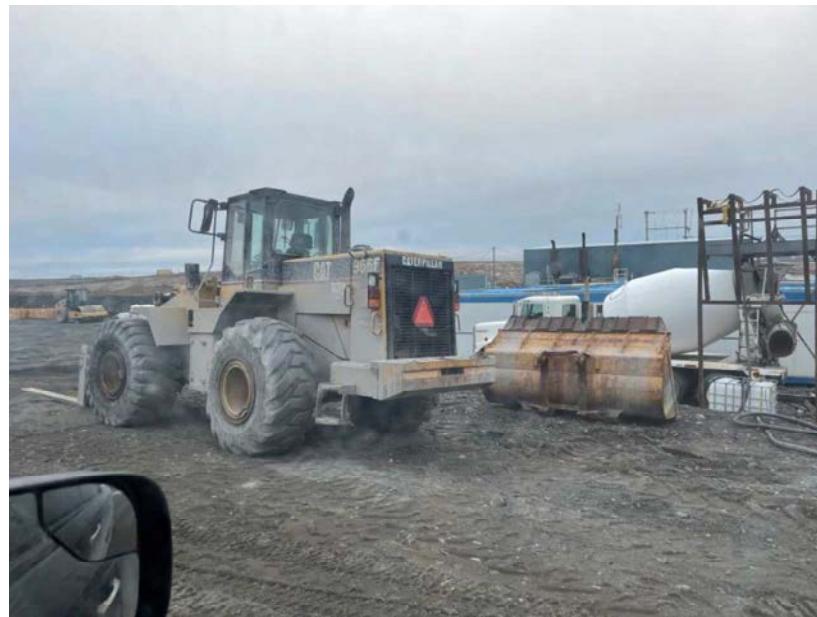
Figure 11: 966 CAT Loader

- A 966 CAT Loader owned by Gary Rumbolt.

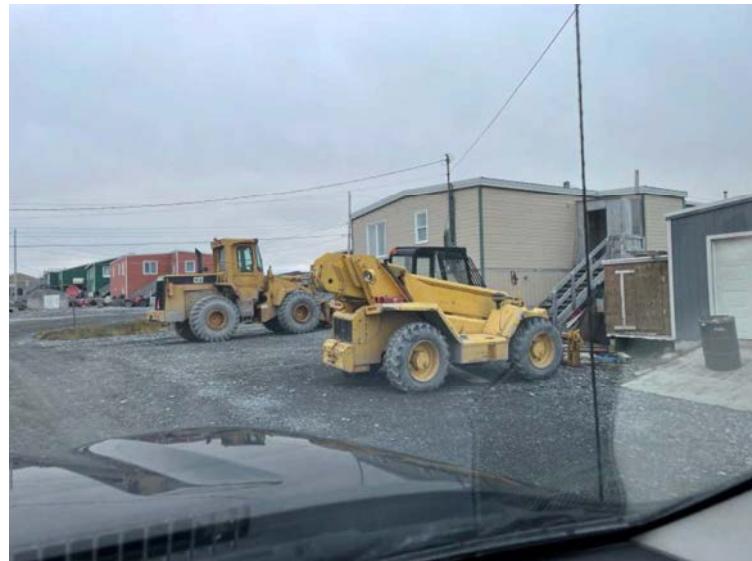
Figure 13: 950 CAT Loader and JCB 530 Telehandler

- 950 CAT Loader owned by Gary Rumbolt.
- JCB 530 Telehandler owned by Gary Rumbolt.

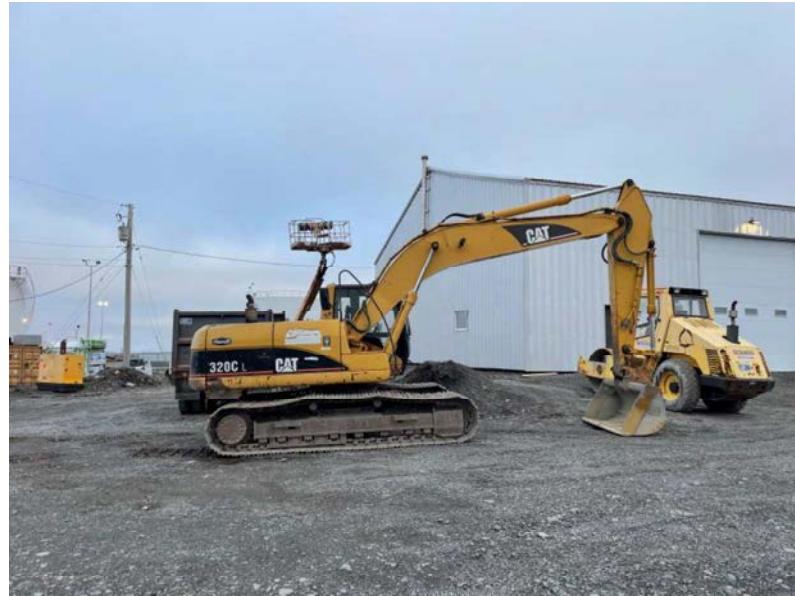
Figure 15: 320c CAT Excavator and Roller (model unknown)

- 320c CAT Excavator owned by another construction company operating in the hamlet (name unknown).

- Roller owned by another construction company operating in the hamlet (model number and company name unknown).

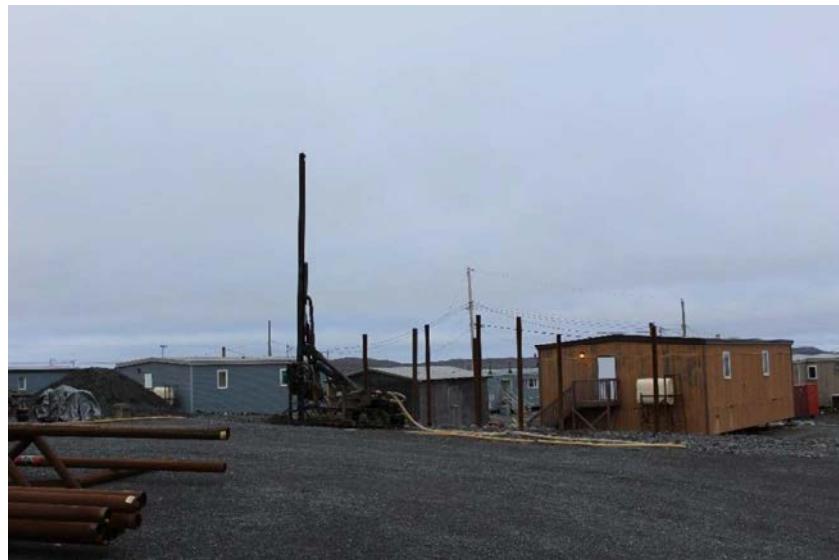
Figure 18: Canadrill Drill

- Drill owned by Canadrill.

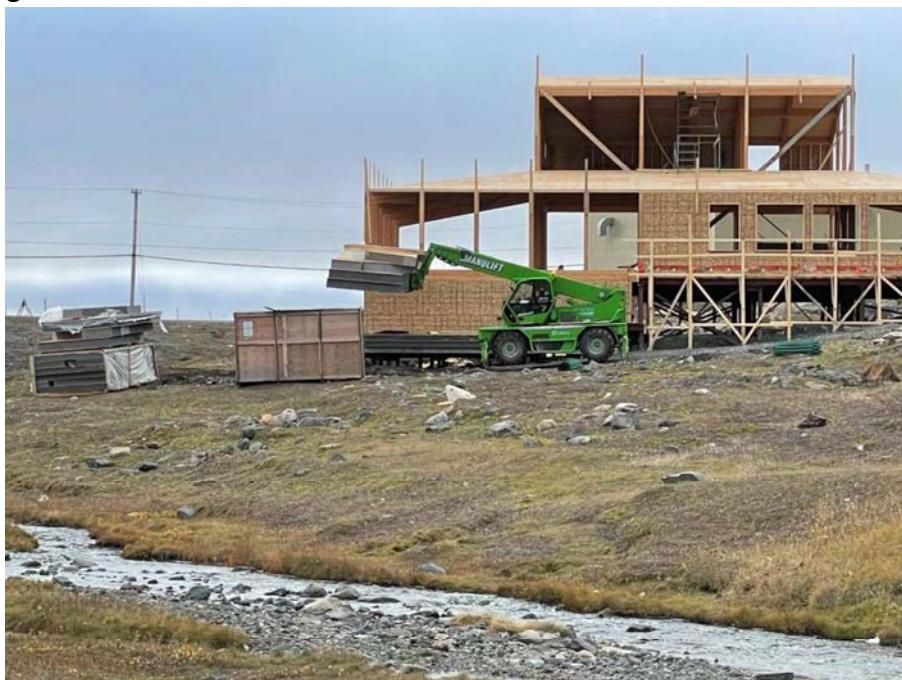
Figure 19: Manulift 4026 Telehandler

- 4026 Manulift Telehandler owner unknown, but Allan Rumbolt expressed interest in purchasing from the current owner instead of a resale to the Montreal-based dealer.

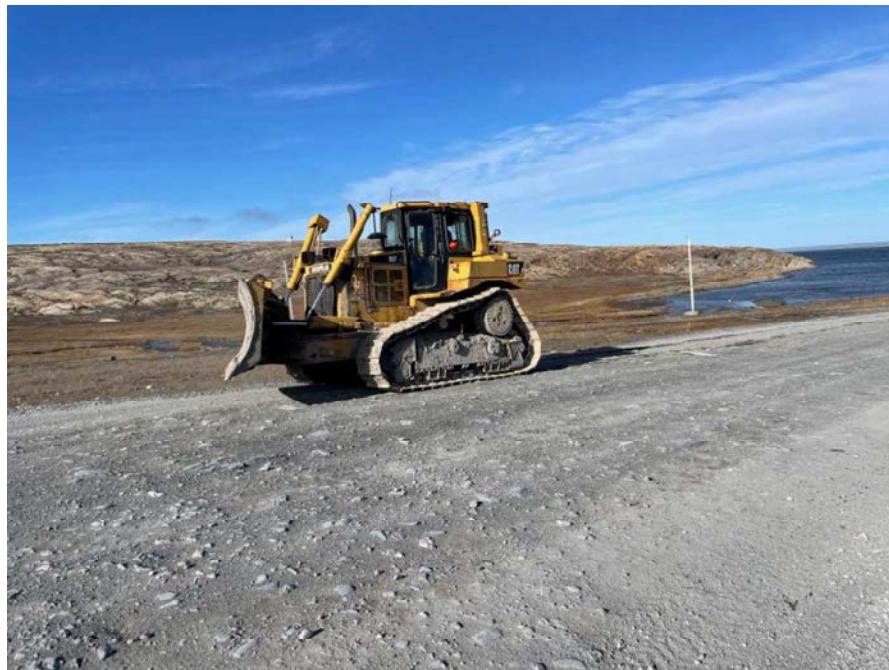
Figure 20: CAT D6 Dozer Owned by Hamlet of Sanikiluaq

- CAT D6 Dozer owned by Hamlet of Sanikiluaq. Information indicates that the rental rate for the dozer is \$300/hr.

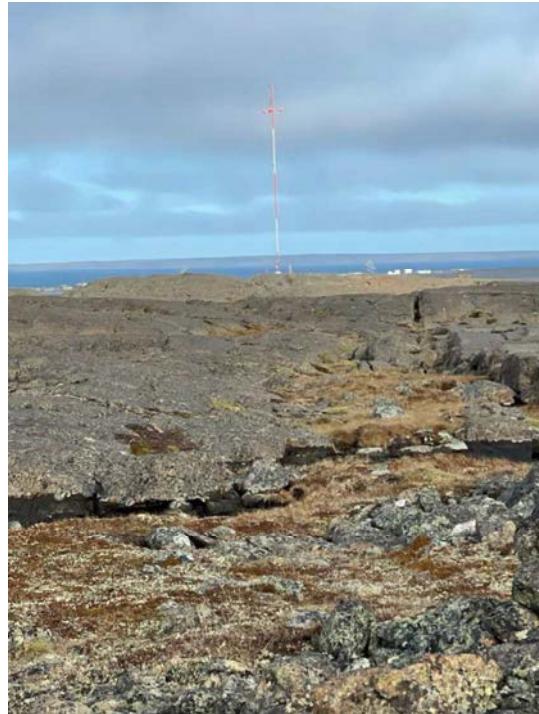
Figure 28: Met Tower at Proposed Project Location

- The Rolling rock outcrops along the top of the ridge provide very little flat working areas for wind turbine installation.

- All turbine locations were visited, no insurmountable barriers identified for construction. Additional fill may be required depending on the turbine supplier's requirements for tower erection.
