ROAD BETWEEN THE HAMLET OF CLYDE RIVER AND CAPE CHRISTIAN

Annual Report 2010 Season

Licence No. 8BW-CLY0810

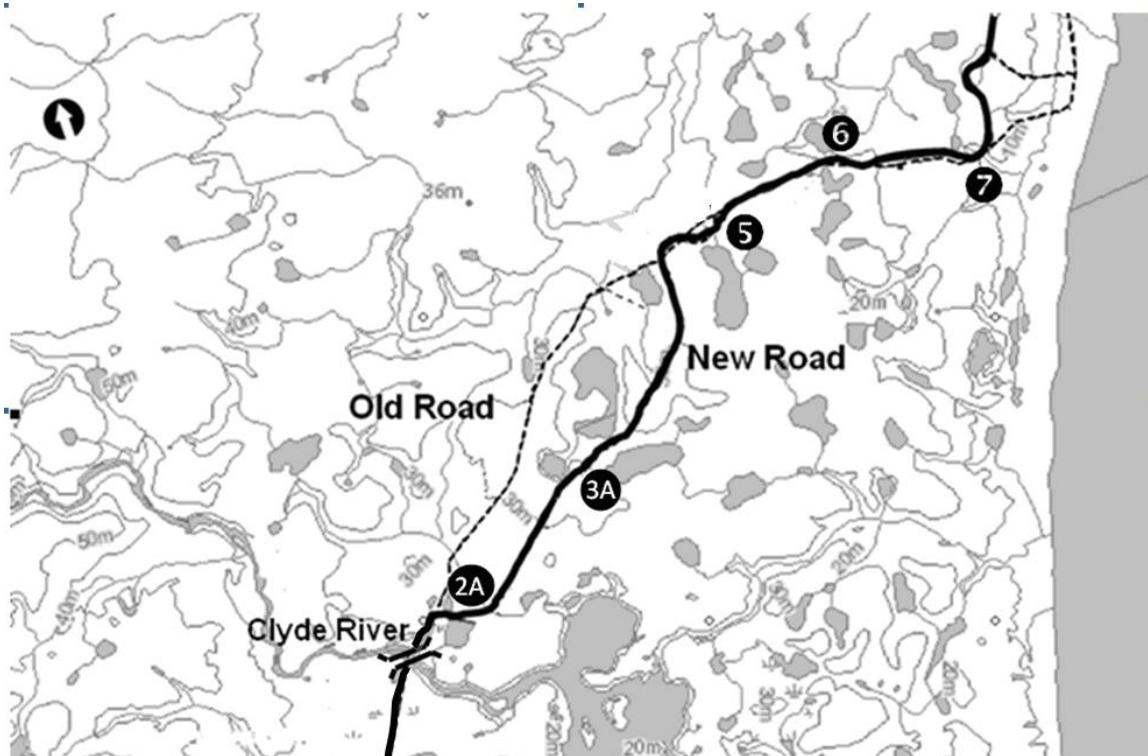
Figure 1: Approximate Location of the New Road

Figure 1 illustrates the re-routing of the road and the approximate location of several of the crossings.
