POND INLET MARINE  
INFRASTRUCTURE  
PROJECT

NUNAVUT WATER BOARD  
ANNUAL REPORT 2020

**DOCUMENT NUMBER:** TA\_NWB\_POND INLET MARINE INFRA  
PROJECT\_ANNUAL\_REPORT\_2020

## WATER LICENCE INSPECTION FORM

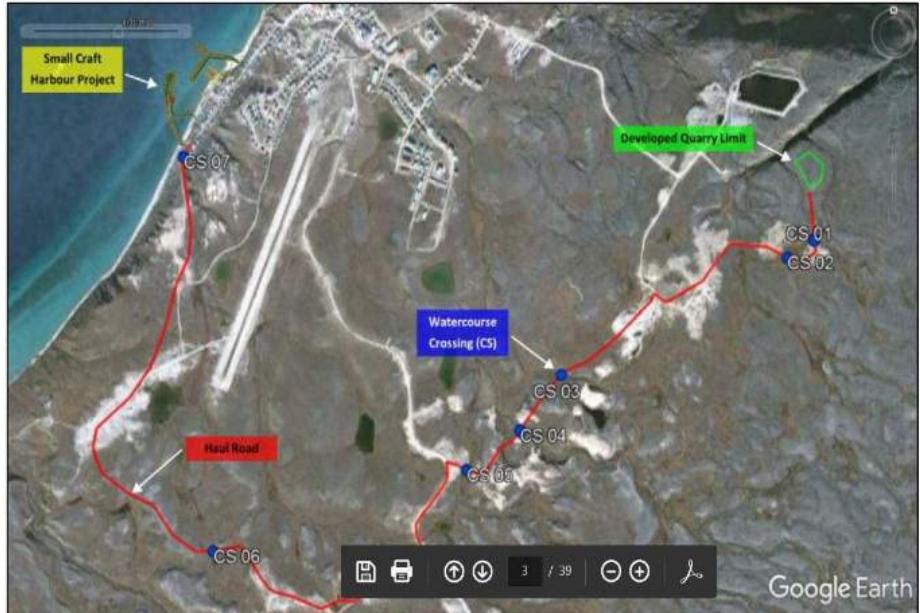
Photo Log #1	Location
Photo 2	Pond Inlet, Qikiqtani Region, Nunavut

3. A total of 7 water crossings along the hauling road from the municipal quarry to the site of the Pond Inlet Infrastructure Project (Photo2).
4. CS-07 Water Crossing (Photo 3)
5. CS-06 Water Crossing (Photo 4)
6. CS-06 Water Crossing (Photo 5)
7. CS-05 Water Crossing (Photo 6)
8. CS-04 Water Crossing (Photo 7)
9. CS-03 Water Crossing (Photo 8)

Description: Construction Map of the Pond Inlet Marina Infrastructure Project. Haul Road from Quarry to the Construction site.
