WATER LICENCE INSPECTION FORM

Licensee	Licensee Representative
University of Exeter	Thomas Brody
Licence No. / Expiry	Representative's Title
8WLC-FDI1415	Researcher
Land / Other Authorizations	Land / Other Authorizations
N2014N0006	
Date of Inspection	Inspector
July 5, 2022	Joseph Monteith
Activities Inspected	
<input checked="" type="checkbox"/> Camp	<input type="checkbox"/> Drilling
<input type="checkbox"/> Roads/Hauling	<input type="checkbox"/> Mining
	<input type="checkbox"/> Construction
	<input checked="" type="checkbox"/> Reclamation
	<input type="checkbox"/> Fuel Storage
	<input type="checkbox"/> Other:

Background			
A water license application was submitted on			
Inspector Statement			
On July 5, 2022, a Water License inspection was conducted by Water Resource Officer(WRO) Joseph Monteith at the site where 8WLC-FDI1415 was located in Schei Peninsula, Axel Heiberg Island,NU.			
Water Use

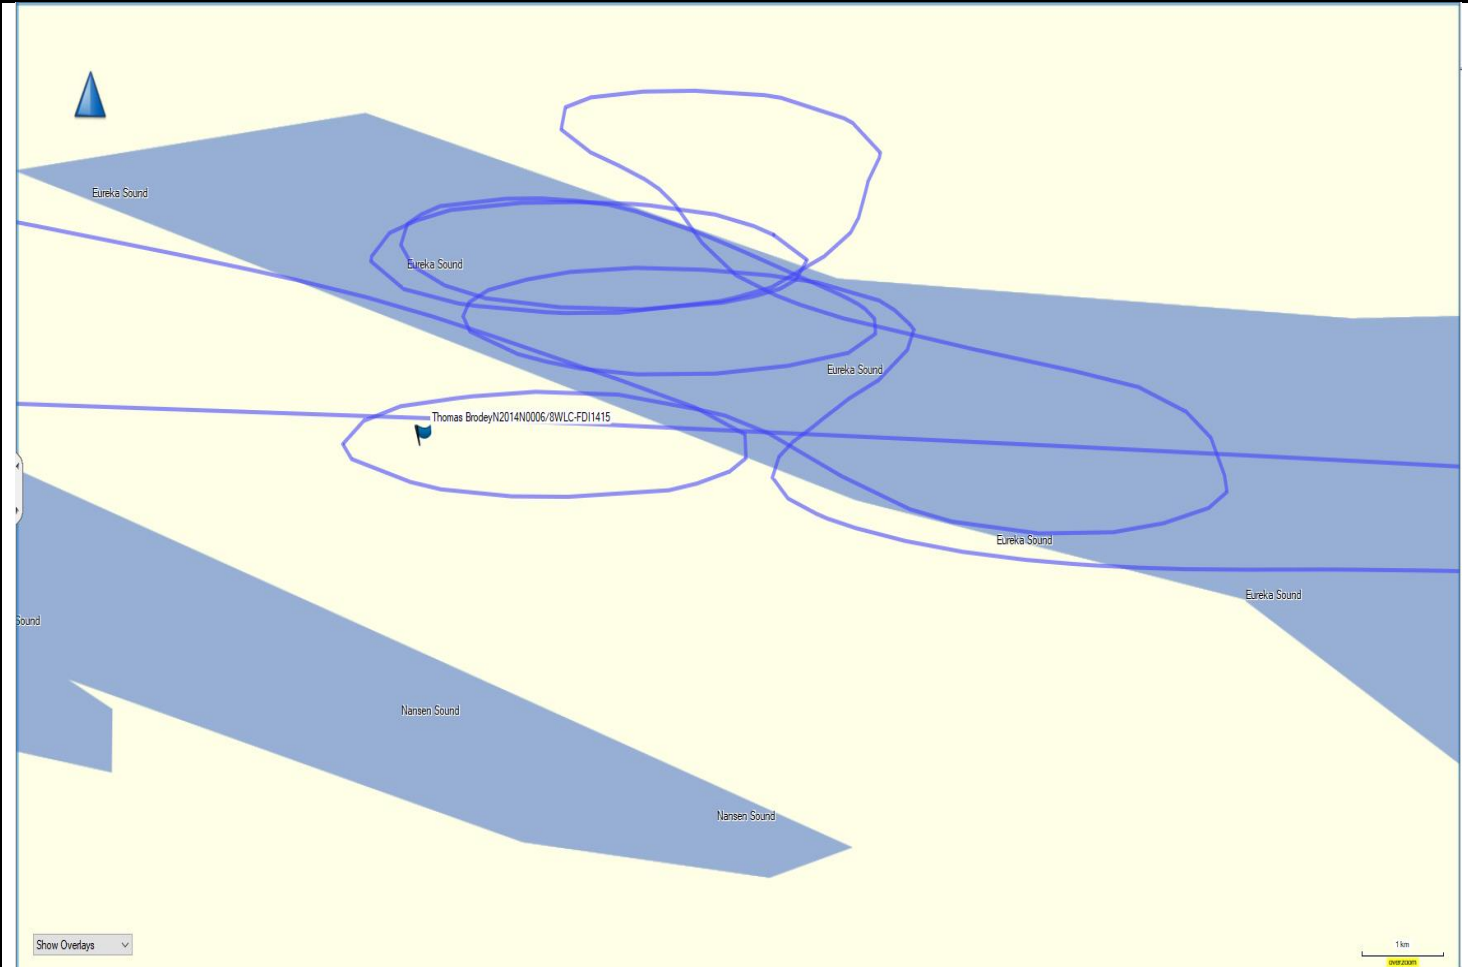
Date	Camera	Inspector
July 5, 2022	Samsung Galaxy S9	Joseph Monteith
Photo Log #1	Location	
Photo 1	Schei Peninsula, Qikiqtani Region, Nunavut	
<div>

</div>		
Description: Basemap routes, tracks and points. General proximity of observed culvert
