Memo

CanZinco Mines Ltd.

1CB002.002

Nanisivik Mine Non-Hazardous Waste Landfill

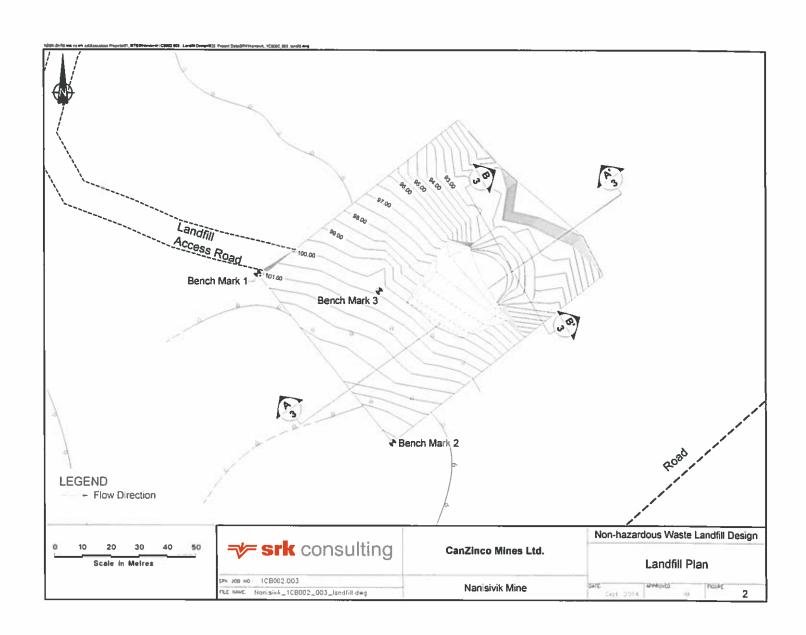
Figure 2 presents the site layout and the approximate area of the former outdoor warehouse yard where the non-hazardous waste will be consolidated.

Survey benchmarks used during the site survey were captured with a handheld GPS at an accuracy of +/-3 m horizontal and vertical. Coordinates to the benchmarks are presented on Figure 2 and in Table 1.

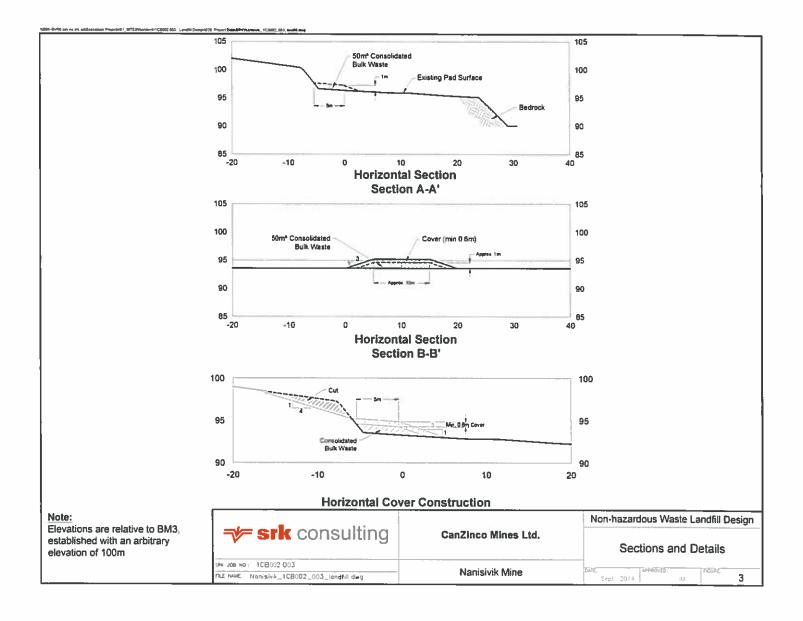
The dry soil cover material consists of a rock, gravel, sand, and silt material sourced immediately upslope of the landfill. It is anticipated that the dry soil cover will be constructed by pushing the material over the landfill with a bulldozer. The upslope area will be regraded to a maximum grade of 4H:1V. Figure 3 presents the proposed cover construction cut and fill details.

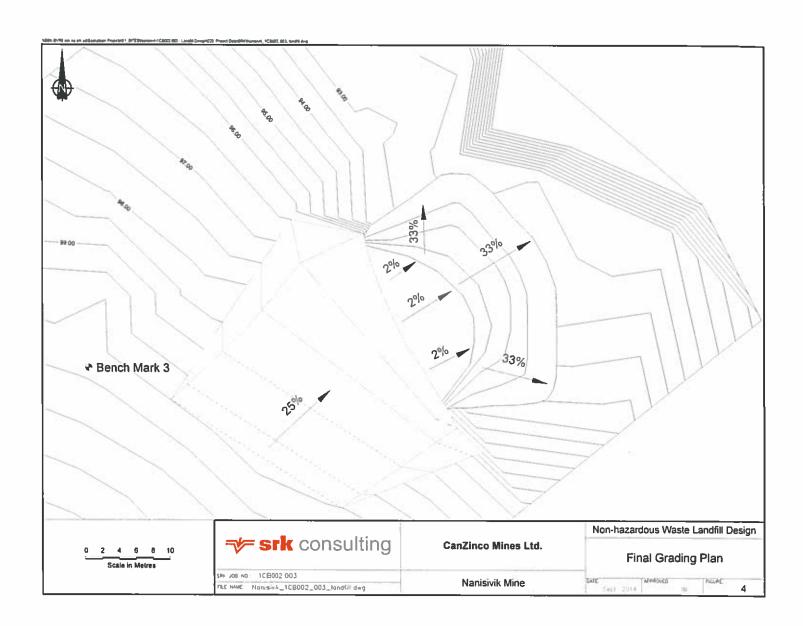
After the landfill is covered with a minimum of 0.6 m of dry soil cover material, the surface will be graded to prevent ponding water. The landfill cover edges will be graded to blend into the adjacent surface slope features. Figure 4 presents the proposed landfill cover grading.

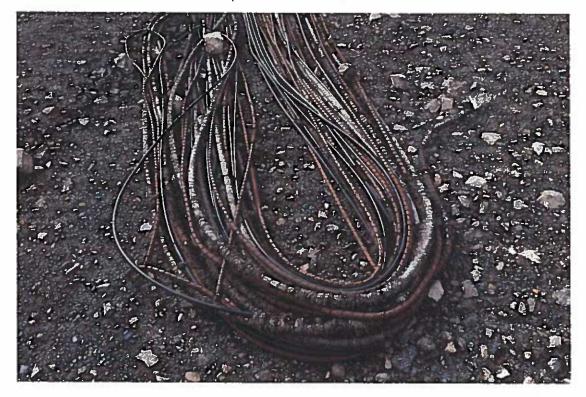
Photo 1: Electrical cables that will be placed in the landfill.

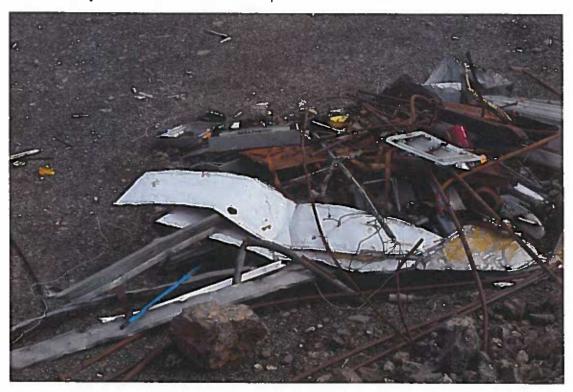
Photo 2: Bulky sheet metal waste that will be placed in the landfill.

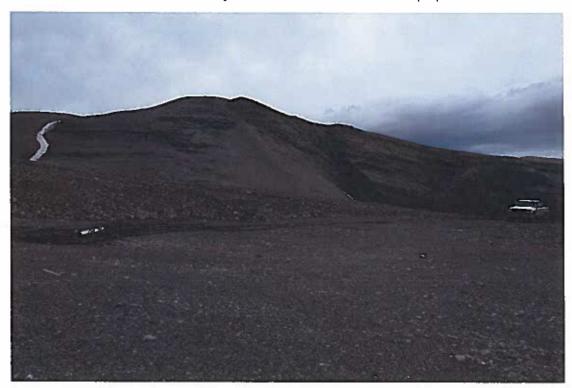
Photo 3: Former outdoor warehouse yard that will be used to construct proposed landfill.

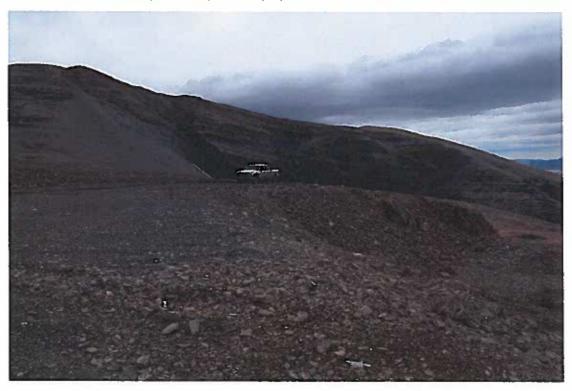
Photo 4: Bedrock outcrop downslope of the proposed landfill.

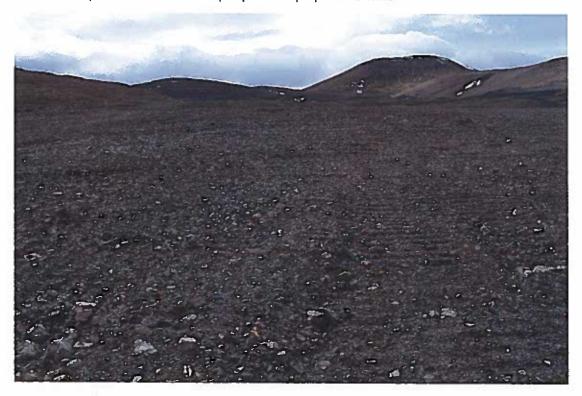
Photo 5: Proposed cover material upslope of the proposed landfill.

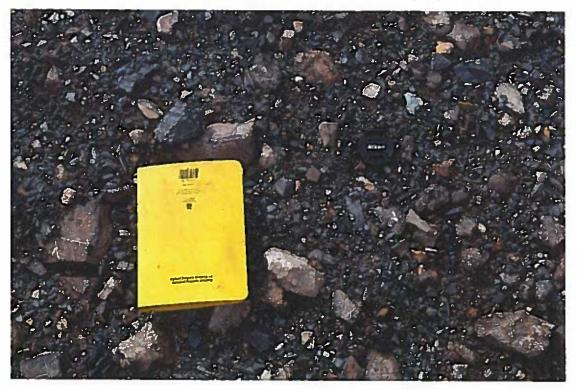
Photo 6: Close-up of the rock, gravel, and sandy cover material from upslope landfill location
