NYRSTAR

NANISIVIK MINE

**UPDATED POST CLOSURE GEOTECHNICAL
MONITORING CONTINGENCY PLAN**

PROJECT NO.: 0255-024-04
DATE: March 17, 2015
DOCUMENT NO.:

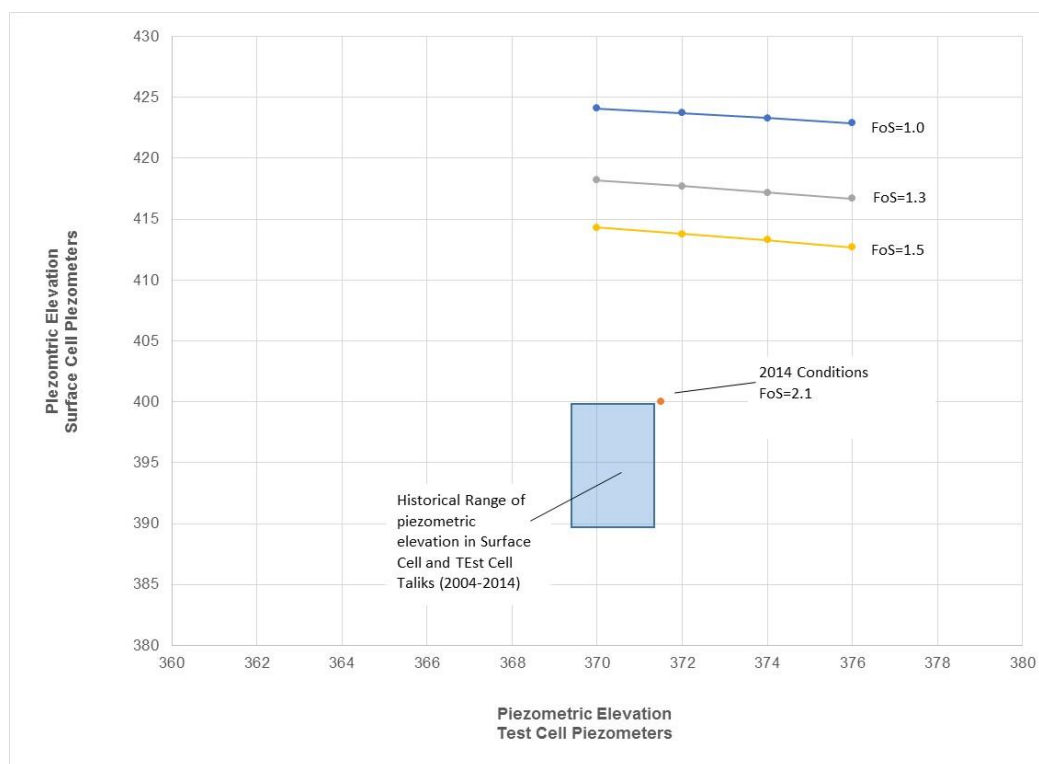
Figure 2. Pore Pressure Trigger Levels for Surface Cell and Test Cell piezometers and corresponding Factors of Safety for Stability of West Twin Dyke.

A stability analysis was conducted to determine the piezometric trigger levels for the current piezometric and geothermal conditions in the Surface Cell and Test Cell. The results are provided in Figure 2. Schematics illustrating the model geometry and piezometric conditions are provided in Appendix B. Rather than a single trigger level, a combination of pore pressures in the Surface Cell and Test Cell are provided. For the stability analysis, it was conservatively assumed that the remnant taliks in the Surface Cell and Test Cell are hydraulically connected. This is not believed to be the case, especially given the response of the piezometers in the Surface Cell to talik freezeback. A freezing point depression of -1.0°C was also assumed to define the leading edge of the freezing front at approximately 370 m elevation. This is thought to be appropriate for deeper depths where the freezing point depression appears to be greater, as indicated by monitoring results discussed in BGC (2015).

The results suggest that the current factor of safety against sliding is 2.1, under static loading conditions. This compares to a factor of safety of 1.9 calculated in 2009, using the geothermal and piezometric conditions observed at that time. Hence, the static stability has marginally increased despite the 6 m increase in piezometric elevation recorded in the remnant Surface Cell talik between 2009 and 2014. This increase in static stability is related to the 8 m downward migration in the freezing front also recorded over that time. The results suggest that as the freezing front continues to migrate downwards, the pore pressures in the remnant talik have less potential to impact the stability of the dike.

Should the combination of pore pressures reach the line indicating a factor of safety of the dike was approaching 1.5, a detailed review of the geothermal and piezometric conditions in the Surface Cell should be undertaken. This would require an increase in the piezometric elevation of approximately 13 m from current conditions. If it is determined that dike stability is a concern, pore pressure relief wells may be required to reduce the pore pressures in the remnant talik to acceptable levels.

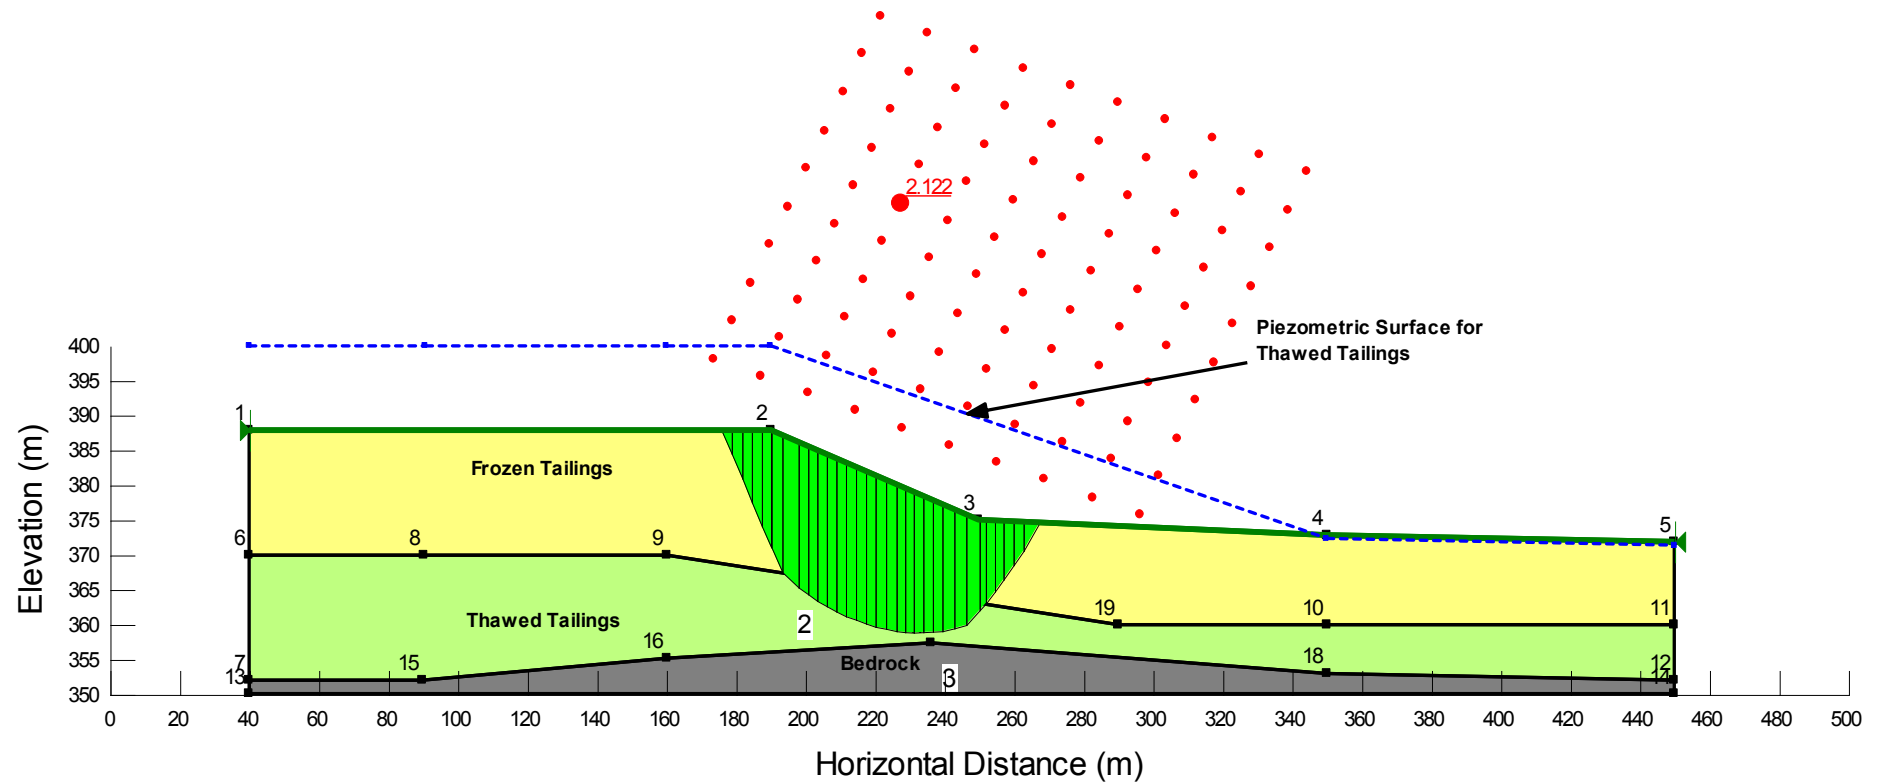
PROJECT:	NANISIVIK MINE: UPDATED POST CLOSURE GEOTECHNICAL MONITORING CONTINGENCY PLAN		
TITLE:	STABILITY ANALYSIS RESULT BASED ON CURRENT CONDITIONS		
DWG No.:	B-2	PROJ No.:	0255-024-04
REV:
