**NYRSTAR**

**NANISIVIK MINE, NUNAVUT**

**2020 UPDATE TO POST CLOSURE  
GEOTECHNICAL MONITORING CONTINGENCY  
PLAN**

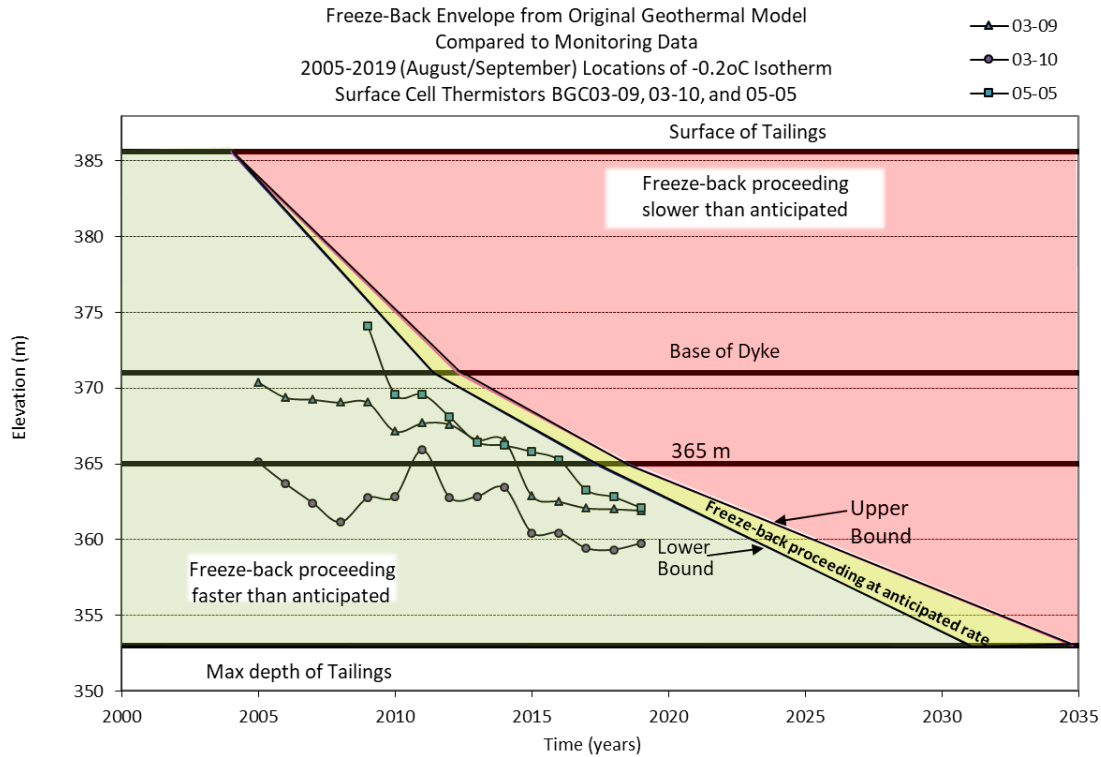
<sup>1</sup> The  $-0.2^{\circ}\text{C}$  isotherm was selected during the initial modelling to account for the effects of freezing point depression. Based on recent monitoring results, the freezing point varies with depth and location within the old lakebed. The freezing point of the remaining thawed tailings in the remnant talik is colder than  $-1^{\circ}\text{C}$ . However,  $-0.2^{\circ}\text{C}$  was used in Figure 1 for comparison purposes with the original modeling results.

**Figure 1. Freeze-back envelope of the Surface Cell talik from the original geothermal model compared to monitoring data (2005-2019) using location of  $-0.2^{\circ}\text{C}$  isotherm.**

The Surface Cell and Test Cell taliks are freezing back with time. The ground temperatures in the Surface Cell and Test Cell taliks are currently being monitored with thermistors and piezometers tips that measure temperature as well. Modelling of the progress of the freezing front into the Surface Cell talik was conducted during the original reclamation plan development and the results were conveyed in BGC (January 30, 2004a). The results of this study suggested that the  $-0.2^{\circ}\text{C}$  isotherm<sup>1</sup> in the Surface Cell talik should progress to the bottom of the dike between 7 and 8 years following construction of the cover system. The results also suggested that the entire Surface Cell tailings deposit would be colder than  $-0.2^{\circ}\text{C}$  between 27 and 32 years following construction of the cover system. This anticipated freeze-back envelope (elevation versus time) is illustrated on Figure 1. The current geothermal conditions in the Surface Cell talik are also illustrated on Figure 1 by plotting the estimated depth of the  $-0.2^{\circ}\text{C}$  isotherm from select thermistors in the Surface Cell. As illustrated on Figure 1, the freeze-back of the Surface Cell talik is currently progressing faster than originally anticipated. Freeze-back is expected to continue but is expected to slow with time until a point of equilibrium is reached. Slower than anticipated freeze-back is not thought to be of significant concern due to the lack of a hydraulic connection between the Surface Cell talik and the Reservoir. However, should the talik cooling trend become significantly slower or reverse, a detailed review of the monitoring results should be undertaken to determine a cause and assess the need for further remedial efforts.

Issues	Trigger Levels	Potential Consequences	Potential Contingency Measures
Ground Temperatures	Vertical location of -0.2°C isotherm from thermistors 03-09, 03-10 and 03-11 on freeze-back envelop plot (Figure 1).	Slower than anticipated freeze-back.	Assess impact and extend post-closure monitoring program.
Pore Pressures	Increasing tip temperature and/or re-establishment of pore pressures	Potential thawing if tailings, pore pressure generation and negative effect on dike stability.	Review geothermal and piezometric conditions. Assess dike stability. Pore pressure relief wells, in extreme case.
Active Layer Thaw	Tailings Covers at WTDA. Active layer thickness exceeds 1.25 m, as indicated by data from frost gauges and thermistors.  Covers over waste rock. Active layer thickness exceeds 2.35 m, as indicated by data from frost gauges and thermistors.	Potential negative impacts on quality of surface water run-off.	Review of monitoring data, including water quality. Local thickening of cover materials in select locations, in extreme case.

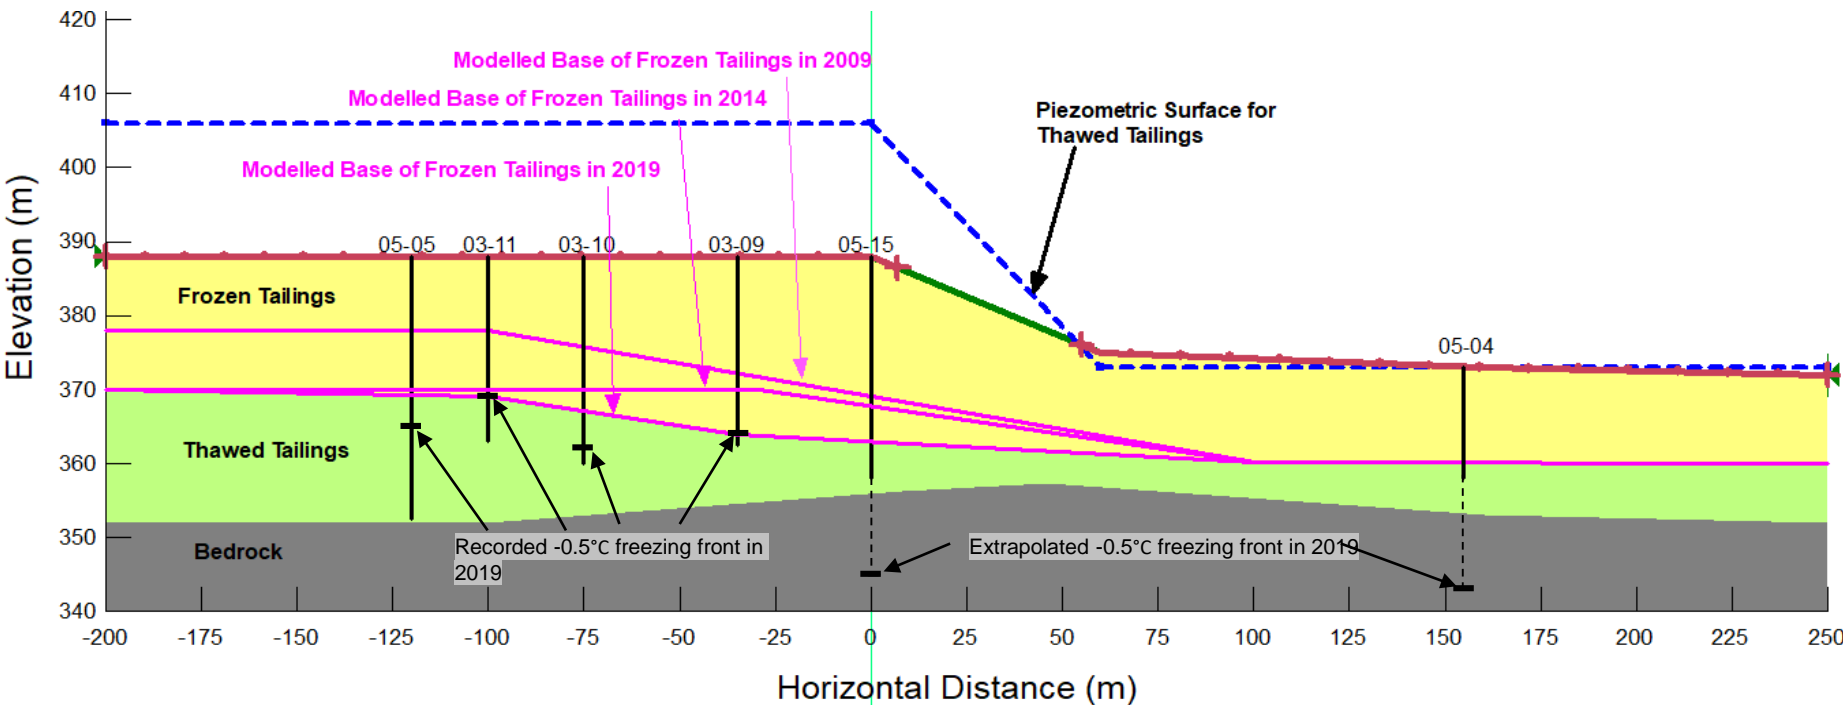
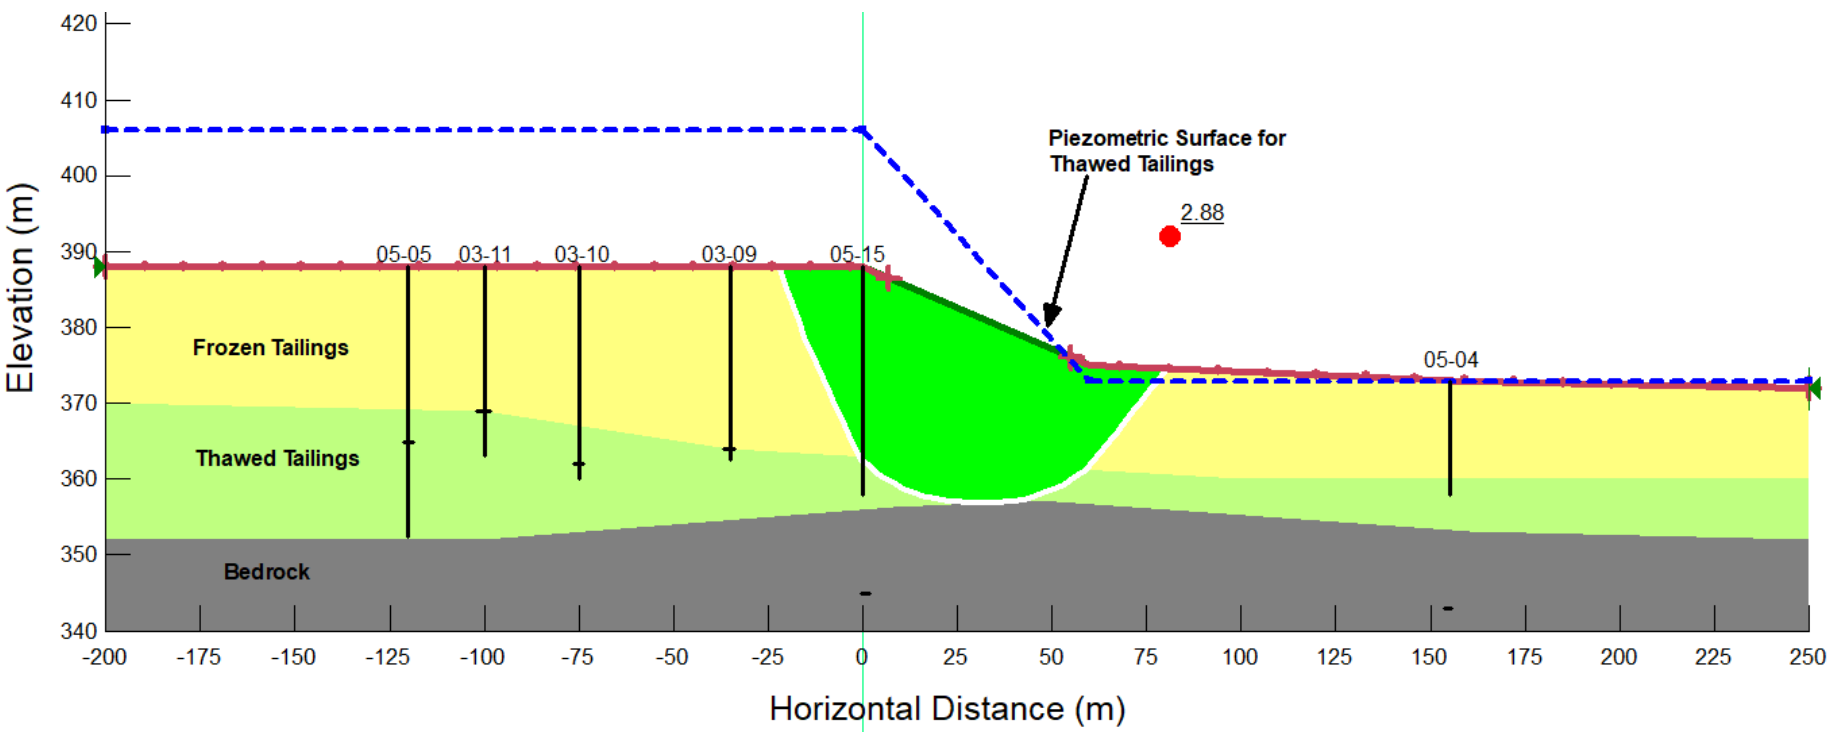
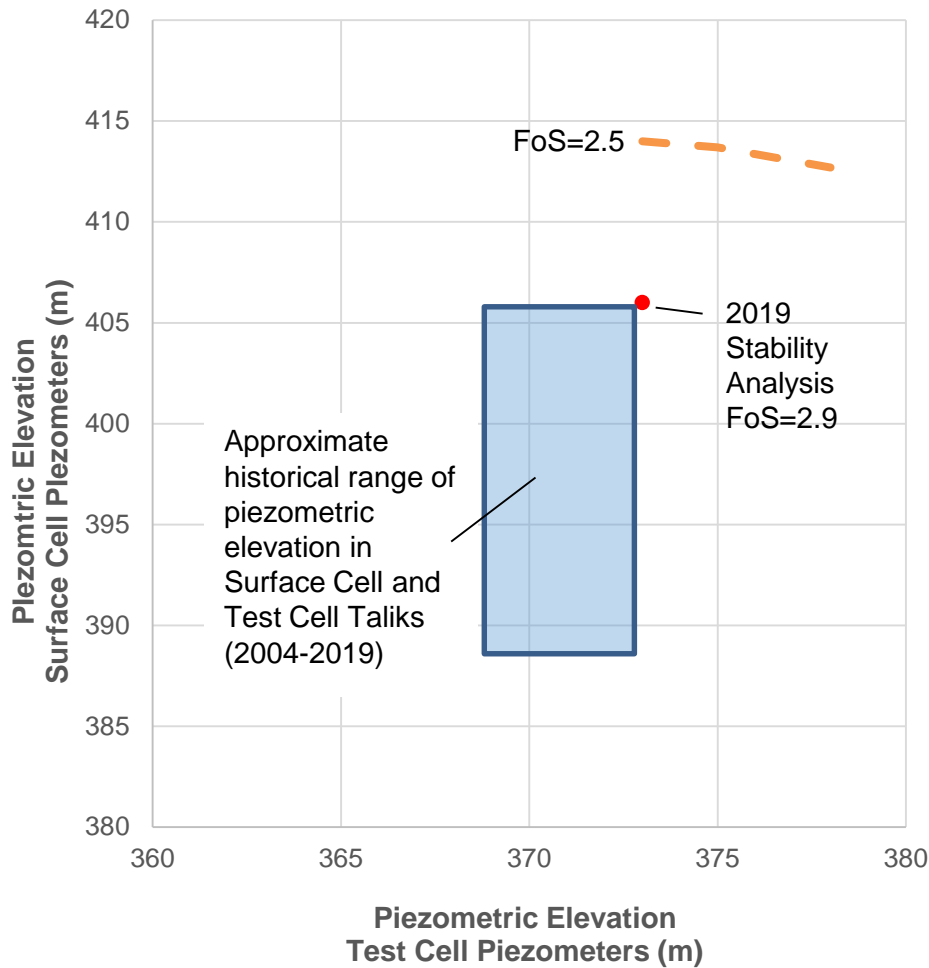
### **2020 WEST TWIN DYKE STABILITY MODELLING UPDATE**

Color	Name	Model	Unit Weight (kN/m³)	Cohesion* (kPa)	Phi* (°)	Piezometric Line
Grey	Bedrock	Bedrock (Impenetrable)				
Yellow	Frozen Tailings	Mohr-Coulomb	24	25	27	
Light Green	Thawed Tailings	Mohr-Coulomb	24	0	27	1

The model was updated again as part of this report, with model setup and results shown in Appendix B. Using 2020 talik geometry, the West Twin Dyke had a factor of safety of 2.9 against sliding under static conditions, with Surface Cell and Test Cell piezometric elevations of 406 and 373, respectively. The test Cell piezometric elevation is slightly higher than is measured in remaining unfrozen piezometers, while the Surface Cell piezometric elevation was extrapolated from stable trends observed in piezometers before they froze-back. It is expected that the factor of safety will continue to increase with downward migration of the freezing front. It should be noted that although the entire footprint below the West Twin Dyke is believed to be frozen into bedrock, the stability model nonetheless considers a thawed layer above bedrock, as a conservative assumption.
