NYRSTAR

NANISIVIK MINE, NUNAVUT

2014 ANNUAL GEOTECHNICAL INSPECTION

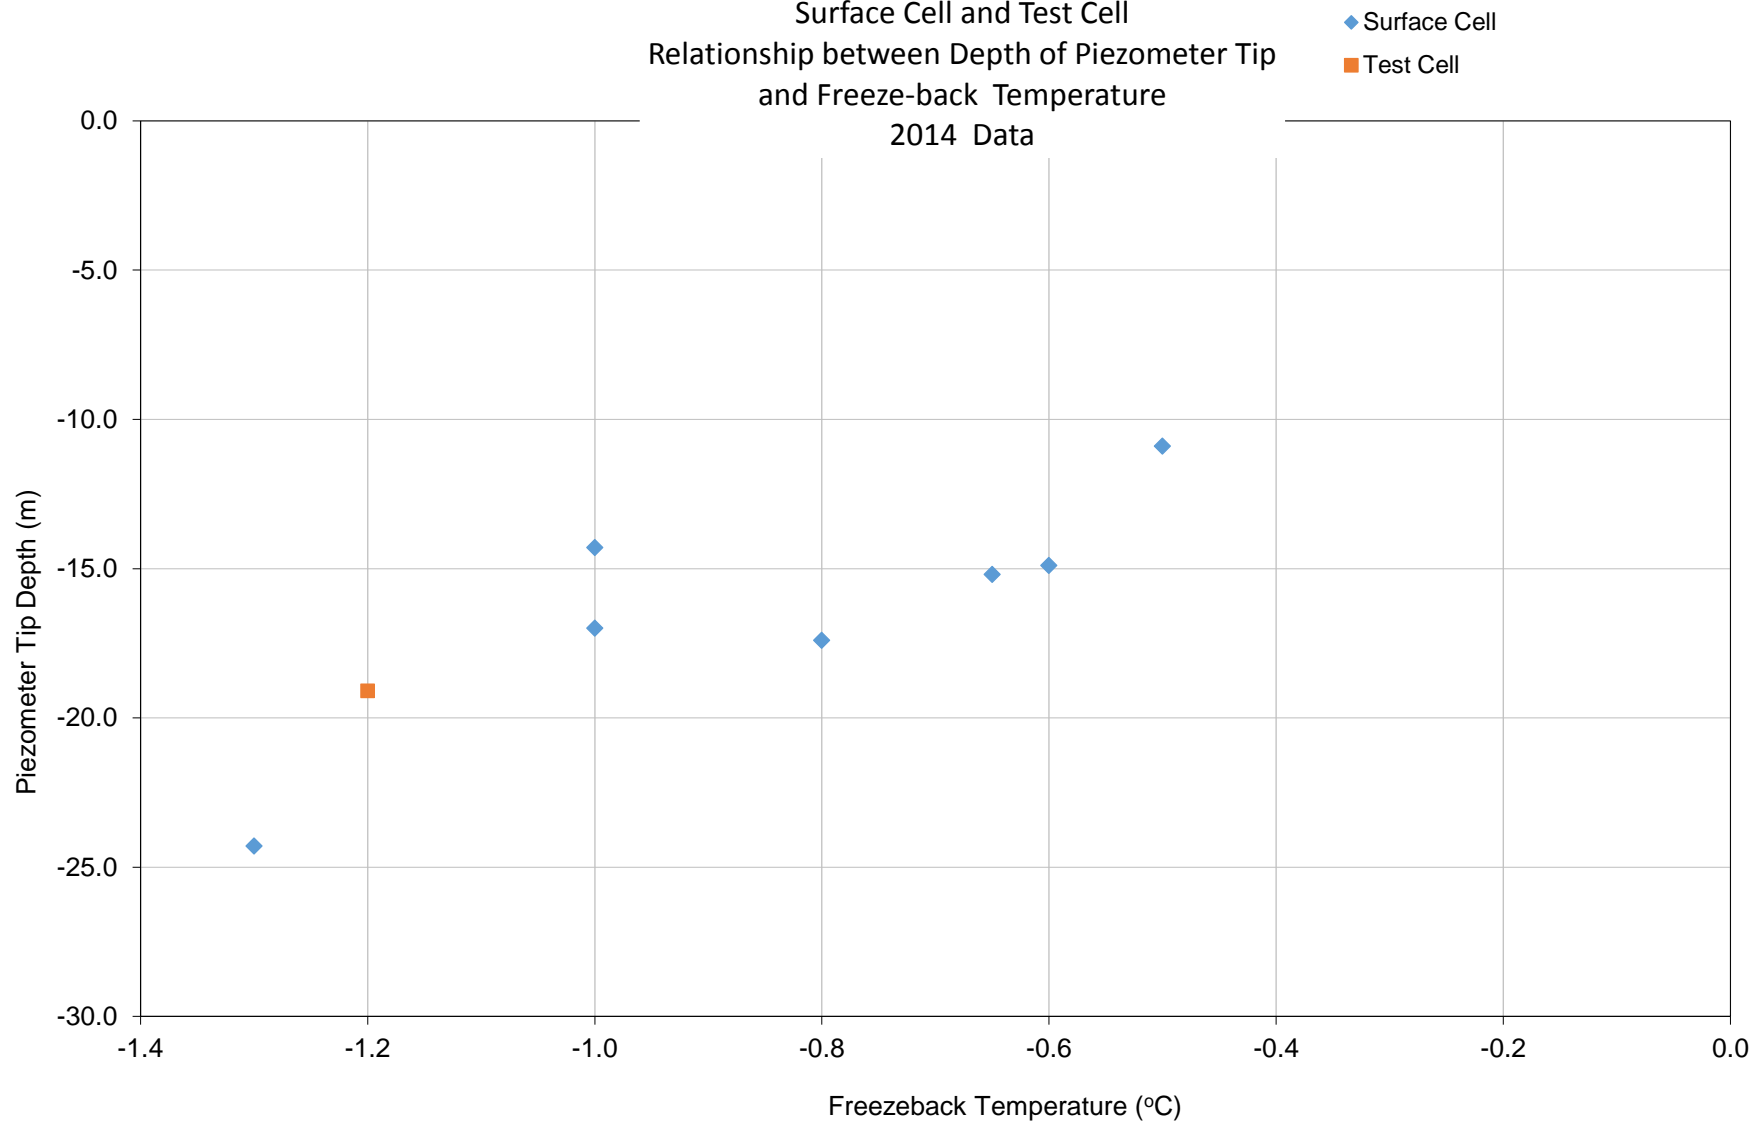
PROJECT: NANISVIK MINE 2014 ANNUAL GEOTECHNICAL INSPECTION		
TITLE: SURFACE CELL TAILINGS COVER GEOTECHNICAL MONITORING DATA 4		
DWG No.: 9	PROJ No.: 0255-024-03	REV:

Geothermal Monitoring
Surface Cell and Test Cell
Relationship between Depth of Piezometer Tip
and Freeze-back Temperature
2014 Data

Freeze-back of the talik in the Surface Cell and Test Cell appears to be proceeding at anticipated rates. Cooling of the entire geothermal profile was observed in most instruments at similar or accelerated rates of cooling compared to recent years.
