**Remediation and Risk
Management Plan for Bathurst
Island (Bent Horn, Ile Vanier,
Stokes Range, Young Inlet
and G-07, K-07, M-21, N-12, J-
34 Well Sites), Nunavut**

Final Report
Project No. 122511001

Prepared by:
Stantec Consulting Ltd.
400-1331 Clyde Avenue
Ottawa, ON K2C 3G4

March 30, 2015

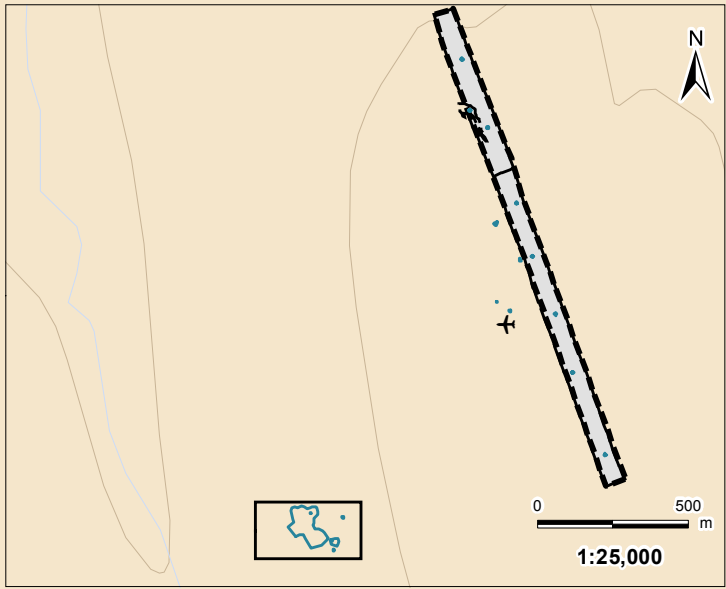
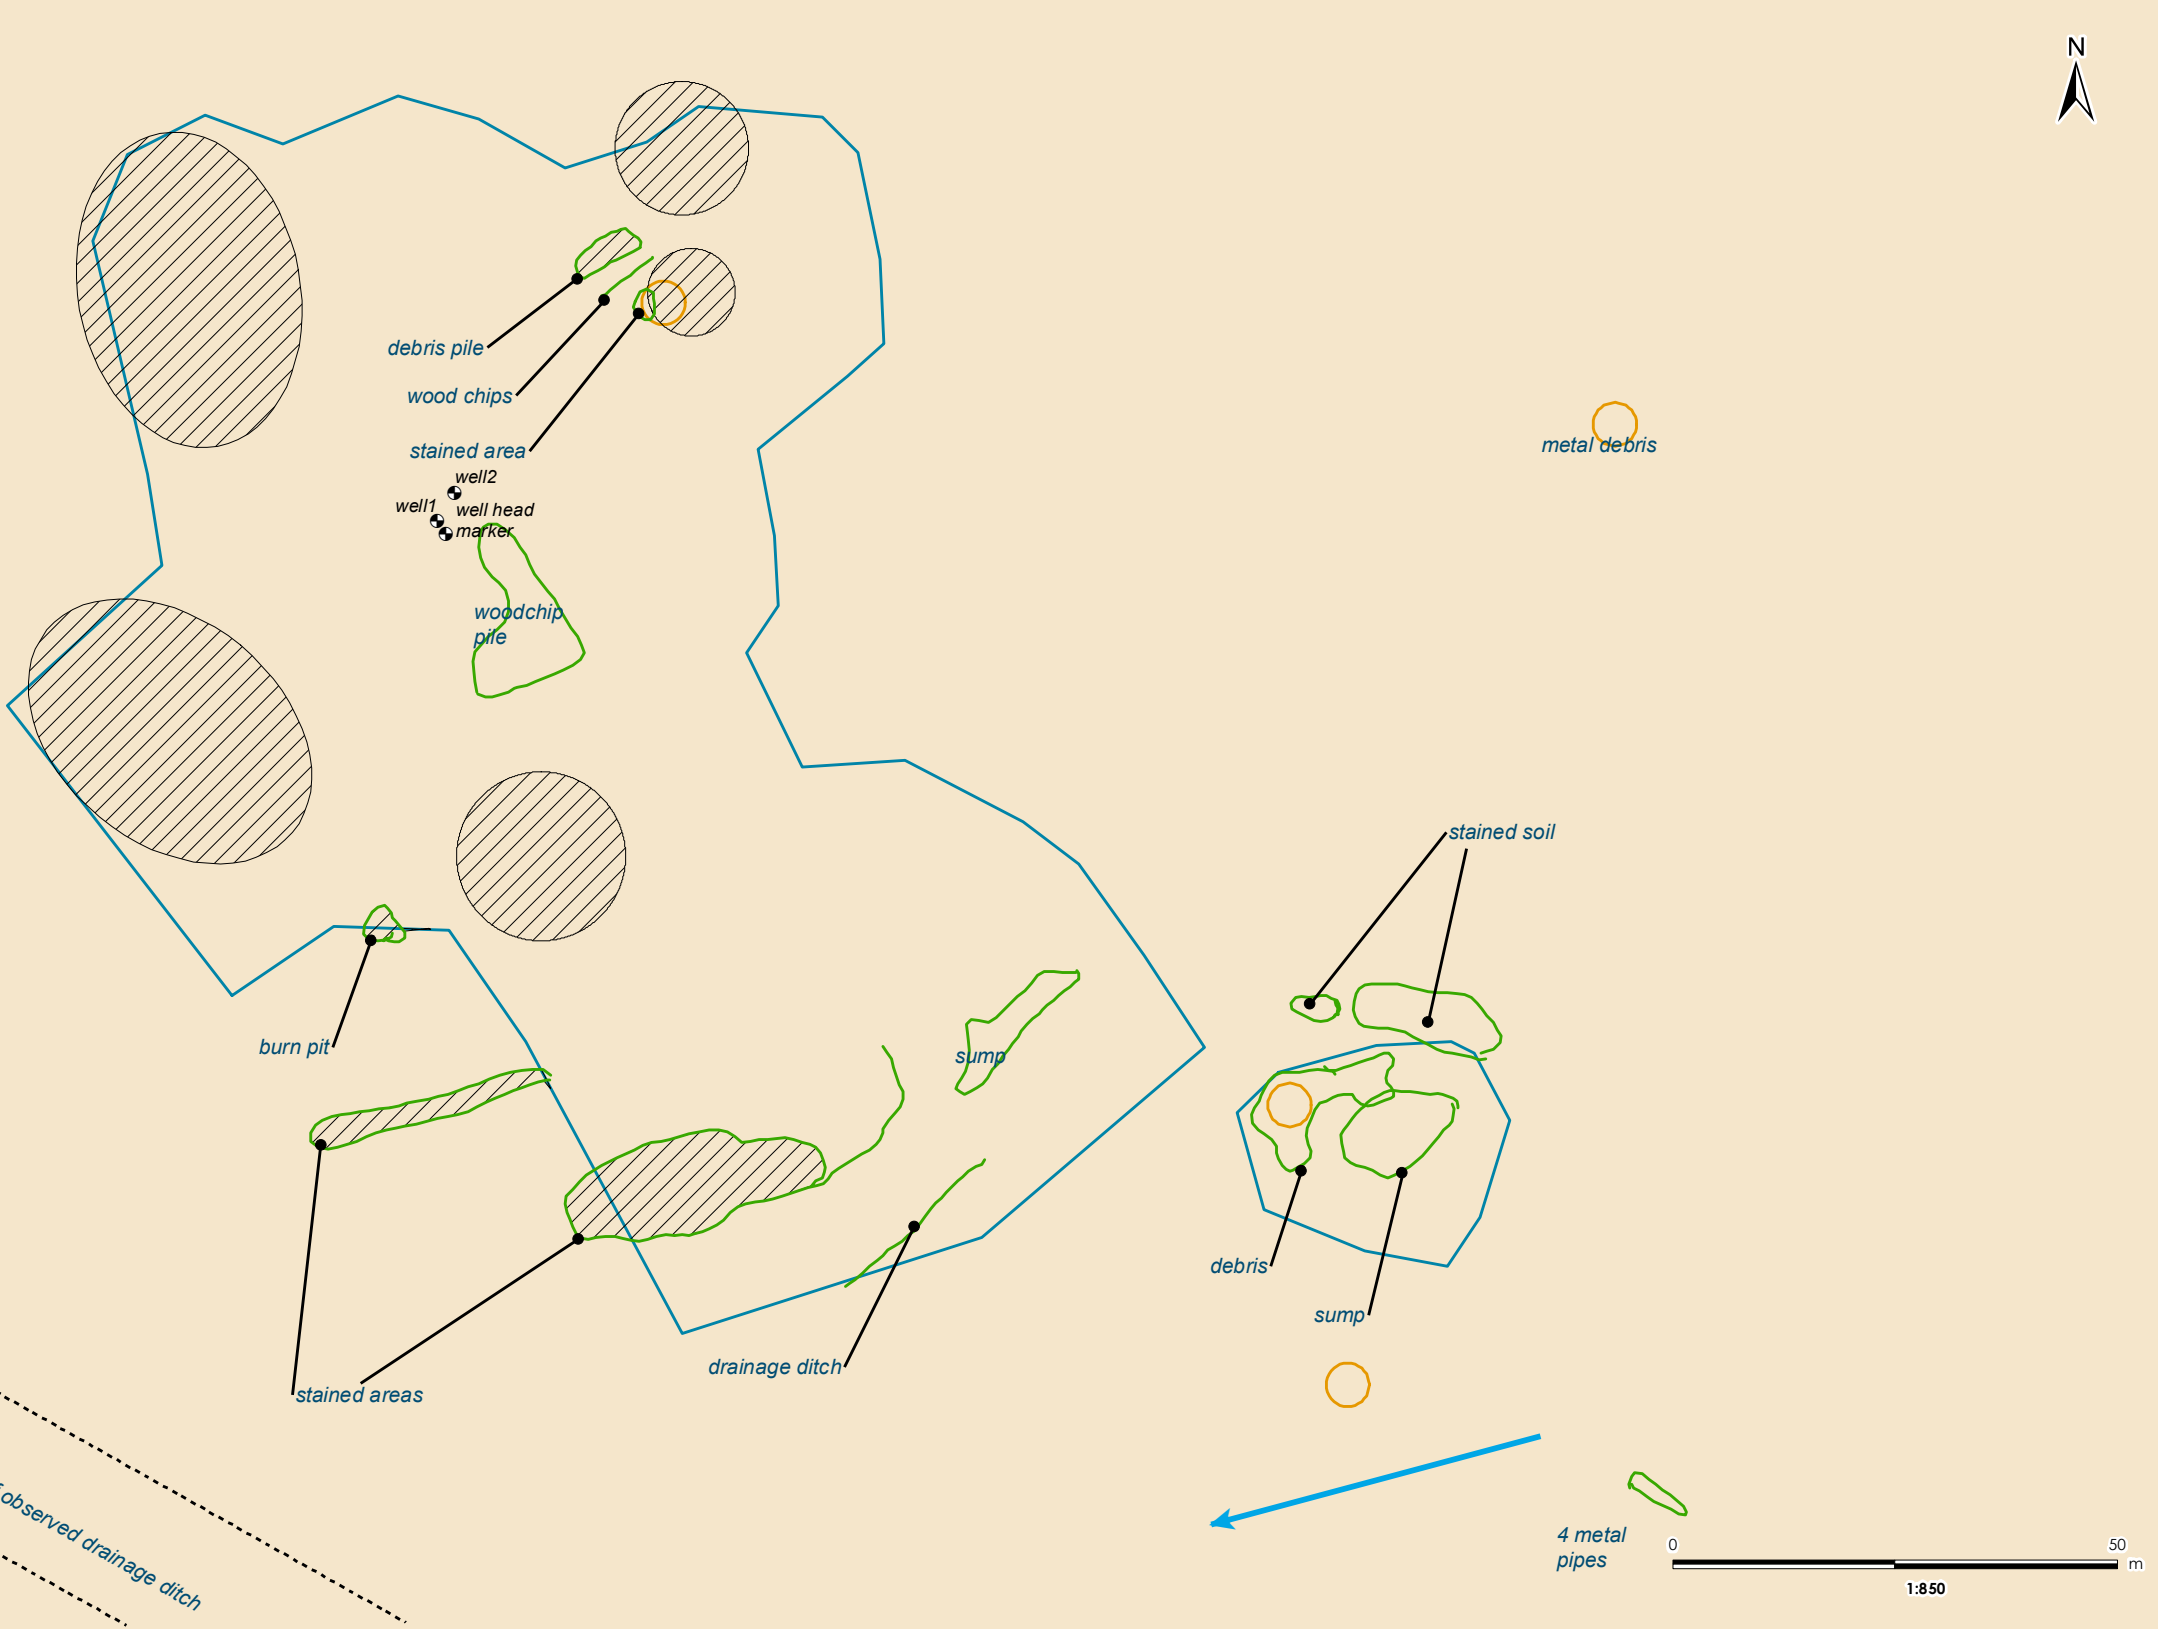
Waste Material Inventory			
Waste Category		Area	Volume/Quantity
Non-Hazardous	Drums	Well Site	10
	Metal	Southeast of well site	5 m3
		Northeast of Well Site	10 m3
		Debris pile by southeast sump	100 m3
		By northeast burnpit	5 m3
	Wood	South of well markers	20 m3
		Northeast	3 m3
	Other debris	Southwest	10 m3
		East	10 m3
Soil Volumes			
Contaminant Type	Quantity	Note	
Metals & PHCs	723	Soils to be left in place and risk managed	
Metals	120	Soils to be left in place and risk managed

- Elevation (m)
- WATERCOURSES
- Well Marker
- Stantec Field Observation
- Drainage ditch
- Geotechnical Field Observation
- Burn Pit
- Disturbed Area
- Inferred Direction of Surface Drainage
- Estimated Area with Soil Impacts

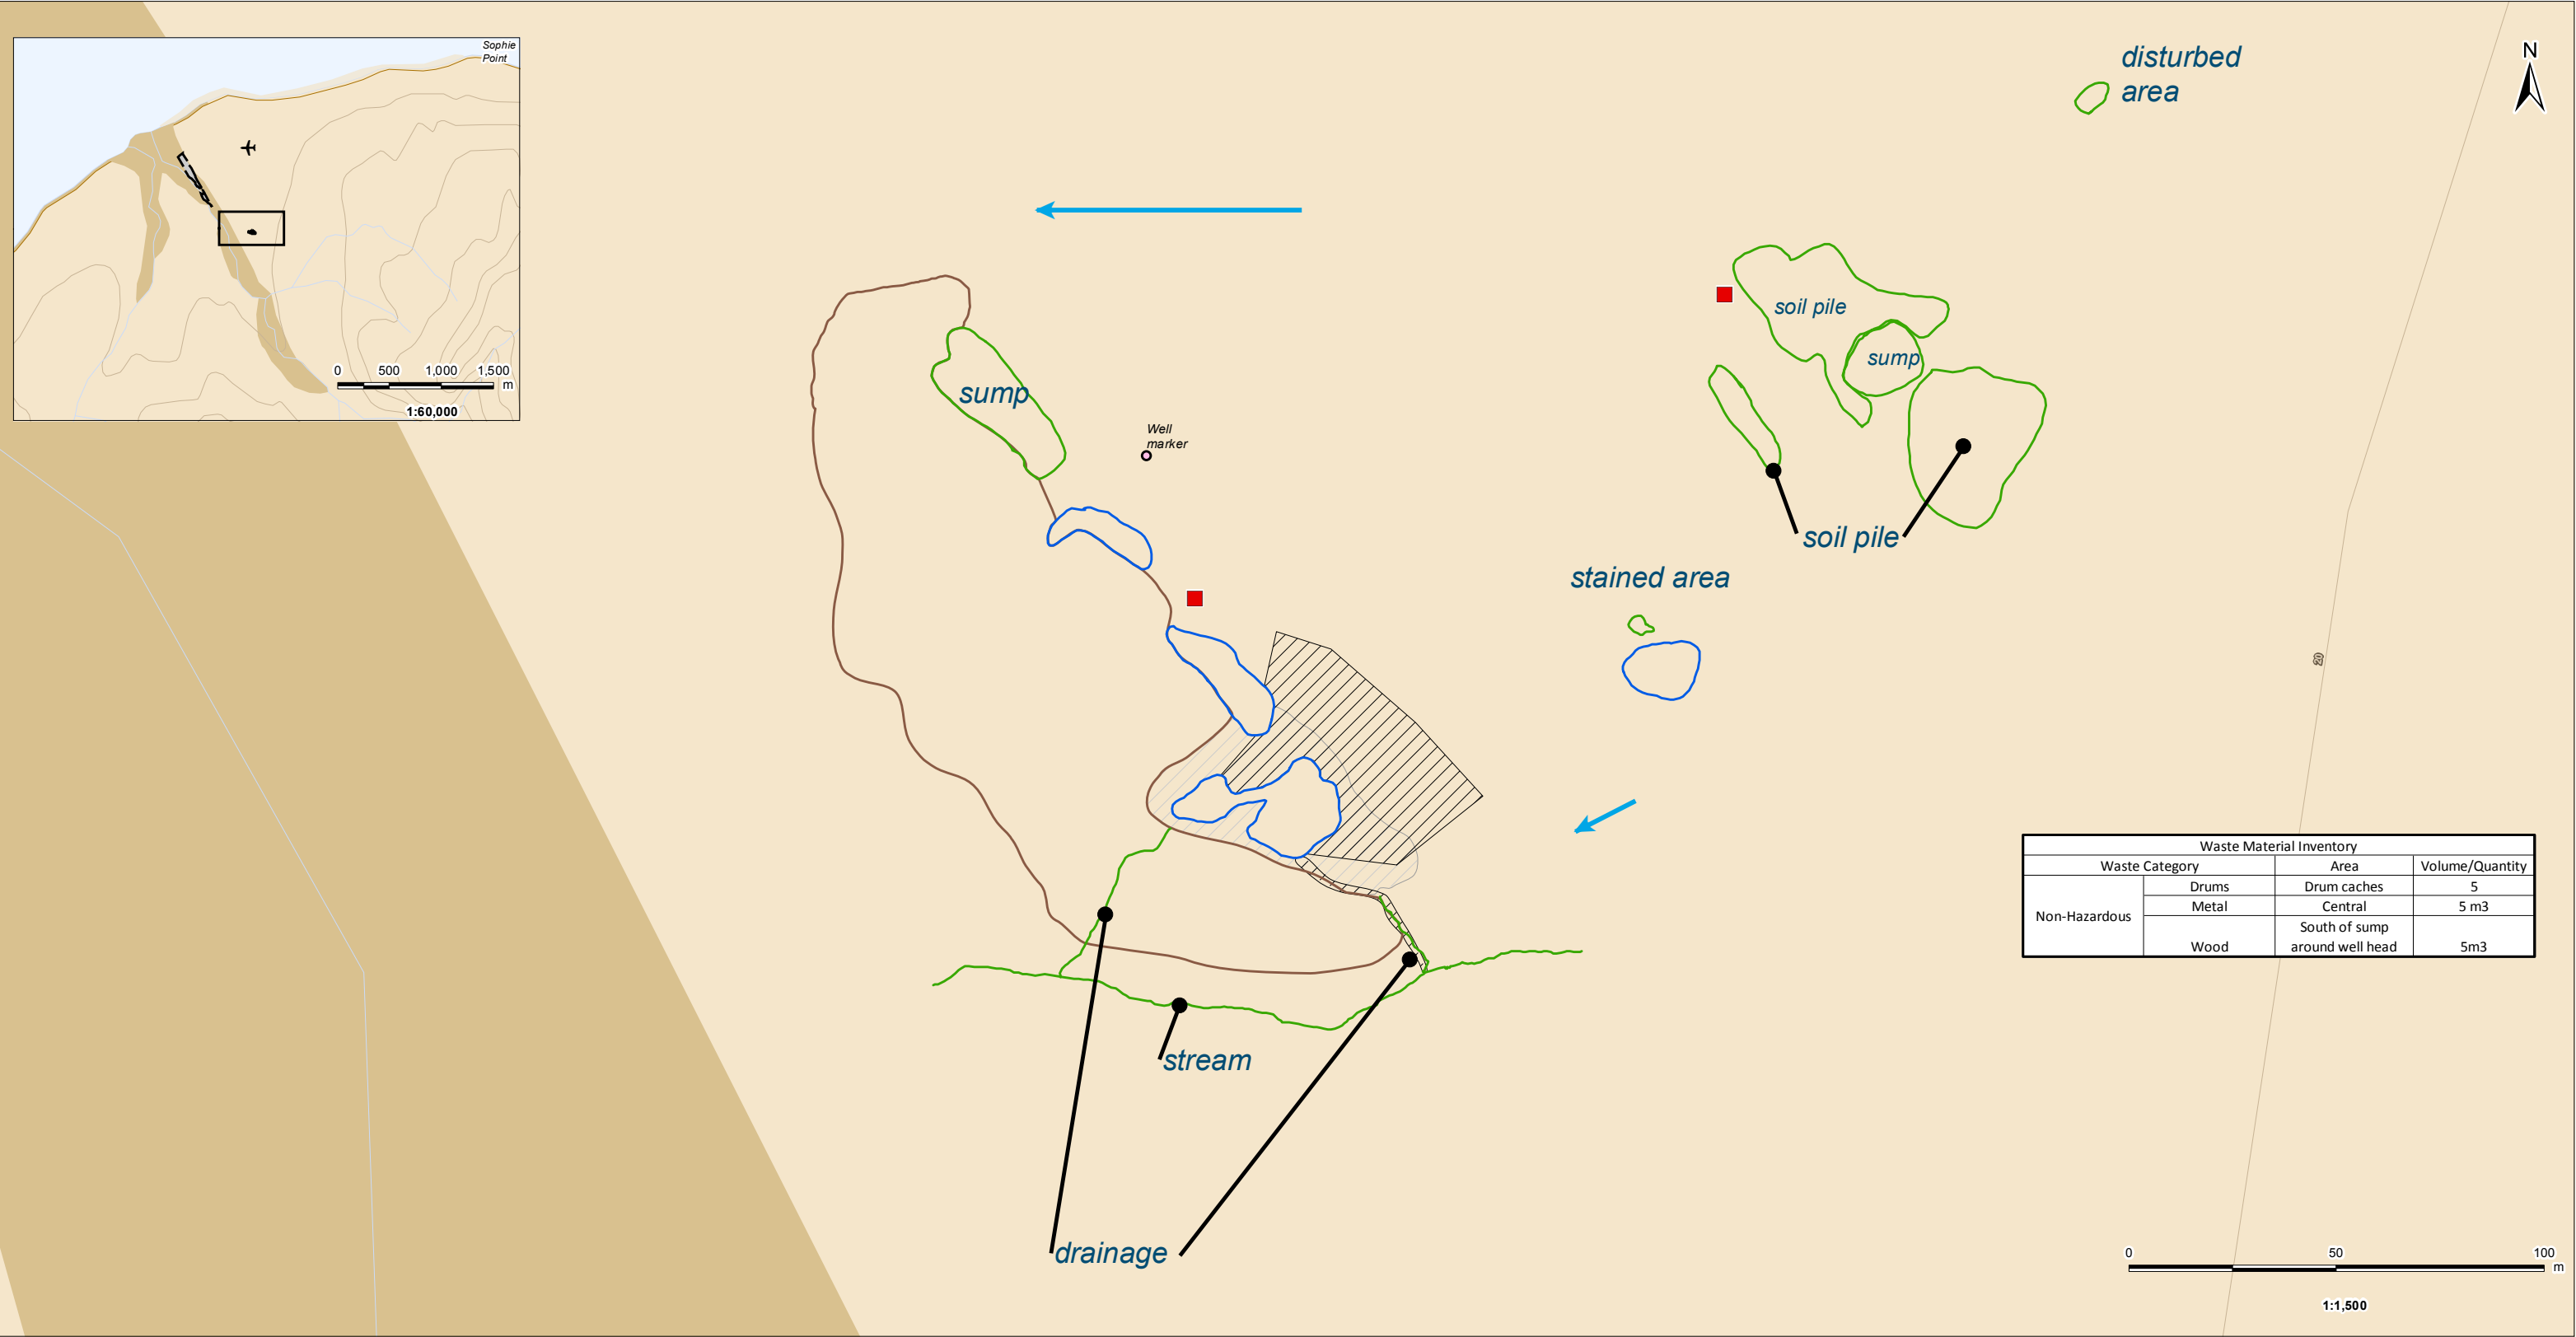
Figure No.
9

Waste Material Inventory			
Waste Category		Area	Volume/Quantity
Non-Hazardous	Drums	Drum caches	5
	Metal	Central	5 m3
	Wood	South of sump around well head	5m3

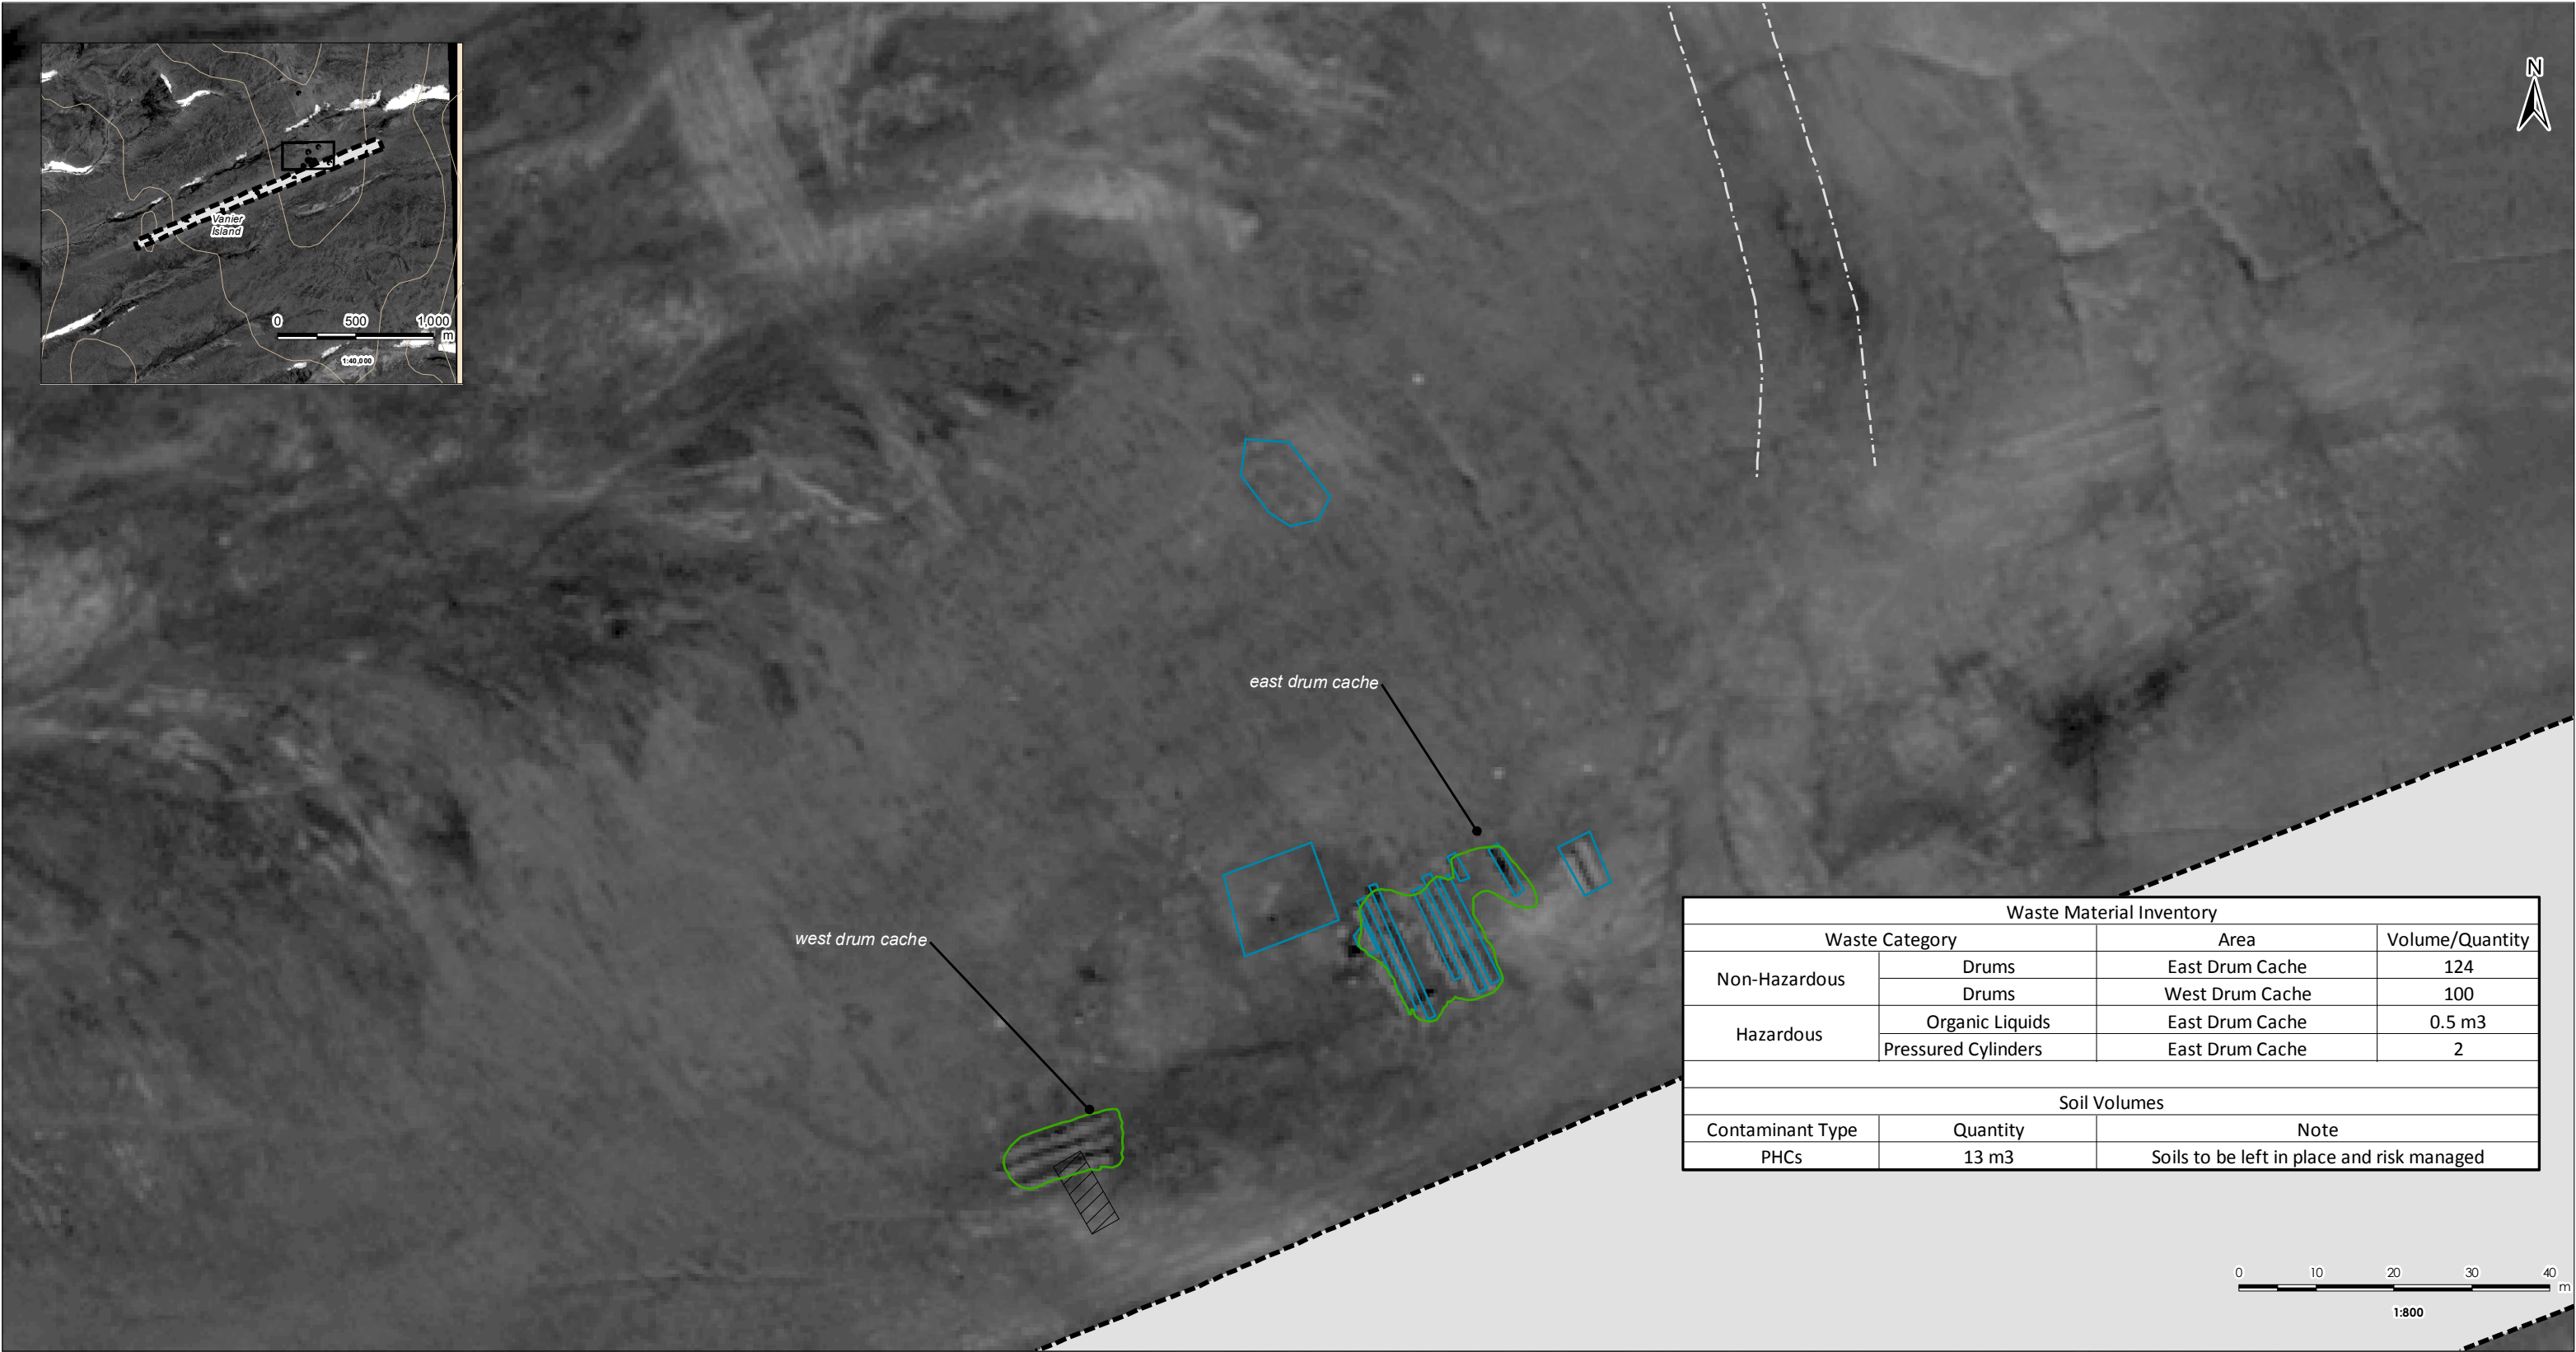
Waste Material Inventory			
Waste Category		Area	Volume/Quantity
Non-Hazardous	Drums	East Drum Cache	124
	Drums	West Drum Cache	100
Hazardous	Organic Liquids	East Drum Cache	0.5 m3
	Pressured Cylinders	East Drum Cache	2
Soil Volumes			
Contaminant Type	Quantity	Note	
PHCs	13 m3	Soils to be left in place and risk managed

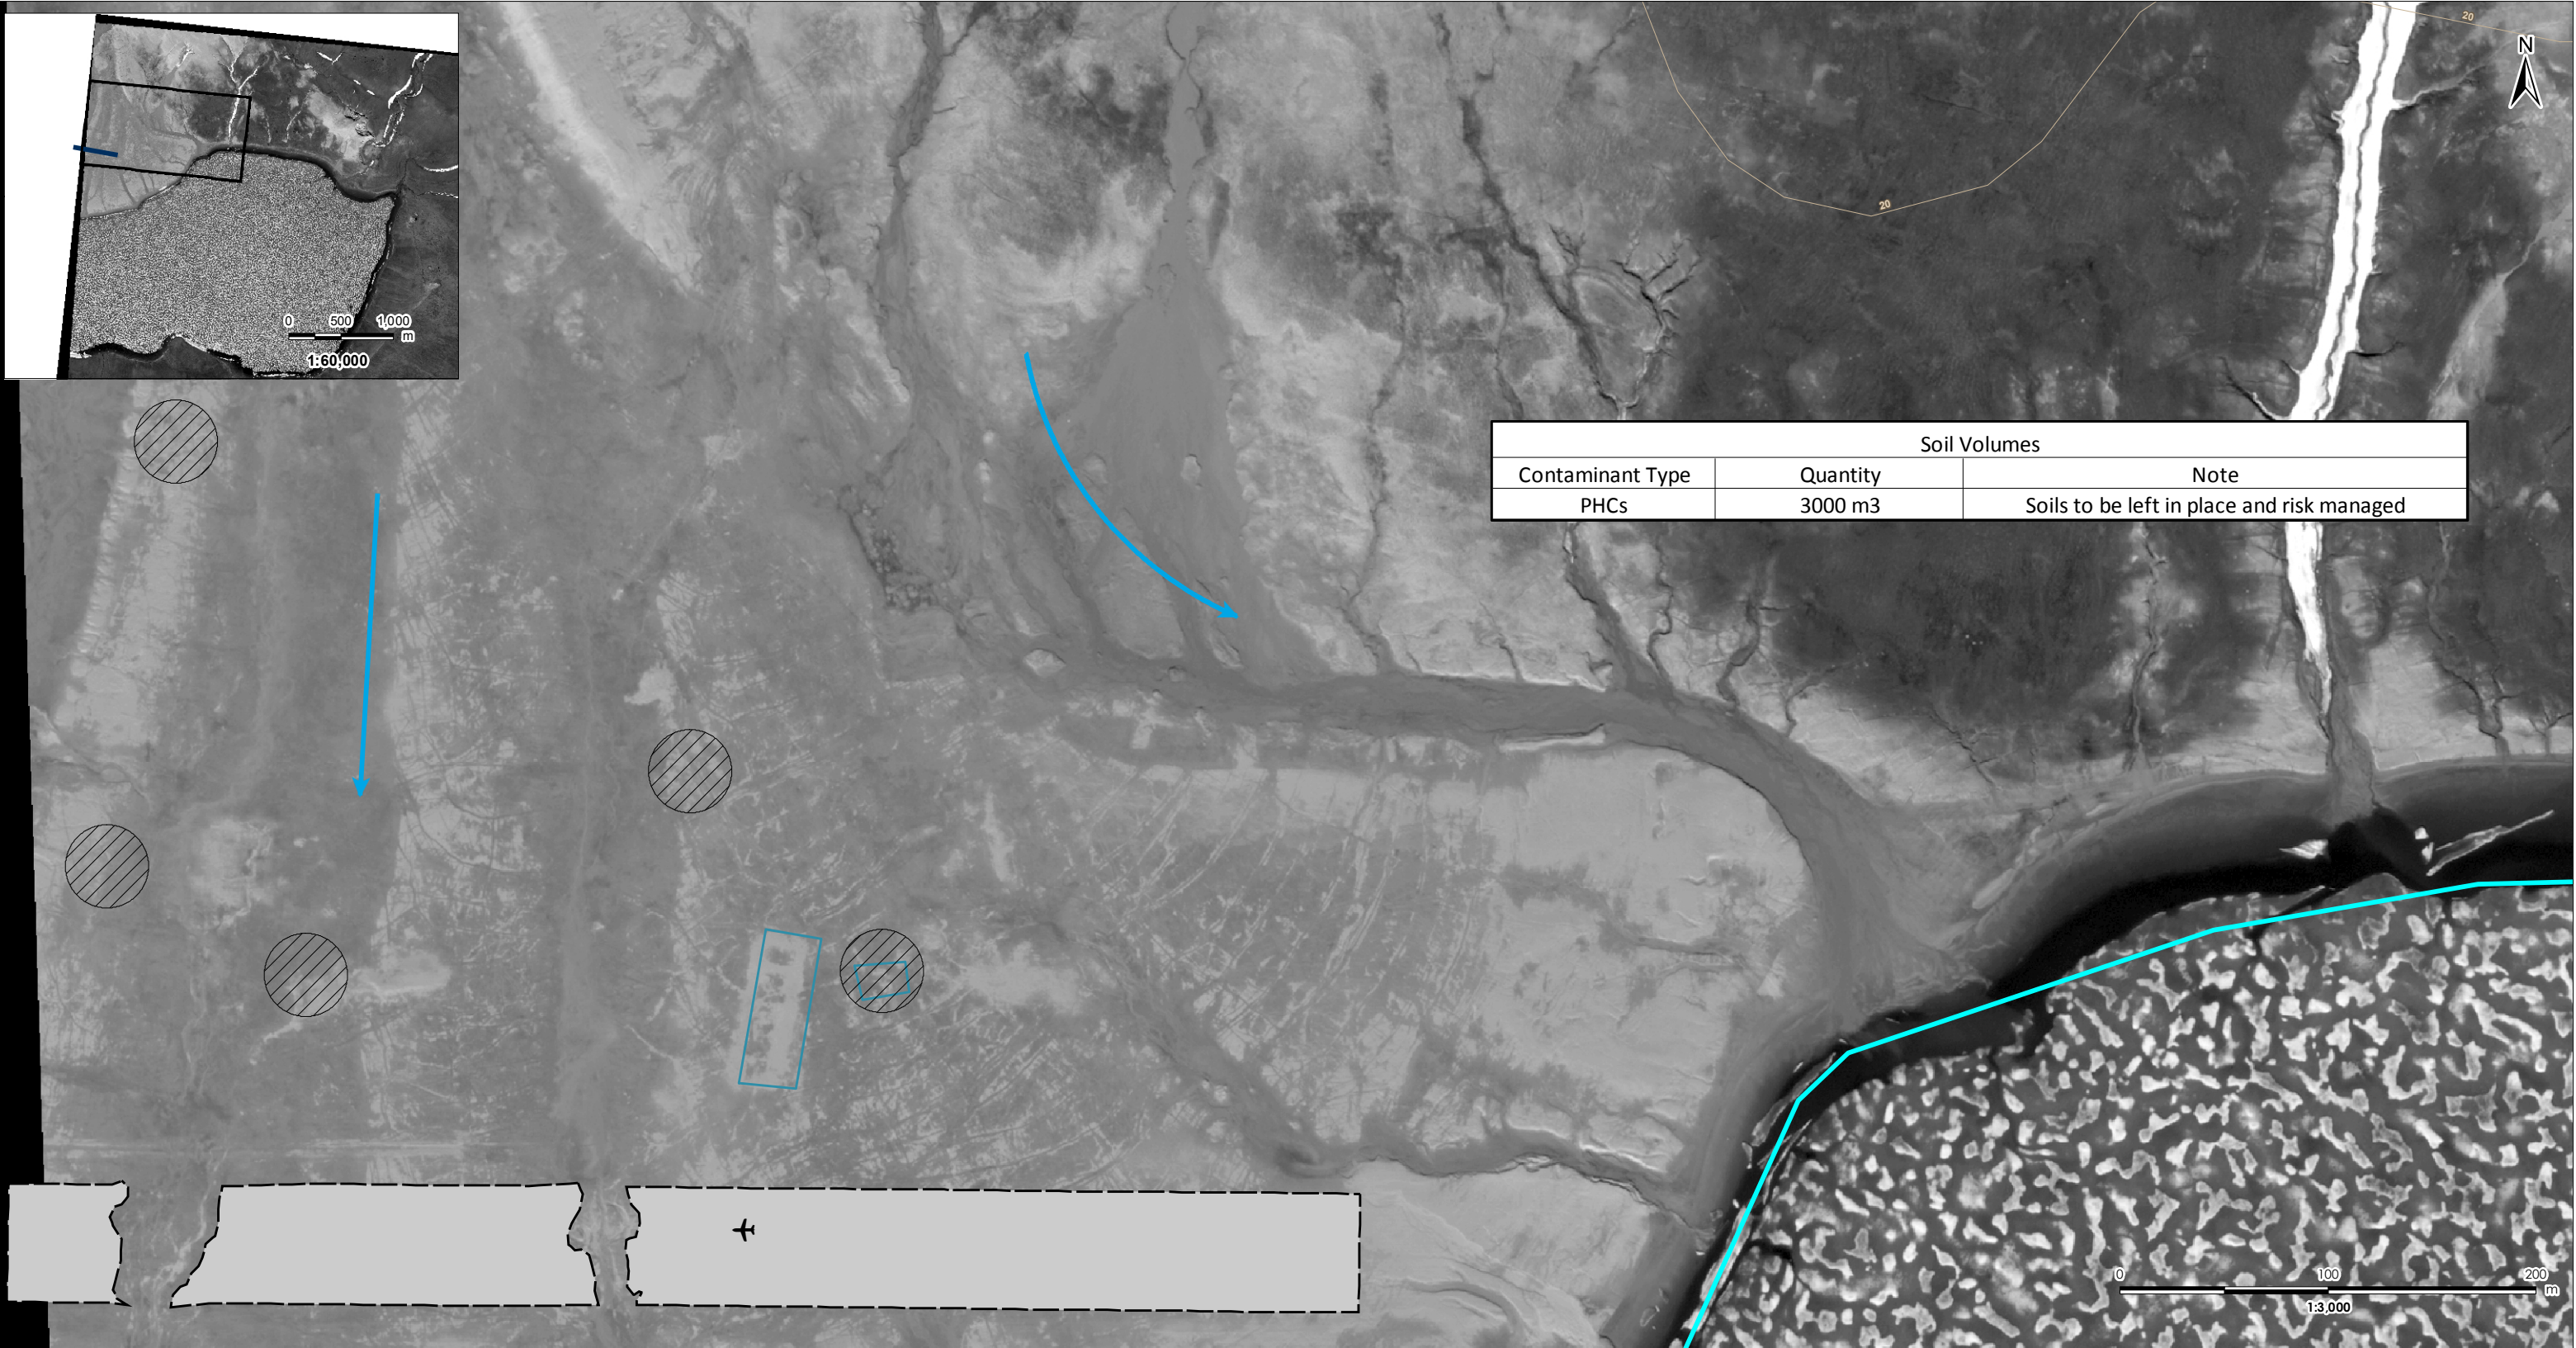
Figure No.
11

Soil Volumes		
Contaminant Type	Quantity	Note
PHCs	3000 m3	Soils to be left in place and risk managed

Bent Horn APEC 3
Soil Volumes

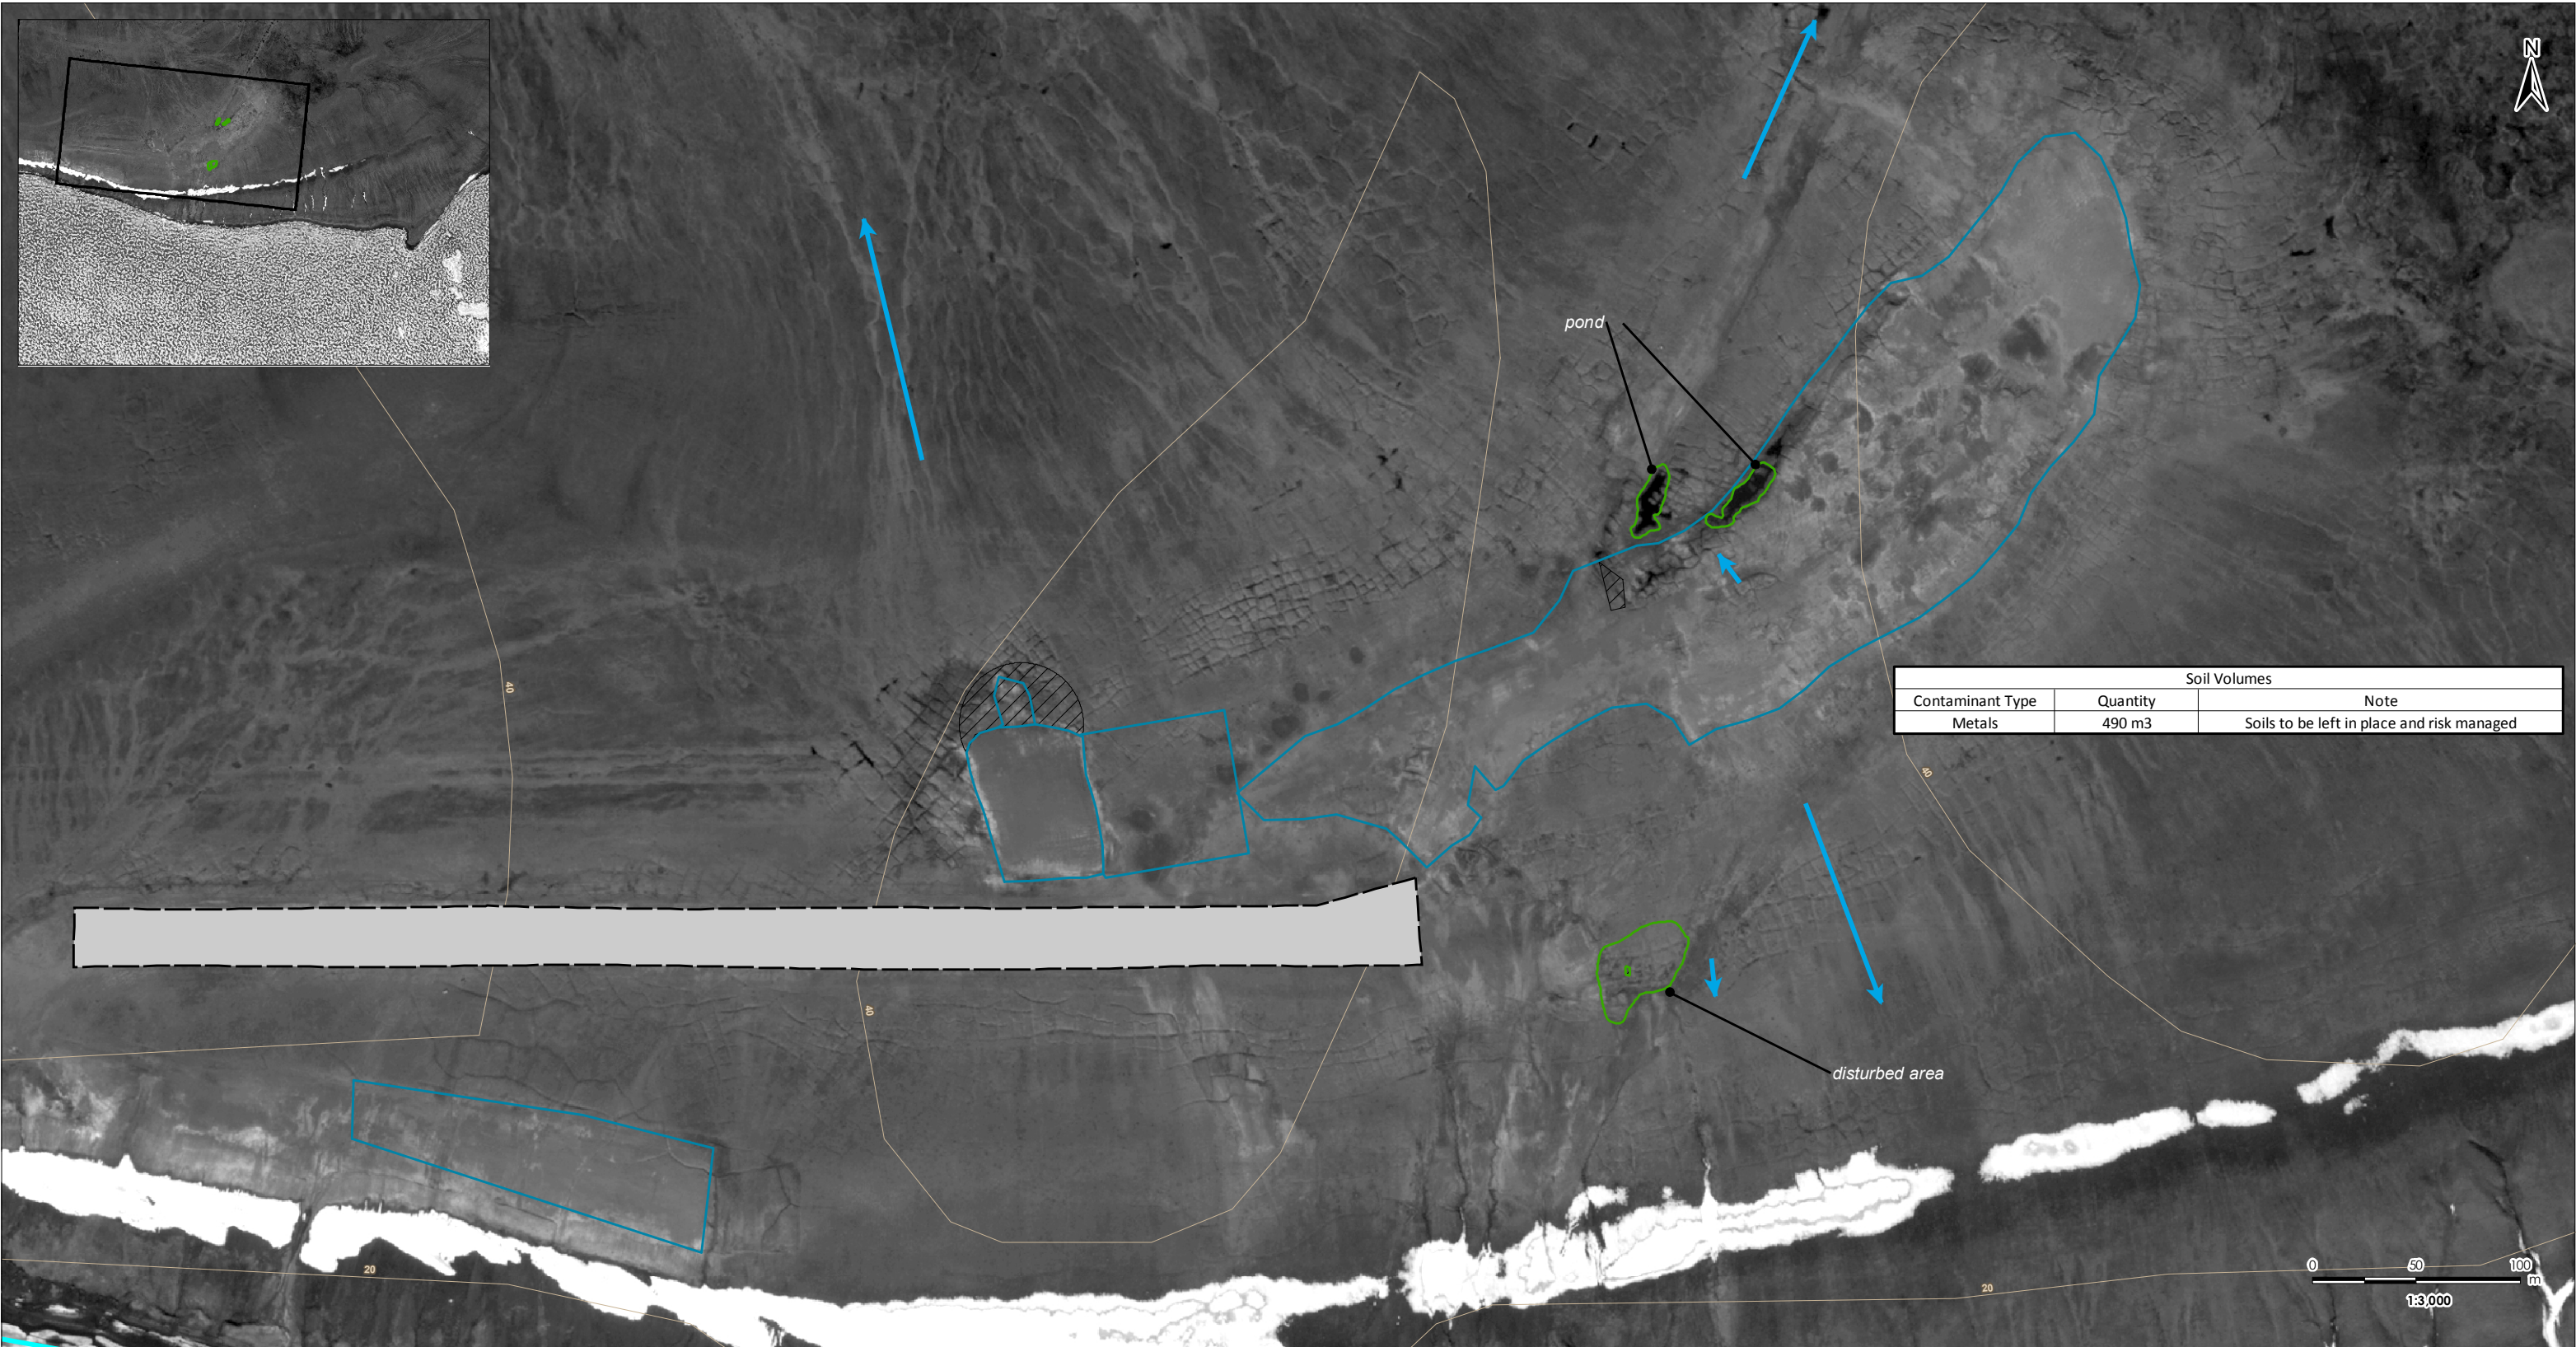
Figure No.
12

Title
**Bent Horn APEC 6
Waste Material Inventory & Soil Volumes**

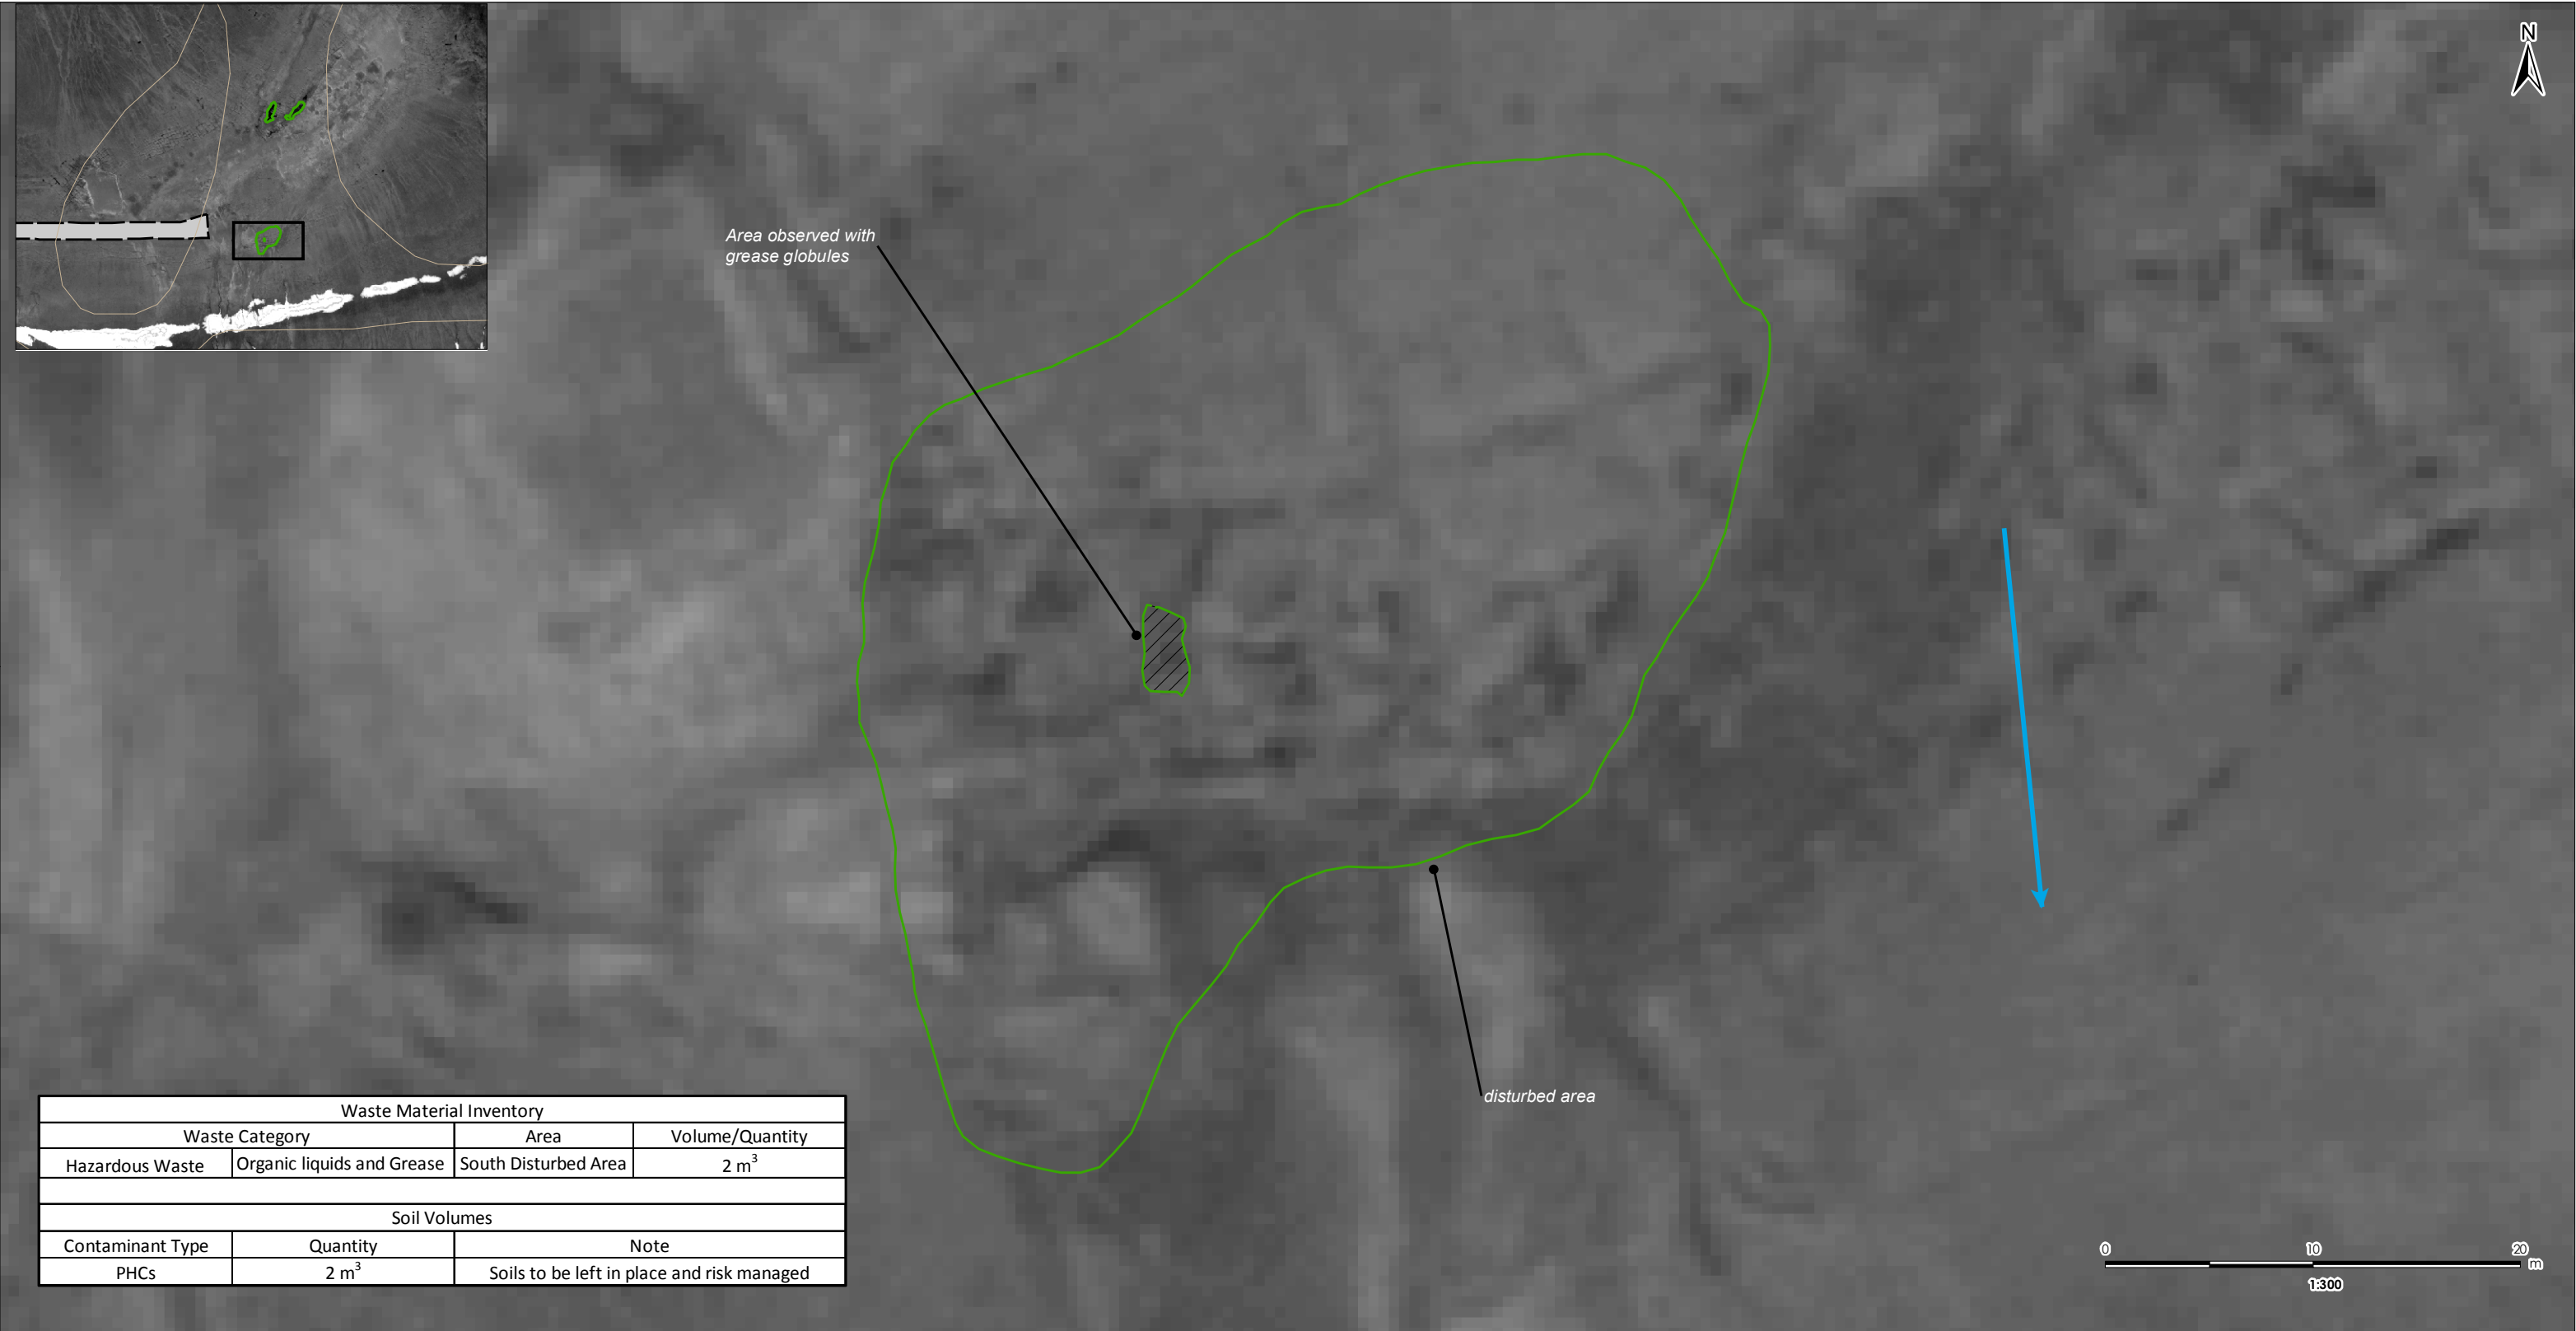
Figure No.
13

- + Runway
- Elevation (m)
- Stantec Field Observation
- Inferred Direction of Surface Drainage
- ▭ Airstrip
- ▨ Estimated Area with Soil Impacts

Title
**Bent Horn APEC 6 South
Waste Material Inventory & Soil Volumes**
