**Remediation and Risk
Management Plan for Bathurst
Island (Bent Horn, Ile Vanier,
Stokes Range, Young Inlet
and G-07, K-07, M-21, N-12, J-
34 Well Sites), Nunavut**

Final Report
Project No. 122511001

Prepared by:
Stantec Consulting Ltd.
400-1331 Clyde Avenue
Ottawa, ON K2C 3G4

March 30, 2015

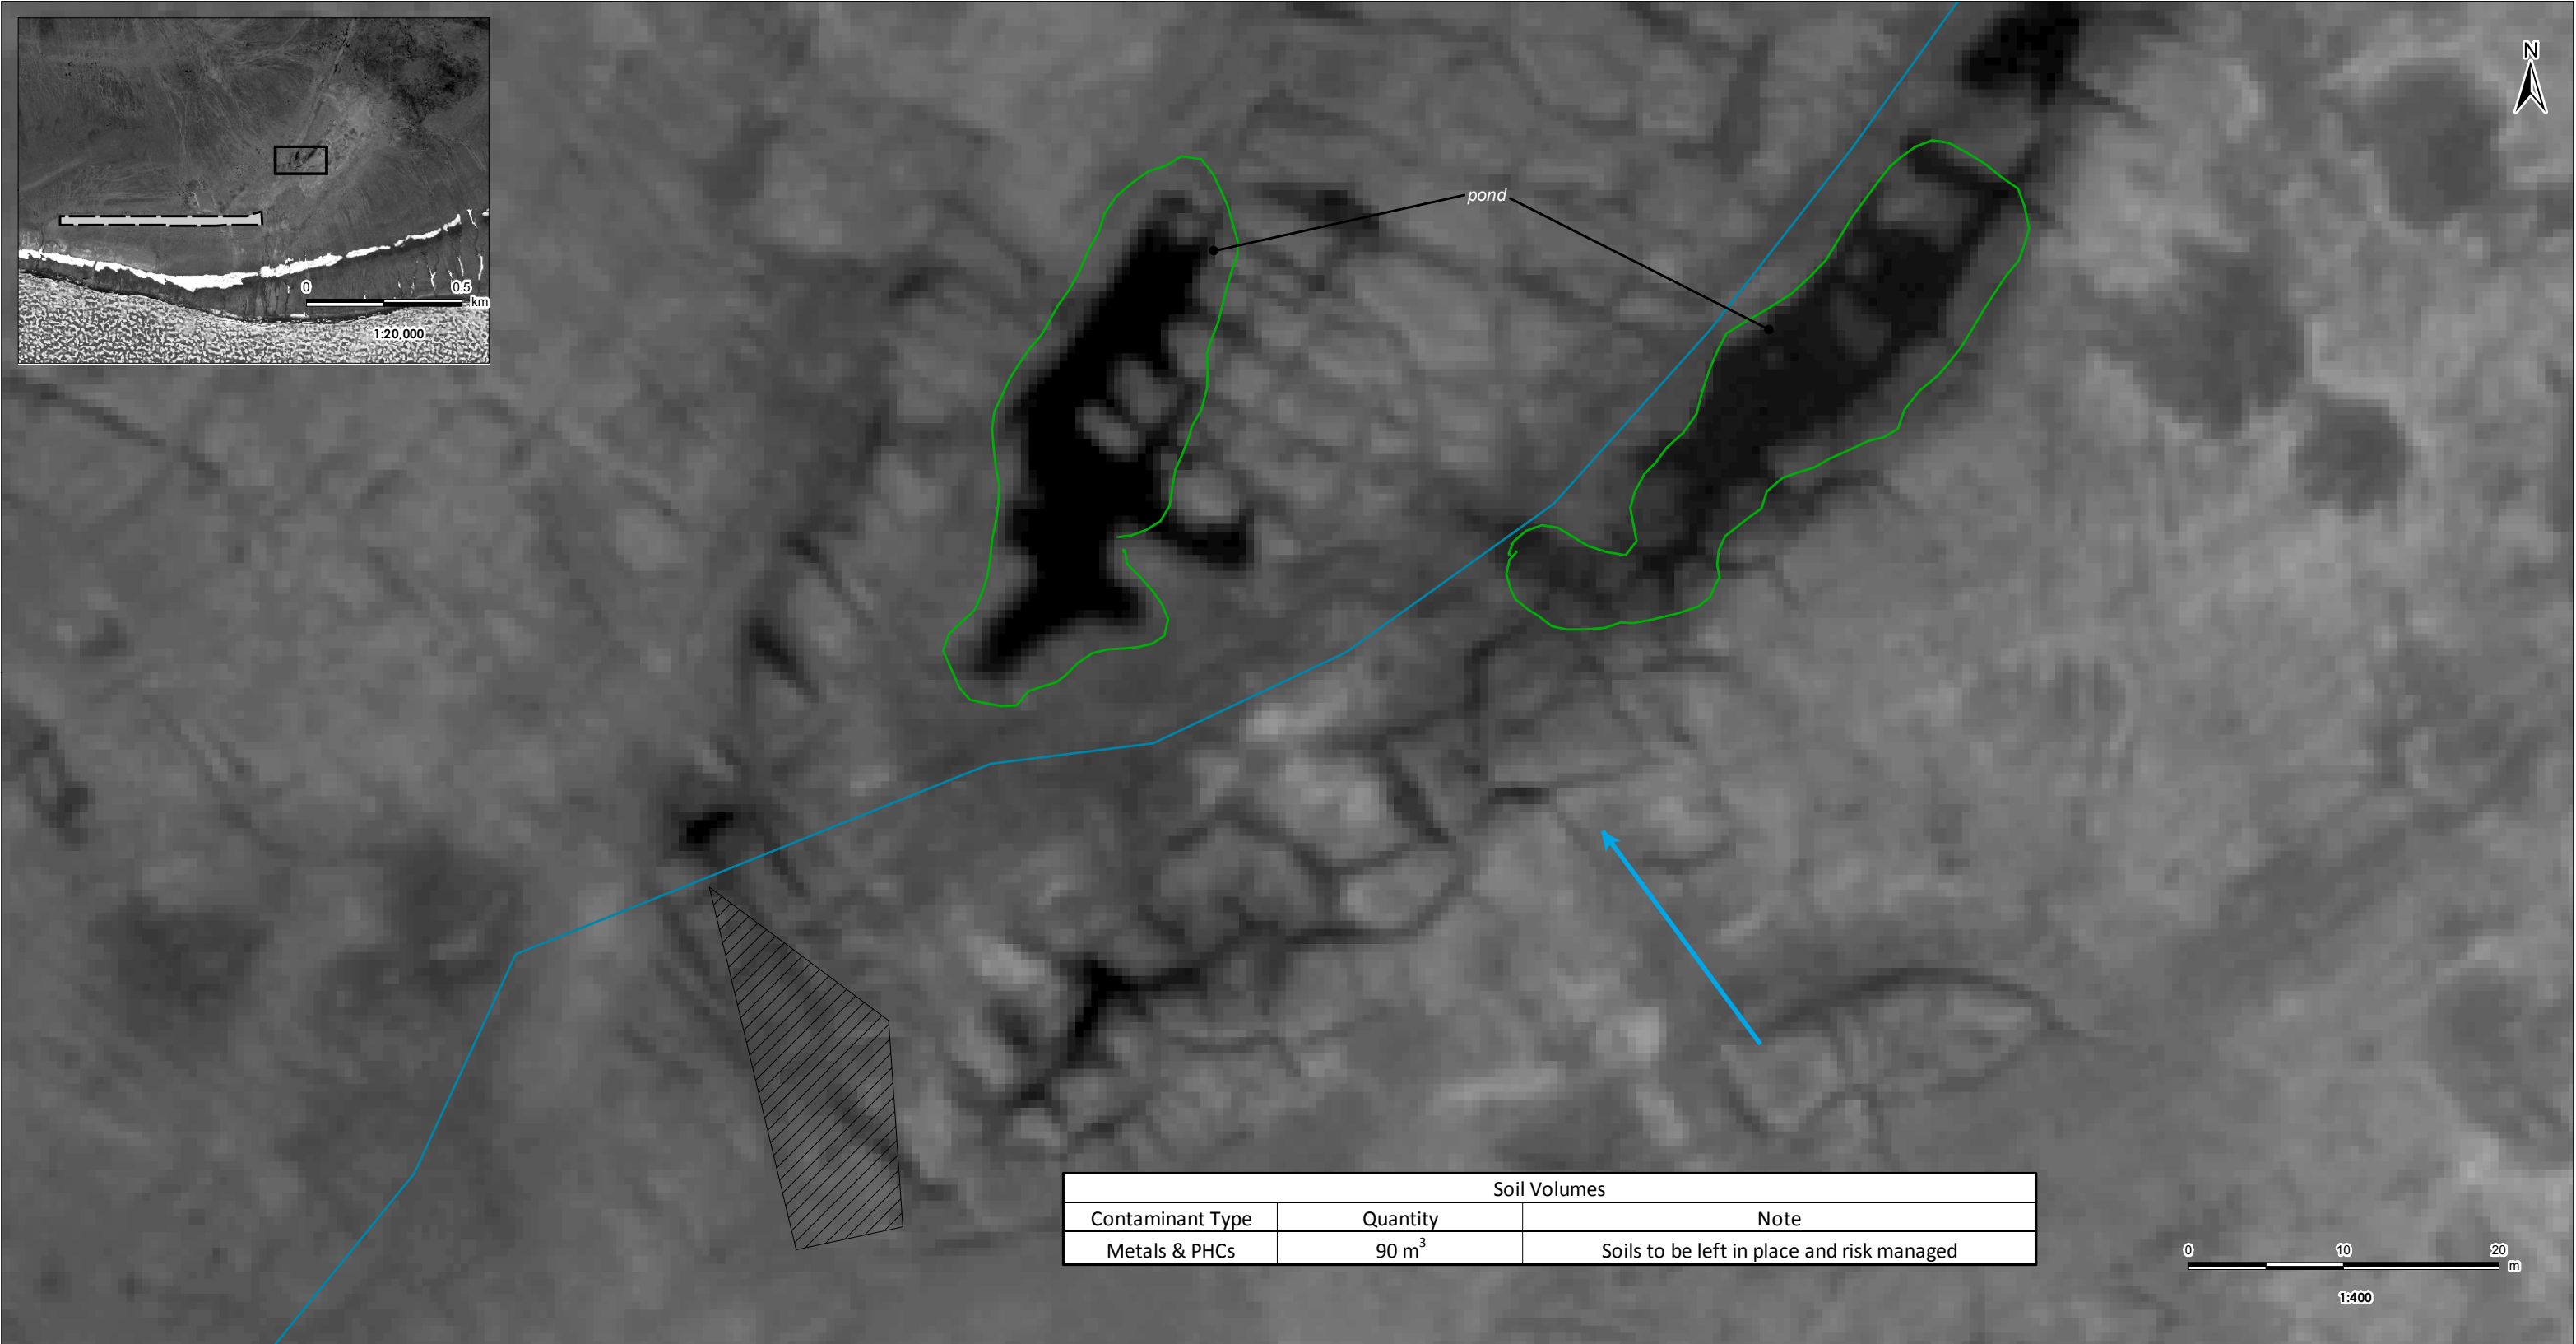
Figure No.
14

Soil Volumes		
Contaminant Type	Quantity	Note
Metals & PHCs	90 m ³	Soils to be left in place and risk managed

Title
**Bent Horn APEC 6 North Disturbed Area
Soil Volumes**

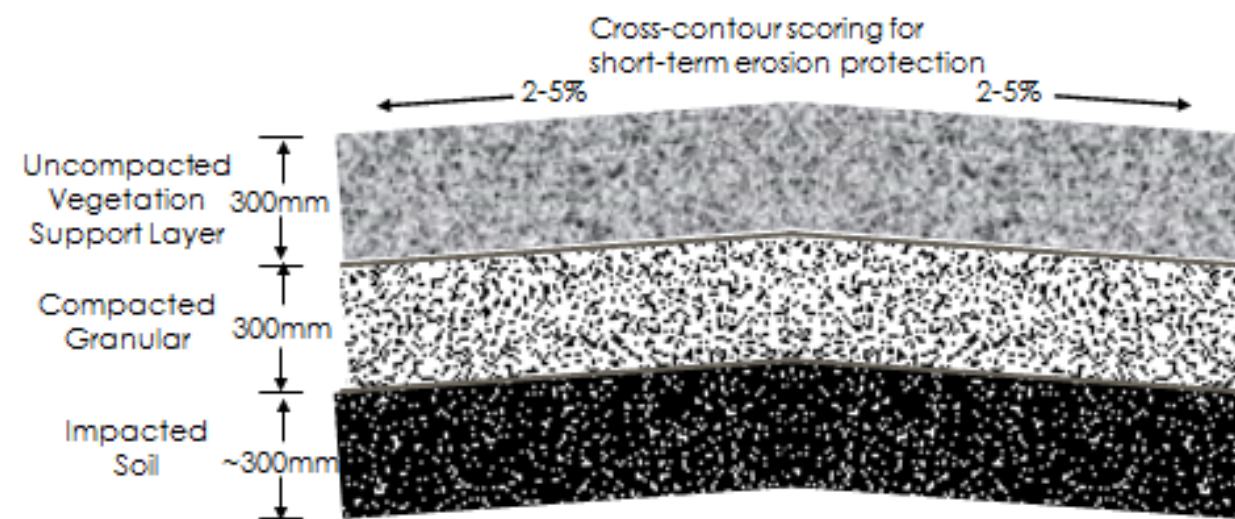
Impacted Soil Cover
Typical Cross-section
No Geomembrane

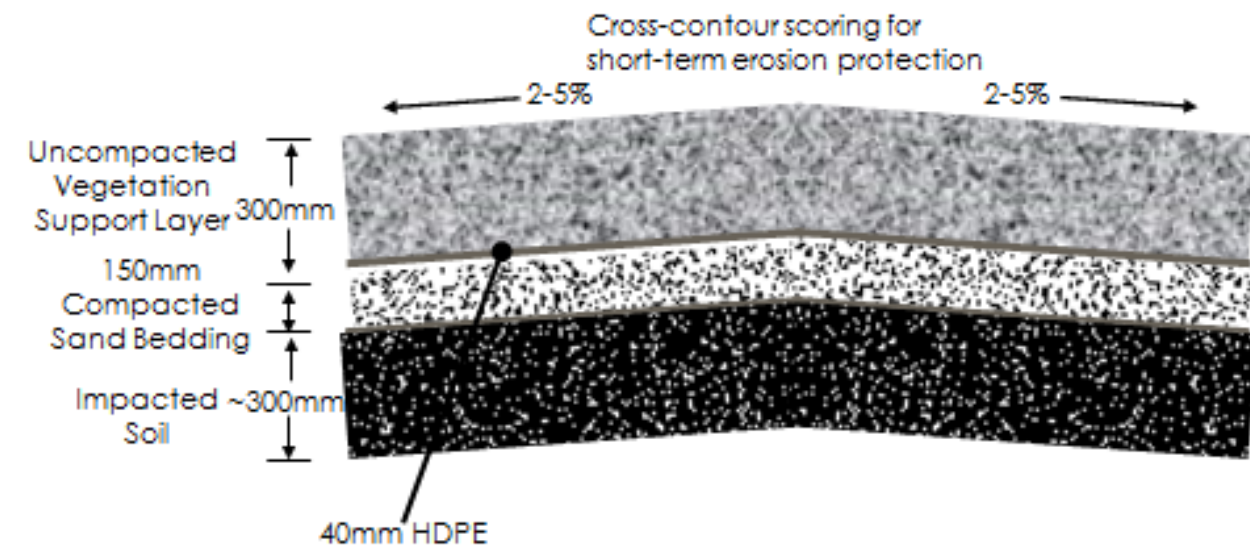
Impacted Soil Cover
Typical Cross-section
With Geomembrane
