NWB Annual Report**Year being reported:** 2023

License No: 1BR-COR2325 **Issued Date:** June 15, 2023
Expiry Date: June 14, 2025

Project Name: Coral Harbour Remediation Project**Licensee:** Crown-Indigenous Relations & Northern Affairs Canada – Contaminated Sites Program**Mailing Address:** P.O. Box 2200
Iqaluit, NU, X0A 0H0**Name of Company filing Annual Report (if different from Name of Licensee please clarify relationship between the two entities, if applicable):**

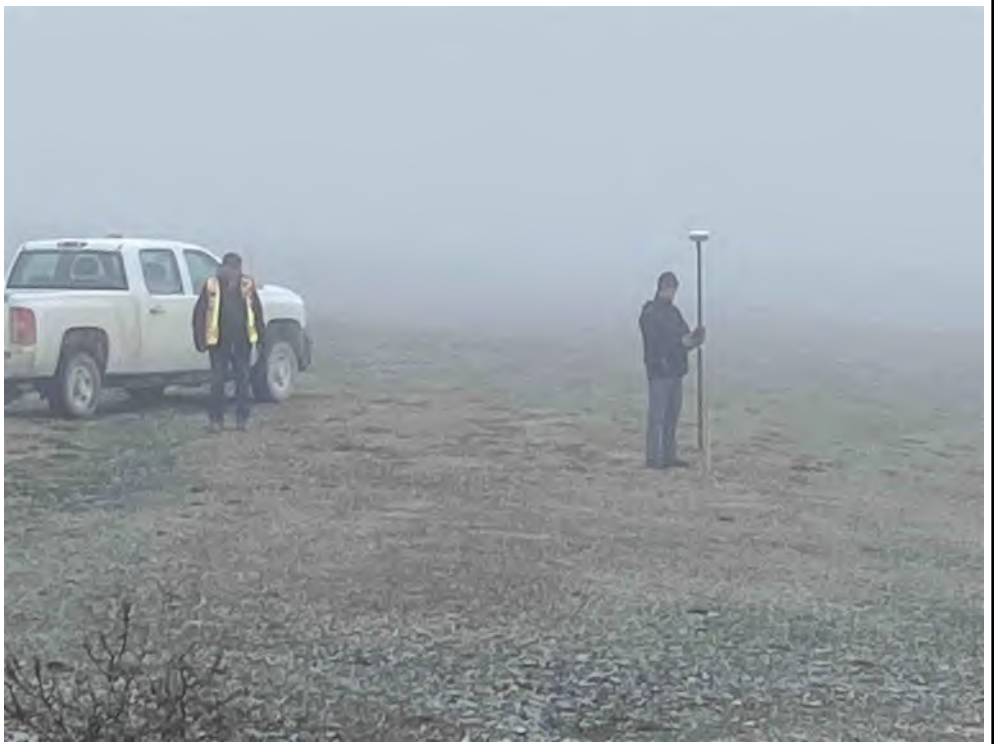
Client:	PSPC/CIRNAC	Project:	Coral Harbour Remediation Project - 123513974
Site Name:	Coral Harbour Site	Site Location:	Coral Harbour, NU
Photograph ID: 1

Photo Location: NHW Facility			
Direction: SE			
Survey Date: 7/12/2023			
Comments: View of third-party surveyor laying out the NHW Facility control points.			
Photograph ID: 2

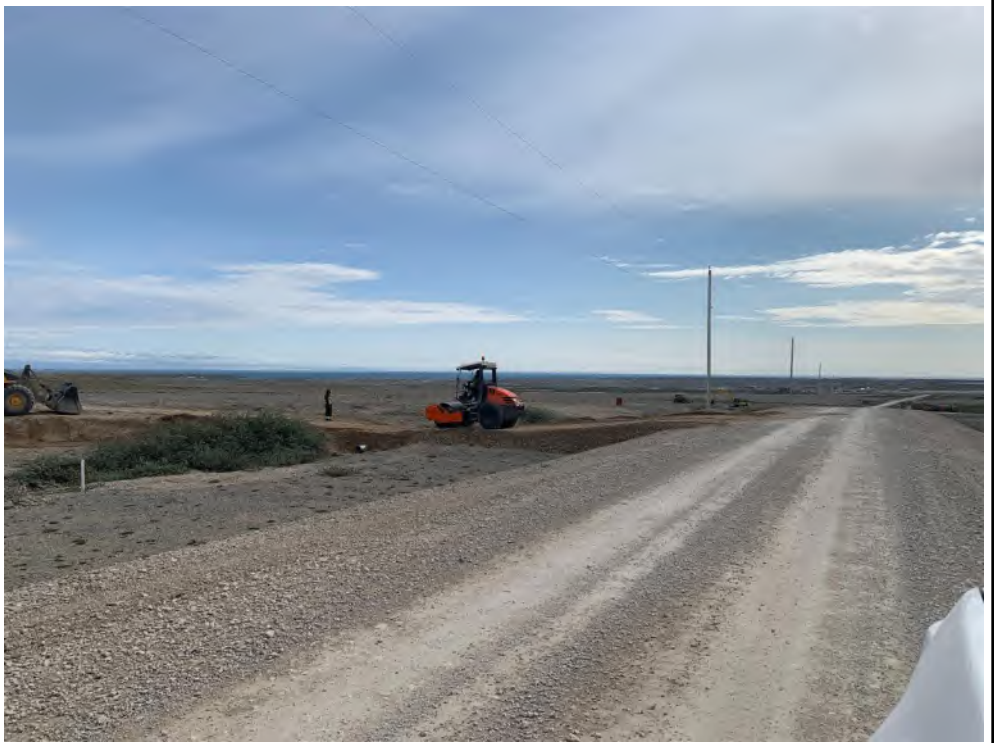
Photo Location: NHW Facility			
Direction: S			
Survey Date: 7/25/2023			
Comments: View of contractor constructing access ramp off Airport Rd. towards the NHW Facility.

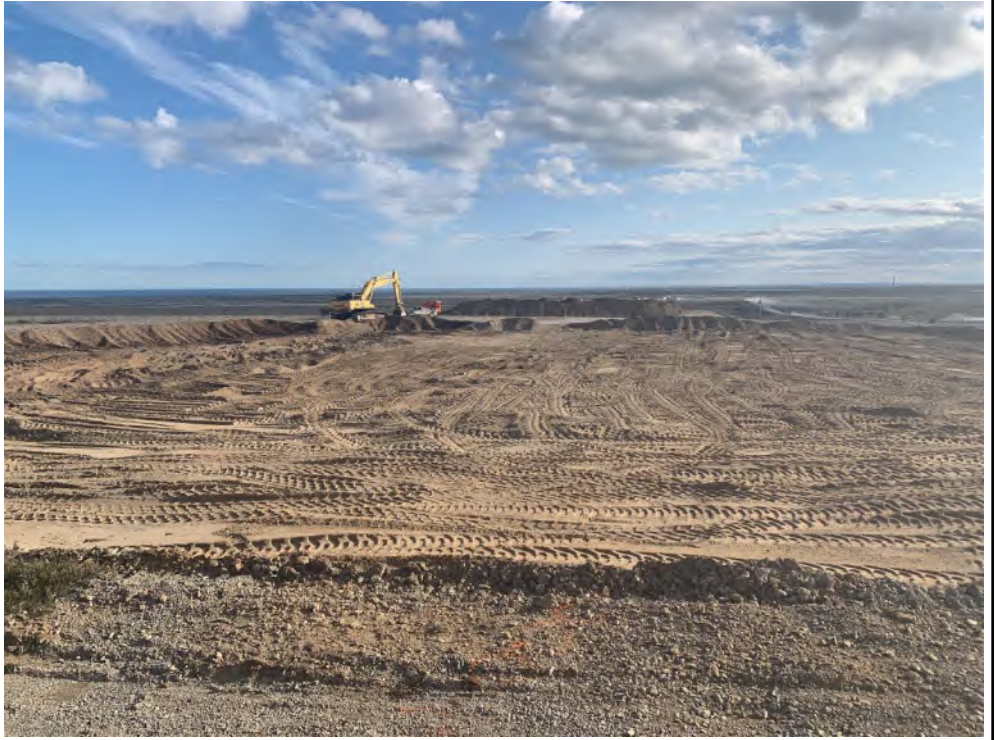
Client:	PSPC/CIRNAC	Project:	Coral Harbour Remediation Project - 123513974
Site Name:	Coral Harbour Site	Site Location:	Coral Harbour, NU
Photograph ID: 3

Photo Location: NHW Facility			
Direction: SW			
Survey Date: 7/28/2023			
Comments: View of contractor excavating the NHW Facility base.			
Photograph ID: 4

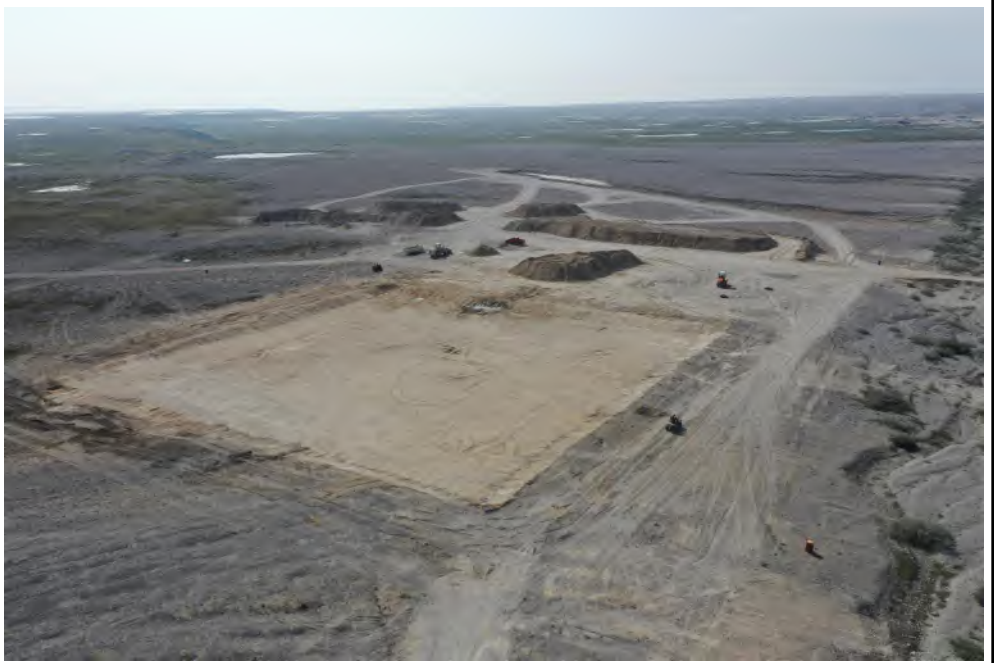
Photo Location: NHW Facility			
Direction: SE			
Survey Date: 8/6/2023			
Comments: Aerial view of the NHW Facility base excavation. Borrow piles in GMD B can be observed in the background.

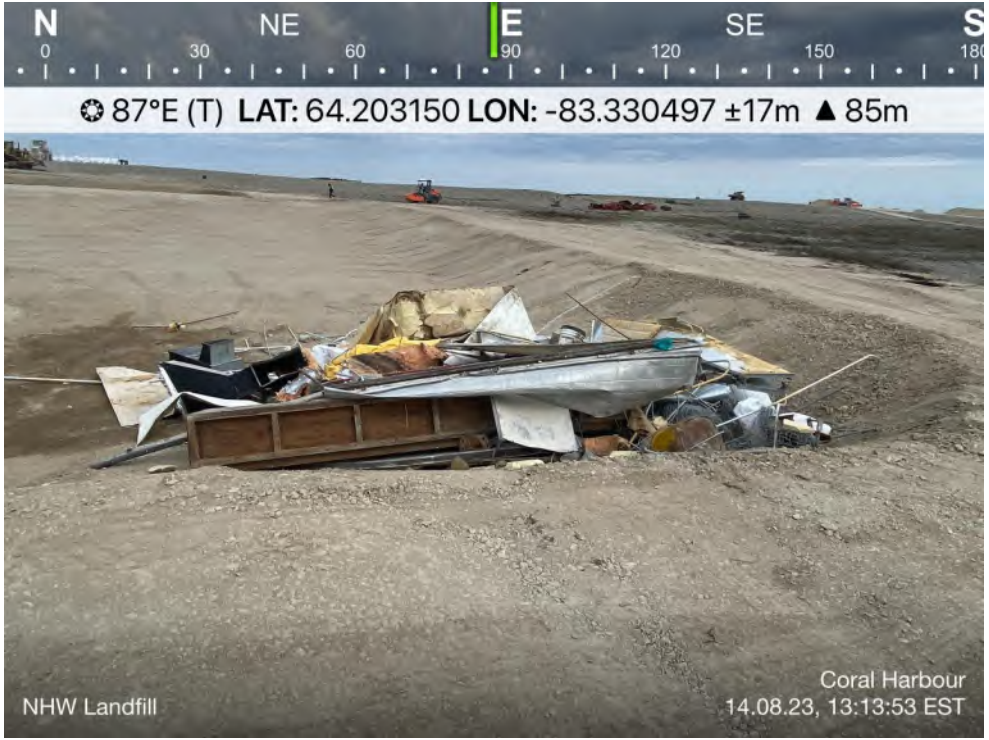
Client:	PSPC/CIRNAC	Project:	Coral Harbour Remediation Project - 123513974
Site Name:	Coral Harbour Site	Site Location:	Coral Harbour, NU
Photograph ID: 5

Photo Location: NHW Facility			
Direction: E			
Survey Date: 8/14/2023			
Comments: First load of non-hazardous debris placed within the NHW Facility.			
Photograph ID: 6

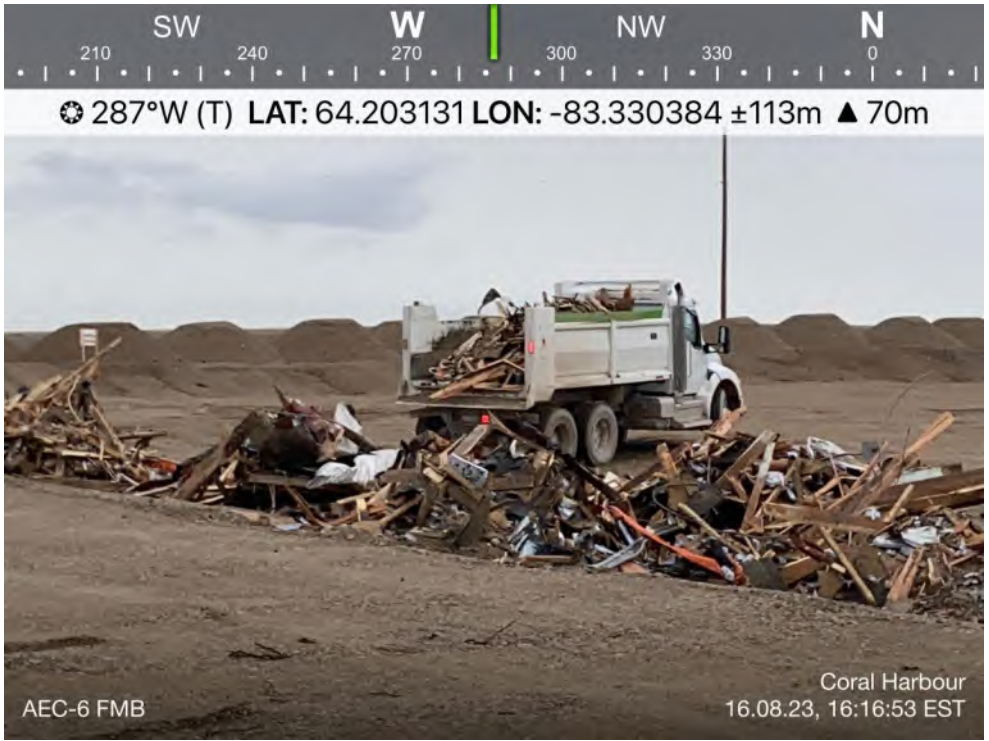
Photo Location: NHW Facility			
Direction: W			
Survey Date: 8/16/2023			
Comments: View of truck unloading FMB demolition debris within the NHW Facility.

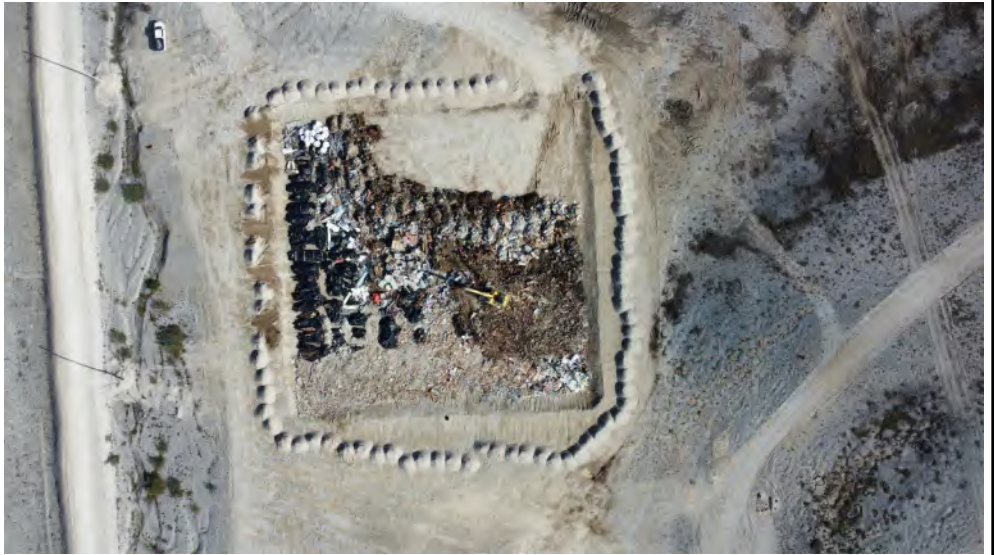
Client:	PSPC/CIRNAC	Project:	Coral Harbour Remediation Project - 123513974
Site Name:	Coral Harbour Site	Site Location:	Coral Harbour, NU
Photograph ID: 9

Photo Location: NHW Facility			
Direction: N/A			
Survey Date: 8/29/2023			
Comments: Aerial view of excavator moving waste within the NHW Facility.			
Photograph ID: 10

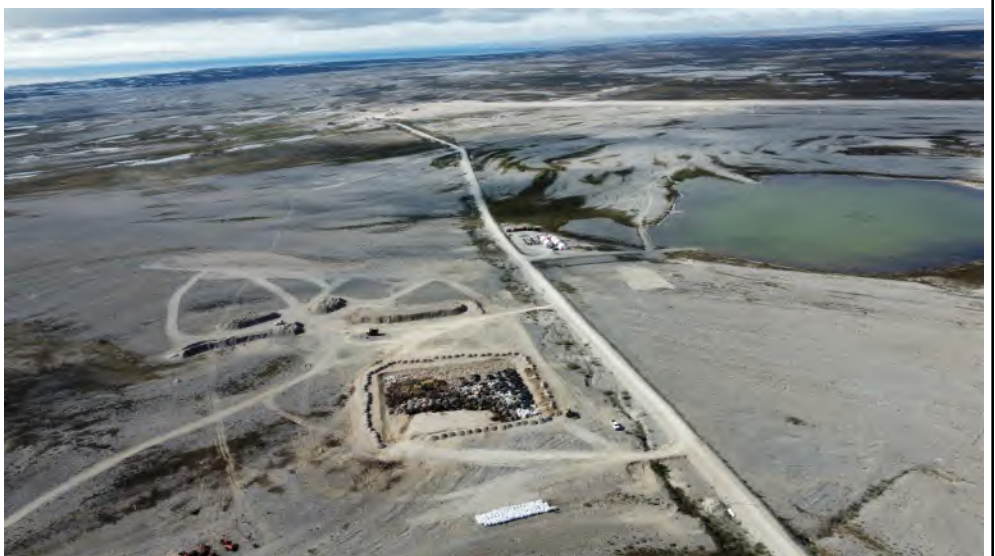
Photo Location: NHW Facility			
Direction: SW			
Survey Date: 8/29/2023			
Comments: View of the NHW Facility in foreground and the camp near the centre.

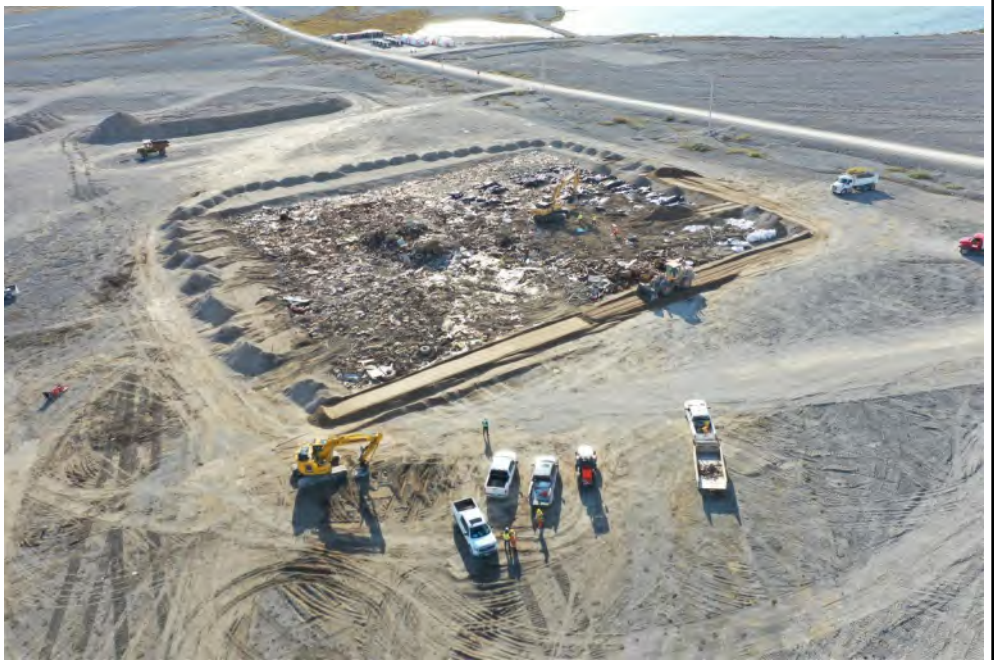
Client:	PSPC/CIRNAC	Project:	Coral Harbour Remediation Project - 123513974
Site Name:	Coral Harbour Site	Site Location:	Coral Harbour, NU
Photograph ID: 11

Photo Location: NHW Facility			
Direction: SW			
Survey Date: 9/9/2023			
Comments: Aerial view of the NHW Facility. Contractor can be observed constructing the perimeter berms.			
Photograph ID: 12

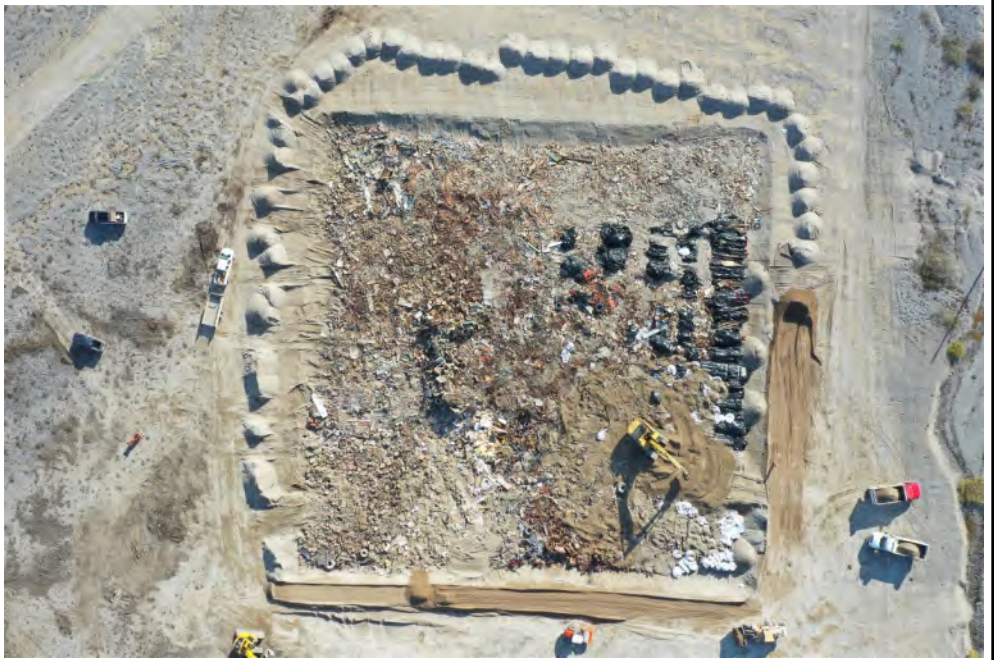
Photo Location: NHW Facility			
Direction: N/A			
Survey Date: 9/9/2023			
Comments: Aerial view of NHW Facility.

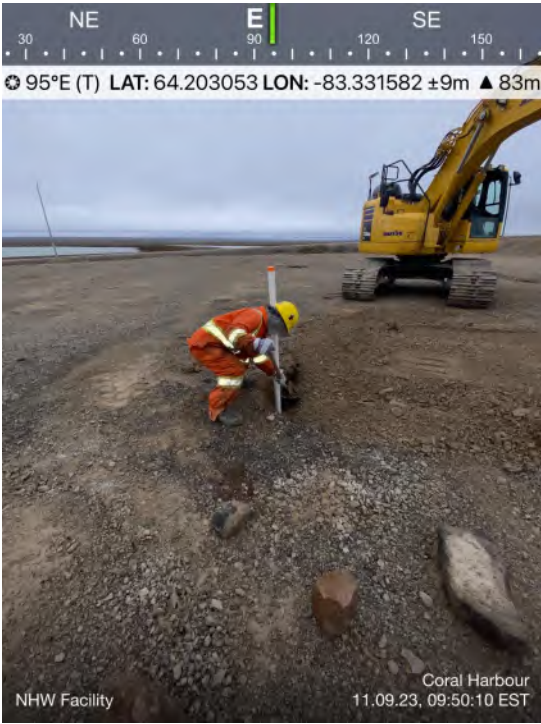
Client:	PSPC/CIRNAC	Project:	Coral Harbour Remediation Project - 123513974
Site Name:	Coral Harbour Site	Site Location:	Coral Harbour, NU
Photograph ID: 13

Photo Location: NHW Facility			
Direction: E			
Survey Date: 9/11/2023			
Comments: View of contractor installing a monitoring well at the NHW Facility.			
Photograph ID: 14

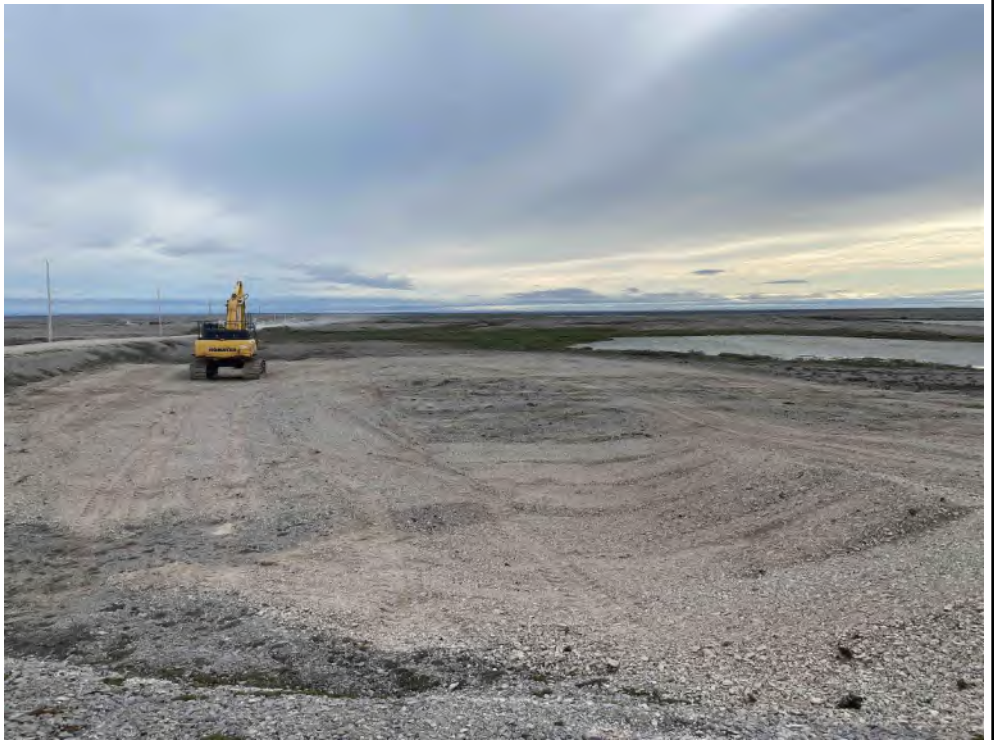
Client:	PSPC/CIRNAC	Project:	Coral Harbour Remediation Project - 123513974
Site Name:	Coral Harbour Site	Site Location:	Coral Harbour, NU
Photograph ID: 15

Photo Location: Camp			
Direction: SW			
Survey Date: 7/10/2023			
Comments: View of contractor preparing ground for future camp construction.			
Photograph ID: 16

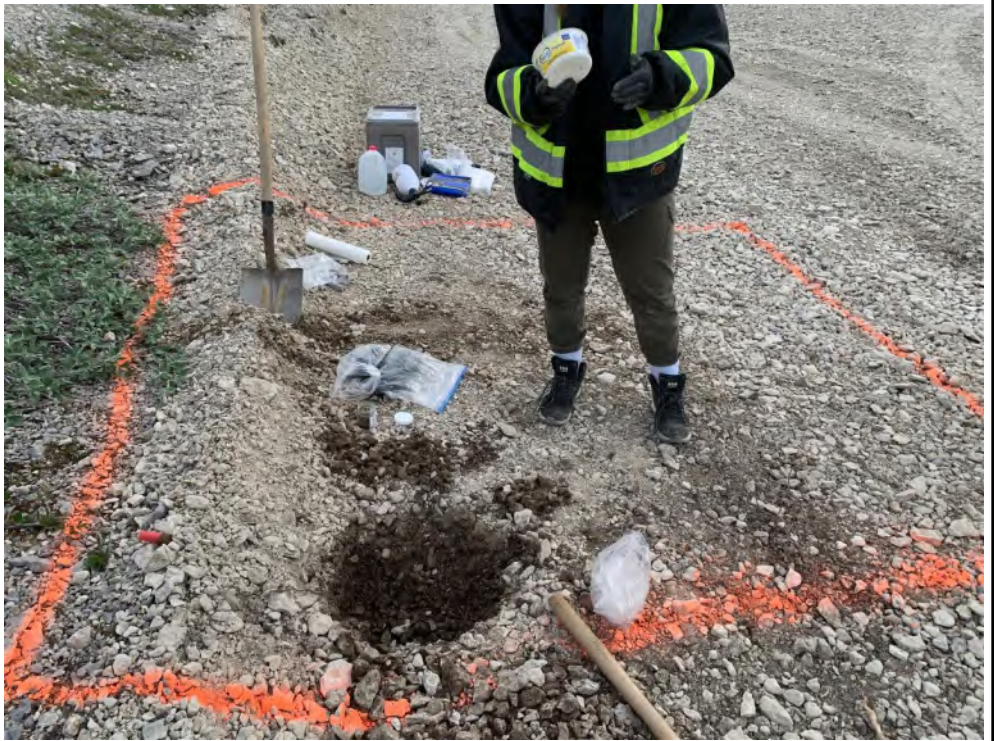
Photo Location: Camp			
Direction: SW			
Survey Date: 7/21/2023			
Comments: View of contractor completing baseline soil sampling at the camp site prior to construction.

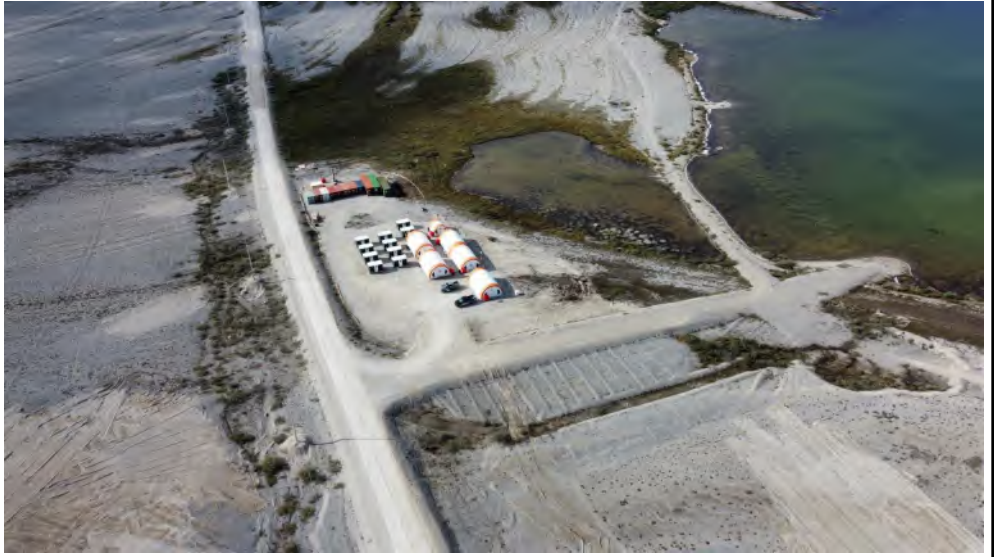
Client:	PSPC/CIRNAC	Project:	Coral Harbour Remediation Project - 123513974
Site Name:	Coral Harbour Site	Site Location:	Coral Harbour, NU
Photograph ID: 19

Photo Location: Camp			
Direction: SW			
Survey Date: 8/29/2023			
Comments: Aerial view of the camp during the 2023 operational period.			
Photograph ID: 20

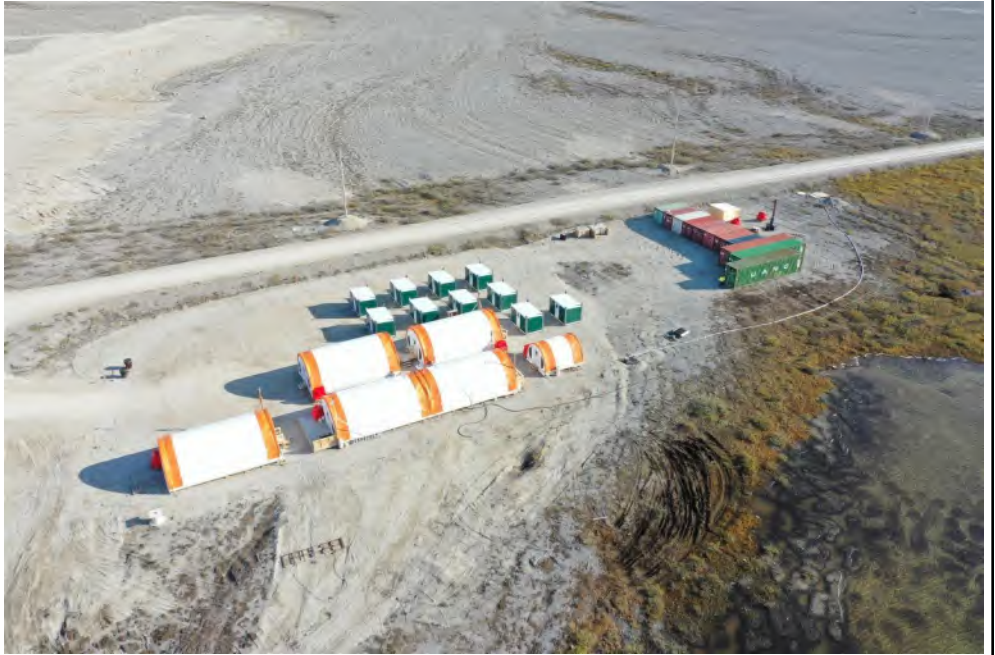
Photo Location: Camp			
Direction: E			
Survey Date: 9/9/2023			
Comments: Aerial view of the camp during the 2023 operational period.
