# **Cullaton Lake Mine**

## **Closure and Reclamation Plan**

*Prepared For*  
Barrick Gold Inc.

June 30, 2017

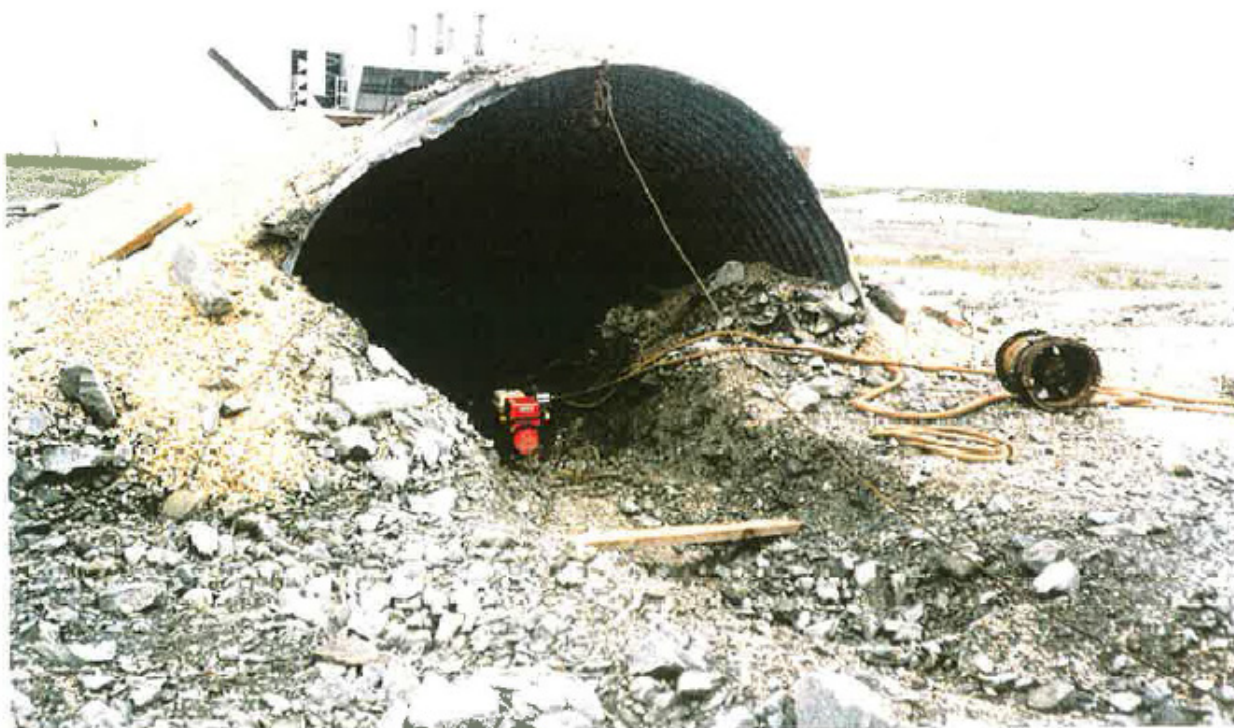
***Photograph 5-1. B-Zone mine portal at the time of closure.***

Photograph 5-1 shows the B-Zone mine portal and is believed to be representative of the portal conditions at the time of closure. Although no information is available to determine whether the stopes were backfilled during mining, the mine drawings show that the stopes were all at depth and that their extent was rather limited.

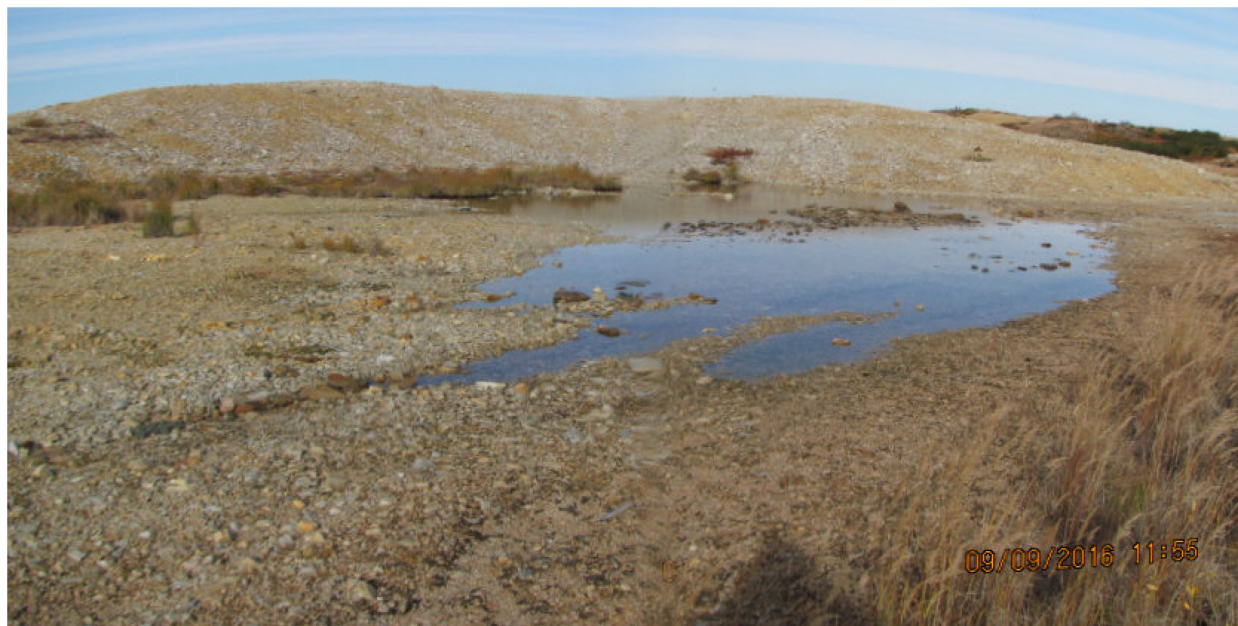
**Photograph 5-5. Shear Lake Low pH Pool Area (SW6 sample location)**

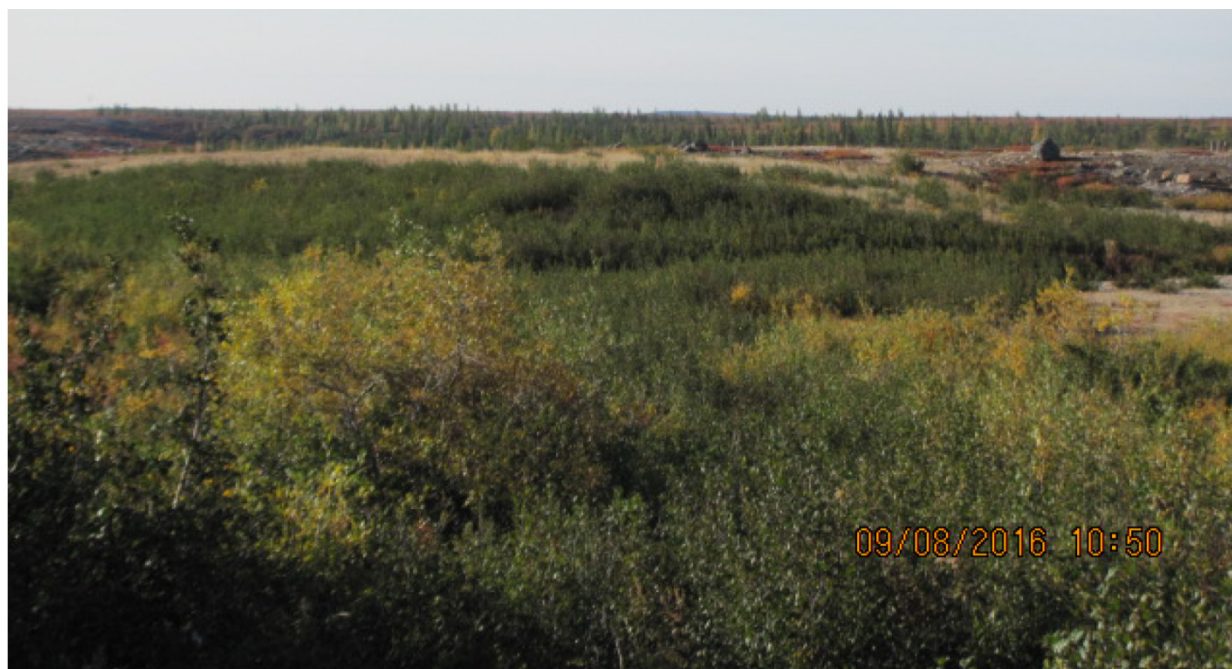
***Photograph 5-6. Encapsulated waste rock at Shear Lake 11 years after the application of additional seed and fertilizer***

In 2005, Barrick personnel oversaw the re-seeding of the EWR cap (with grasses) to promote some vegetation growth and reduce the erosion of the cover due to runoff, particularly along the side slopes. While some sparse areas remain (particularly on the top), the vegetation is helping to reduce erosion, in that a few small erosion gulleys / channels (20 to 30 cm deep/wide) (exp. 2014) were observed on the side slopes. These generally were short and did not extend the full length of the slope. It is expected that it will take several more years for the vegetation to establish itself fully (Brugger, 2017). Photograph 5-6 shows a region of established vegetation on the waste rock cap.

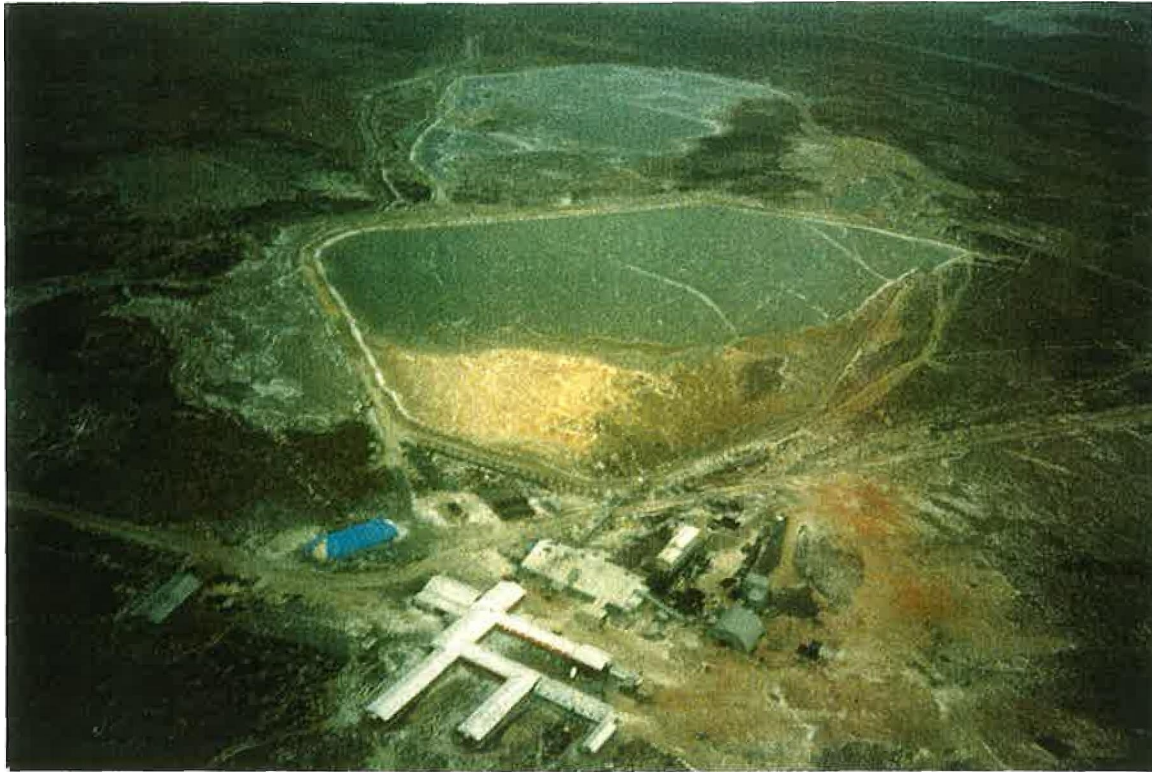
***Photograph 5-9. Overview of Mill Site and Tailings Area (Homestake, 1996)***

Photograph 5-9 shows the aerial view of the mill complex and tailings area, and Photograph 5-10 shows a composite view of the Mill Complex showing Mill Service Buildings, Mill and Crusher Unit (Homestake, 1996).

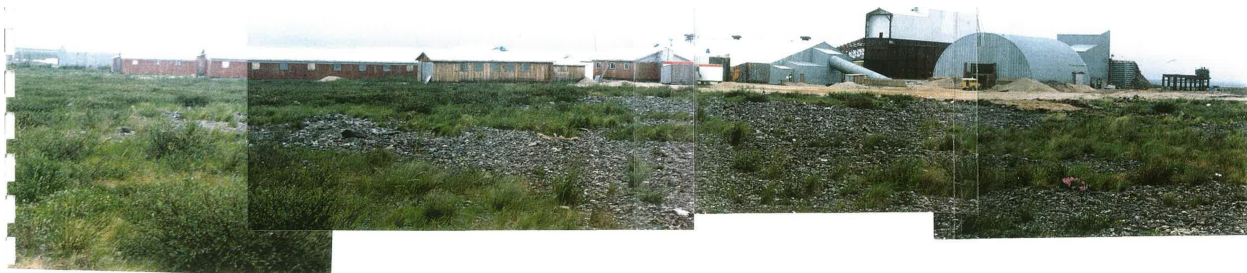
***Photograph 5-10. Composite View of Mill Complex showing Mill Service Buildings, Mill and Crusher Unit (Homestake, 1996)***

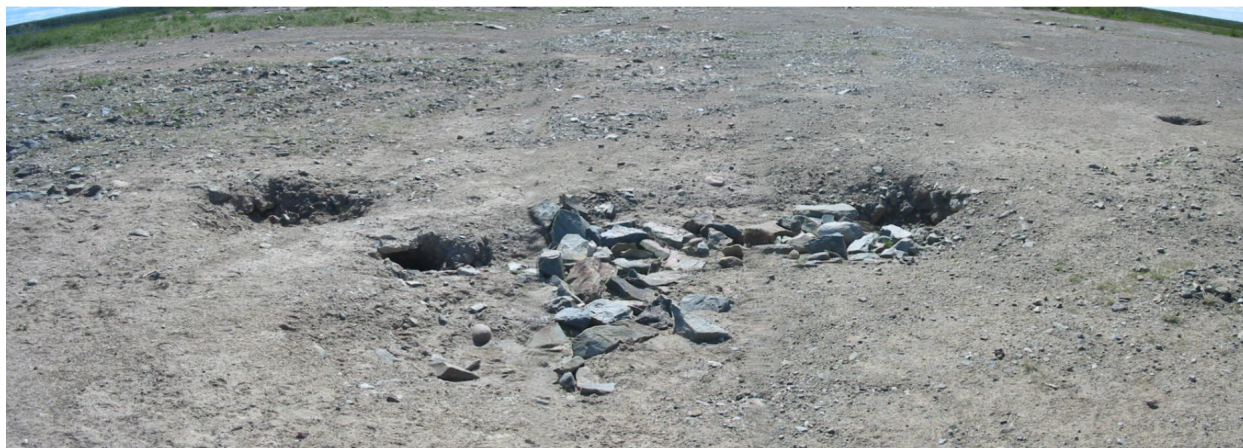
*Photograph 5-12. Settlement areas in southeast corner of quarry pit cover (July 2007)*

Minor settlement in the southeast corner of the quarry pit cover was observed during the annual inspection of 2007 (Photograph 5-12). The settlement areas remained largely unchanged and became populated by arctic ground squirrels until 2016, when two additional sinkholes were identified during the annual inspection (Photograph 5-13).

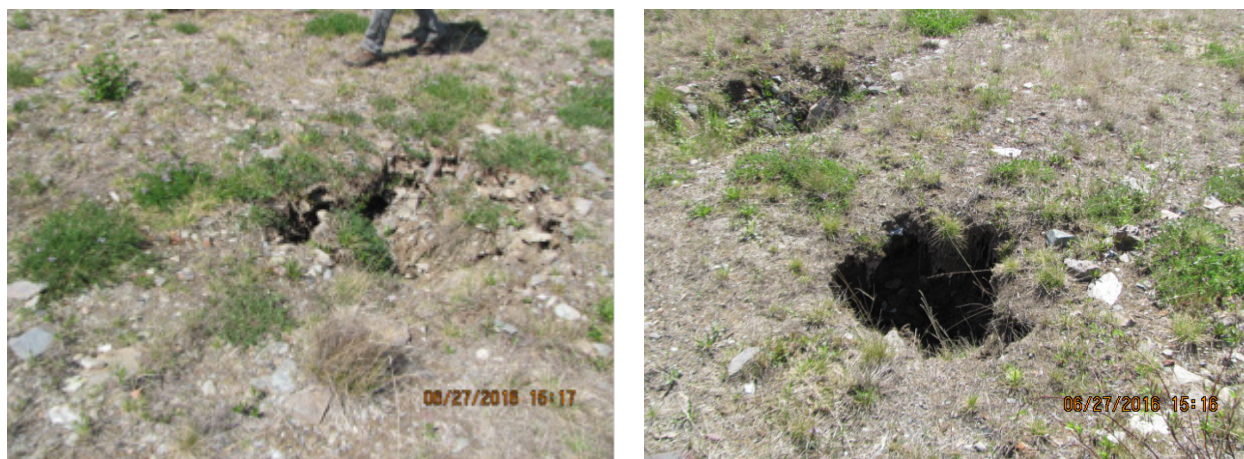
***Photograph 5-13. Settlement areas in southeast corner of quarry pit cover (left) and new sinkholes identified in 2016 (right).***

The 2016 inspection conducted in relation to the current water license identified that some of the sinkholes in the quarry pit cover expose metal waste.
