Cullaton Lake Mine

Closure and Reclamation Plan (2017)

Presentation April 27, 2018

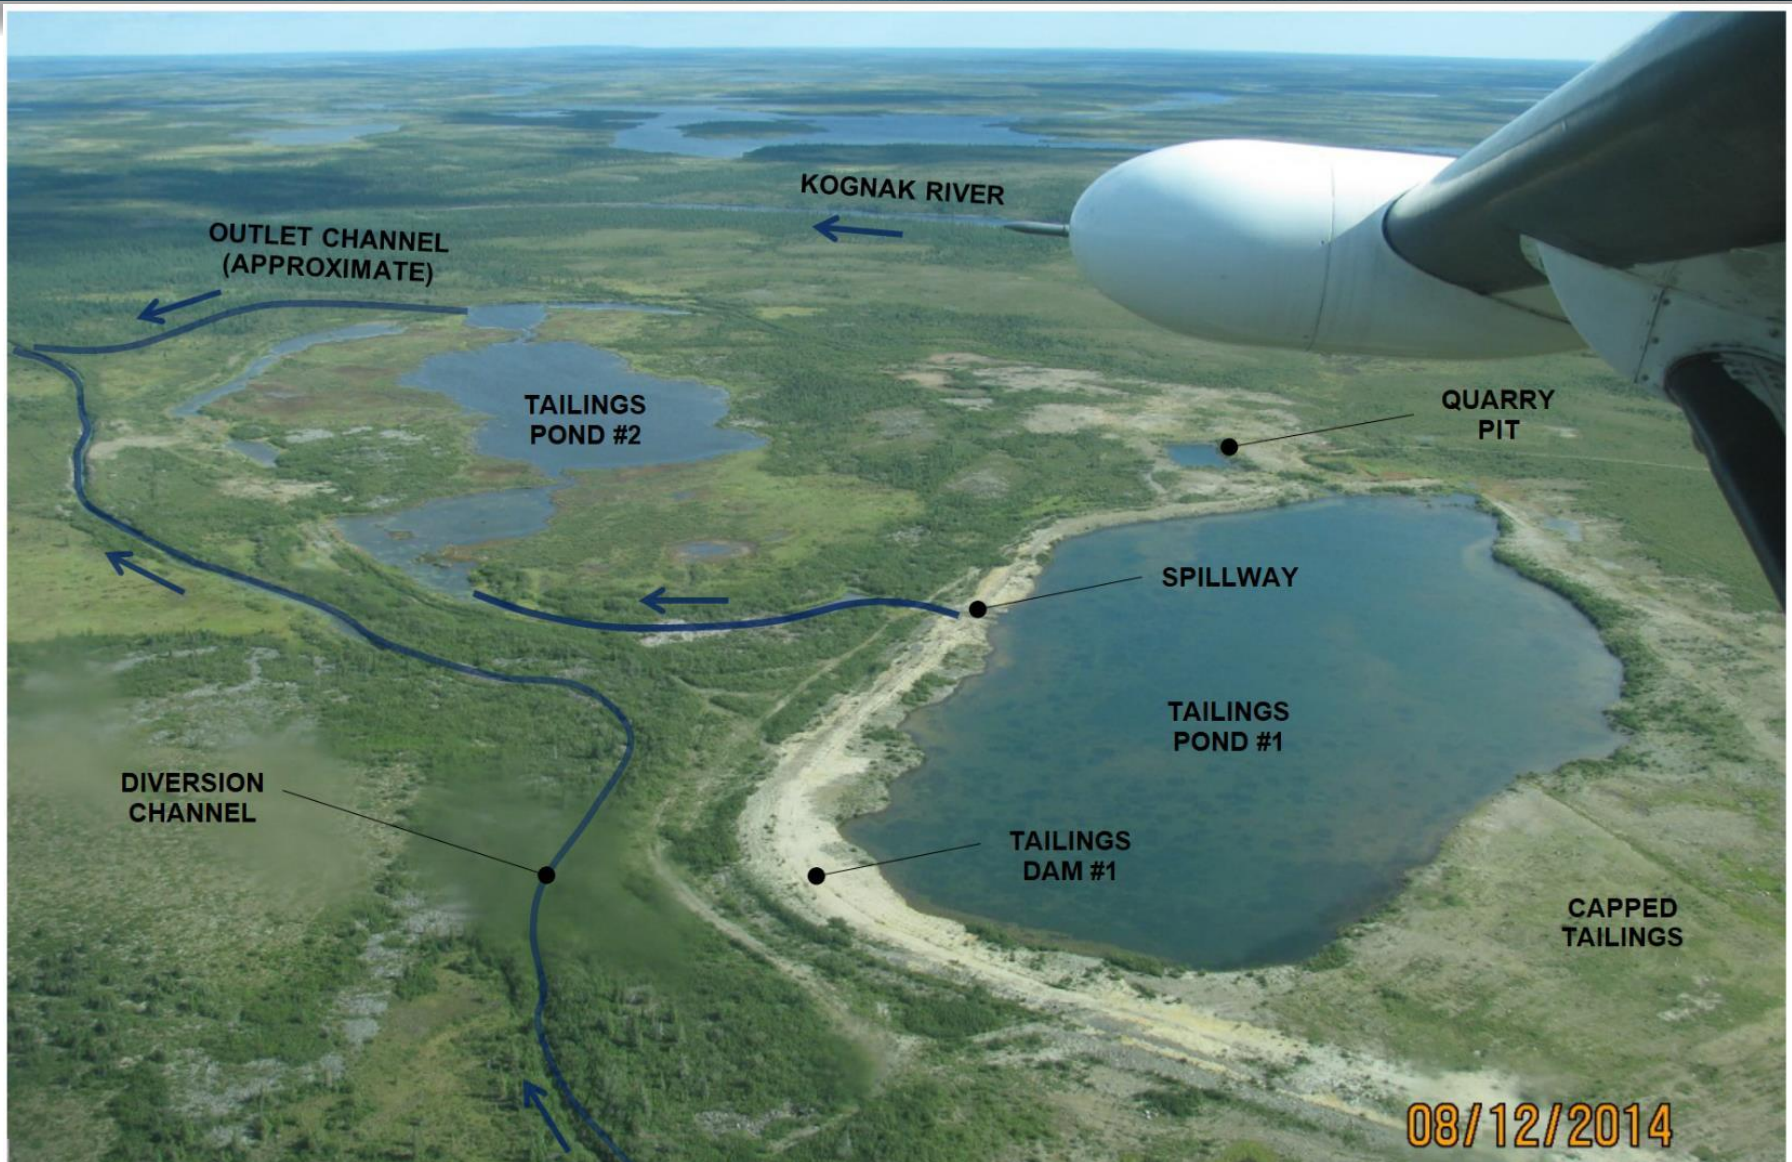
Tailings Area – looking southeast

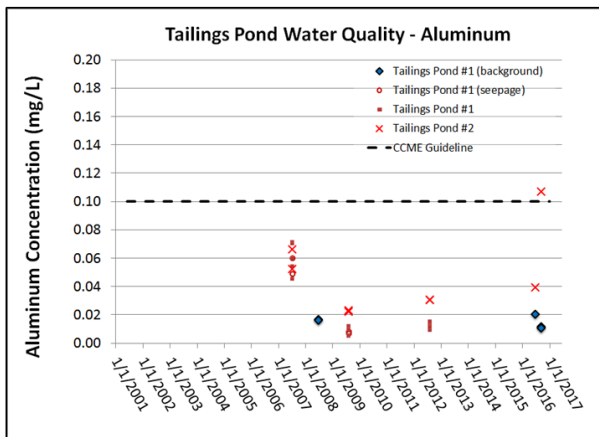
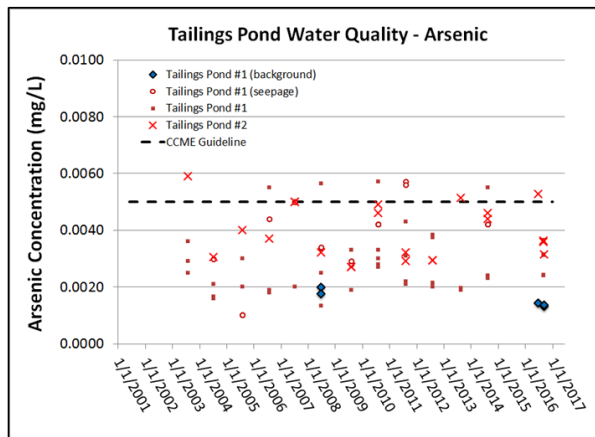
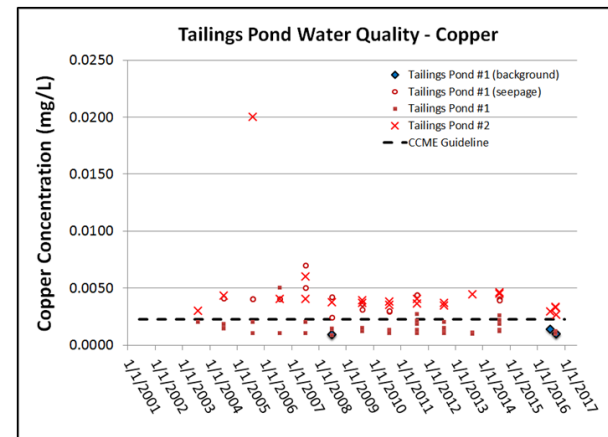
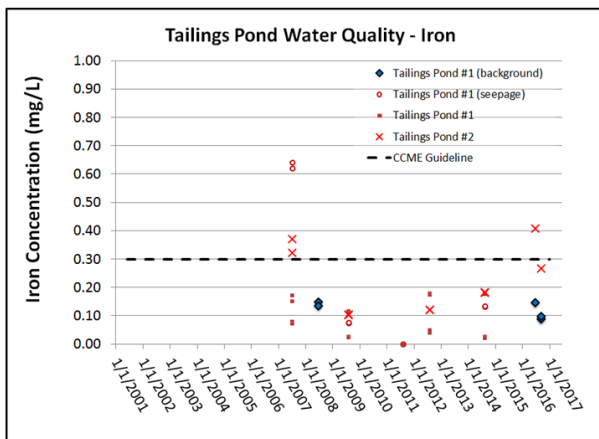
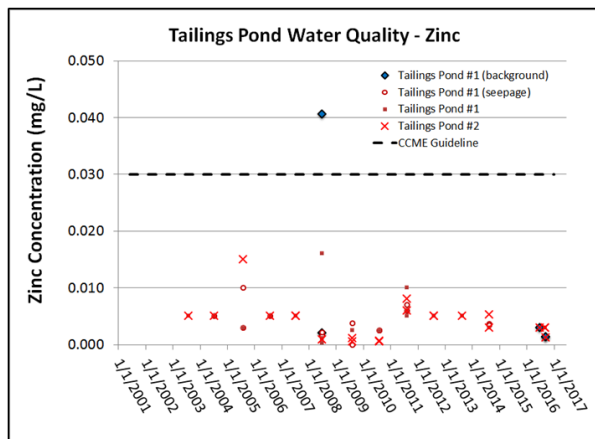
Tailings Pond – Water Quality

Concentrations of water quality parameters of potential interest do not appear to be increasing with time.

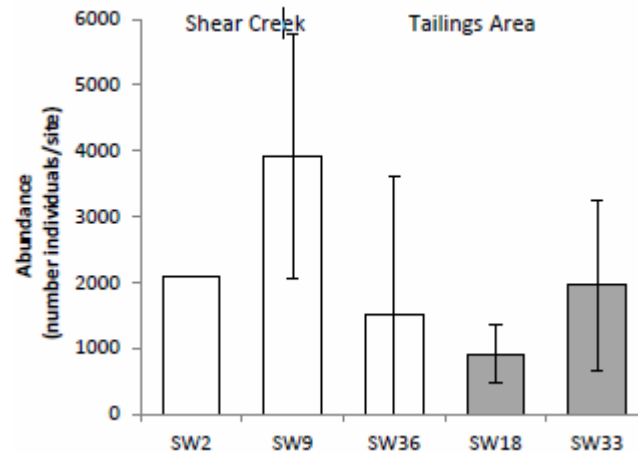
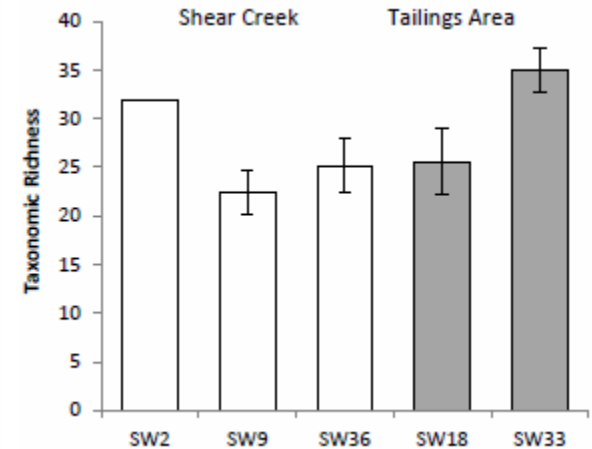
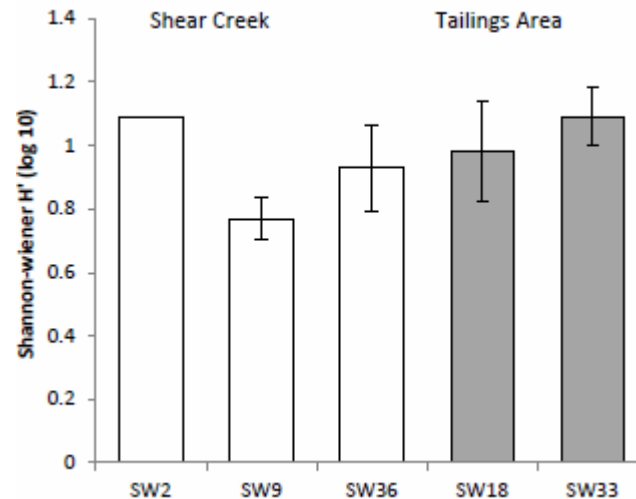
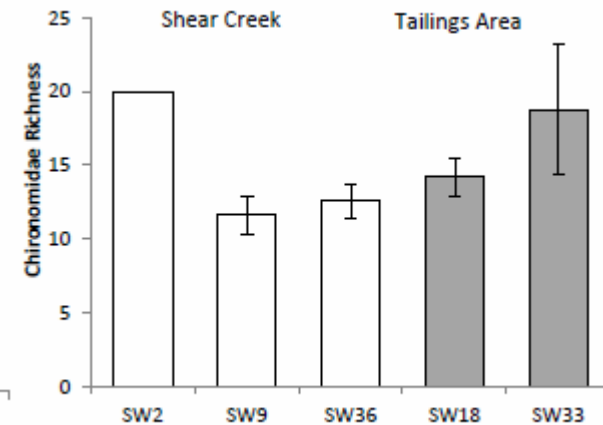
Tailings Area – Benthic Invertebrates

- Benthic invertebrate community more diverse in this area than Shear Creek area
- Higher EPT organisms at SW18 indicative of a healthier benthic community upstream of the tailings pond
- SW33, downstream of the tailings pond had higher proportion of Oligochaeta than SW18, which are typically more tolerant of organic pollution

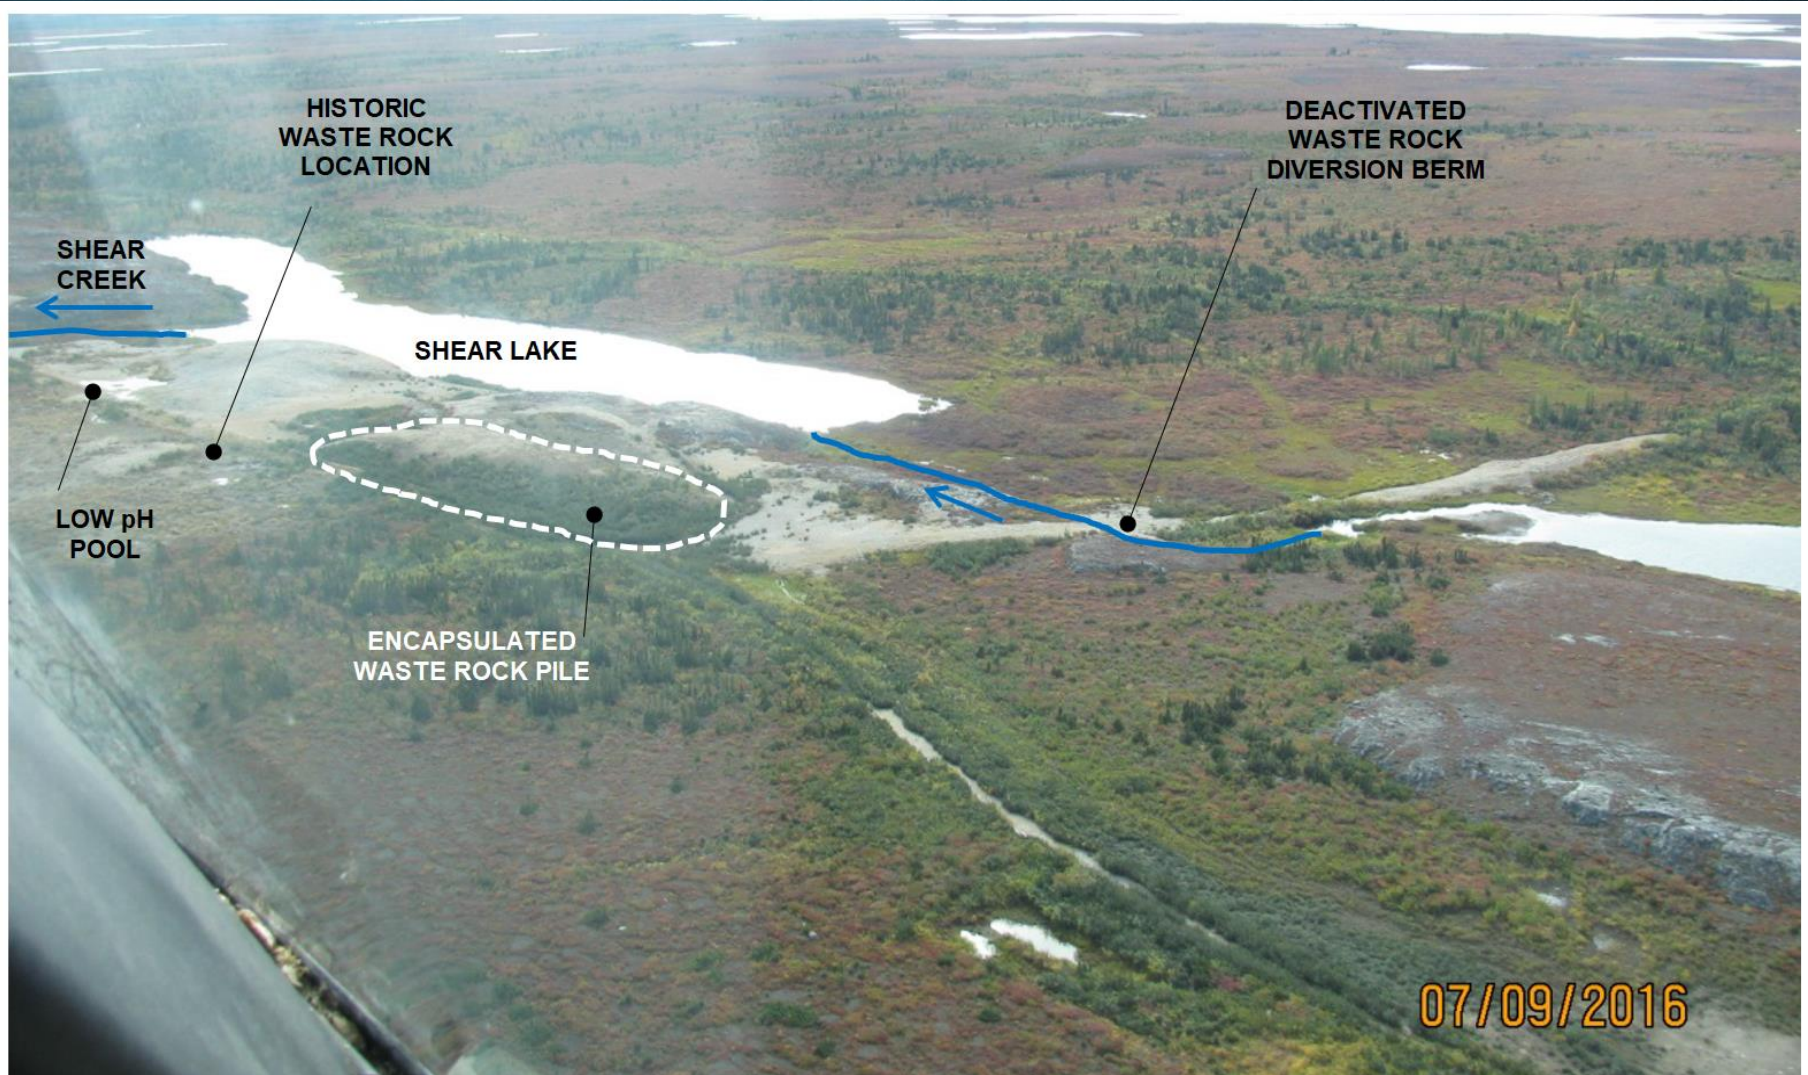
Photo source: Brugger (2017) Photo date: July 9, 2016.

Shear Lake - Overview

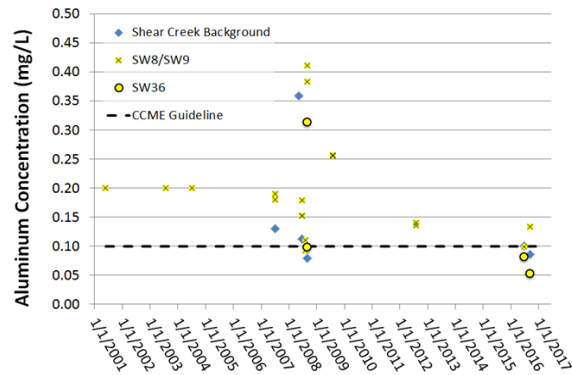
Shear Creek Water Quality - Aluminum

Water quality monitoring in Shear Creek, downstream from the waste rock pile, suggests that Shear Creek water quality returns to nearly background concentration by station SW36.

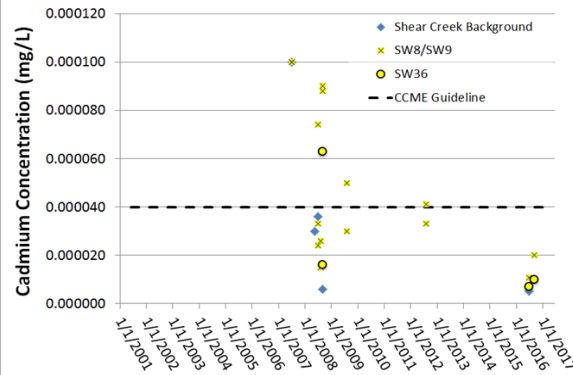
Shear Creek Water Quality - Cadmium

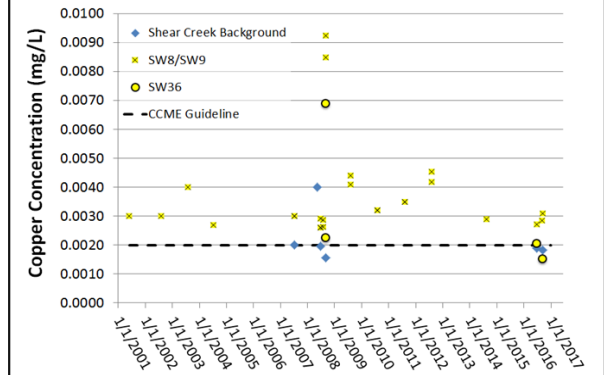
Shear Creek Water Quality - Copper

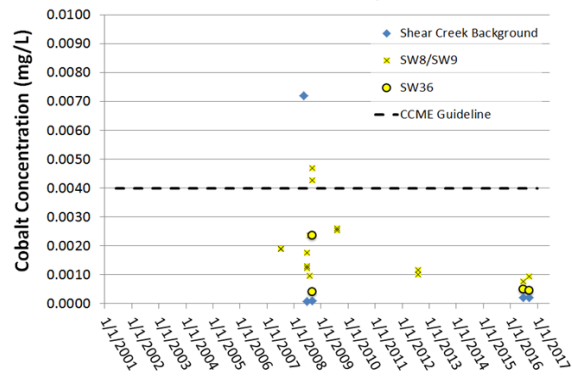
Shear Creek Water Quality - Cobalt

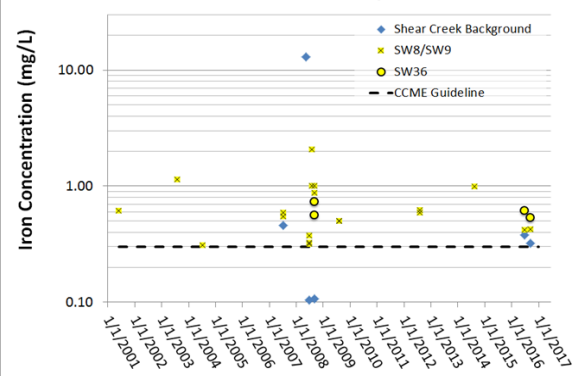
Shear Creek Water Quality - Iron

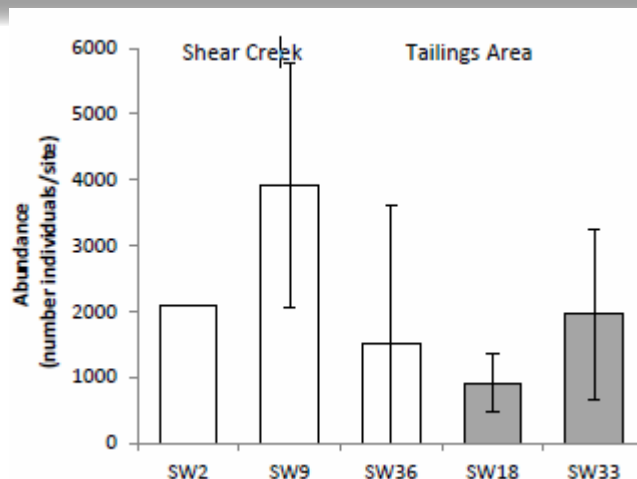
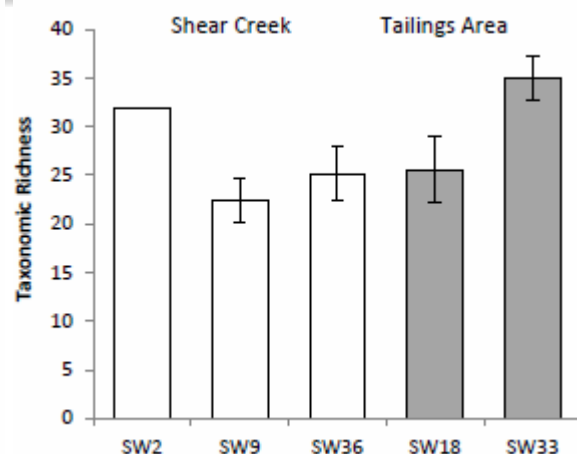
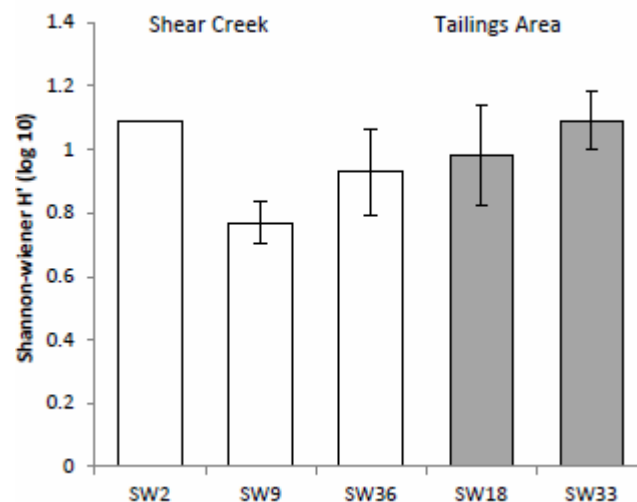
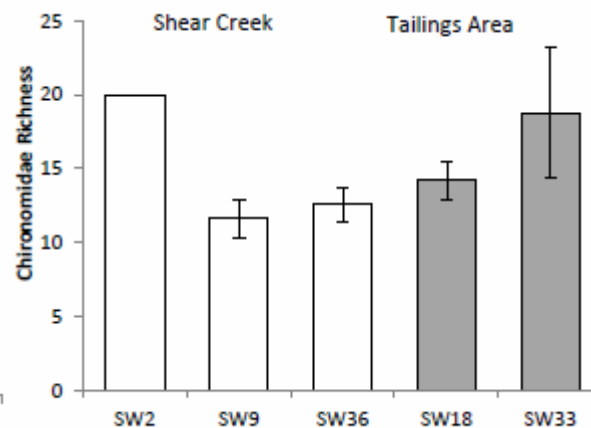
Shear Lake Area – Benthic Invertebrates

- SW2 site – only 1 replicate was obtained
- No statistical difference in abundance between SW9 and SW36
- Benthic invertebrate community mostly chironomids with no statistical differences in various metrics of richness and diversity
- However, Shannon-Wiener diversity significant higher at SW36, and slightly higher at SW2, providing some indication that community composition is more diverse at SW2 upstream of the waste rock pile
