PWGSC FOX-C DEW LINE SITE PLAN Figure 2.0

FOX-C DEW LINE SITE - BEACH AREA **BOREHOLE LOCATION PLAN PWGSC**

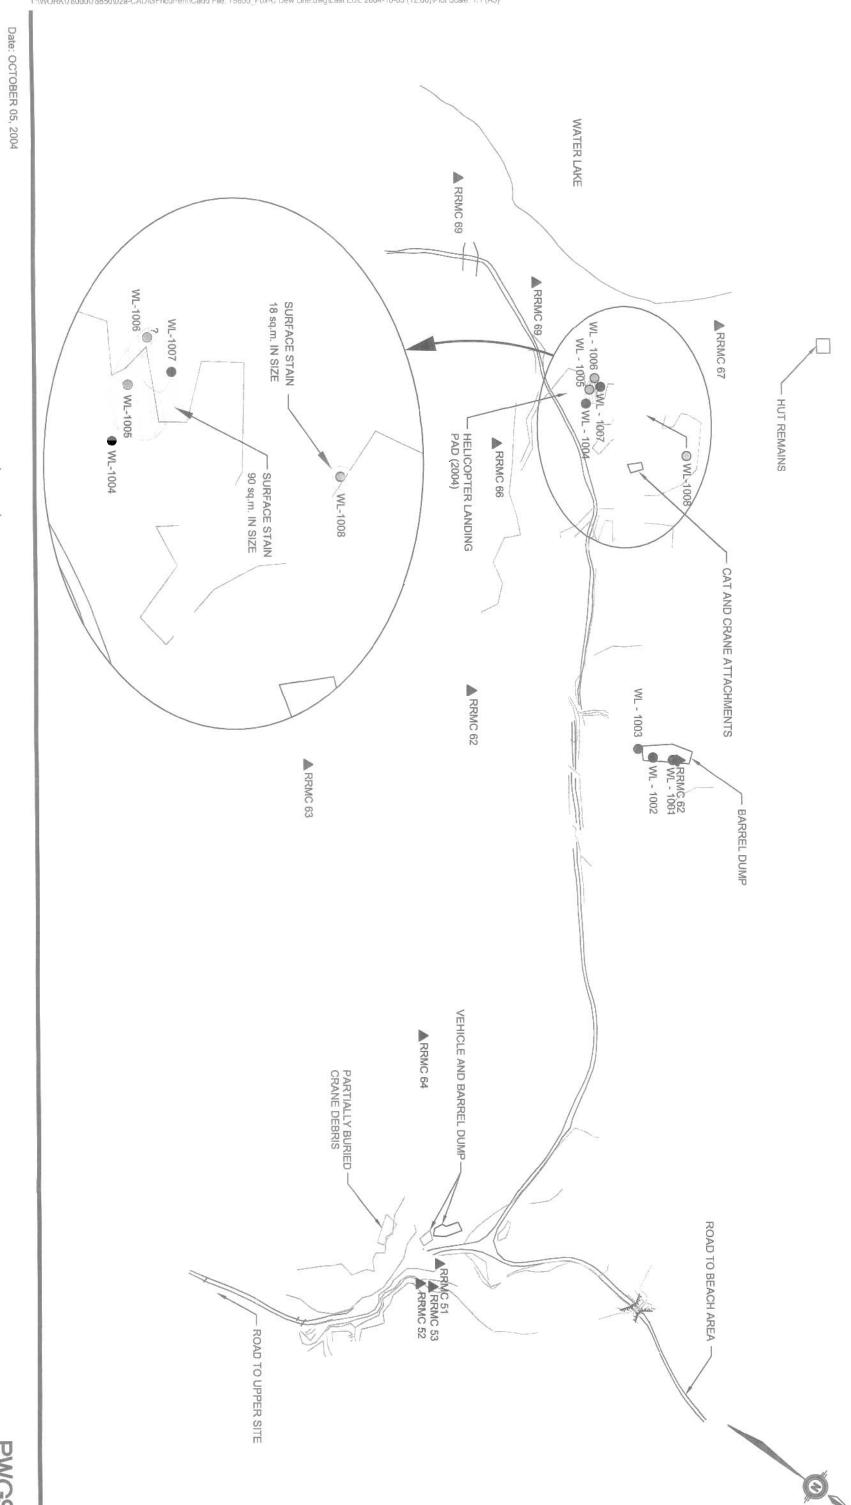
Figure 3.0

Legend
 PCBs exceedance
 PCBs exceedance
 PCBs contamination plume

○ SOIL SAMPLE
 METALs exceedance
 METALs contamination plume

○ PHCs exceedance
 PHCs exceedance
 PHCs contamination plume

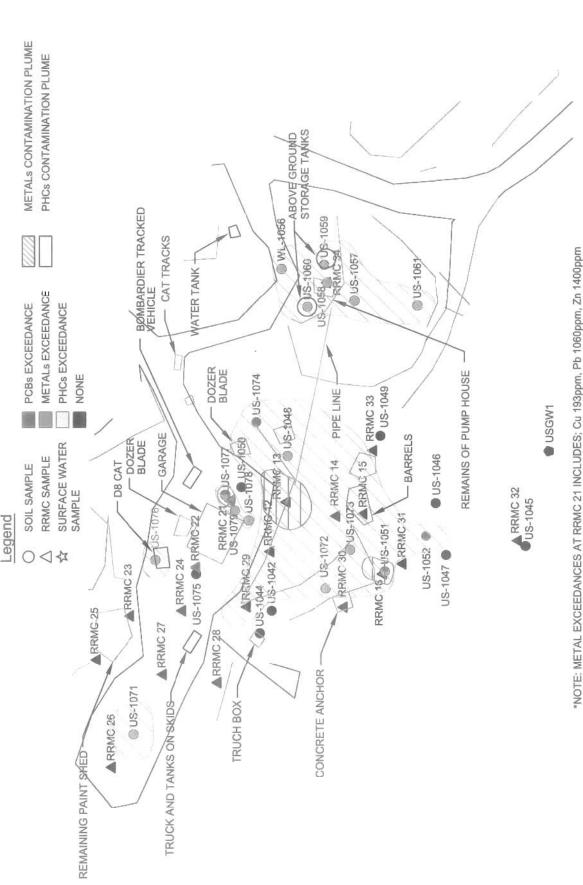
Figure 6.2

PWGSC FOX-C DEW LINE SITE - UPPER STATION 'B' UPPER STATION 'B' PLAN

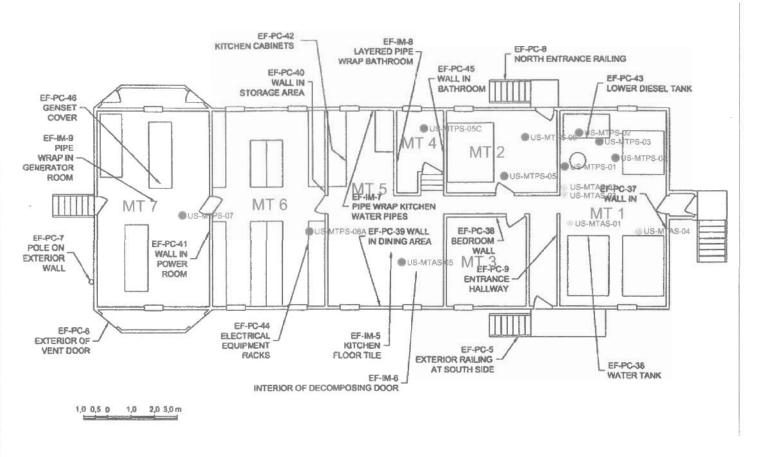
Figure 6.3

UPPER STATION 'B' PLAN
