Former U.S. Coast Guard LORAN Station, Cape Christian, Nunavut Remediation Action Plan

### **Remediation Action Plan (FINAL)**

Earth Tech Canada Inc. 17203-103<sup>rd</sup> Ave., Edmonton, Alberta, T5S 1J4 (780) 488-6800

January 2007

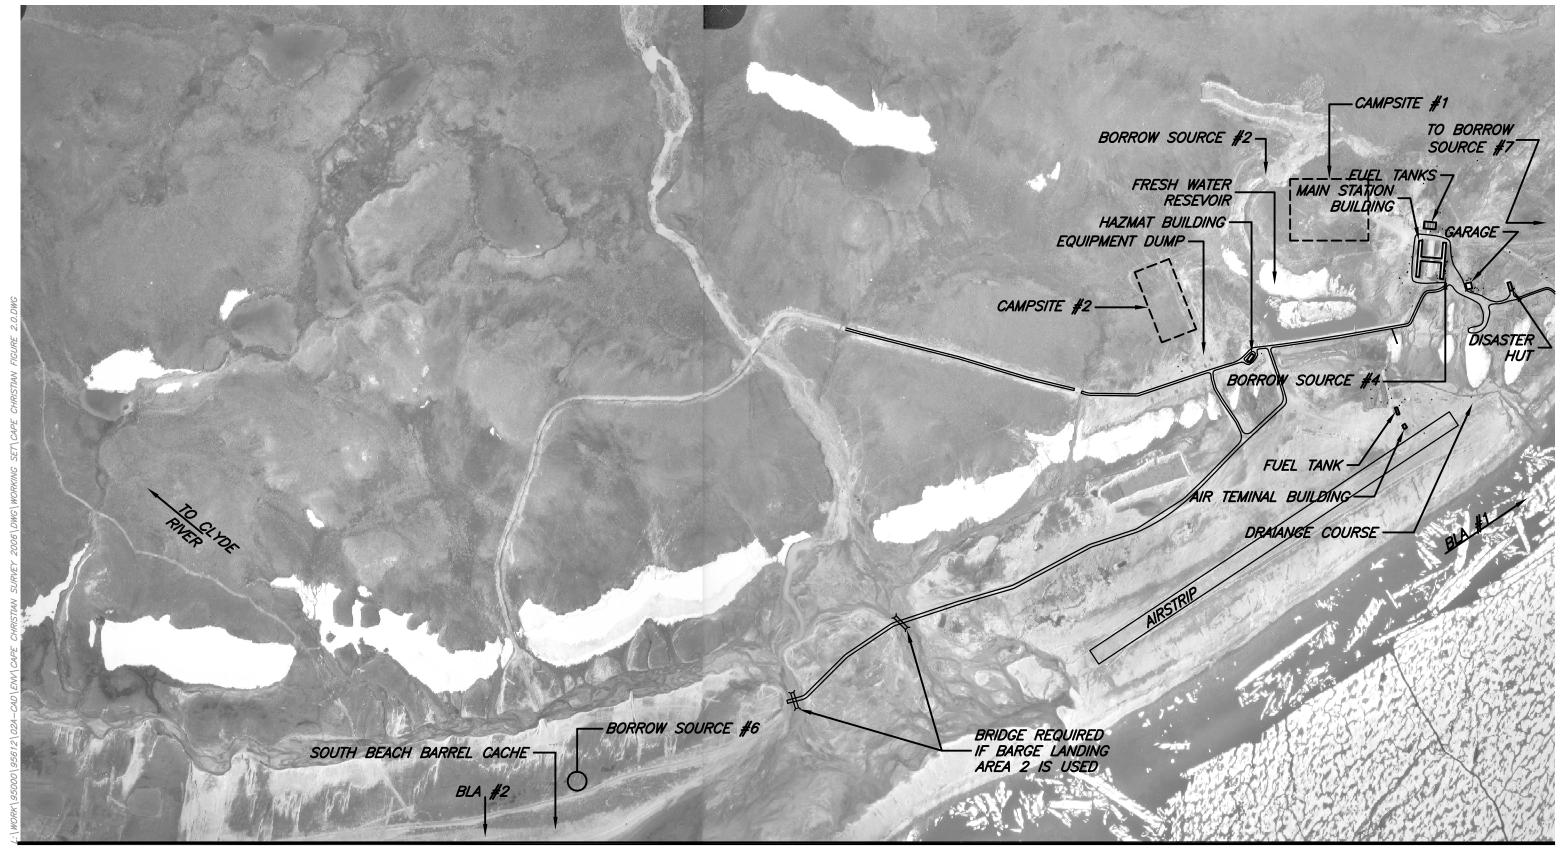
INDIAN AND NORTHERN AFFAIRS CANADA
CAPE CHRISTIAN LORAN STATION
OVERALL SITE PLAN
FIGURE 2.0

NOTE: BLA = BARGE LANDING AREA

High tide at the Cape Christian site is noted as being approximately at 2 am and 5 pm with a low tide at around 10 am and 10 pm during the month of August. The maximum tide elevation variance is noted to be approximately 1.2 meters. Sites that were investigated for barge landings are indicated in Figure 2.0 of Appendix A. It was stated by the son of a former RCMP officer at Cape Christian that the barge servicing the Cape Christian site landed at BLA # 2. This requires two river crossings at the areas indicated on Figure 2.0 if heavy equipment is to be offloaded at BLA #2 and driven to the Cape Christian site. Barge Landing Area #1 is closer to the site and does not require a temporary bridge to be built over the Clyde River; however the barge operator shall investigate the underlying marine topography in this area prior to selecting barge landing area #1. It should also be noted that at all beach landing areas have very high groundwater tables which may cause heavy equipment to sink into the sand and become stuck. Consideration should be given to stabilization of the areas where equipment is off loaded. The site can also be accessed via Clyde River. The contractor can barge into Clyde River and CAT Train out to the site. If the CAT Train is to take place during the summer, significant improvements to the road from Clyde River to Cape Christian will be required. If the Contractor decides to upgrade the existing road or build a new road between Clyde River and the Cape Christian site, it shall be noted that it is the responsibility of the Contractor to return the upgraded road to its original state or decommission the newly constructed road.

A camp will be required during the remedial activities. It is recommended that the camp be located at Site #2 as shown on **Figure 2.0** of **Appendix A**, however the final camp location is at the discretion of the Contractor. The camp must be large enough to support the Contractor staff, the camp staff approximately 3-5 visitors, consultants and/or inspectors. There shall be a potable water supply that meets the Canadian Drinking Water Quality Guidelines. Potable water can be obtained from Clyde River and the Freshwater Reservoir on site; however the water used must be sampled to ensure the water meets the Canadian Drinking Water Quality Guidelines. Non potable water can be obtained from the ocean or the freshwater reservoir as required. The sewage and greywater from the site will be treated in accordance with applicable regulations. Any solid waste developed will be collected and disposed of with other non hazardous materials in the on site landfill. The camp shall also have bear safety measures, emergency rations and an emergency rescue contingency plan in place.

| Borrow Source | Location | Type of Material | Estimated Amount of<br>Material Available m <sup>3</sup> |
|---|--|---|--|
| Borrow Source # 6 | Near South Beach Barrel<br>Cache (Figure 2.0) | poorly graded gravelly sand | 5250 |

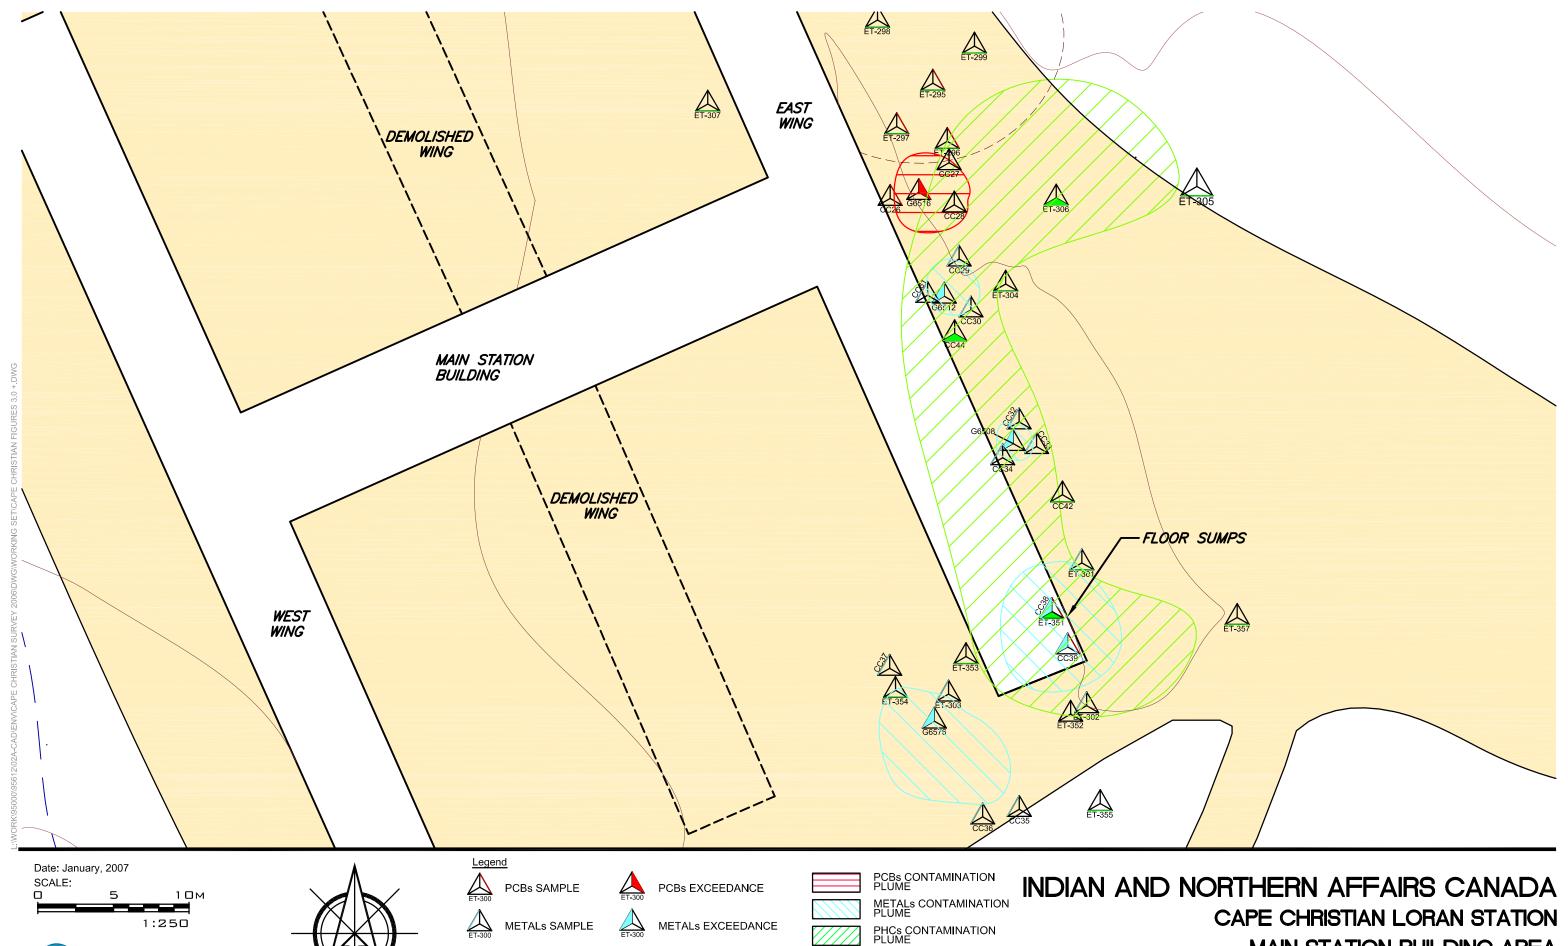
CC ESG SAMPLE MAIN STATION BUILDING AREA FIGURE 3.2

DRAINAGE COURSE EARTH TECH 2006 SAMPLE EARTH TECH 2001 SAMPLE

| Location | Contaminant Exceeding<br>INAC Criteria (Max<br>Concentration ppm) | DCC I | DCC II<br>m³ | INAC PHC<br>m <sup>3</sup> | Comments |
|---|---|---|---|---|--|
| Main Station Building<br>East of East Wing<br>(Figure 3.2) | Metals (Lead: 210) | 41 | | | Plume associated with<br>ESG Sample G6576 |

The 443 m<sup>3</sup> (41 m<sup>3</sup> –DCC -I and 402 m<sup>3</sup> DCC – II) of metal contaminated soil that exists on site is located at the main station building (**Figures 3.1 and 3.2**), the main station garage and disaster hut (**Figure 3.3**) and the outfall area (**Figure 4.1**).

Environmental investigations at Cape Christian have identified approximately 1699 m³ of PHC contaminated soil that exceed the INAC Abandoned Military Sites Remediation protocol. It should be noted that full delineation of impacted soils was not achieved at the main station ASTs and soil volumes are likely to increase as a result of bulking during excavation, therefore a 15% contingency should be applied to the total volume of PHC contaminated soil. The hydrocarbon contaminated soils are located at main station ASTs area (**Figure 3.1**), the main station building area (**Figure 3.2**), the main station garage (**Figure 3.3**), and the Worked Area #1 (**Figure 4.2**).

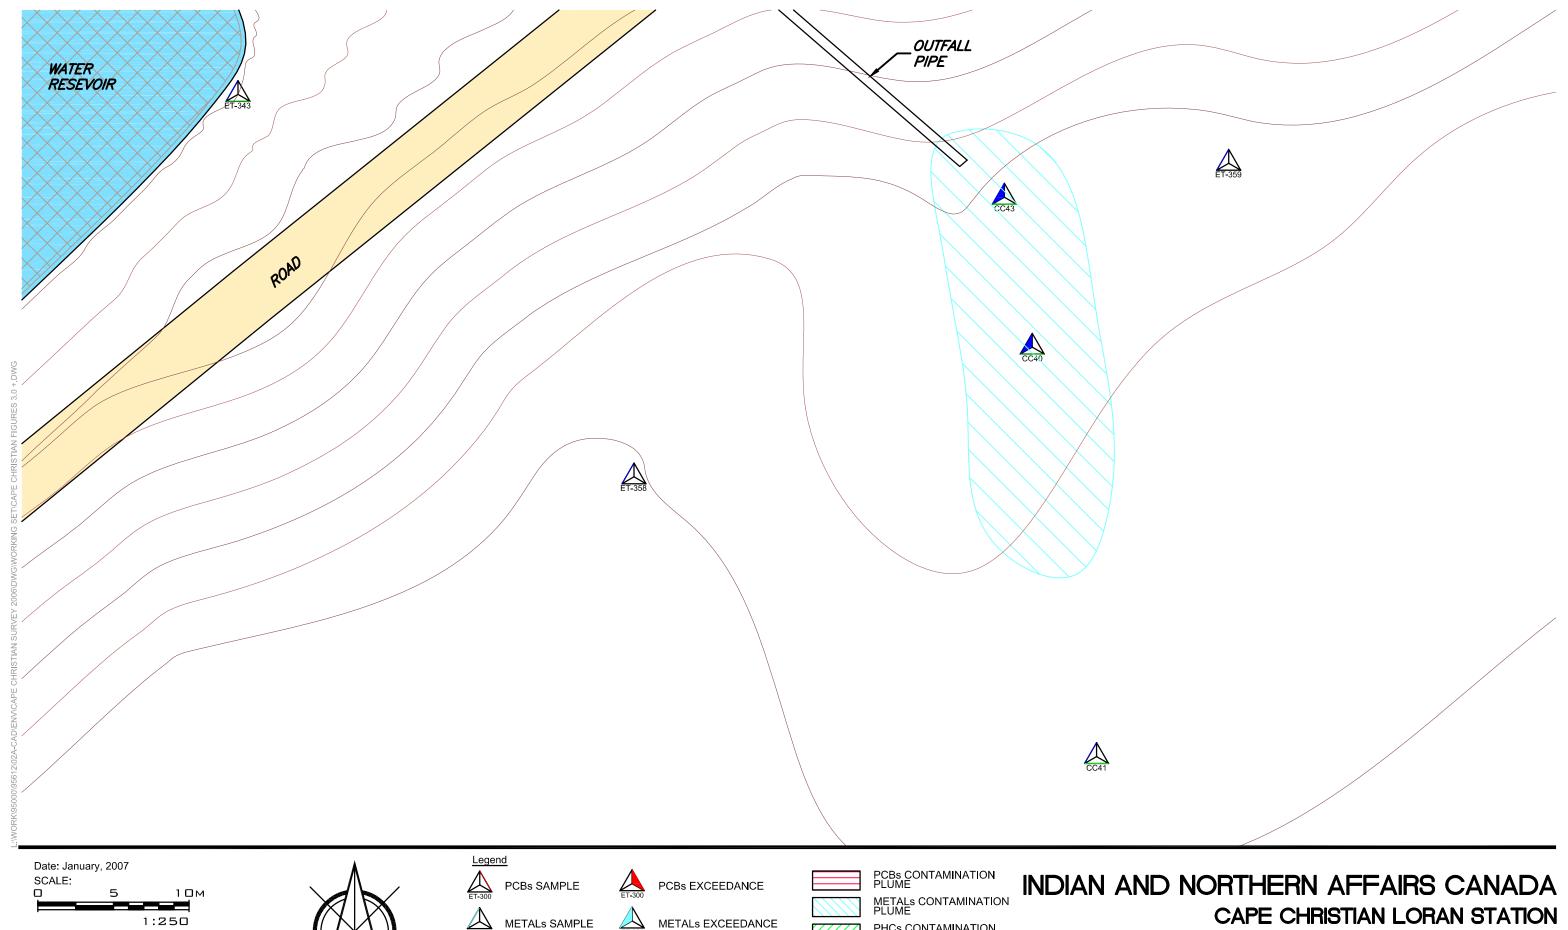
CAPE CHRISTIAN LORAN STATION **OUTFALL AREA** FIGURE 4.1

DRAINAGE COURSE EARTH TECH 2006 SAMPLE CC EARTH TECH 2001 SAMPLE G6543 ESG SAMPLE

| Location | Contaminant Exceeding<br>INAC Criteria (Max<br>Concentration ppm) | DCC I<br>m³ | DCC II | INAC PHC<br>m <sup>3</sup> | Comments |
|--|---|---|---|---|--|
| Beach Area, Outfall<br>(Figure 4.1) | Metals (Copper: 273) | | 207 | | Plume associated with<br>Earth Tech 2001<br>samples CC43 and<br>CC40 |

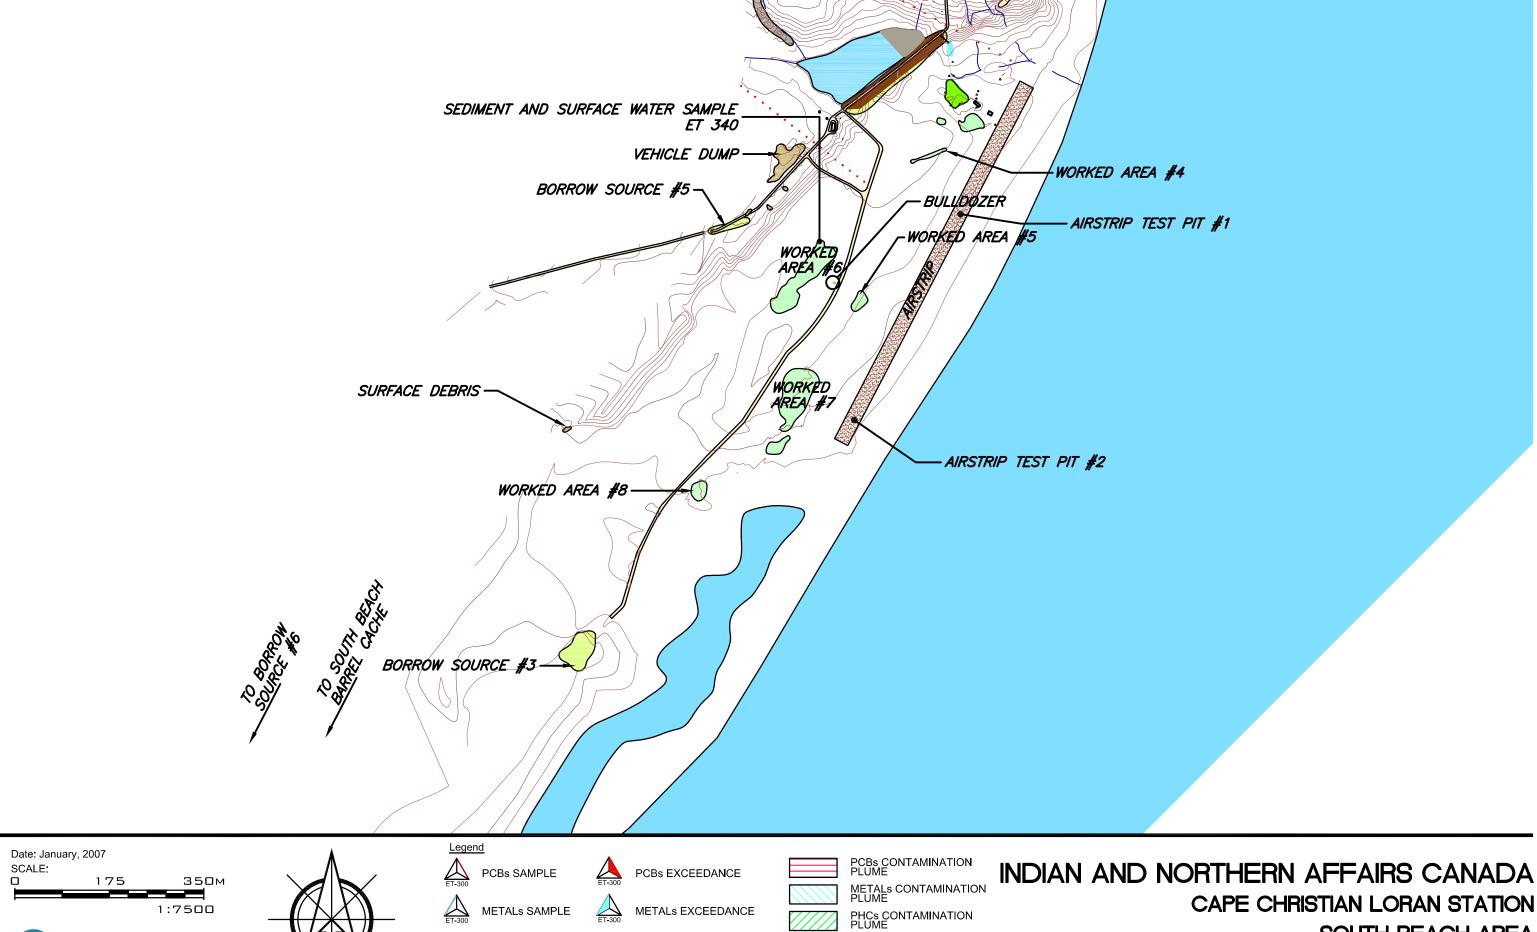
SOUTH BEACH AREA FIGURE 5.0

EARTH TECH 2006 SAMPLE EARTH TECH 2001 SAMPLE G6543 ESG SAMPLE

| Borrow Source | Location | Type of Material | Estimated Amount of<br>Material Available m <sup>3</sup> |
|---|--|---|--|
| Borrow Source # 3 | main Approach Road before<br>River Crossing (Figure 5.0) | poorly graded sand | 10000 |
| Borrow Source # 5 | End of Road Past Equipment<br>Dump (Figure 5.0) | fairly well graded gravelly sand | 1700 |

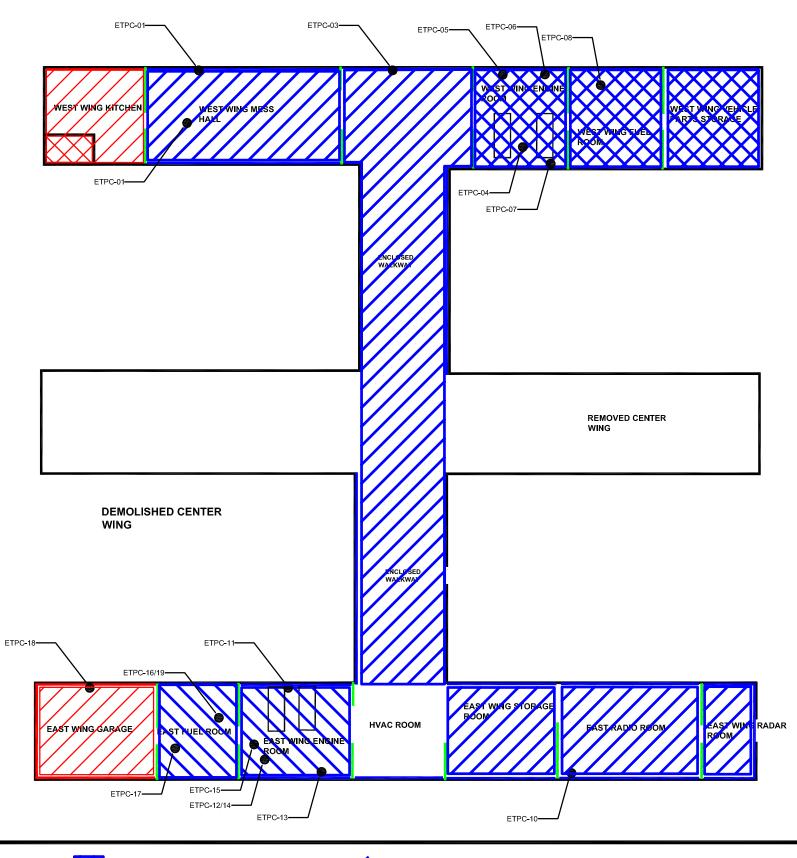
INDIAN AND NORTHERN AFFAIRS CANADA
CAPE CHRISTIAN LORAN STATION
MAIN STATION BUILDING PAINT ASSESSMENT
FIGURE 6.0

Note: asbestos piping throughout building
