PUBLIC WORKS AND GOVERNMENT SERVICES CANADA

ENVIRONMENTAL ASSESSMENT, PROPOSED REMEDIATION OF THE NOTTINGHAM ISLAND WEATHER AND RADIO STATIONS, NUNAVUT

REPORT

MARCH 2013 ISSUED FOR REVIEW EBA FILE: Y22101291

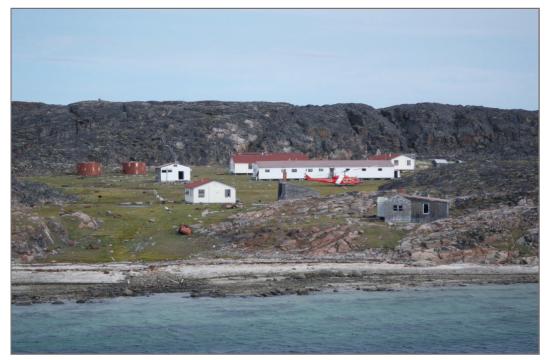
The proposed barge landing area is located directly south of the Site. Photo 2:

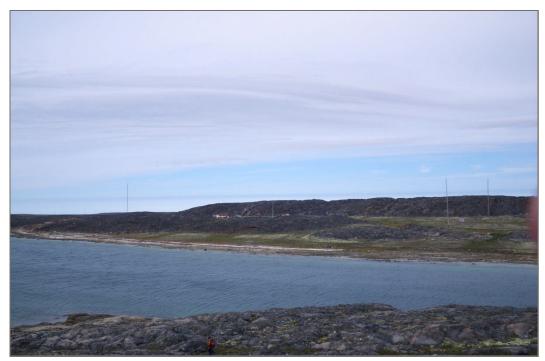
Photo 3: The Site and the proposed shoreline locations, far side of shoreline, selected for the proposed temporary on-site camp.

Three areas were identified as potential locations for construction of the on-site camp (Figure 3). All three recommended camp locations are situated along the beach south and southeast of the Site (Photo 3). The camp will need to house workers and will need to meet the specifications laid out by PWGSC and Workers Safety and Compensation Committee. Facilities that will be required include the following:

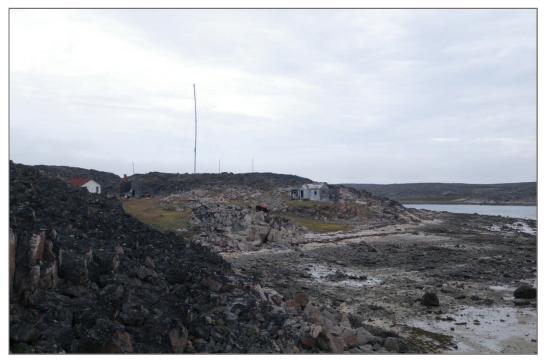
Photo 4: Barren land cover unit exists at the intertidal zone south of Site.

Barren – Barren area with less than 2% vegetation cover over parent material. This land cover unit exists primarily at the proposed barge landing area and within the intertidal zone (Photo 4). This area consists primarily of unvegetated sand, boulder, and cobbles with seaweed near the high tide.

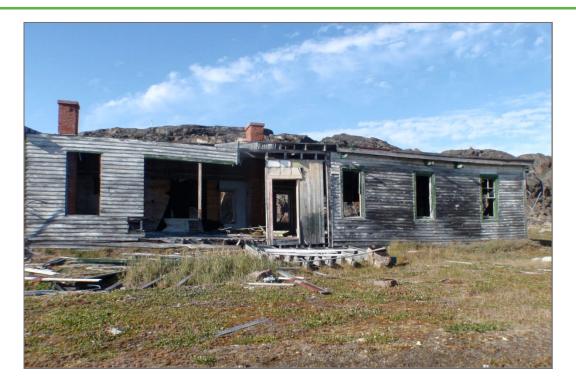
This Moist to Dry Non-Tussock Graminoid/Dwarf Shrub land cover unit is common Photo 5: across the Site.

Moist to Dry Non-Tussock Graminoid/Dwarf Shrub – Moist to dry tundra with 50-70% vegetation cover principally consisting of a mixture of graminoids (grasses, sedges, and rushes), dwarf shrubs, and possibly trace amounts of moss and lichen. This land cover unit was frequently encountered on the Site, primarily in dry upland areas, including surrounding the old kitchen, storage shed, bunkhouse, helipad, and food cache storage areas (Figure 2) (Photo 5). Plant species detected include snow willow (*Salix reticulate*) (and other willow species), polar grass (*Arctagrostis latifolia*), sea lyme grass (*Leymus mollis*), sedge species (*Carex* species), rush species (*Juncas* species), alpine bistort (*Polygonum viviparum*), long-stalked chickweed (*Stellaria longpipes*), river beauty (*Chamerion latifolium*), lichen, and moss.

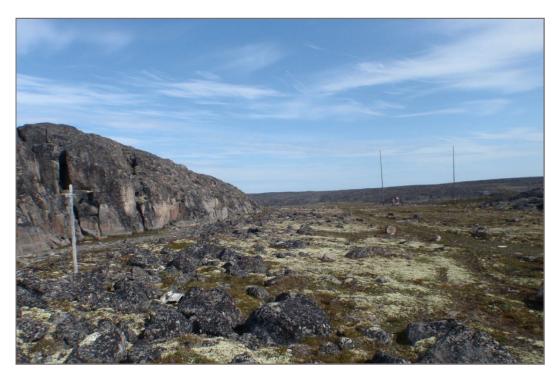
Narrow bands of Prostrate Dwarf Shrub land cover units exist in dry upland areas including the northern edge of the Site, as seen here. Photo 6:

Prostrate Dwarf Shrub – Dry areas on bedrock or till with greater than 50% vegetation cover, consisting of prostrate dwarf shrubs (e.g. *dryas*), graminoids, and possibly less than 10% lichen and moss. This land cover unit was primarily a located along the northern edge of the Site near the bedrock outcrop (Photo 6). Dominant plant species identified in this unit includes lichen (including crustose lichen), crowberry (*Empetrum nigrum*), mountain avens (*Dryas* species), and snow willow; however, other species such as large-flowered wintergreen (*Pyrola grandiflora*), three-toothed saxifrage (*Saxifraga tricuspidata*), Arctic white heather (*Cassiope tetragona*), and long-stalked chickweed were also noted.

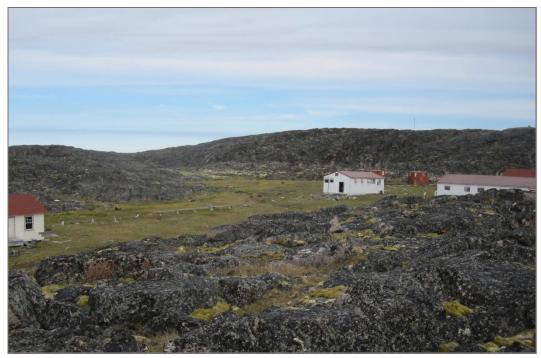
Photo 7: As seen in the foreground, plant cover is restricted primarily between rock crevices in the Sparsely Vegetated Bedrock land cover unit.

Sparsely Vegetated Bedrock – Barren surfaces on bedrock with 2 – 10% vegetation cover primarily located within bedrock crevices (Photo 7). Vegetation cover generally consists of graminoids and prostrate dwarf shrubs. This land cover unit occurs on exposed bedrock outcrops, including the bedrock outcrop directly north of the Site. During the Phase III ESA, vegetation cover was less than 2% and plant species detected included: lichen, moss, willow, polar grass, river beauty, mountain sorrel (*Oxyria digyna*), alpine chickweed (*Cerastium alpinum*), snow cinquefoil (*Potentilla nivea*), and cliff fern species.

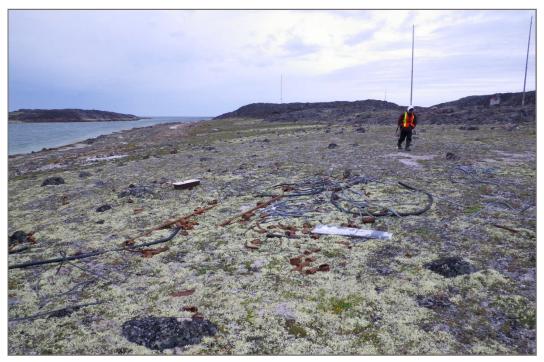
Photo 8: Sparsely Vegetated Till-Colluvium Bare Soil land cover units, as seen here, are most dominant along the marine shoreline in the proposed camp locations.

Sparsely Vegetated Till-Colluvium Bare Soil – Barren area with 2 – 10% vegetation cover over bedrock, till and/or colluvium. Of the vegetation present, graminoids and prostrate dwarf shrubs dominate. This land cover unit is mapped primarily along the marine shoreline in the location of the proposed camp (Photo 8). At the time of the Phase III ESA, this area supported primarily lichen, moss, willow species, and mountain avens, salt grass (*Puccinellia* species), sea lyme-grass, saxifrage species, and river beauty.

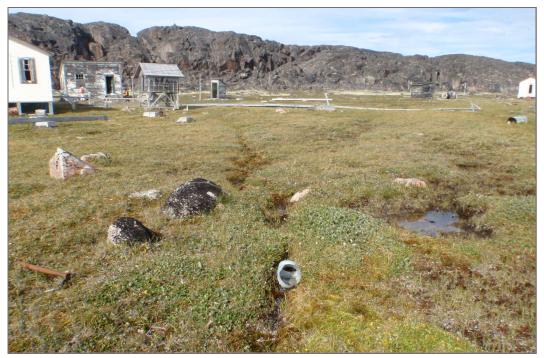
Wet Sedge land cover units, as seen here, are most common across the central and southern portions of the Site. Photo 9:

Wet Sedge – Vegetated areas that are saturated for a significant part of the growing season. This land cover unit is dominated by grasses, sedges, rushes, cottongrass, and moss; and may include less than 10% cover of dwarf shrubs (less than 40 cm tall). This land cover unit was most common near the former house, garage, shed, radio buildings, and chicken coop, and much of the southern half of the Site (Figure 2) (Photo 9). At the time of the Phase III ESA, the dominant vegetation species identified were water sedge (Carex aquatilis), rush species, sheathed cottongrass (Eriophorum vaginatum), snow willow and other willow species, polar grass, river beauty, and flame-tipped lousewort (*Pedicularis flammea*).
