**PUBLIC SERVICES AND PROCUREMENT CANADA  
ENVIRONMENTAL SERVICES – WESTERN REGION**

# **Operations and Maintenance Manual Resolute Bay Landfill Remediation Project, Resolute Bay, Nunavut**

**PSPC Project R.095508.001**

**Final Report**

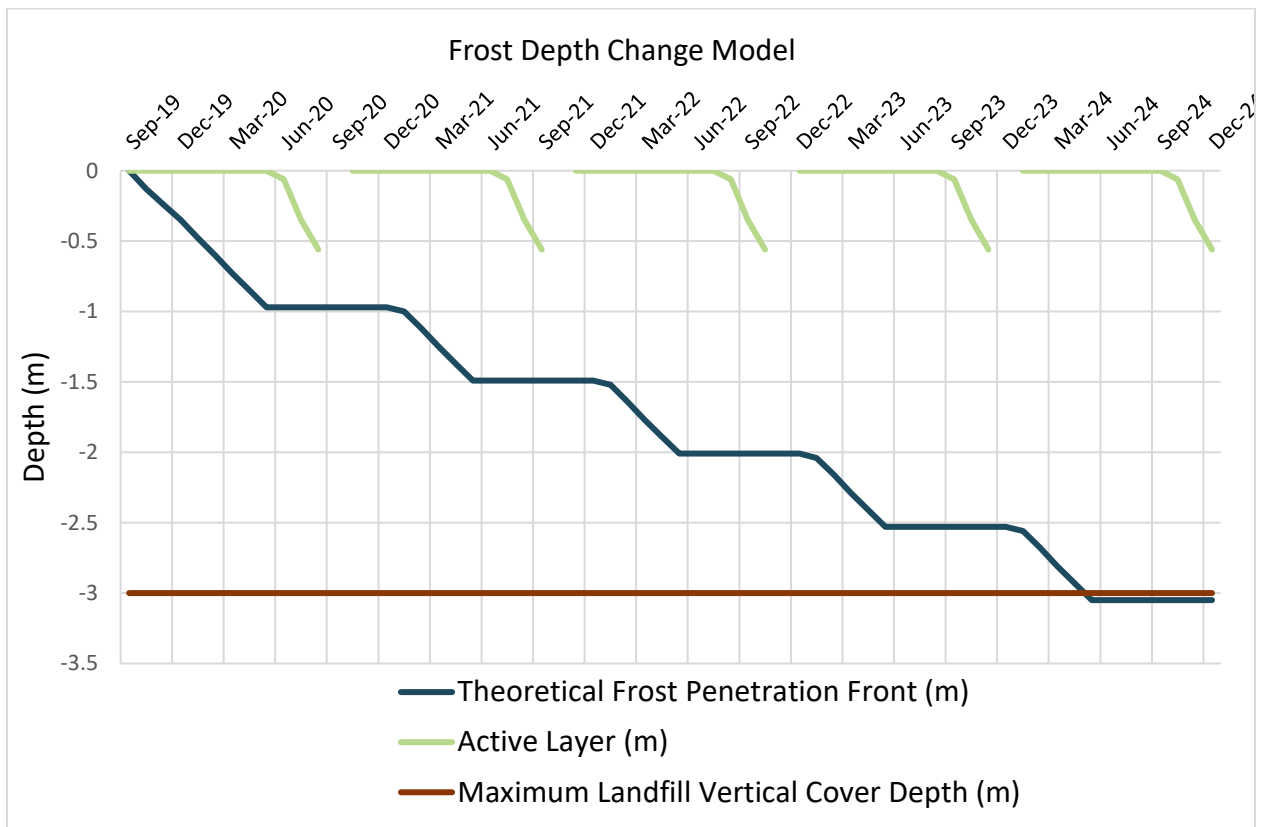
FIGURE 4: PERMAFROST AGGRADATION MODEL

- Thermal conductivity of  $0.37 \left( \frac{W}{m K} \right)$  was used, based on a weighted average of  $0.3 \left( \frac{W}{m K} \right)$  for Type 1 and  $0.4 \left( \frac{W}{m K} \right)$  for Type 2.
- Ice density of  $997 \left( \frac{kg}{m^3} \right)$
- Volumetric fraction of ice in frozen soil of 0.2 based on sieve analyses and field reports of rain records
- Latent heat of fusion of  $334,000 \left( \frac{W \times s}{kg} \right)$
- Average Temperature during freezing cycles of  $-1^\circ C$  based on a conservative estimate of the insulating factors of snow
- Ground temperature to air temperature factor of 3, based on a conservative estimate of the summertime radiation effects in the arctic region.

It should be noted that the average permafrost maximum depth between data retrieved between 2011 and 2015 was found to be 1.95m in depth. As such a lower limit for the model was set to this value. Furthermore, empirical data from test pitting was incorporated to this model. The average test pit depth from previous on-site test pitting outlined in the Phase 3 Site Assessment identified 5 test pits in AEC 1 with an average active layer of 0.56m in depth before permafrost was encountered. An upper bound for permafrost was established based on this data.

Monthly predictions of permafrost aggradation were generated using Environment and Climate Change Canada historic weather station data of the Resolute. As stated previously, a conservative correlation was made between air temperature and ground temperature for cases above  $0^{\circ}\text{C}$ . The model was then cross referenced with the historic ice thickness data in the figure above to provide confidence. Upon the presence of thermistor data for ground temperatures, more accurate calibrations of the model can be made.

Based on the analysis of data, it is proposed that a thermistor minimum depth of 3m be used to collect ground temperatures over time to verify the permafrost aggradation formation.

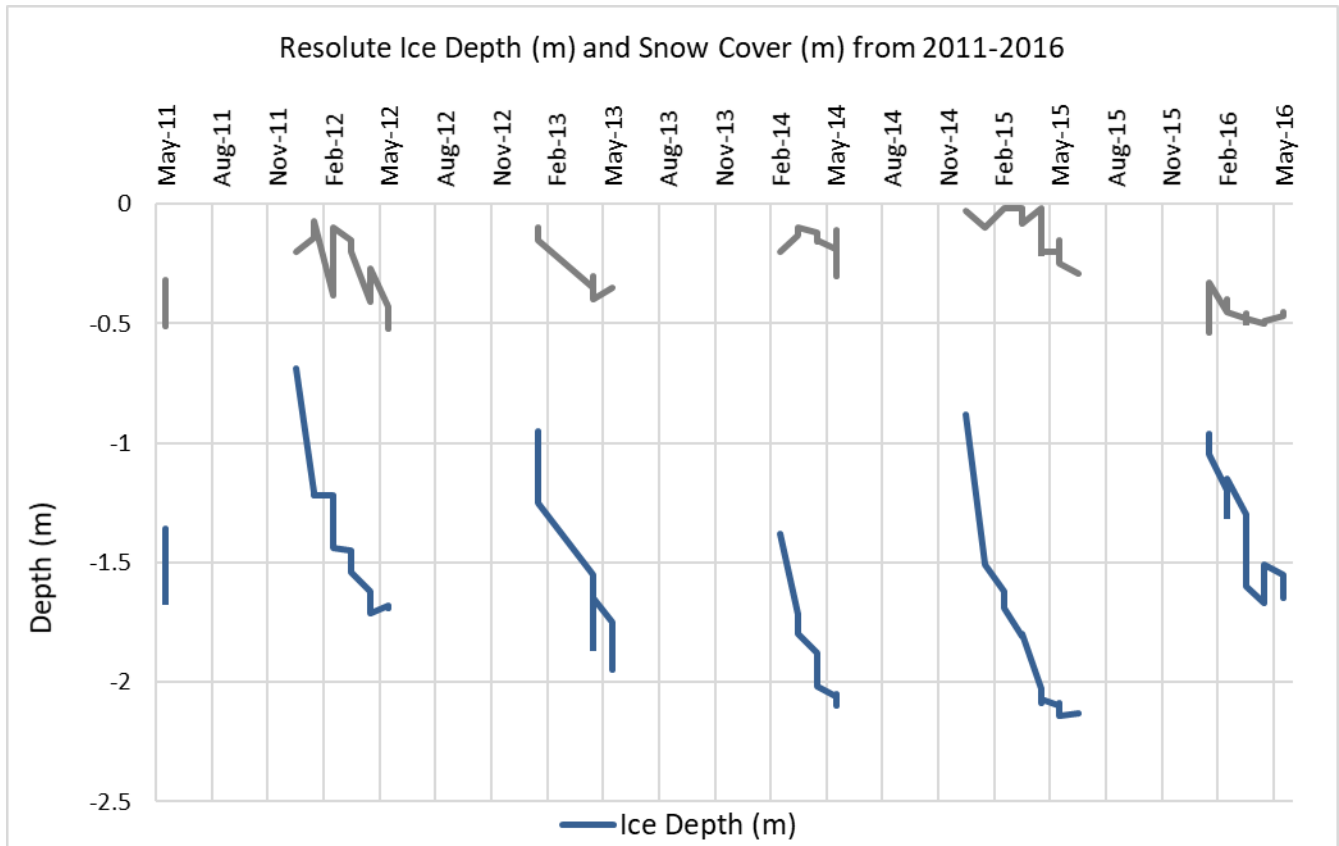
FIGURE 5: RESOLUTE ICE DEPTH (M) AND SNOW COVER (M) FROM 2011-2016

Historic ice thickness and snow cover was analyzed during the baselining of the model. Results from May 2011 to May 2016 are depicted in Figure 5.
