## **Remediation Action Plan**

**ROBERTS BAY AND IDA BAY  
ABANDONED MINE SITES  
REMEDICATION PLAN**

**WX15131  
January 2007**

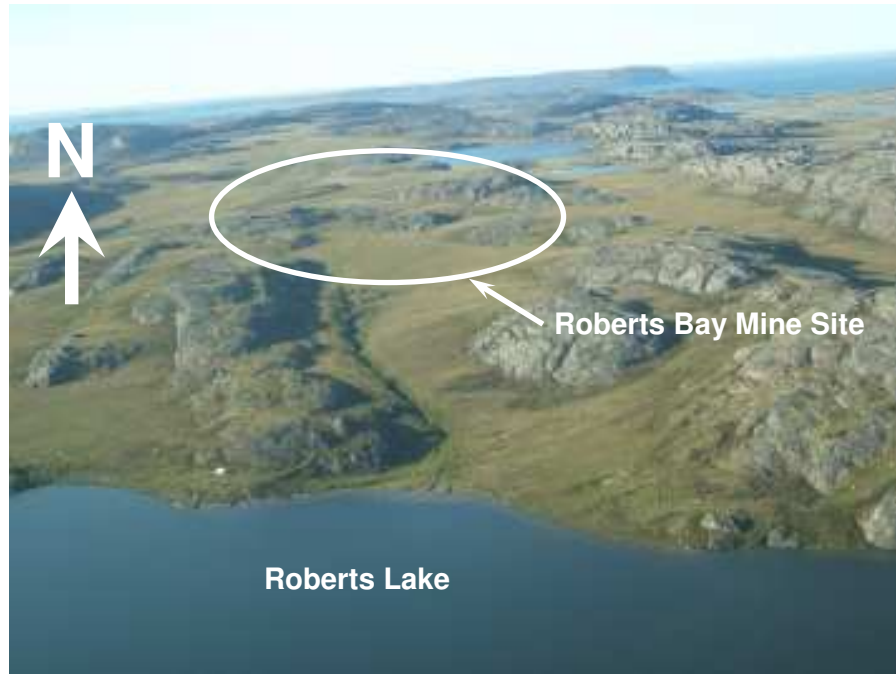
**Figure 2**      **Aerial view of the Roberts Bay mine site from the south, with Roberts Lake in the forefront.**

The Roberts Bay abandoned silver mine (see Figures 2 and 3) is located approximately 1 km north of Roberts Lake, and approximately 2 km east of Roberts Bay. Roberts Lake is accessible by float plane. The local topography ranges from sea level at Roberts Bay to 8.2 m above mean sea level (amsl) at Roberts Lake to between 65 and 70 m amsl at the main Roberts Bay Mine site, and about 85 m amsl at the entrance to the partially collapsed adit opening (Adit #2) on the ridge about 200 m east of the center of the main site (see Figure 4).

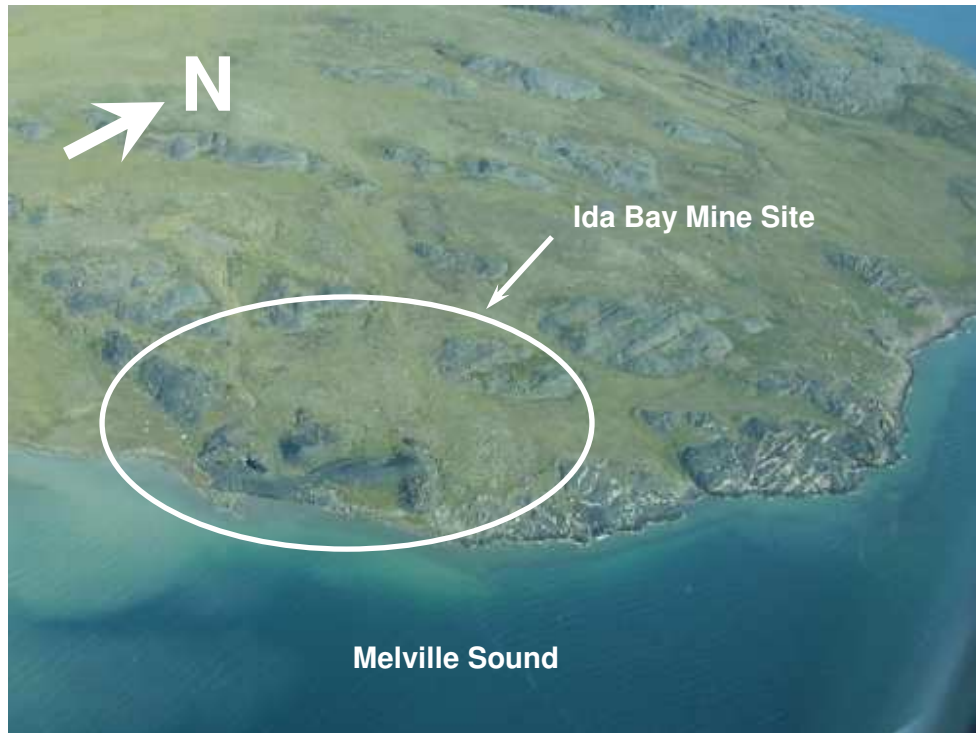
**Figure 6: Aerial view of the Ida Bay Mine Site from the southeast.**

The Ida Bay mine site (see Figures 6 and 7) is located on a southeast-facing slope of Ida Bay along the shore of Melville Sound. Many erratic boulders on the order of 0.5 to 1.0 m diameter are scattered on the bedrock surface around the perimeter of the site. The adit opening at Ida Bay is about 20 m from the shoreline with elevation of 3.0 m amsl. Elevation increases gradually to the north and west. An old camp site for the mine located about 150 m from the shoreline has elevation of 11 m amsl. A small creek running from the west through coarse till empties into Melville Sound at the head of Ida Bay about 300 m southwest of the adit (see Figure 7)
