Indian and Northern
Affairs Canada

CAM-F SARCPA LAKE LONG-TERM MONITORING PLAN

Revised March 2, 2017

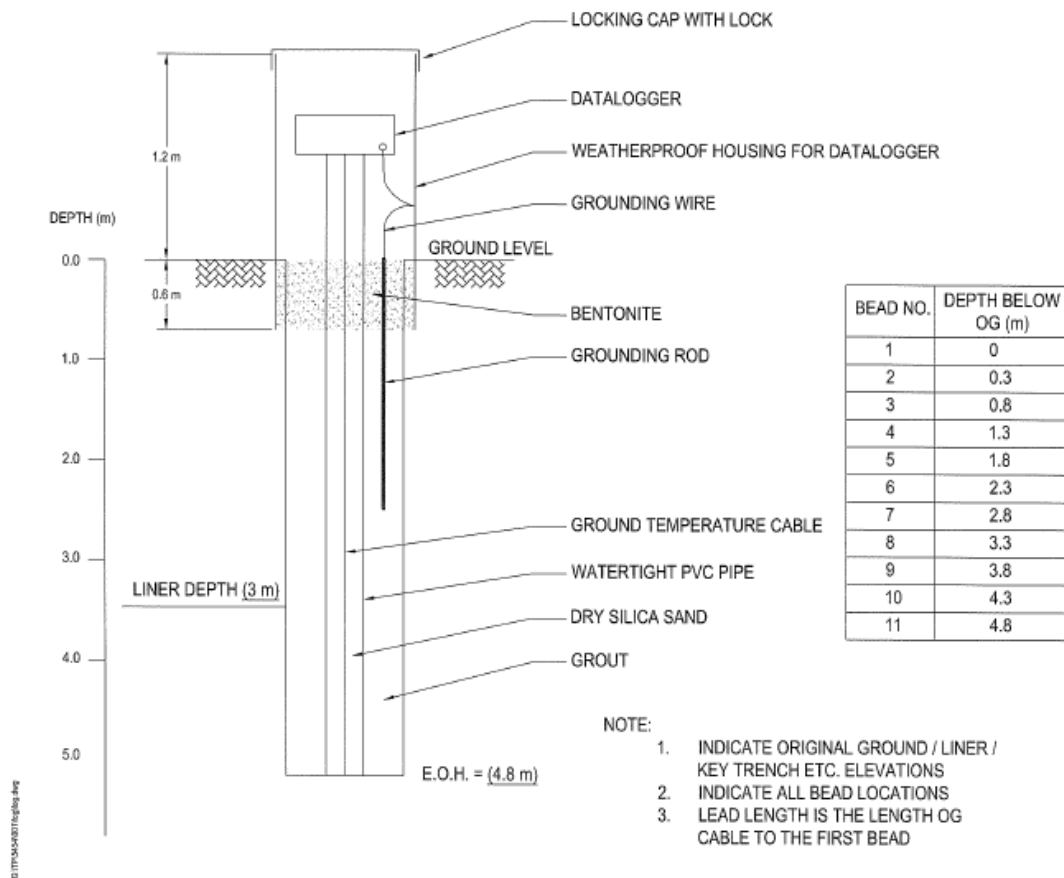
SITE: SSDF SE & SW CORNERS
LOCATION NORTHING: -
GROUND ELEVATION: -
CABLE LENGTH: 7.8 m
CABLE LENGTH ABOVE GROUND: 3.0 m
NUMBER OF BEADS: 11

CABLE INSTALLATION NO.: 3
CABLE SERIAL NO.: CAMF VTO1
EASTING: -
DATE: SEPT. 2007
LEAD LENGTH: 3.0 m
FIRST BEAD ELEVATION: 0 m BOG
HOLE DEPTH: 4.8 m
VT01 STICKUP: 76 cm

- Polychlorinated biphenyls (PCBs)
 - Total Petroleum Hydrocarbons (TPH)
- Thermal Monitoring
 - The thermal monitoring system consists of 4 thermistor strings with beads at selected intervals to provide ground temperature profiles at various locations within the SSDF (See Appendix G for the Thermistor Installation Reports). Automatic data loggers attached to the thermistors allow remote data collection. The data from this system will be collected and analysed to determine the permafrost aggradation in the facility.

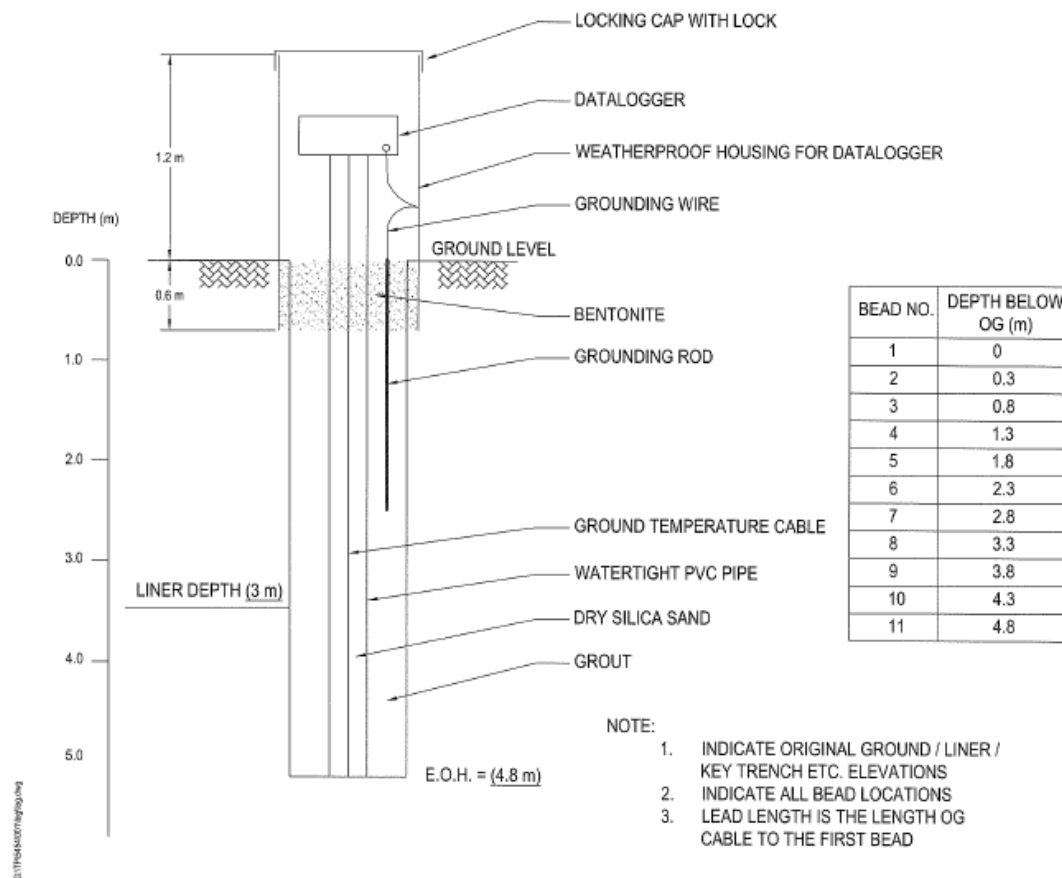
CAM-F DEW LINE CLEAN UP PROJECT
GROUND TEMPERATURE CABLE INSTALLATION REPORT

SITE: SSDF SE & SW CORNERS	CABLE INSTALLATION NO.: 4
LOCATION NORTHING: -	CABLE SERIAL NO.: CAMF VT02
GROUND ELEVATION: -	EASTING: -
CABLE LENGTH: 7.8 m	DATE: SEPT. 2007
CABLE LENGTH ABOVE GROUND: 3.0 m	LEAD LENGTH: 3.0 m
NUMBER OF BEADS: 11	FIRST BEAD ELEVATION: 0 m BOG
	HOLE DEPTH: 4.8 m
	VT02 STICKUP: 90 cm

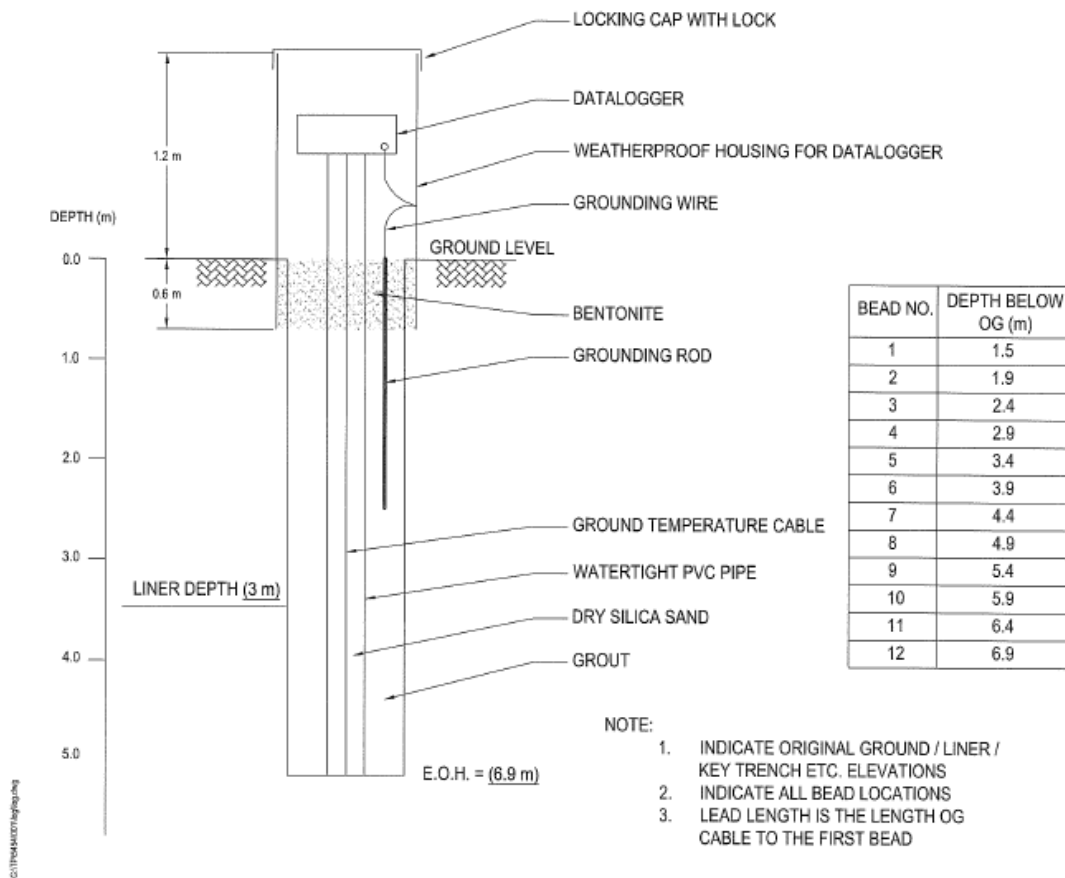
CAM-F DEW LINE CLEAN UP PROJECT
GROUND TEMPERATURE CABLE INSTALLATION REPORT

SITE: SSDF NE & NW CORNERS
LOCATION NORTHING: -
GROUND ELEVATION: -
CABLE LENGTH: 8.4 m
CABLE LENGTH ABOVE GROUND: 1.5 m
NUMBER OF BEADS: 12

CABLE INSTALLATION NO.: 1
CABLE SERIAL NO.: CAMF VTO3
EASTING: -
DATE: SEPT. 2007
LEAD LENGTH: 3.0 m
FIRST BEAD ELEVATION: 1.5 m
HOLE DEPTH: 6.9 m
VT03 STICKUP: 76 cm

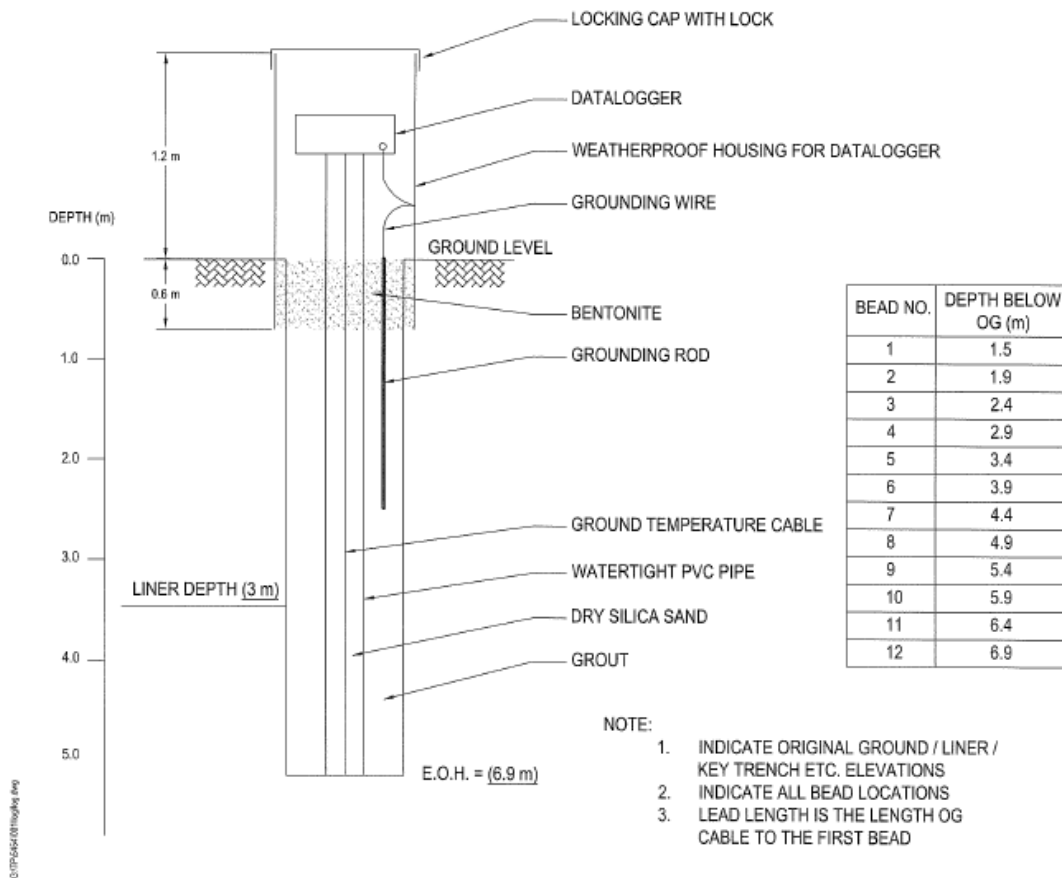
CAM-F DEW LINE CLEAN UP PROJECT
GROUND TEMPERATURE CABLE INSTALLATION REPORT

SITE: SSDF NE & NW CORNERS	CABLE INSTALLATION NO.: 2
LOCATION NORTHING: -	CABLE SERIAL NO.: CAMF VT04
GROUND ELEVATION: -	EASTING: -
CABLE LENGTH: 8.4 m	DATE: SEPT. 2007
CABLE LENGTH ABOVE GROUND: 1.5 m	LEAD LENGTH: 3.0 m
NUMBER OF BEADS: 12	FIRST BEAD ELEVATION: 1.5 m BOG
	HOLE DEPTH: 6.9 m
	VT04 STICKUP: 73 cm
