Indian and Northern
Affairs Canada

CAM-F SARCPA LAKE LONG-TERM MONITORING PLAN

January 23, 2007

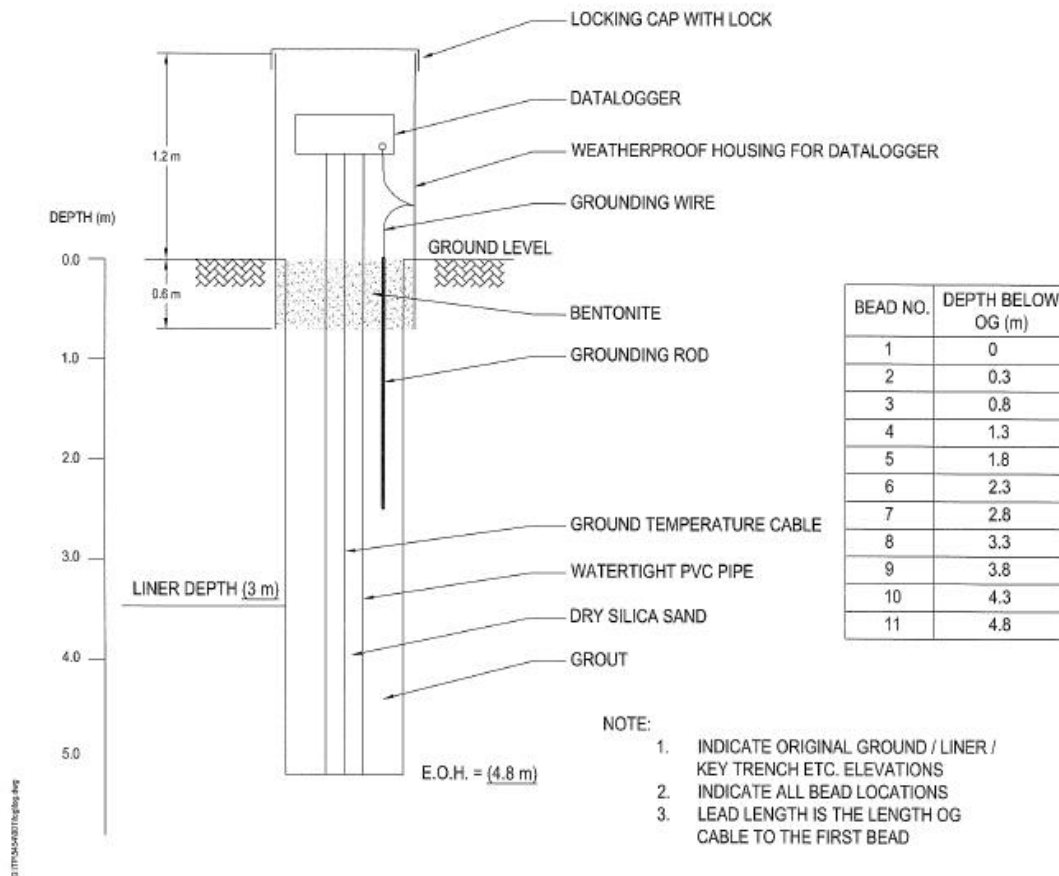
CAM-F DEW LINE CLEAN UP PROJECT
GROUND TEMPERATURE CABLE INSTALLATION REPORT

SITE: SSDF SE & SW CORNERS	CABLE INSTALLATION NO.: 3
LOCATION NORTHING: -	CABLE SERIAL NO.: CAMF VTO1
GROUND ELEVATION: -	EASTING: -
CABLE LENGTH: 7.8 m	DATE: SEPT. 2007
CABLE LENGTH ABOVE GROUND: 3.0 m	LEAD LENGTH: 3.0 m
NUMBER OF BEADS: 11	FIRST BEAD ELEVATION: 0 m BOG
	HOLE DEPTH: 4.8 m
	VT01 STICKUP: 76 cm

- Thermal Monitoring
 - The thermal monitoring system consists of 4 thermistor strings with beads at selected intervals to provide ground temperature profiles at various locations within the SSDF (See Appendix G for the Thermistor Installation Reports). Automatic data loggers attached to the thermistors allow remote data collection. The data from this system will be collected and analysed to determine the permafrost aggradation in the facility.

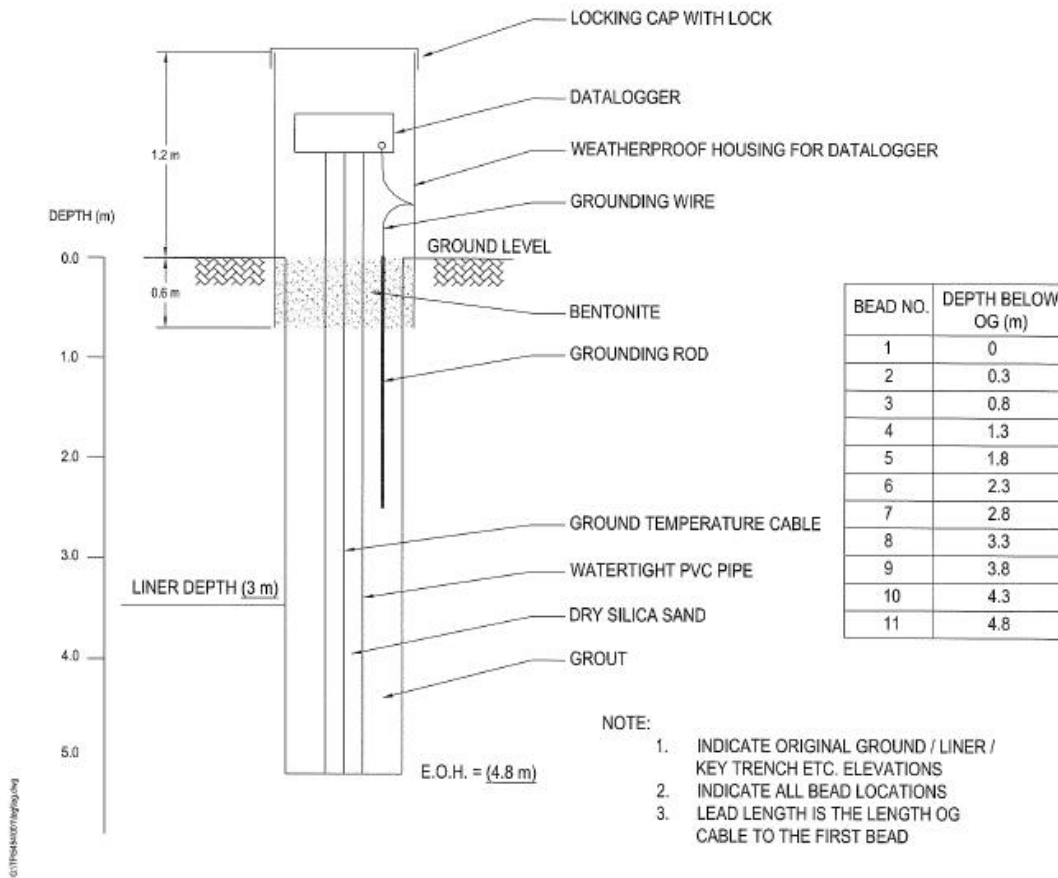
CAM-F DEW LINE CLEAN UP PROJECT
GROUND TEMPERATURE CABLE INSTALLATION REPORT

SITE: SSDF SE & SW CORNERS	CABLE INSTALLATION NO.: 4
LOCATION NORTHING: -	CABLE SERIAL NO.: CAMF VTO2
GROUND ELEVATION: -	EASTING: -
CABLE LENGTH: 7.8 m	DATE: SEPT. 2007
CABLE LENGTH ABOVE GROUND: 3.0 m	LEAD LENGTH: 3.0 m
NUMBER OF BEADS: 11	FIRST BEAD ELEVATION: 0 m BOG
	HOLE DEPTH: 4.8 m
	VT02 STICKUP: 90 cm

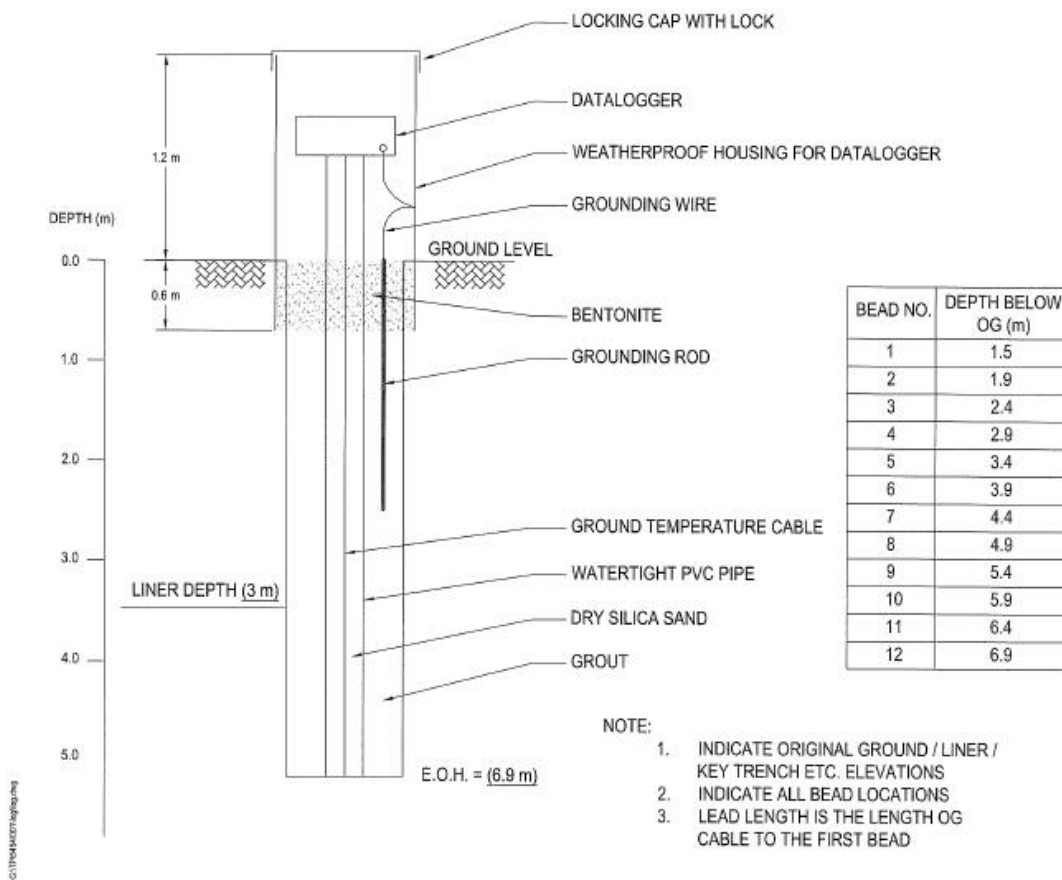
CAM-F DEW LINE CLEAN UP PROJECT
GROUND TEMPERATURE CABLE INSTALLATION REPORT

SITE: SSDF NE & NW CORNERS
LOCATION NORTHING: -
GROUND ELEVATION: -
CABLE LENGTH: 8.4 m
CABLE LENGTH ABOVE GROUND: 1.5 m
NUMBER OF BEADS: 12

CABLE INSTALLATION NO.: 1
CABLE SERIAL NO.: CAMF VTO3
EASTING: -
DATE: SEPT. 2007
LEAD LENGTH: 3.0 m
FIRST BEAD ELEVATION: 1.5 m
HOLE DEPTH: 6.9 m
VT03 STICKUP: 76 cm

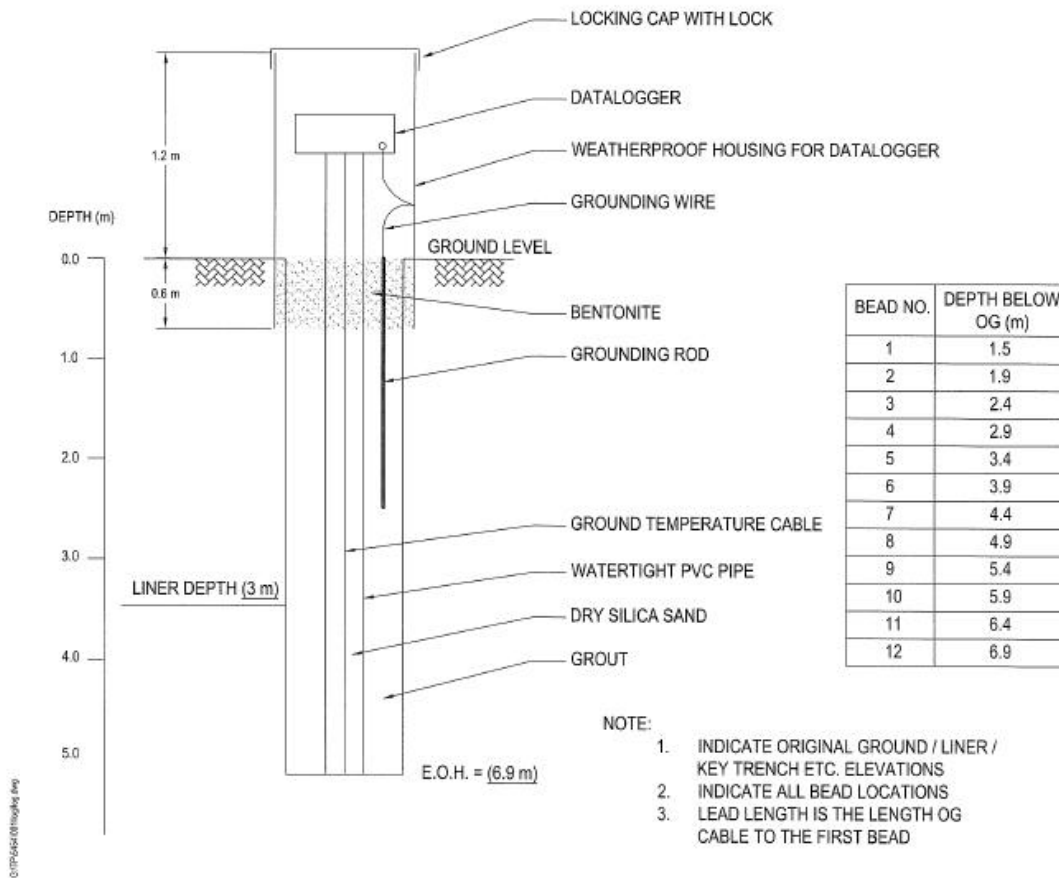
CAM-F DEW LINE CLEAN UP PROJECT
GROUND TEMPERATURE CABLE INSTALLATION REPORT

SITE: SSDF NE & NW CORNERS	CABLE INSTALLATION NO.: 2
LOCATION NORTHING: -	CABLE SERIAL NO.: CAMF VTO4
GROUND ELEVATION: -	EASTING: -
CABLE LENGTH: 8.4 m	DATE: SEPT. 2007
CABLE LENGTH ABOVE GROUND: 1.5 m	LEAD LENGTH: 3.0 m
NUMBER OF BEADS: 12	FIRST BEAD ELEVATION: 1.5 m BOG
	HOLE DEPTH: 6.9 m
	VT04 STICKUP: 73 cm
