**APPENDIX D**  
**AS BUILT REPORTS**

**APPENDIX D.2**  
**GEOTECHNICAL INSPECTION**

**Re: Baffinland Iron Mines Corporation (BIMC) - Submission of 2013 Annual Geotechnical Inspection, Water Licences Type 'A' No. 2AM-MRY1325 and Type 'B' 2BB-MRY1114**

**ANNUAL GEOTECHNICAL INSPECTION**  
**Baffinland Iron Mines Corporation**  
**Mary River Project**

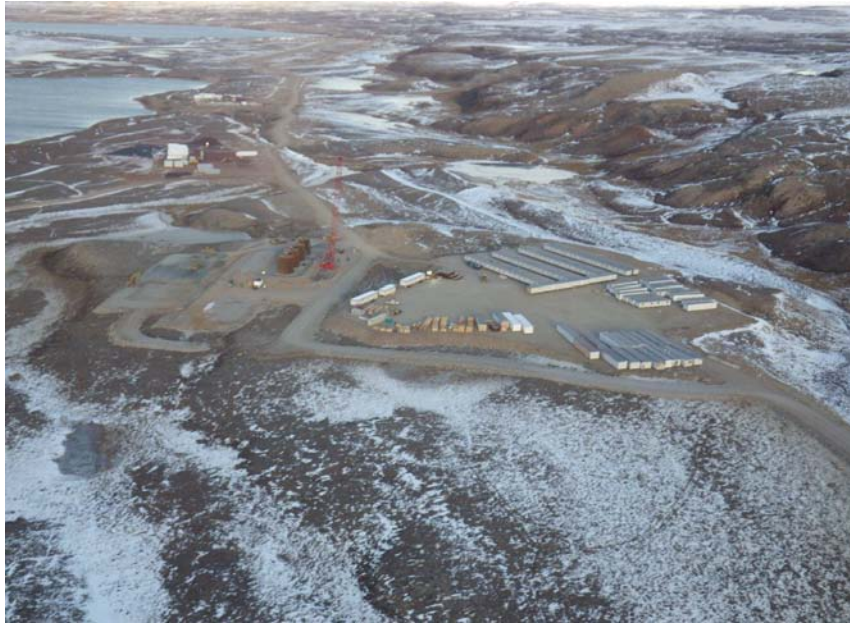
**PHOTO 2** Mary River Mine Site Complex Aerial Layout #2 – During 2013 Construction Program

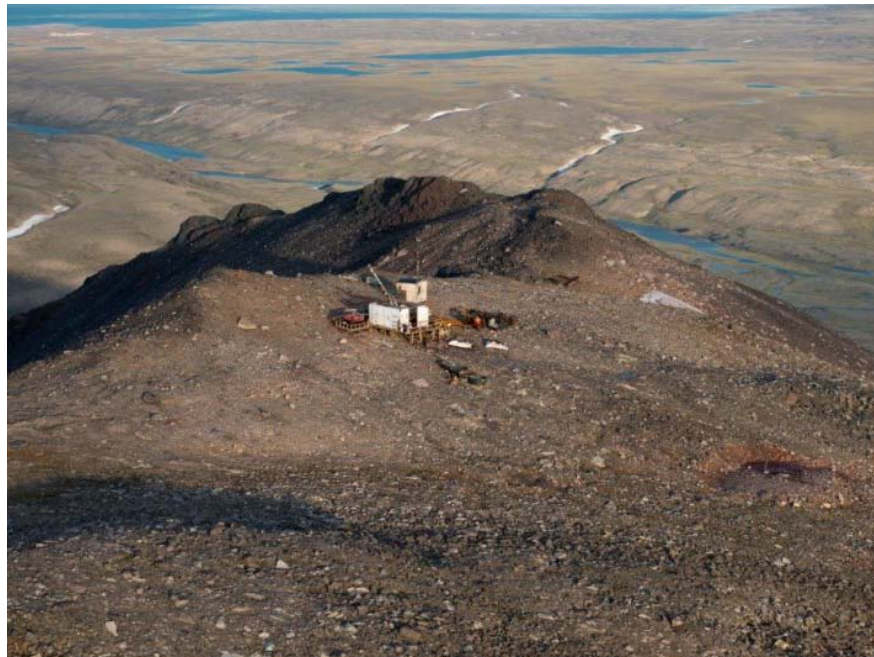
**PHOTO6 5** Geochemical Investigation Drilling Equipment at Deposit #1

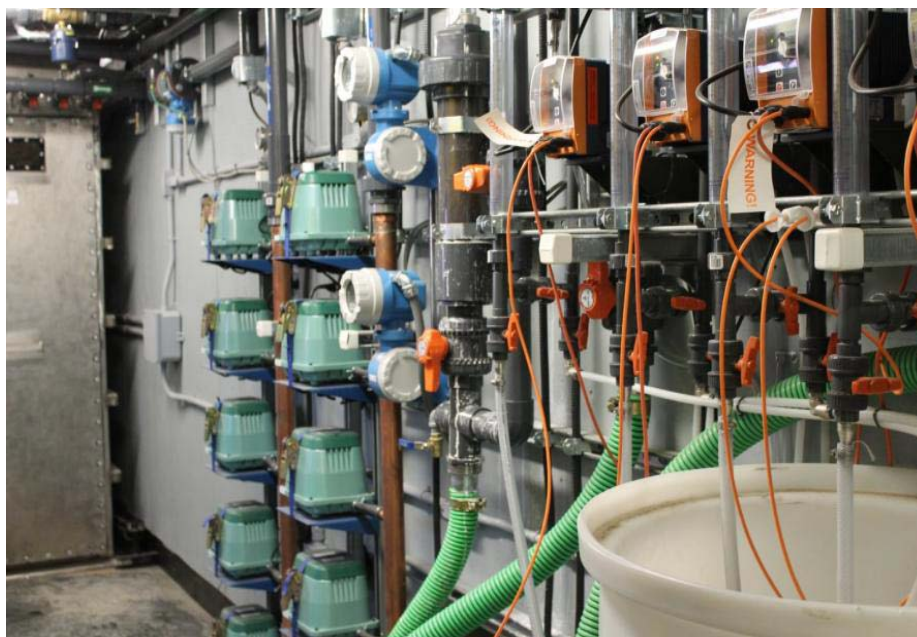
**PHOTO 10** Internal components of the Wastewater Treatment Facility utilizing MBR Technology

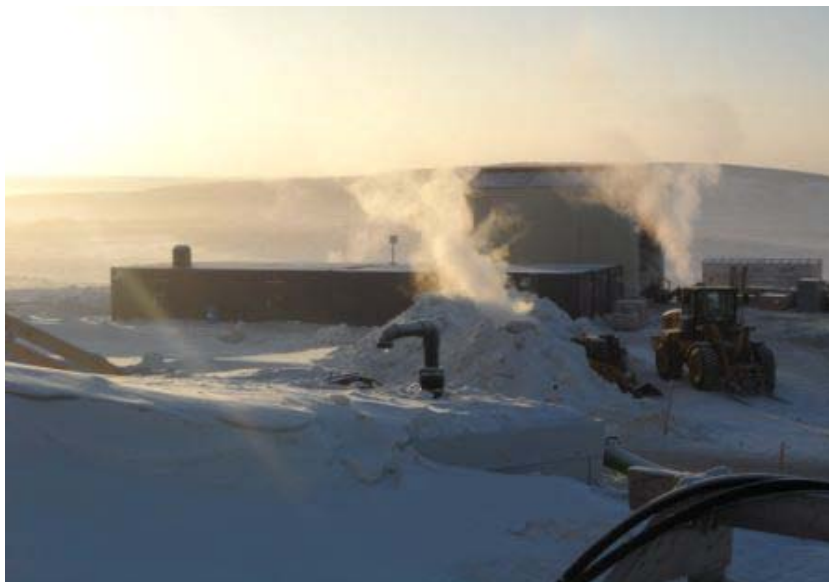
**PHOTO 12** Wastewater Treatment Facility utilizing MBR Technology and adjacent Sewage Truck Building (alternate view) November 2013

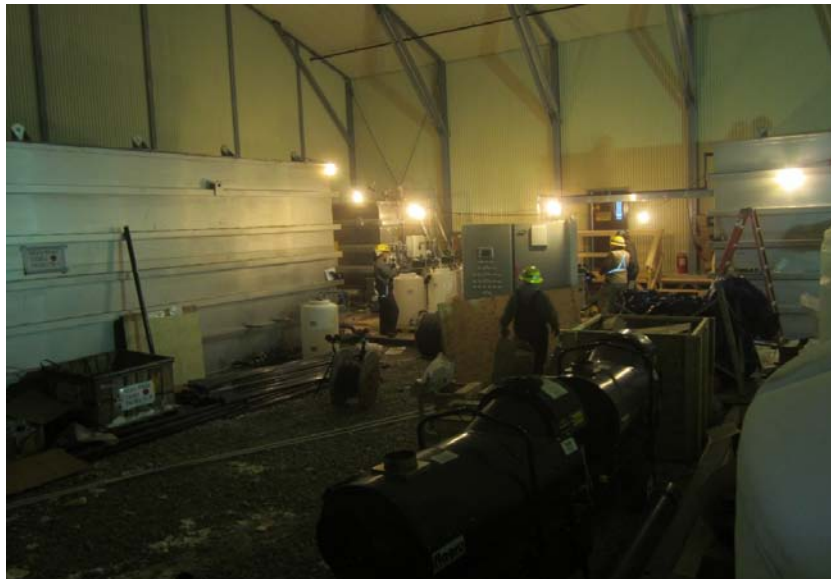
**PHOTO 13** Water (Fresh) Treatment System Installation November 2013

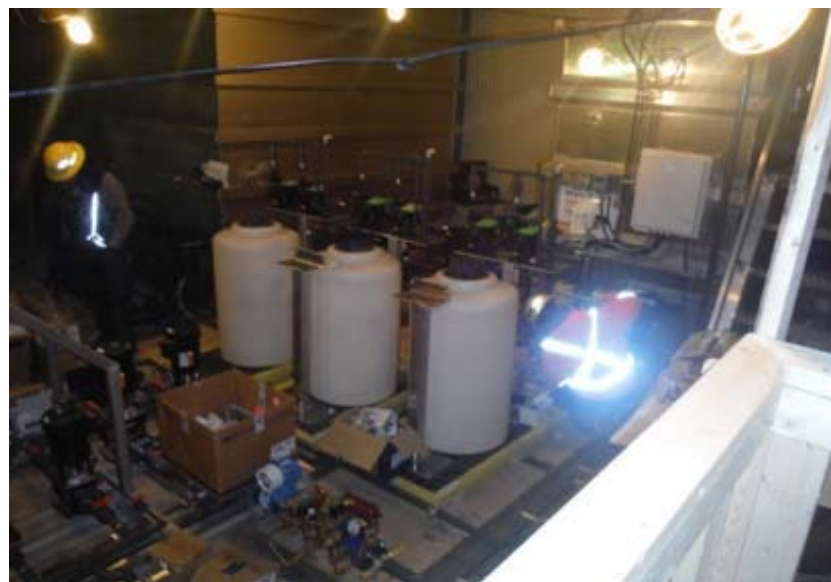
**PHOTO 14** Water Building - Mechanical Installation November 2013

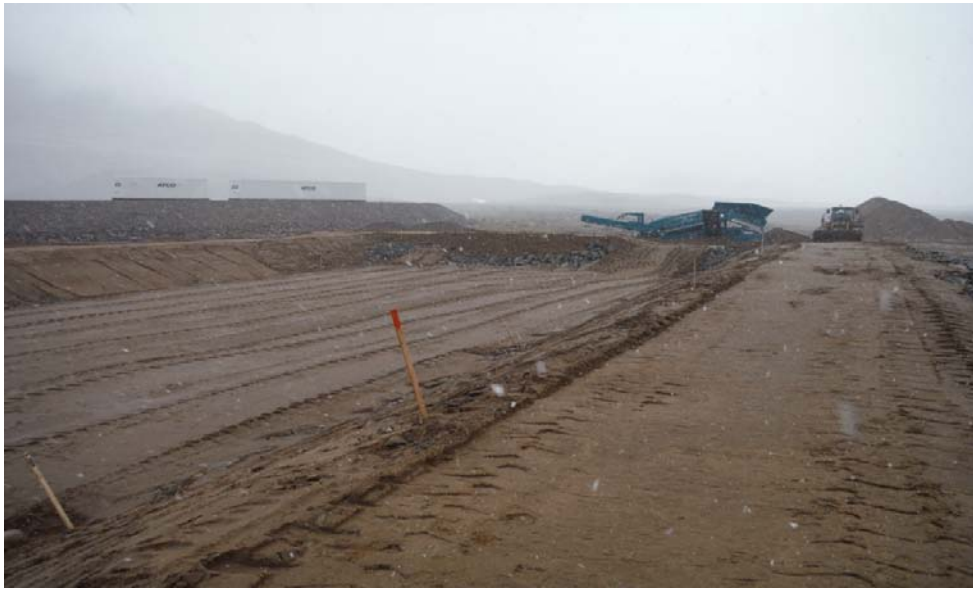
**PHOTO 21** Steel Tank Bulk Fuel Storage Facility Pad August 2013

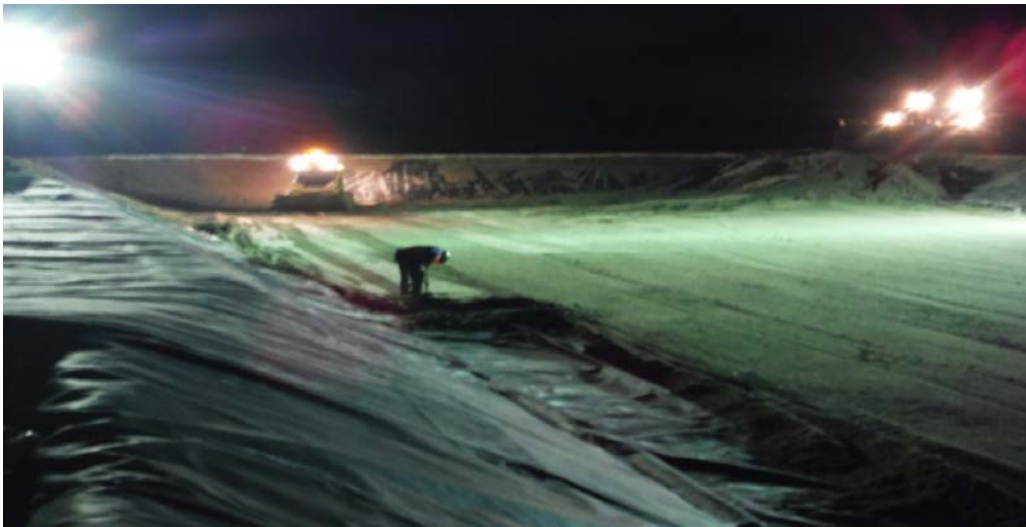
**PHOTO 22** Installing arctic liner at Steel Tank Bulk Fuel Storage Facility engineering containment structure August 2013

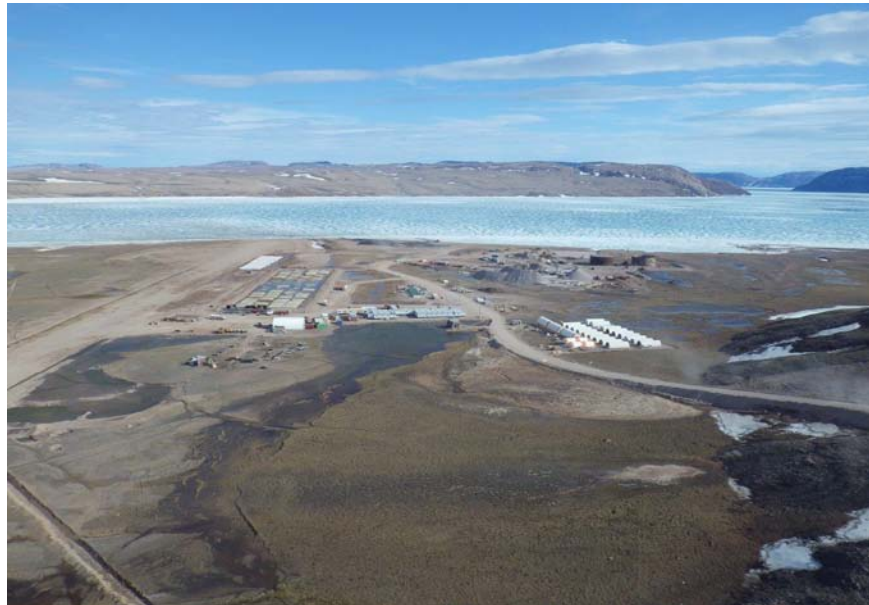
**PHOTO 2** Aerial View – Milne Port Infrastructure Layout June 2013

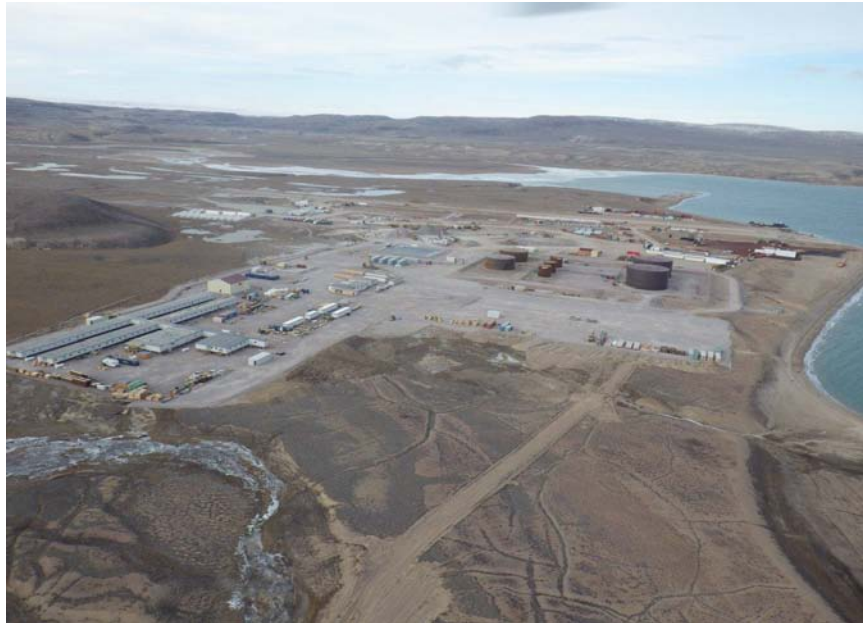
**PHOTO 4** Aerial View – Infrastructure Layout September 2013

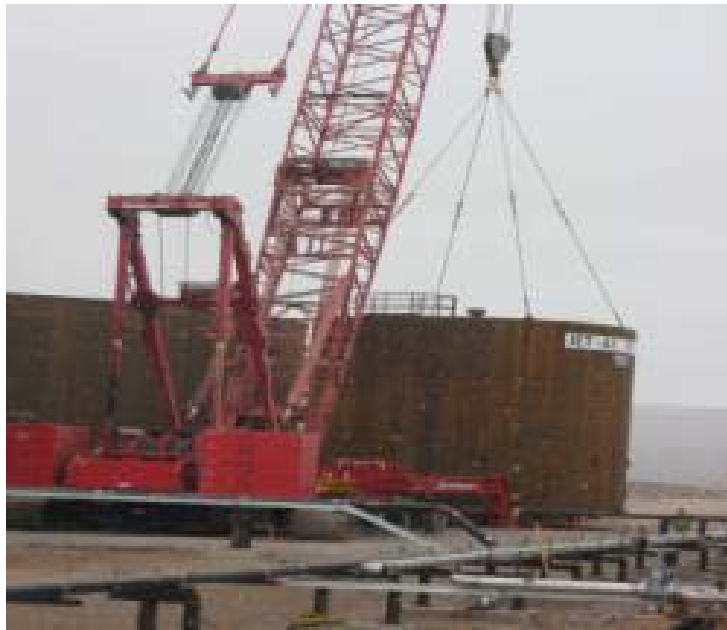
**PHOTO 13** 300 Ton crane placing 1<sup>st</sup> 750,000L Jet A Tank  
August 2013

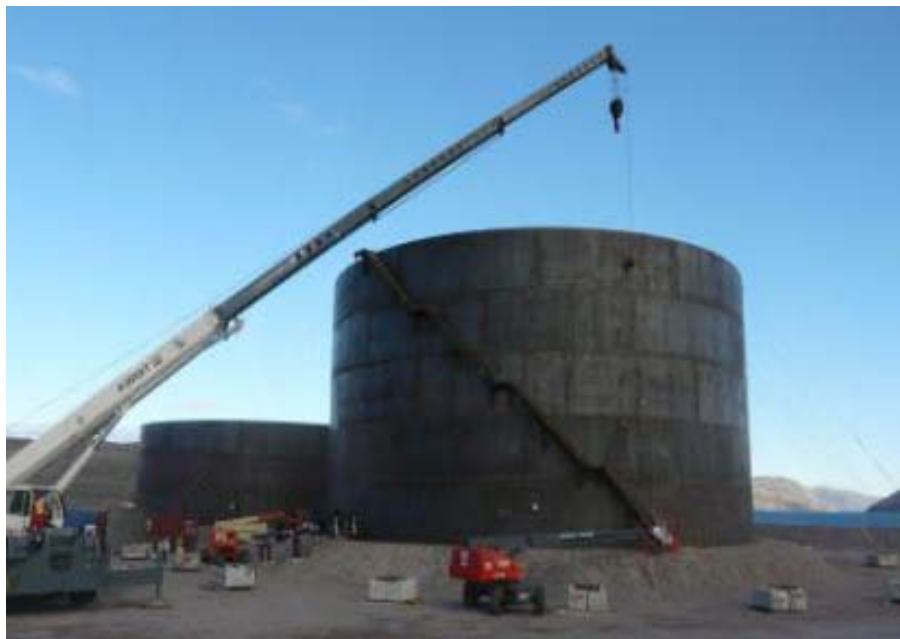
**PHOTO 14** Installing roof on Tank #1 August 2013

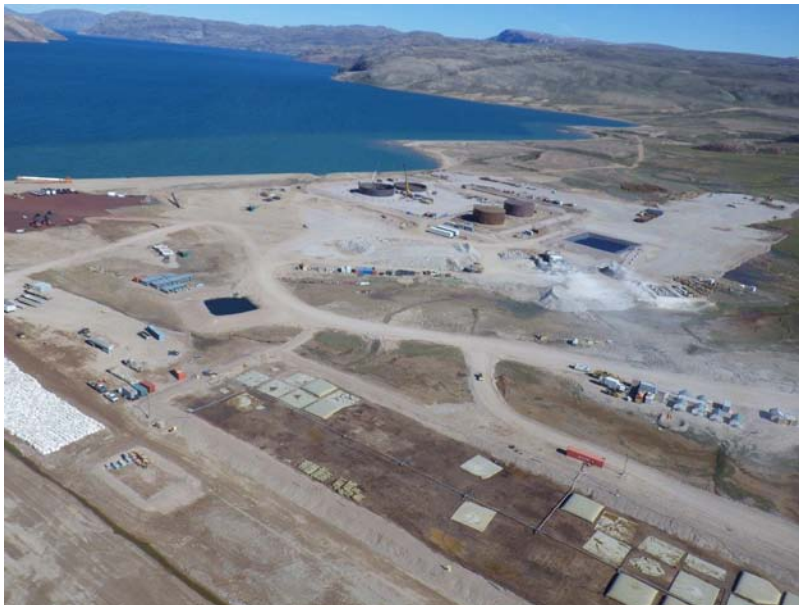
**PHOTO 20** Milne Port Bulk Fuel Bladder Farm Decommissioning  
August 2013
