BACK RIVER PROJECT
Responses to 2021 Annual Report Comments

28 September 2022

Responses to 2021 Annual Report Comments

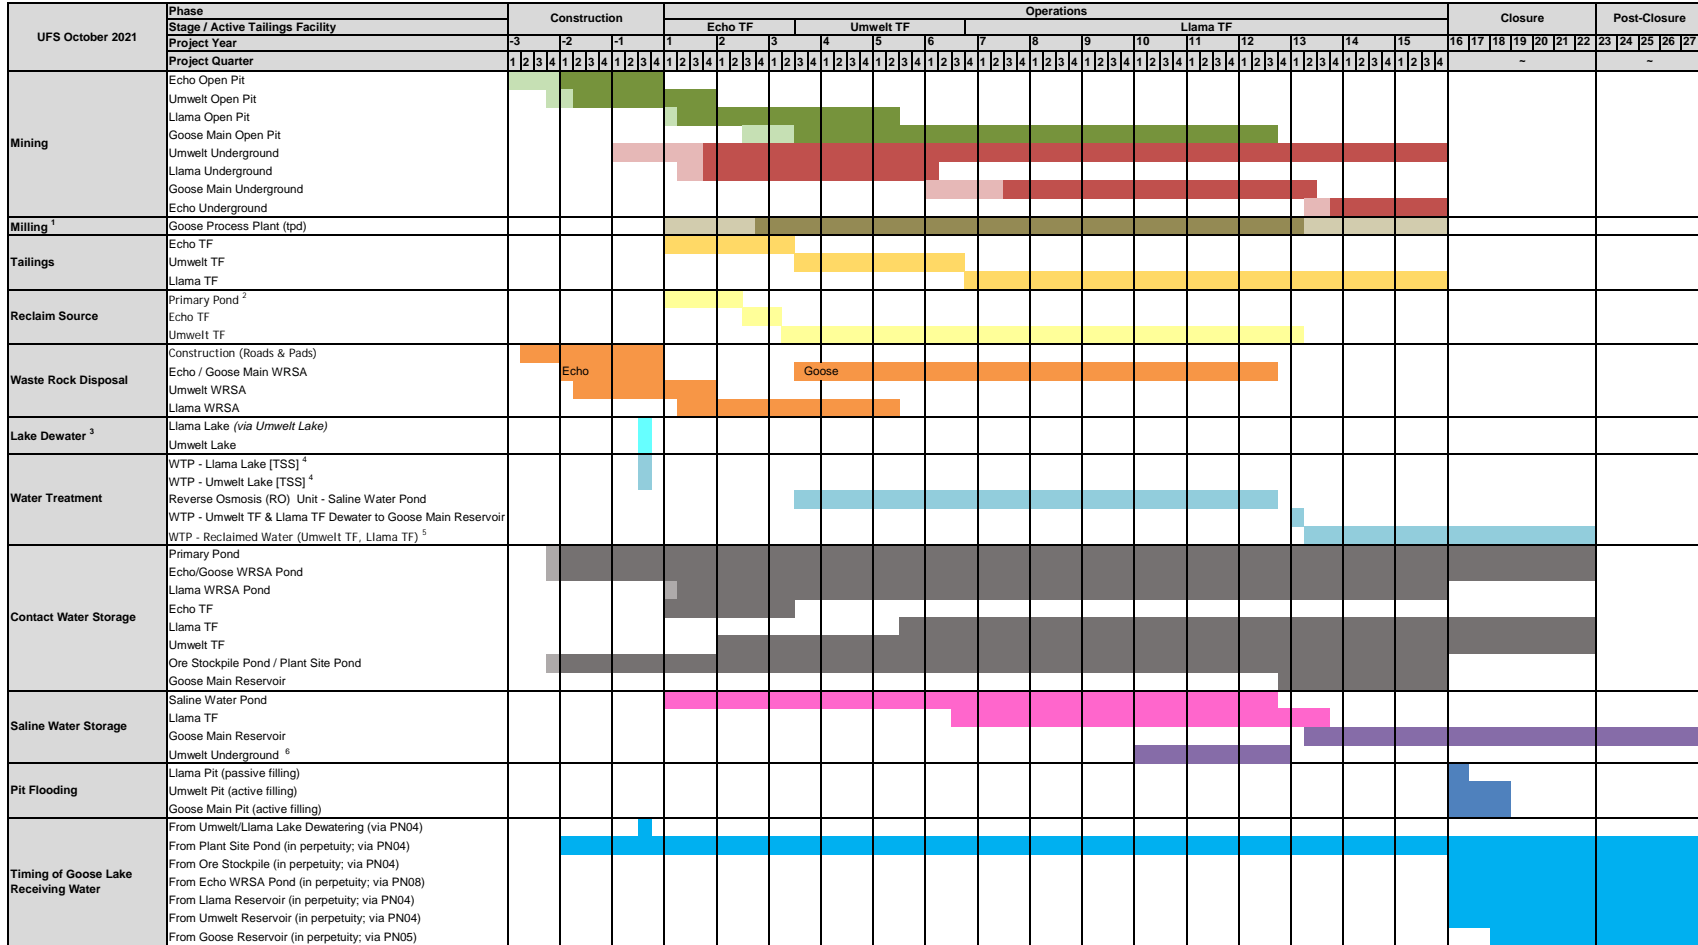
Project Timeline – UFS October 2021 (WSP Golder WLB Update; based on average climate conditions)

- Milling will be at 2,000 to 3,000 tpd between Y1, Q1 and Y2, Q3, and 4,000 tpd starting in Y2, Q4, ramping down (variable feed rate) starting in Y13, Q2 till closure.

Appendix A Project Timeline
