Doris-Madrid Interim Closure and Reclamation Plan Comparison

Hope Bay, Nunavut, Canada
Agnico Eagle Mines Limited

SRK Consulting (Canada) Inc. ■ CAPR002317 ■ February 2023

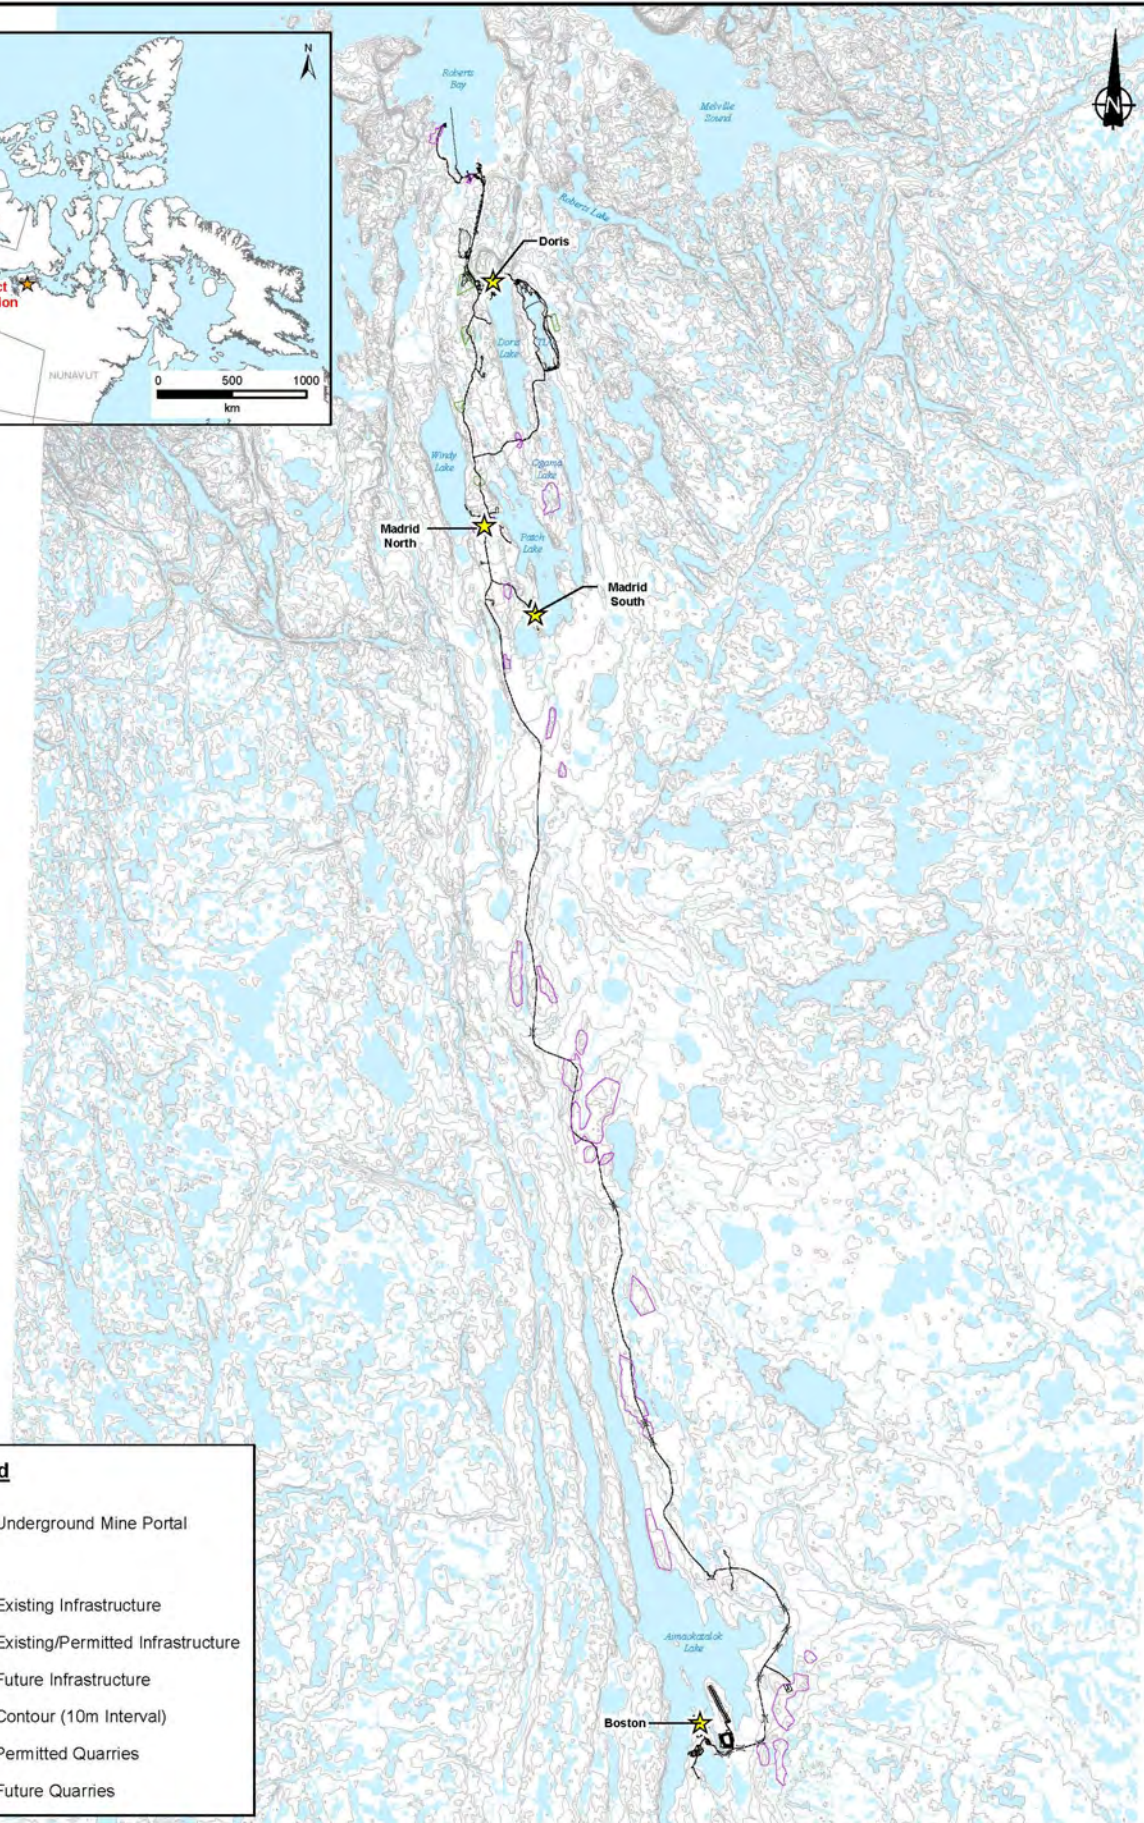
Date: 2023/02/16	Approved: MMM	Figure 1
---------------------	------------------	-------------

Site Location Map

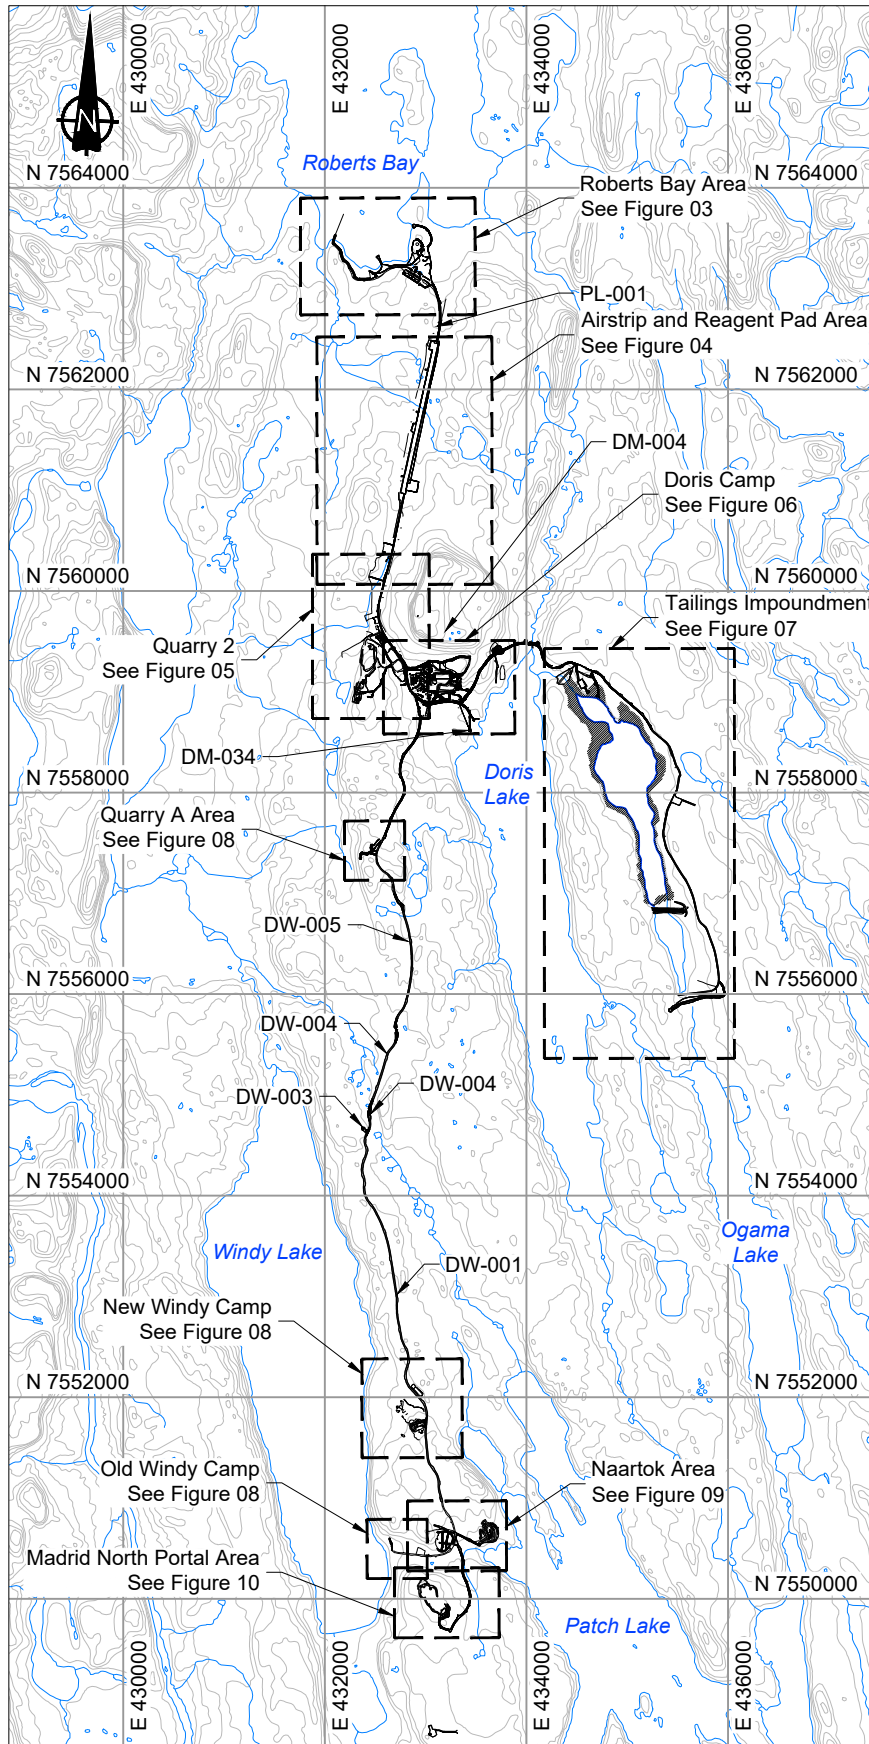
02

1. All units are in meters unless otherwise specified.
2. Contours are shown at 20.0 m intervals.
3. New Windy Camp was not constructed, name maintained for consistency with permitted closure plan.

Work Area	Facility	WBS Code
Doris Windy Road	All-Weather Road	DW-001
	Quarry B	DW-003
	Clear-span Crossings	DW-004
	Arched Culvert Crossing	DW-005
Pipeline	Roberts Bay Discharge System	PL-001
Doris	Communications Tower	DM-004
	Vent Raise	DM-034

General Arrangement Work
Breakdown Structure

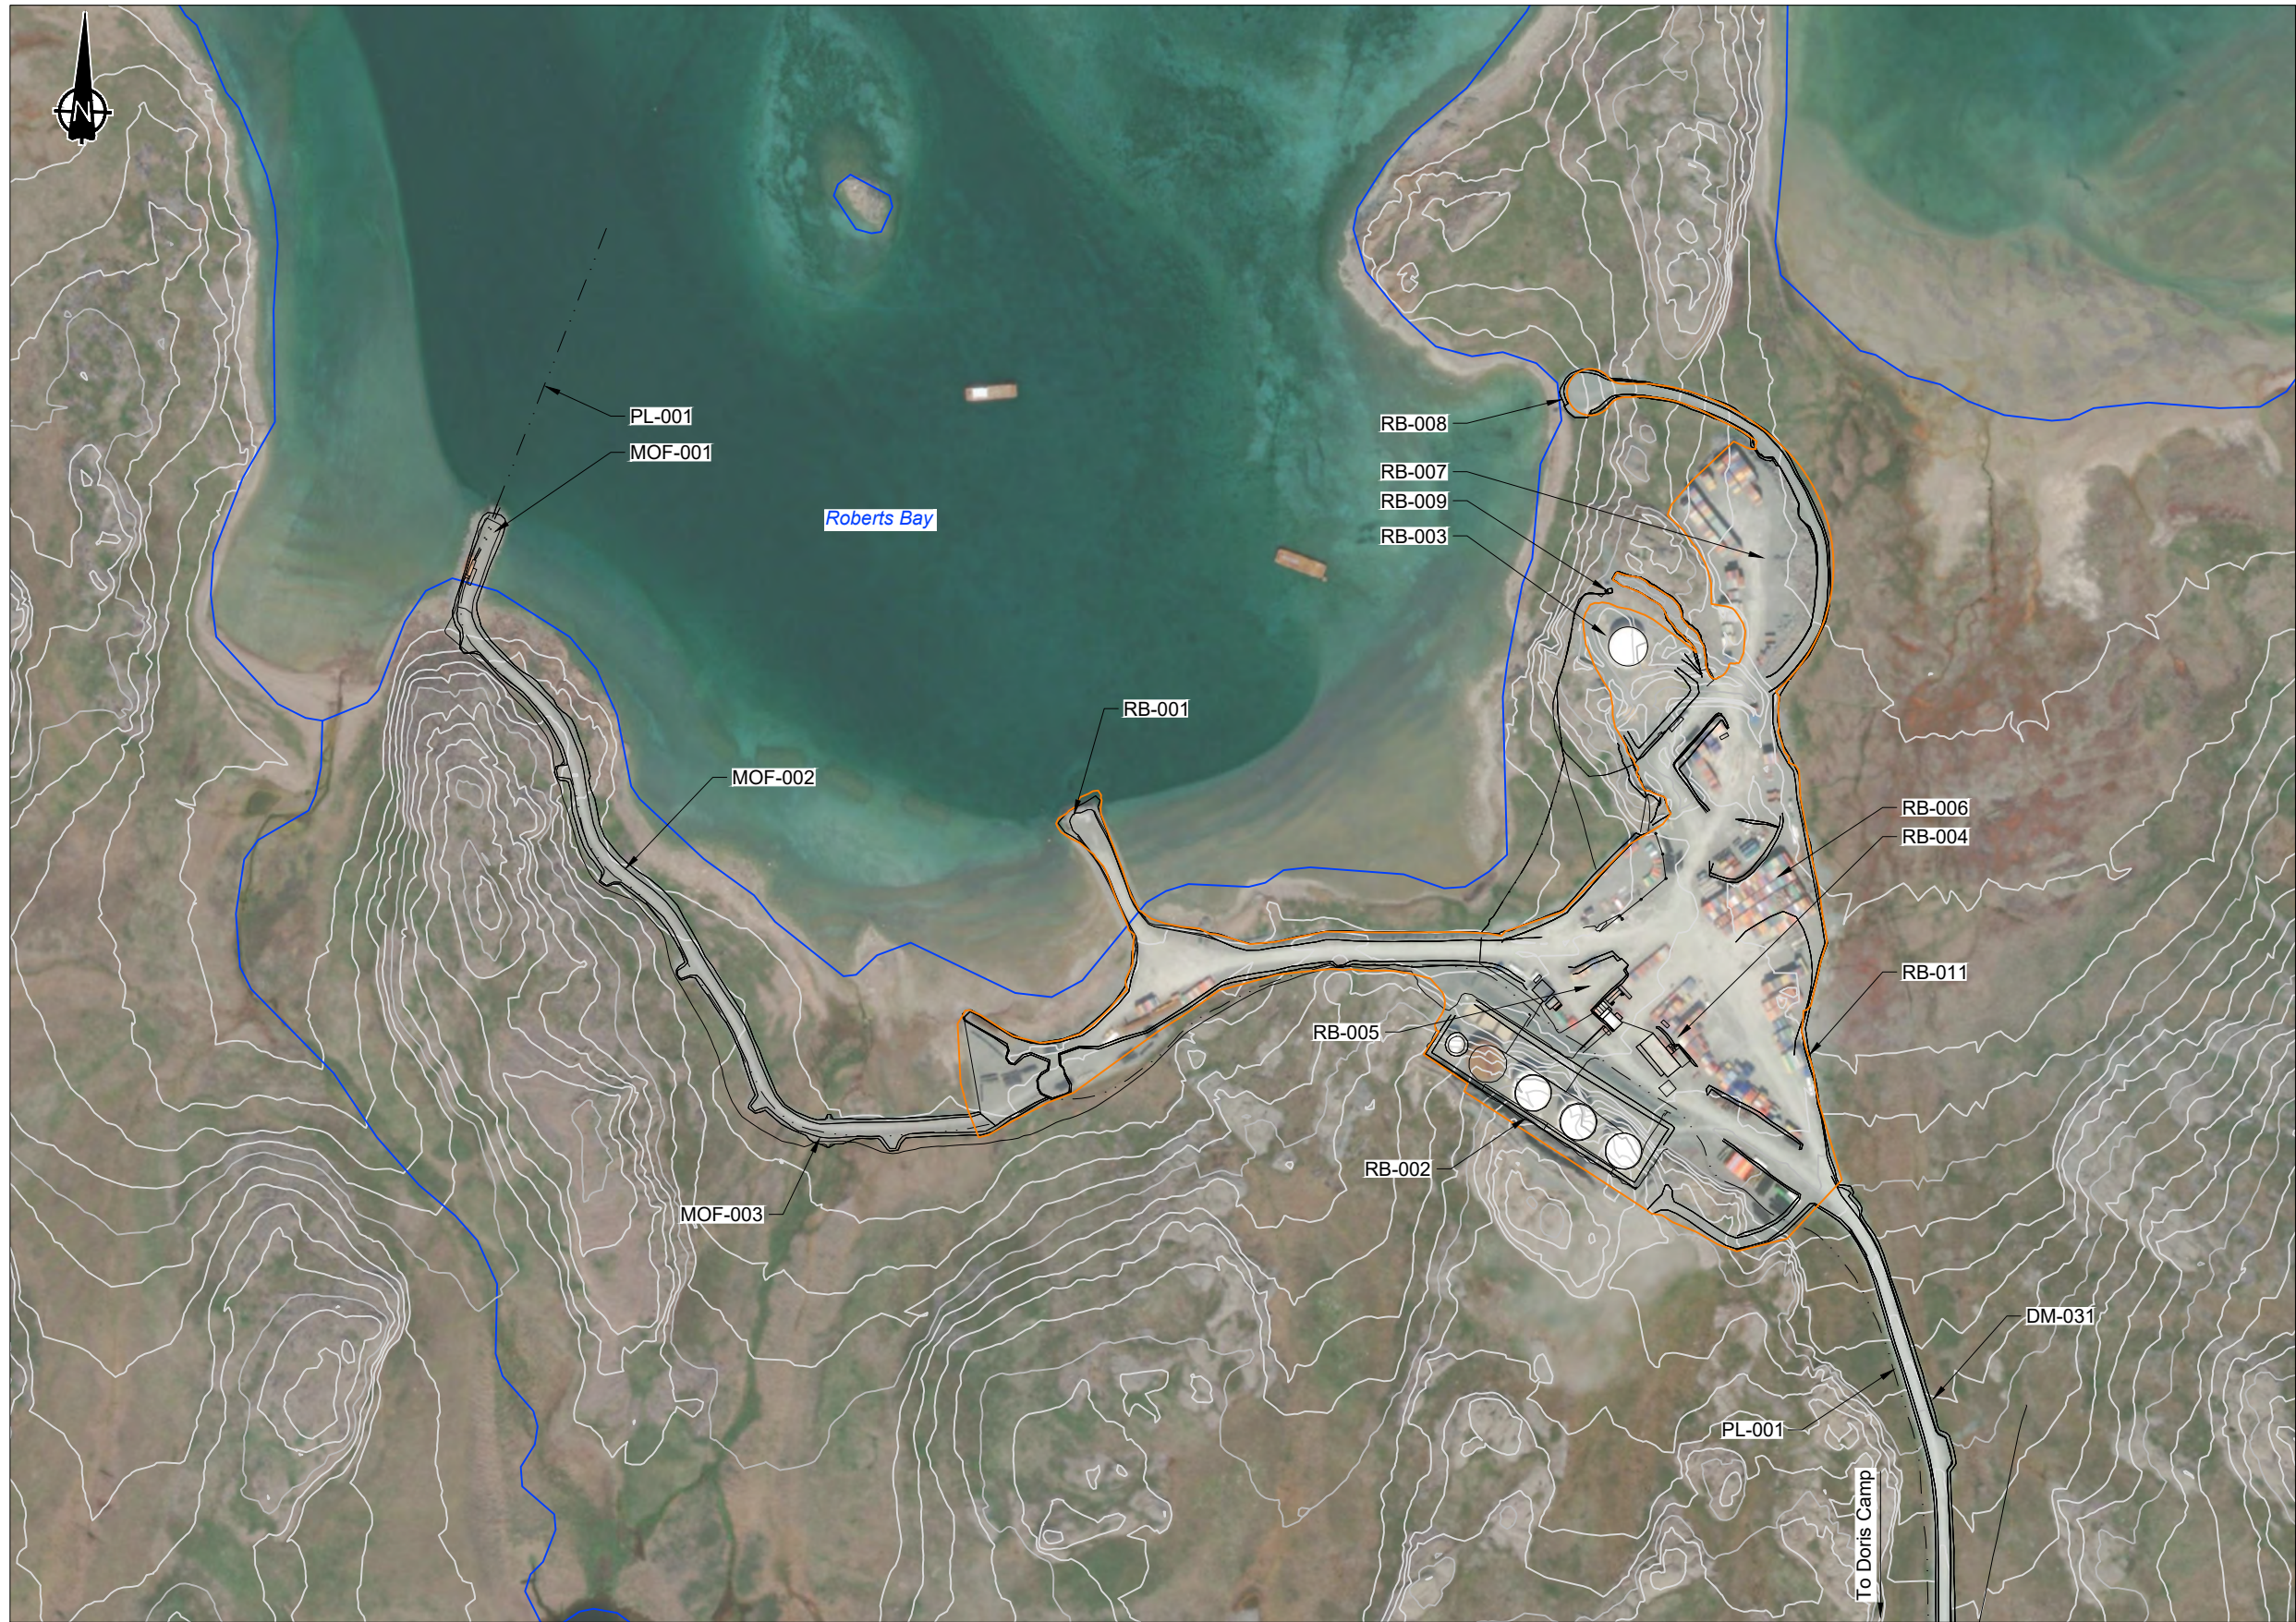
FIGURE: 03

- NOTES**
1. All units are in meters unless otherwise specified.
 2. Contours are shown at 2.0 m intervals.
 3. Marine outfall pipeline location in Roberts Bay is approximate.

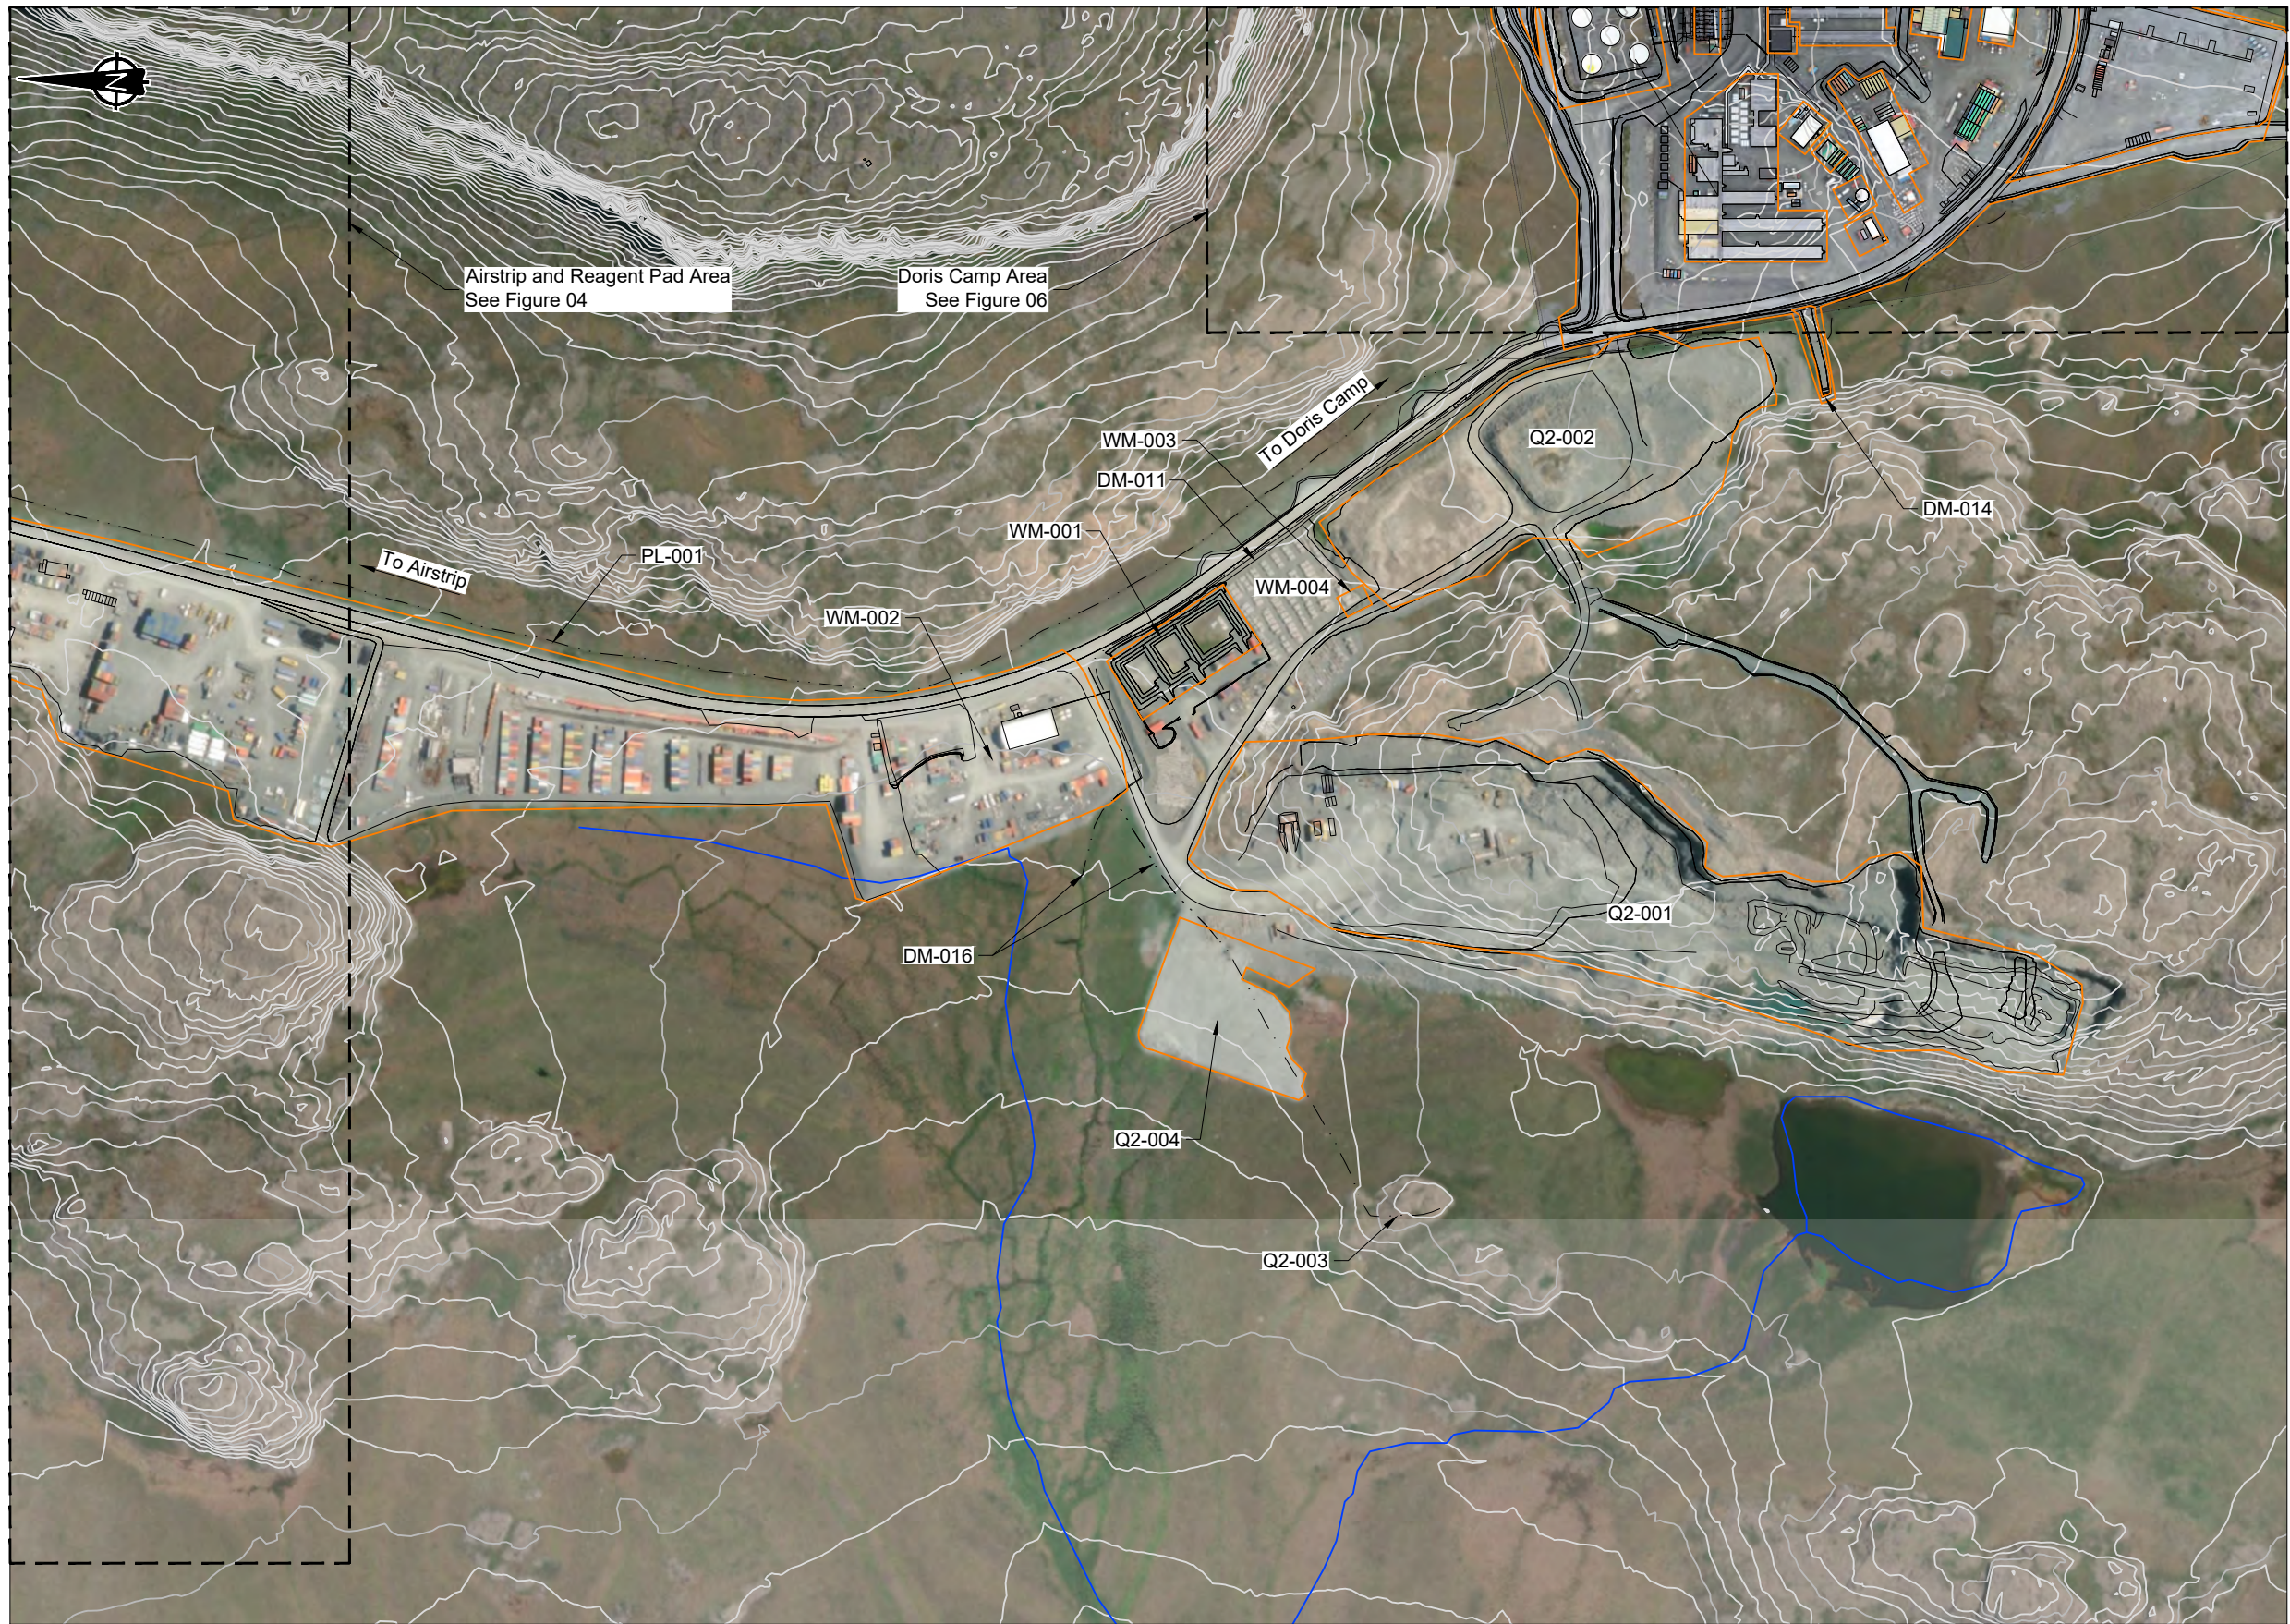
FIGURE:
05

Work Area	Facility	WBS Code
Waste Management Area	Land Farm	WM-001
	Batch Plant Pad	WM-002
	Burn Pan	WM-003
	Core Storage Area	WM-004
Quarry #2 Area	Quarry	Q2-001
	Overburden Dump	Q2-002
	Treated Sewage Discharge Areas	Q2-003
	Laydown	Q2-004
	Sedimentation Berm	DM-014
Pipelines	Roberts Bay Discharge System	PL-001
	Sewage Discharge Line	DM-016

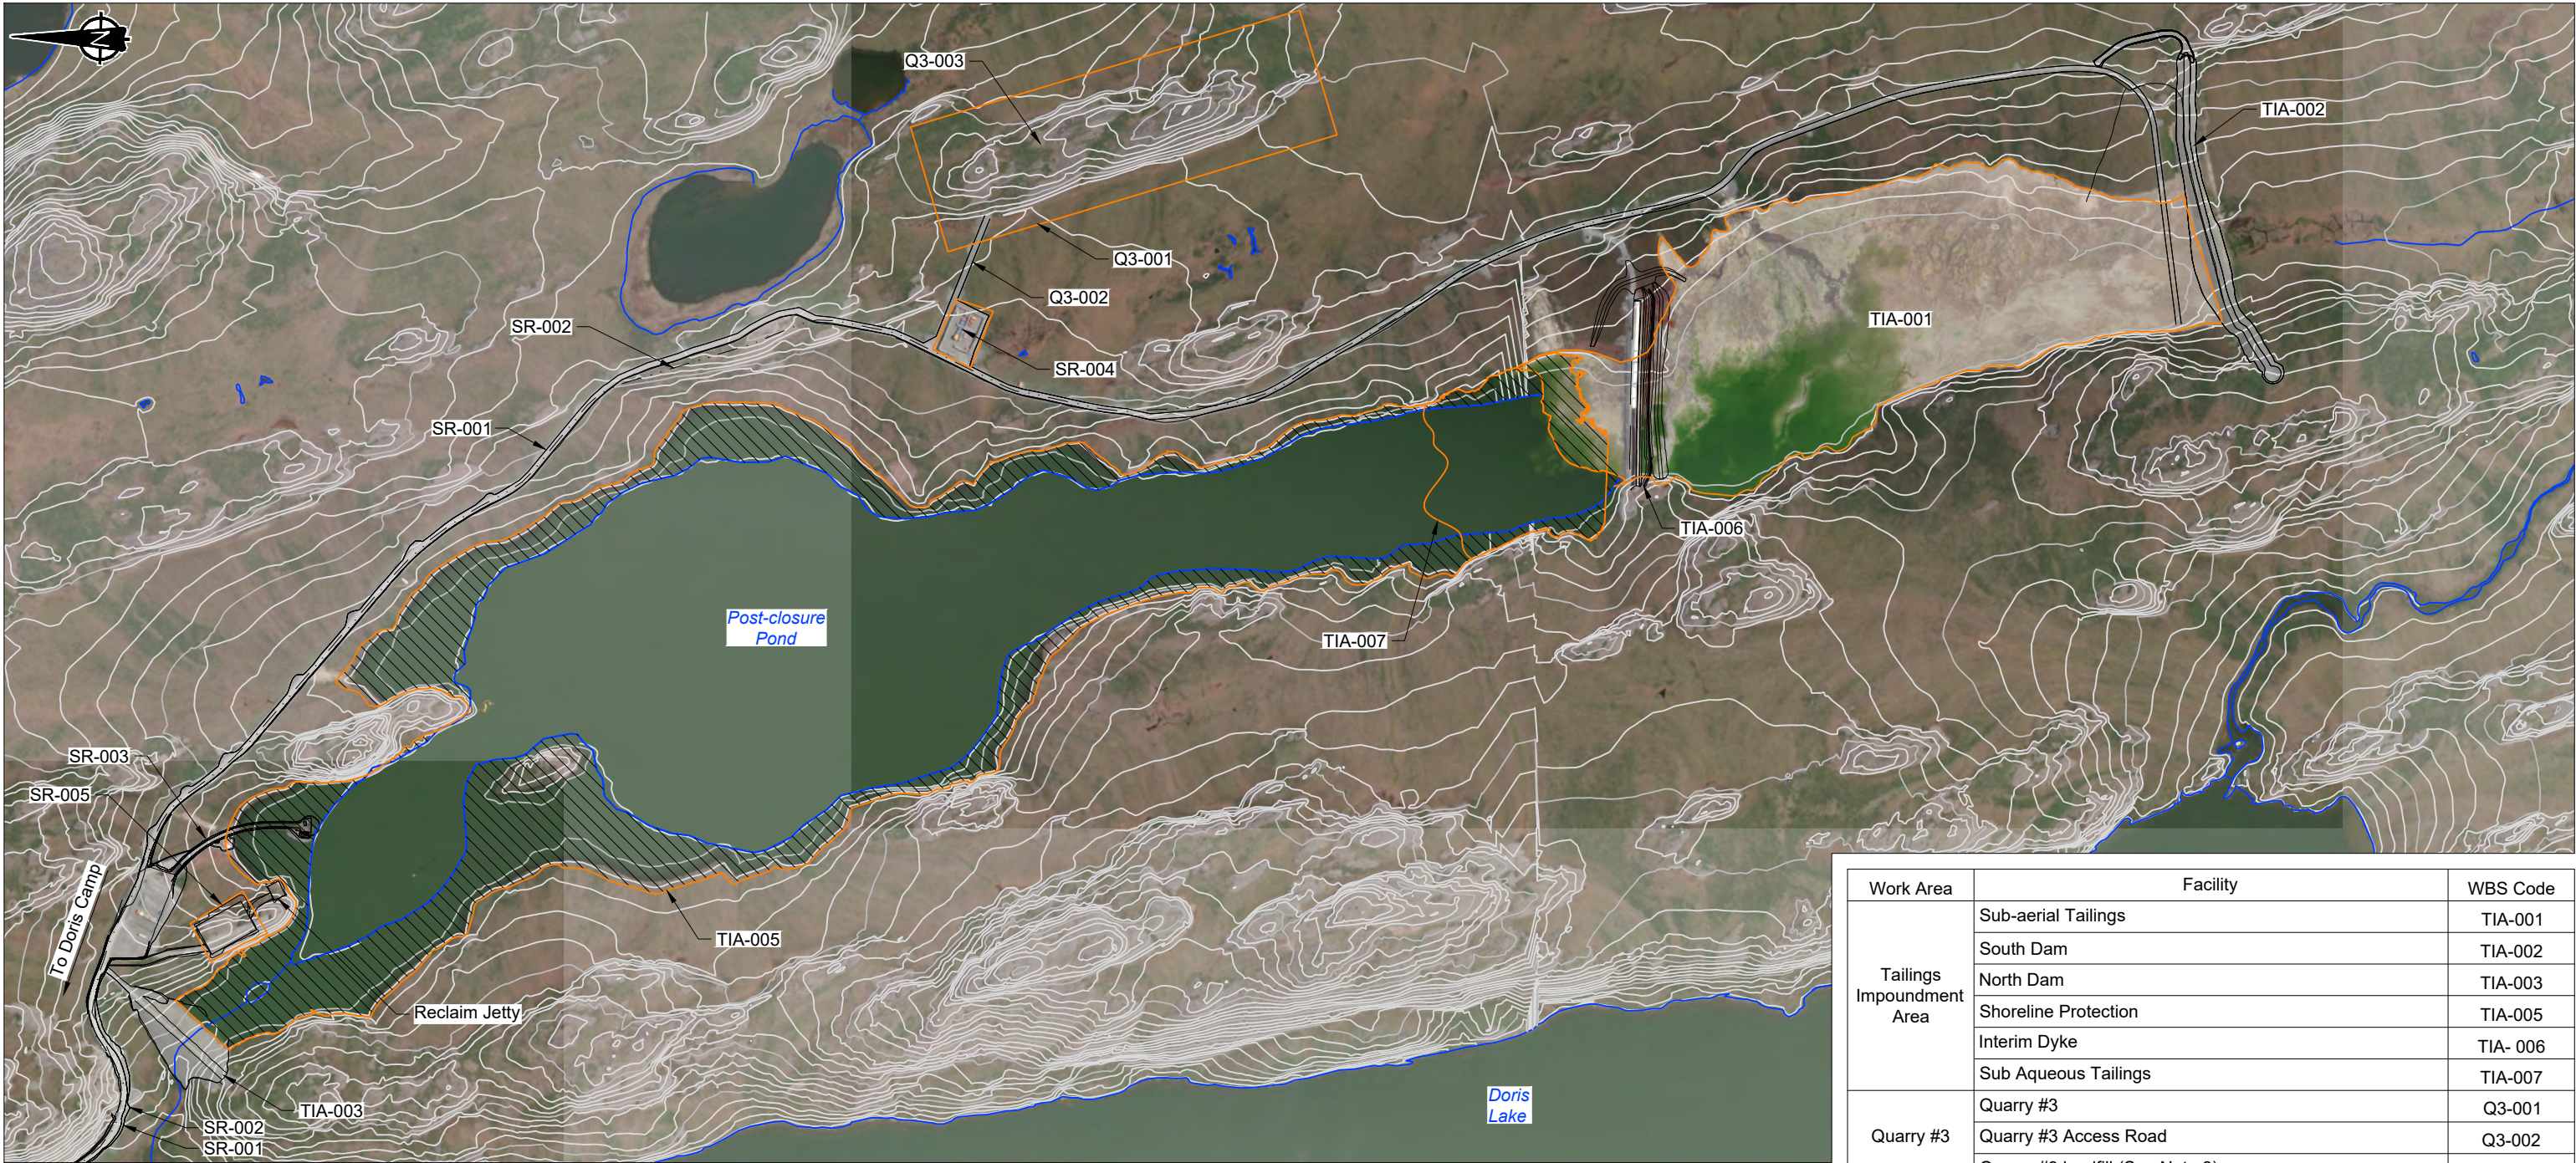
FIGURE: 07

Work Area	Facility	WBS Code
Tailings Impoundment Area	Sub-aerial Tailings	TIA-001
	South Dam	TIA-002
	North Dam	TIA-003
	Shoreline Protection	TIA-005
	Interim Dyke	TIA-006
	Sub Aqueous Tailings	TIA-007
Quarry #3	Quarry #3	Q3-001
	Quarry #3 Access Road	Q3-002
	Quarry #3 landfill (See Note 3)	Q3-003
Secondary Road Area	Secondary Road	SR-001
	Tailings and Reclaim Water Pipelines	SR-002
	Tail Lake Access Road (Chainage 0.725 of Secondary Rd) and Reclaim Jetty	SR-003
	Explosives Facility	SR-004
	Water Treatment Plant	SR-005

The key differences in the current TIA conditions are summarized in Table 3. Construction of the Interim Dyke is currently underway. For the purpose of this comparison, it is assumed that the interim dyke construction has been completed.

Early closure of the TIA means the area of natural ground with vegetation die back, due to being submerged for an extended period of time, is significantly larger than expected at LOM closure. Shoreline protection is required in this area to prevent erosion of the area due to thermal degradation of the permafrost. For the purpose of the quantity estimate the elevation of 32.5 masl was selected as the most reasonable estimate for the top of the shoreline protection area, as this elevation is the highest elevation the TIA pond has reached for an extended period of time (more than 4 months). However, it is possible that shoreline protection may be required to the highest measured water elevation in the TIA 32.7 masl (measured October 2022).
