**Re: Agnico Response to KIA Comments regarding Water License 2AM-DOH1335 – Conditions Applying to Construction and Operation – Construction of 2022 Interim Dike**

Agnico Eagle Mines Ltd. (Agnico) is providing this letter in response to comments received from Kitikmeot Inuit Association (KIA) on October 19<sup>th</sup>, 2022. Agnico's response is detailed below:

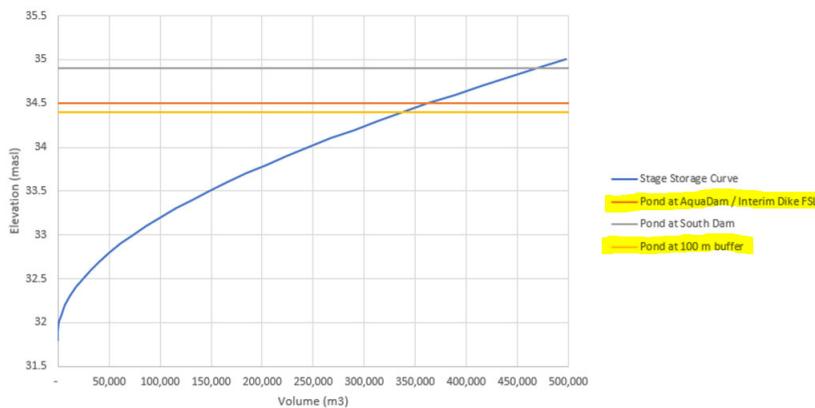
Fig 1. – Interim Dike FSL Graph (100m buffer actually reached at water El. ~34.4 masl)

The maximum water elevation for the interim dike is controlled by an overflow channel with an inlet elevation of 34.5 masl. During the design process for the Interim Dike, the elevation for the channel inlet was selected such that the operation beach length requirement (100 m) is maintained at the South Dam (see figures below).

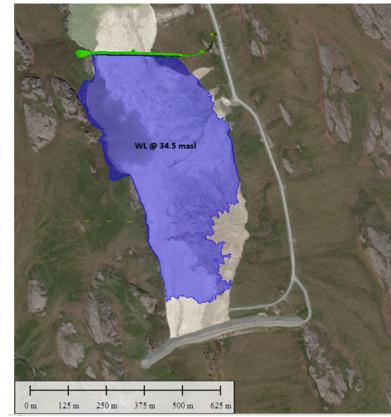
Fig 2. – Satellite image with pond elevation at FSL
