**HOPE BAY PROJECT**  
**DORIS TAILINGS IMPOUNDMENT AREA OPERATIONS,**  
**MAINTENANCE, AND SURVEILLANCE MANUAL**

**HOPE BAY, NUNAVUT**

AUGUST 2016

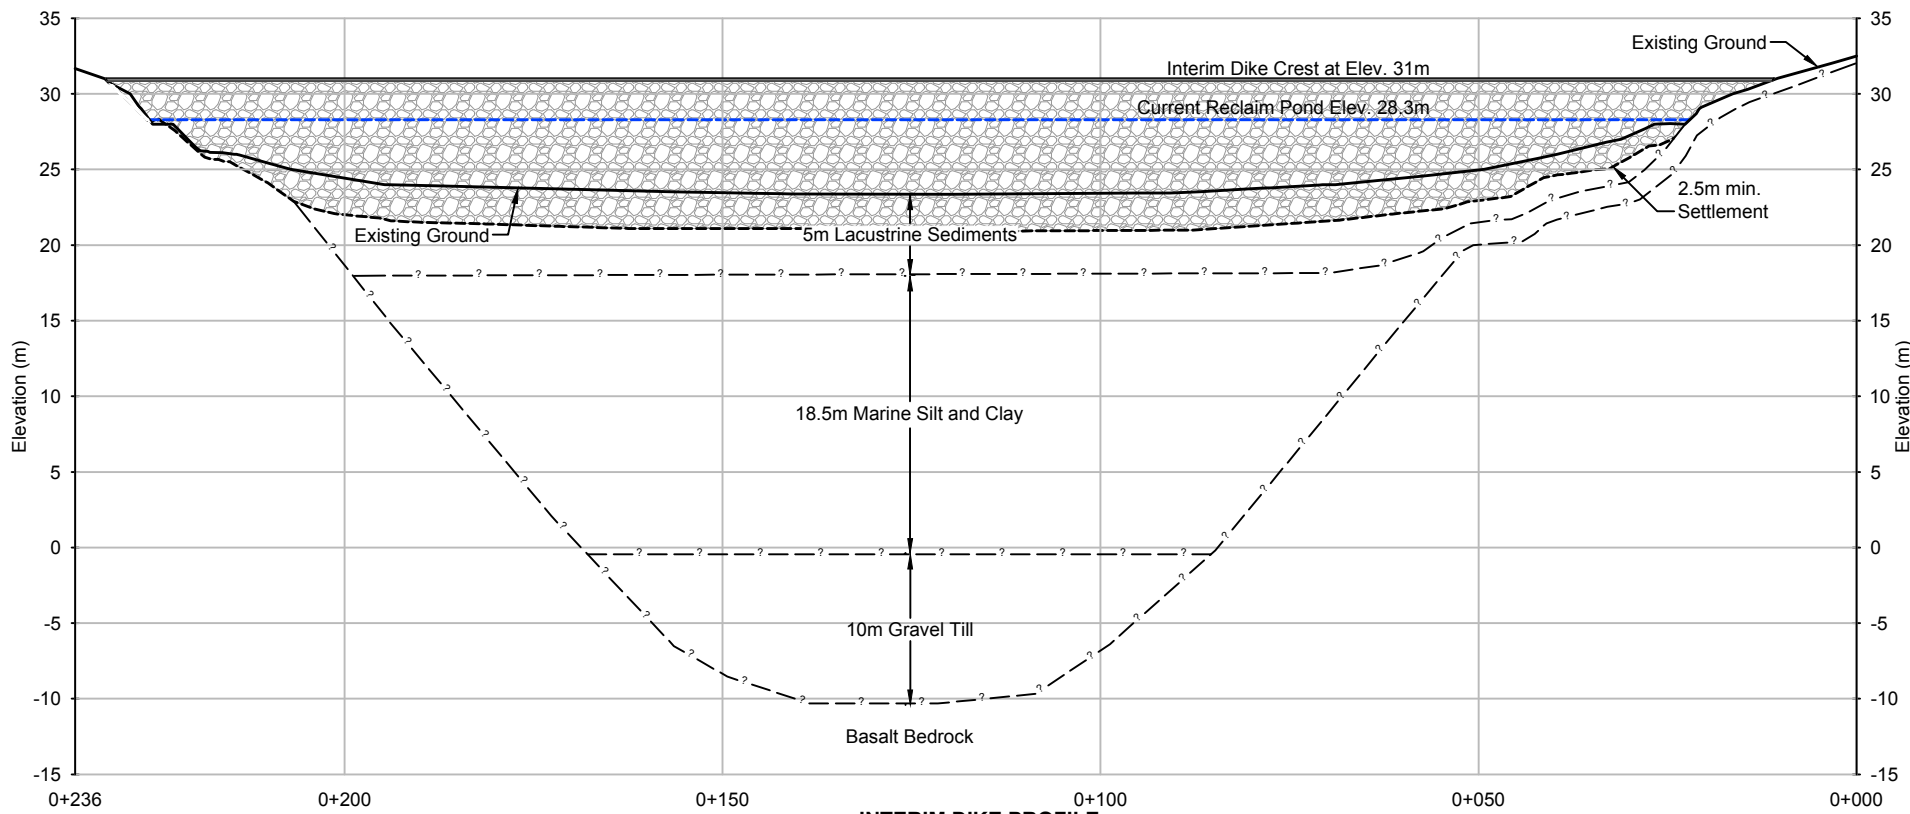
DORIS NORTH TIA OMS MANUAL		
Interim Dike Profile and Cross Section		
DATE: May 2016	APPROVED: EK/SA	FIGURE: 5

**INTERIM DIKE PLAN VIEW**  
Scale in Metres  
0 5 10 15 20 25

**INTERIM DIKE PROFILE**  
Horizontal Scale in Metres  
Vertical Scale X2  
0 5 10 15 20 25

**INTERIM DIKE SECTION**  
Horizontal Scale in Metres  
Vertical Scale X2  
0 5 10 15 20 25

The Interim Dike is a homogeneous ROQ rock fill dike constructed with the confines of the TIA, directly on the existing lake bed sediments, without dewatering the TIA. The complete design parameters are provided in Table 5 and Figure 5. The Interim Dike is not required to hold back tailings supernatant water, but is expected to retain tailings solids. To achieve this, the upstream face of the Interim Dike will include a filter zone. The Interim Dike is expected to undergo significant settlement over its operating life and as a result will be constructed in stages. The initial stage will focus on attaining crest elevation of approximately 0.5 m above the normal operating water level in the TIA (SRK 2015a, e, 2016).

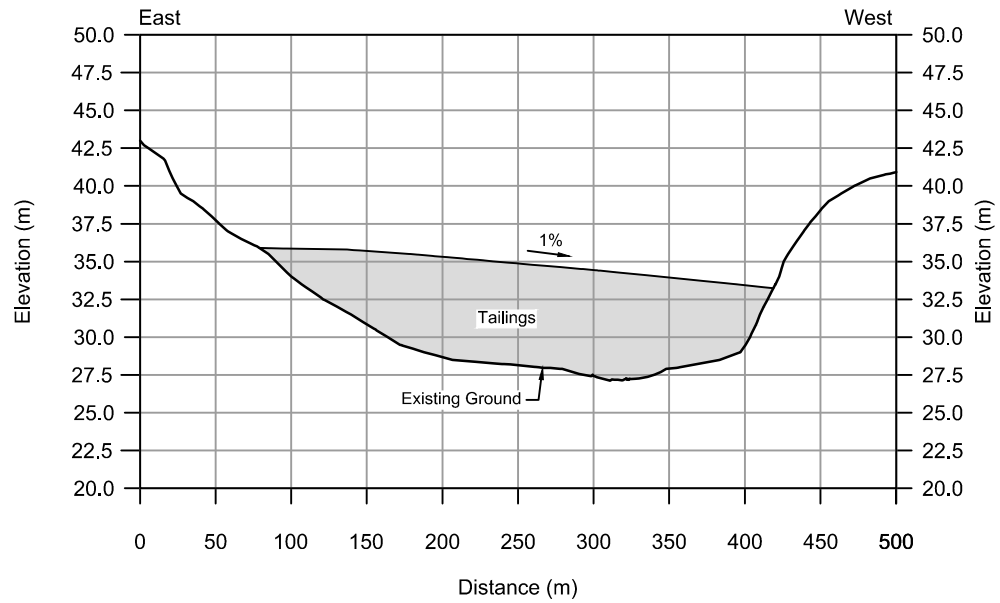
**A**  
**09** CROSS SECTION A-A'

**B**  
**09** CROSS SECTION B-B'
