Emergency Management Guidance

1 Overview of Doris TIA

Existing and Phase 2 Plans at Hope Bay

3 Dam Break Analysis

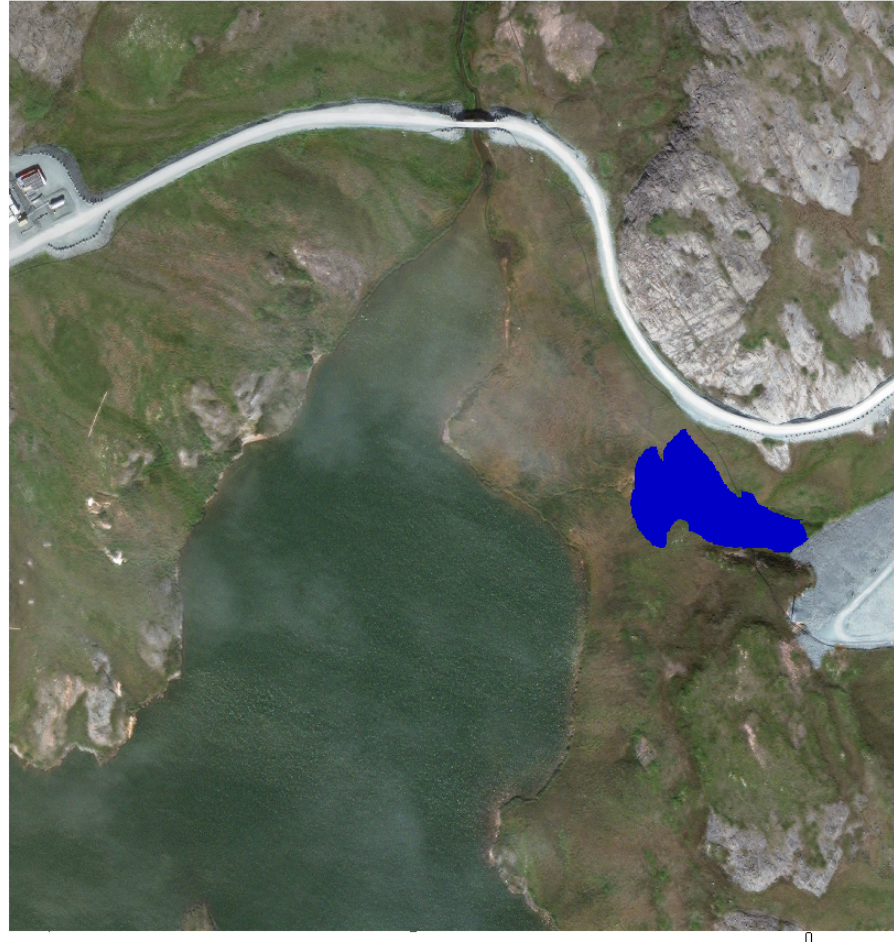
Grid Element Flow Depth (360 sec.) [0:6:0]

North Dam – Detailed / Local Model (focus on bridge)

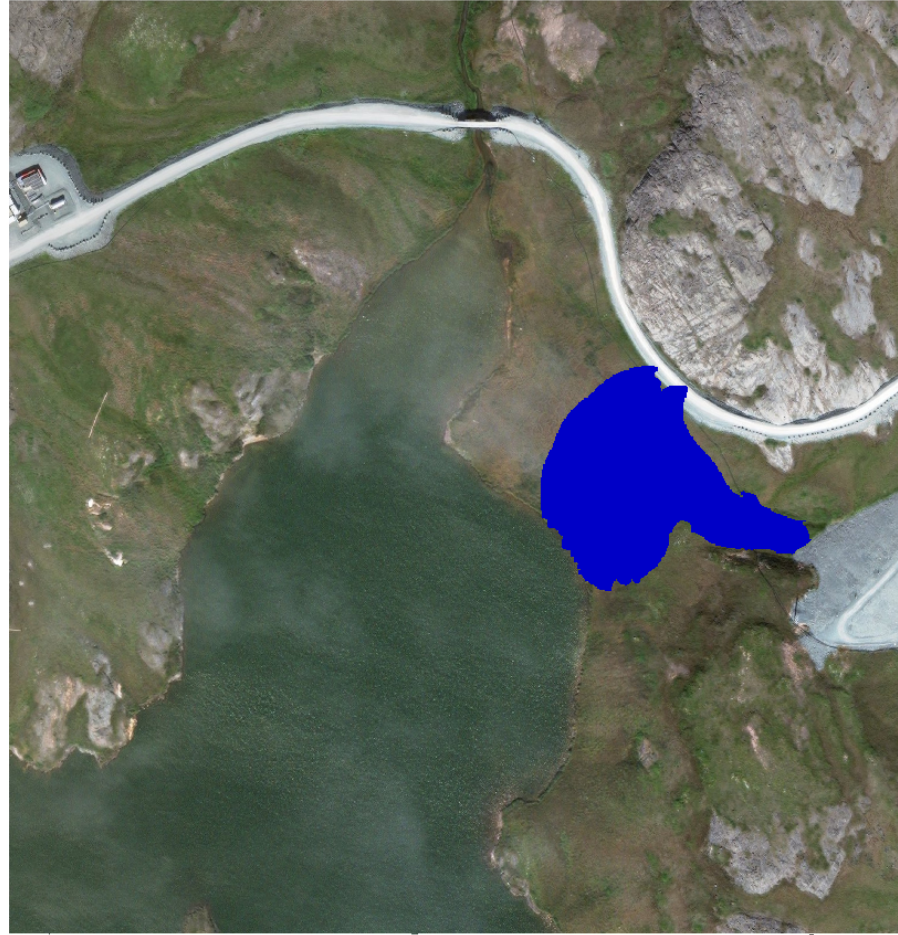
Grid Element Flow Depth (720 sec.) [0:12:0]

~ 12 mins

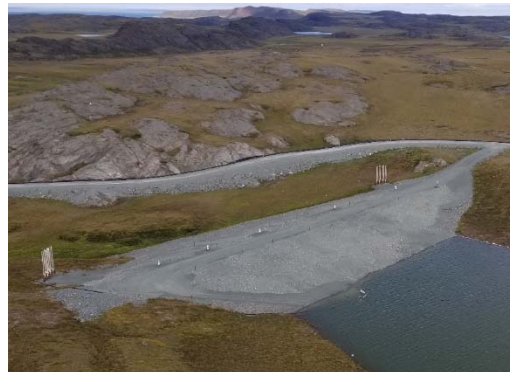
Based on the current deposition plans (off the South and West dams on the south end of the TIA) there is no conceivable chance of tailings solids being released as a result of a breach of the North Dam.

Note: under a conservative case where the largest possible volume of supernatant water (over 12 Mm³) is discharged rapidly over a period of less than 8hrs, then the Doris Creek Bridge would also be damaged.

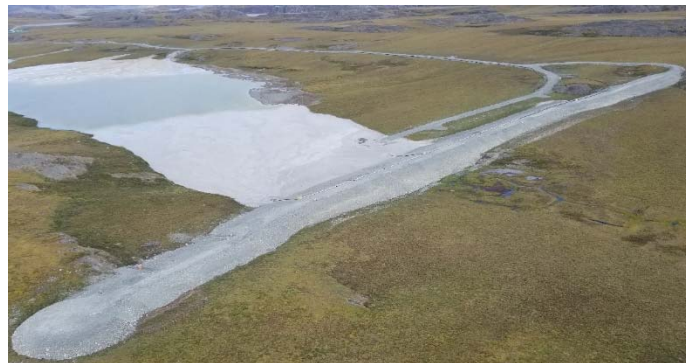
- into Ogama Lake and
- though a remote chance, into the Ogama Lake outflow and ultimately Doris Lake.

Tailings solids would not be expected to be transported any further than Doris Lake, with most tailings between the South Dam and down to and into Ogama Lake.
