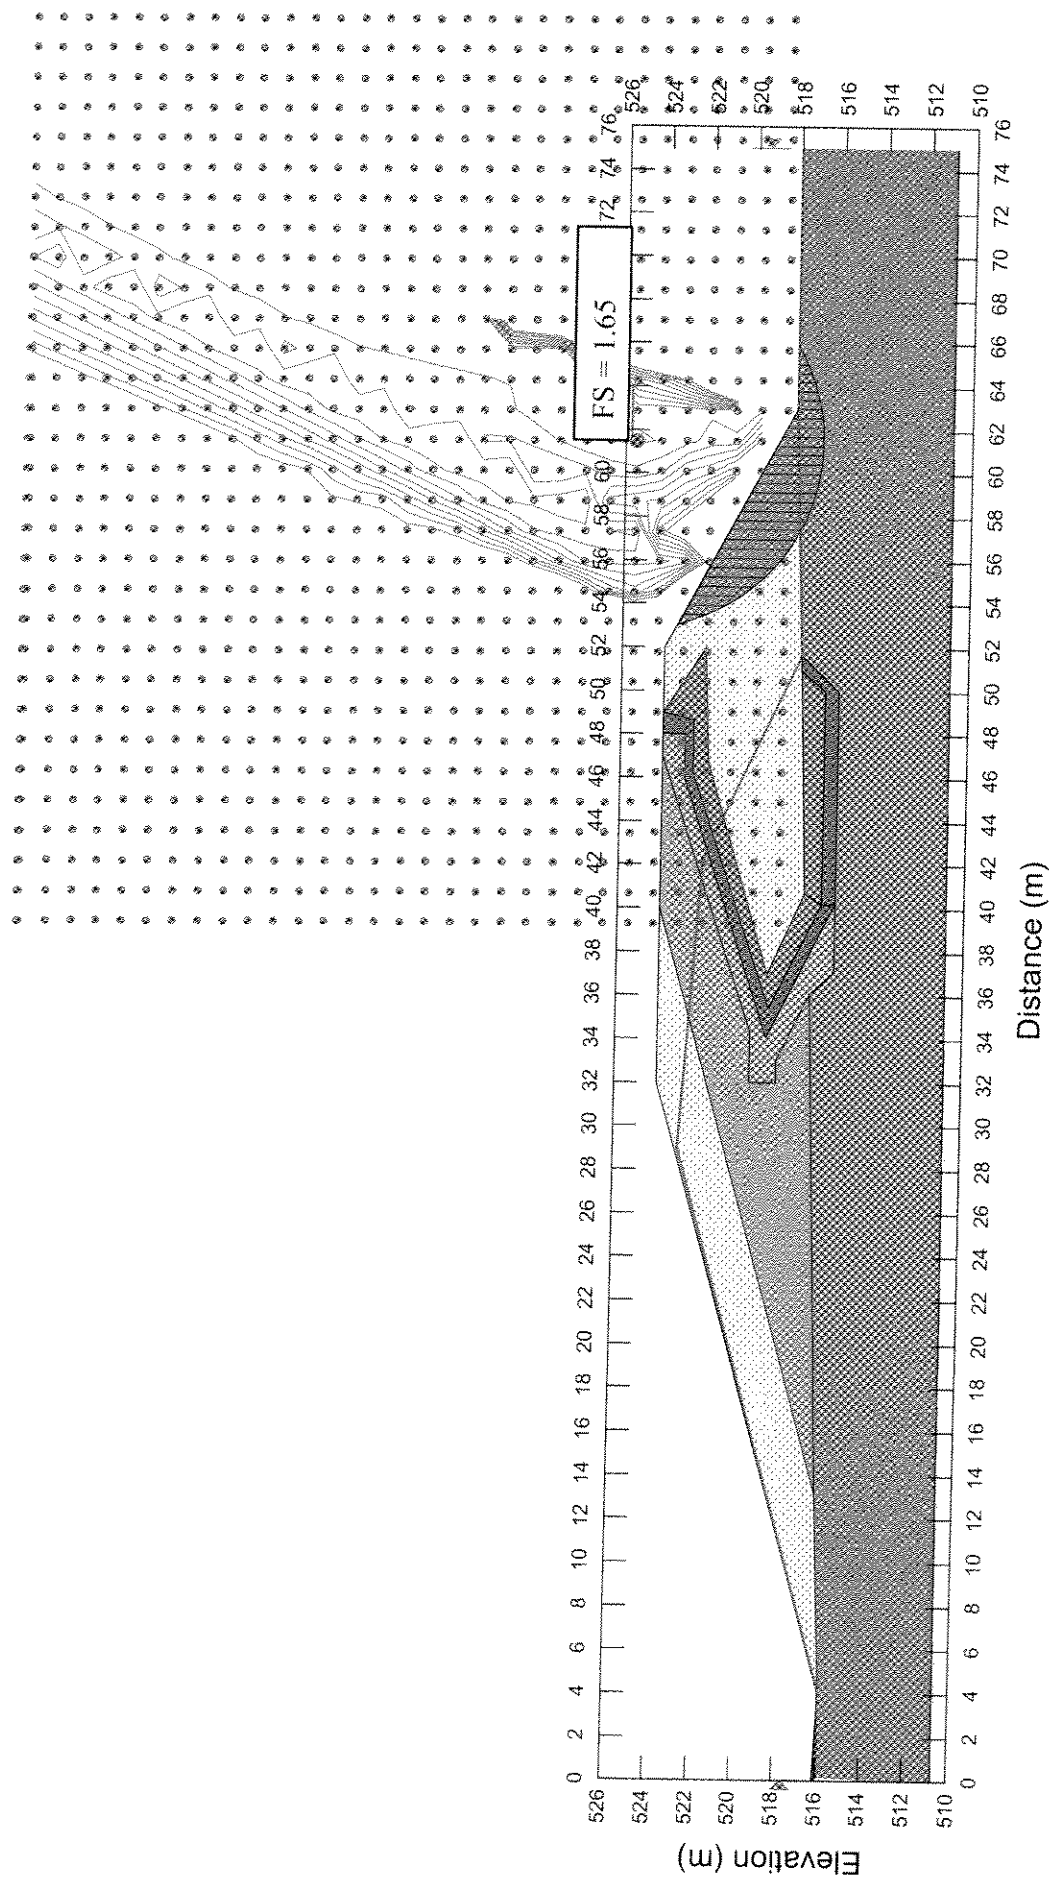
Figure A10  
Stability Analysis - Downstream, Rapid Drawdown - Rotational Slip Surface

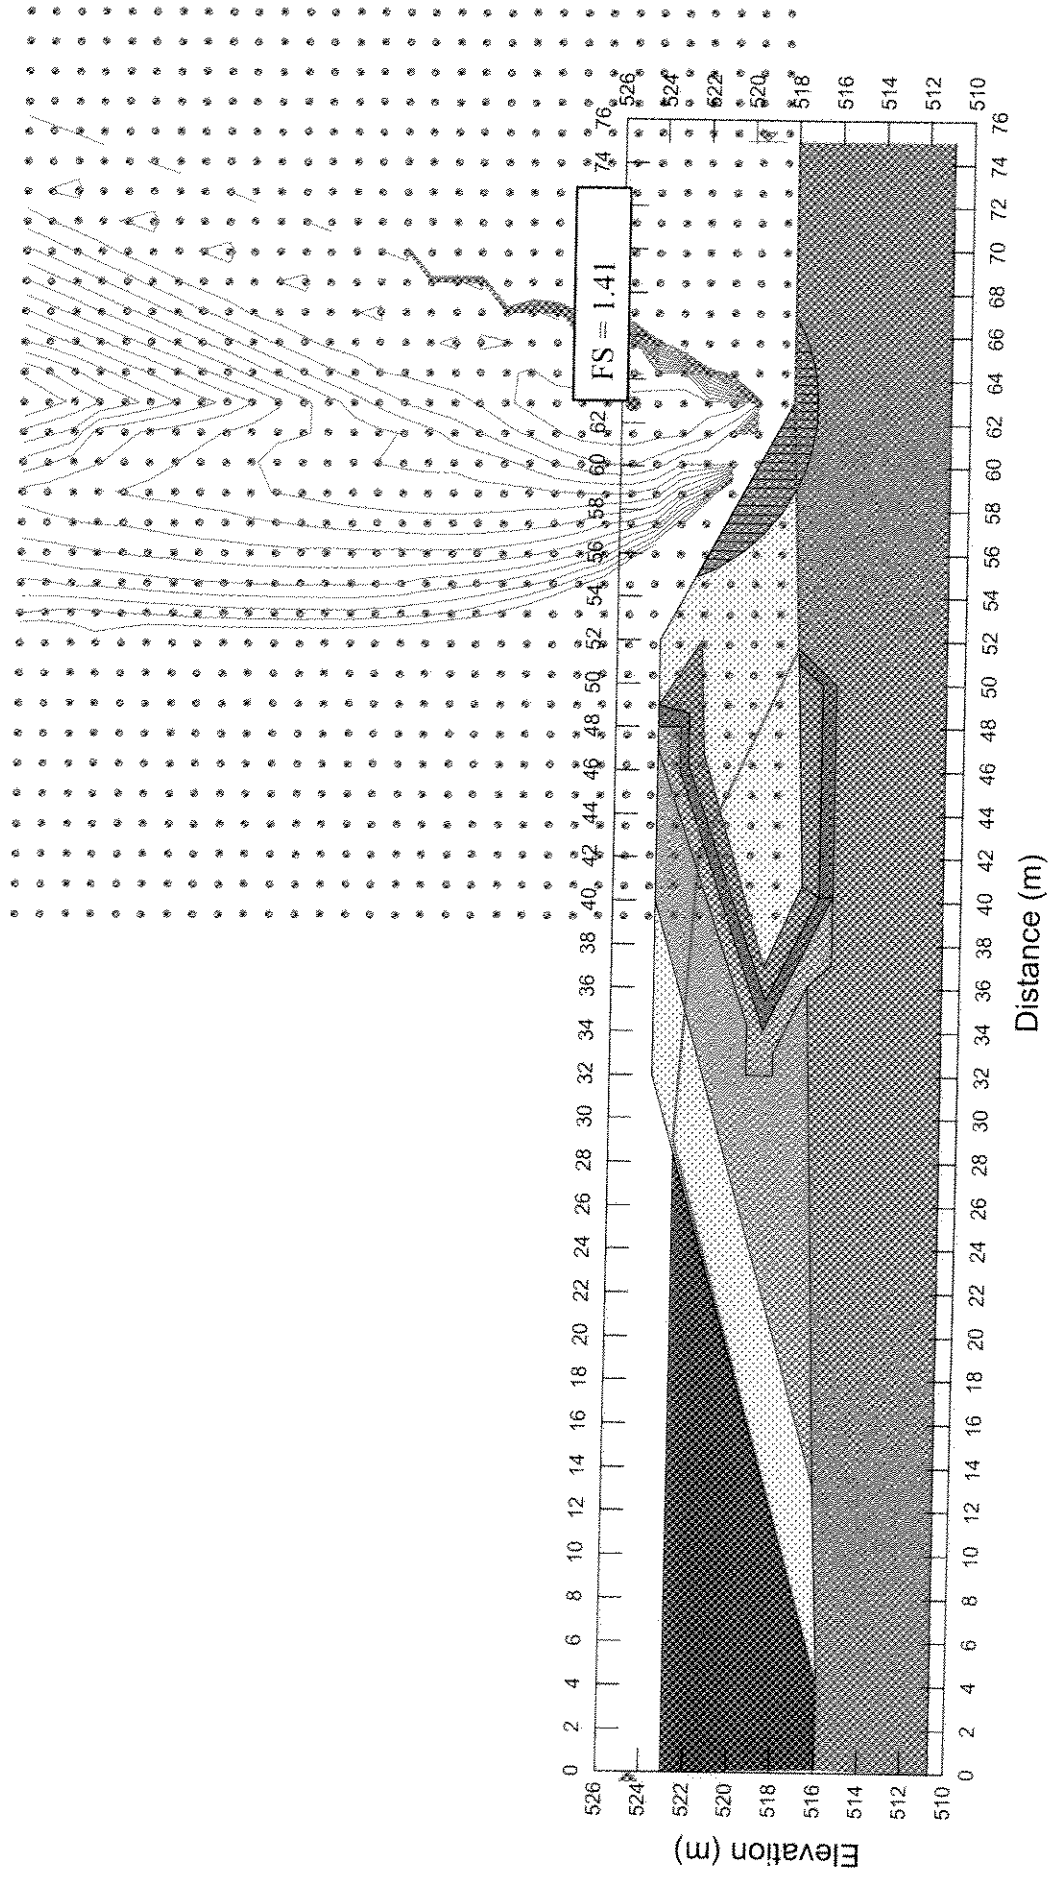
Figure A11  
Stability Analysis - Downstream, Seismic - Rotational Slip Surface

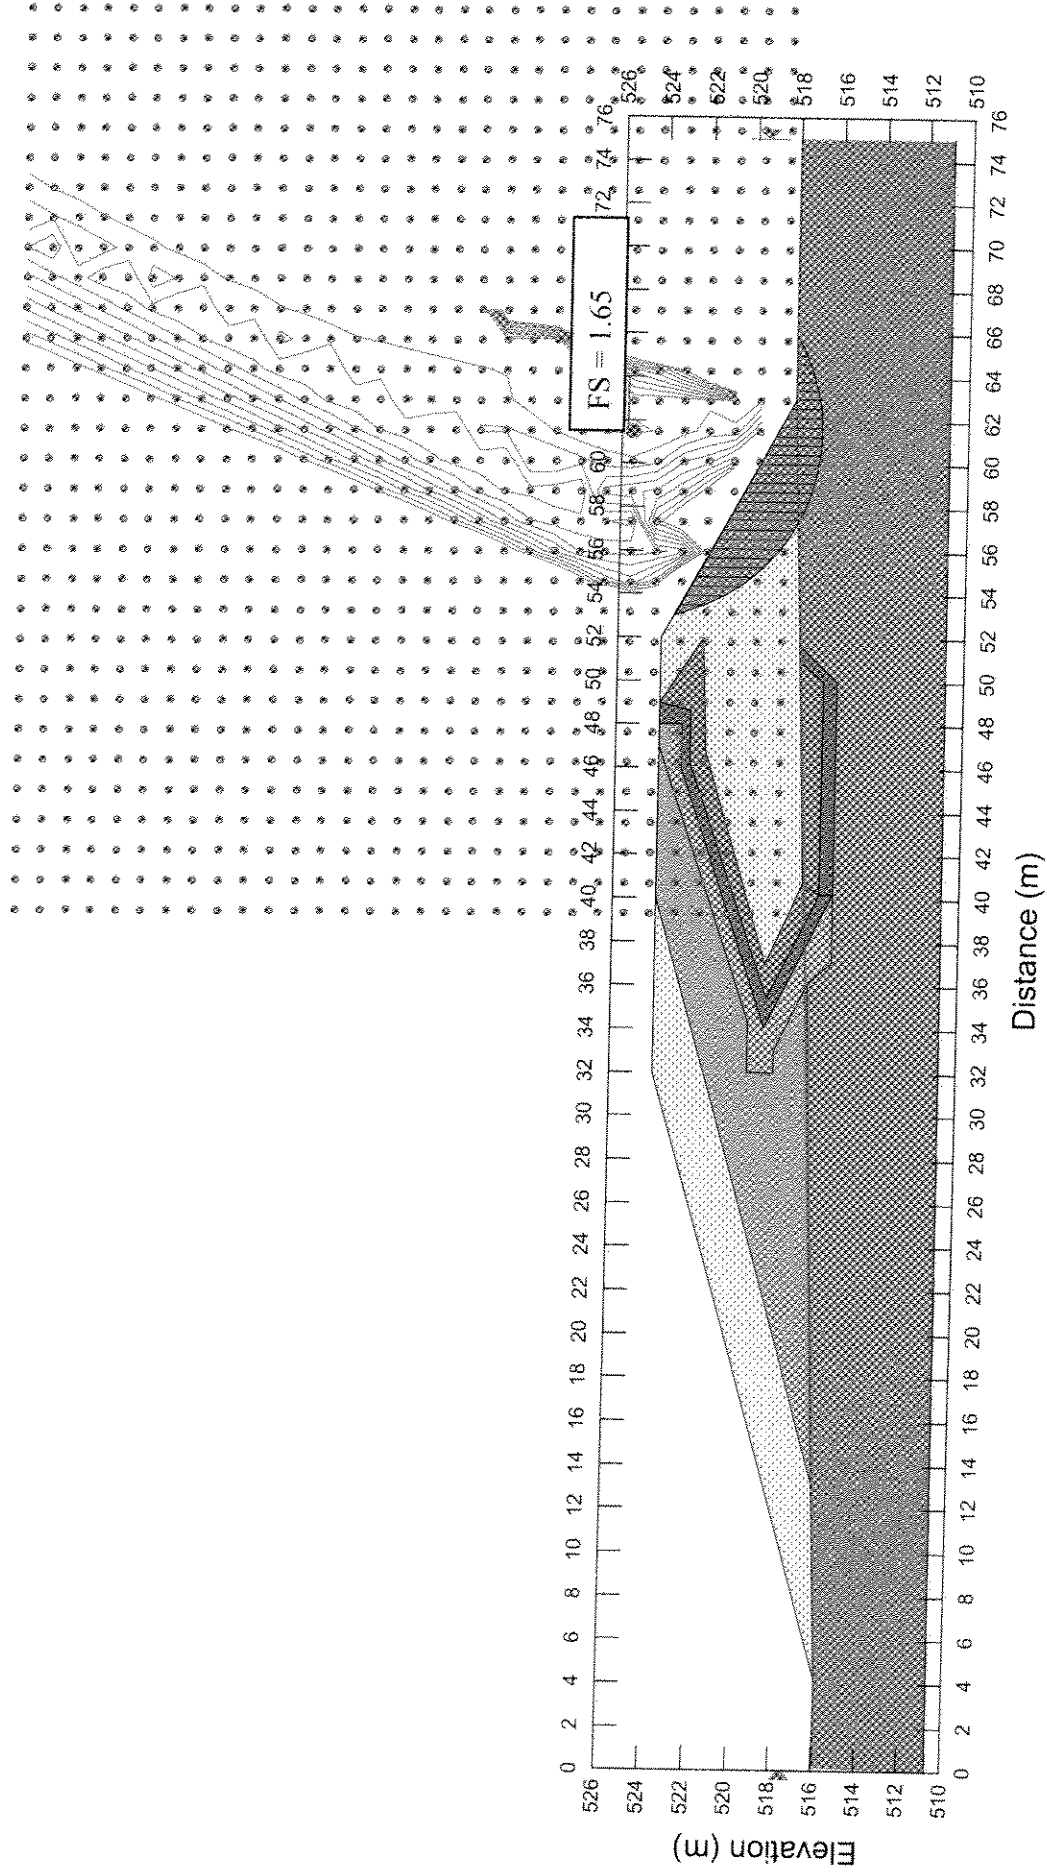
Figure A12  
Stability Analysis - Downstream, End of Construction - Rotational Slip Surface

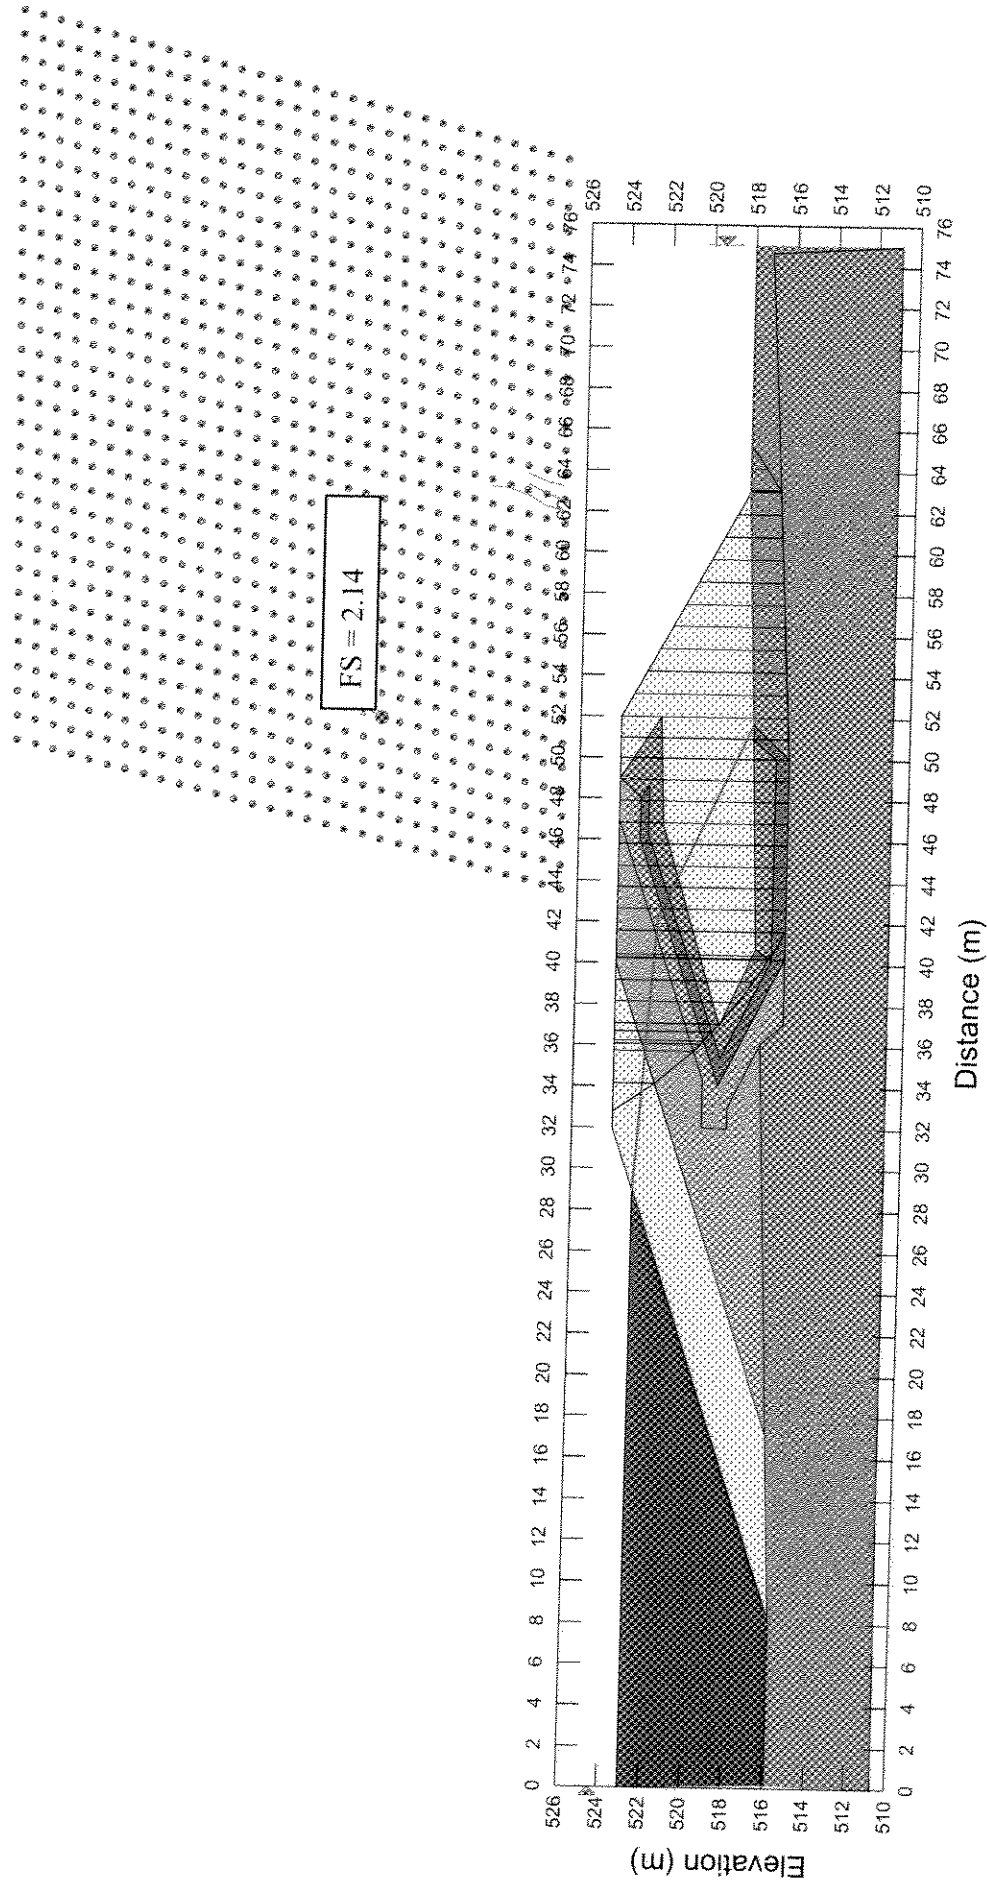
Figure A13  
Stability Analysis - Downstream, Static Analysis - Slip Surface along Liner

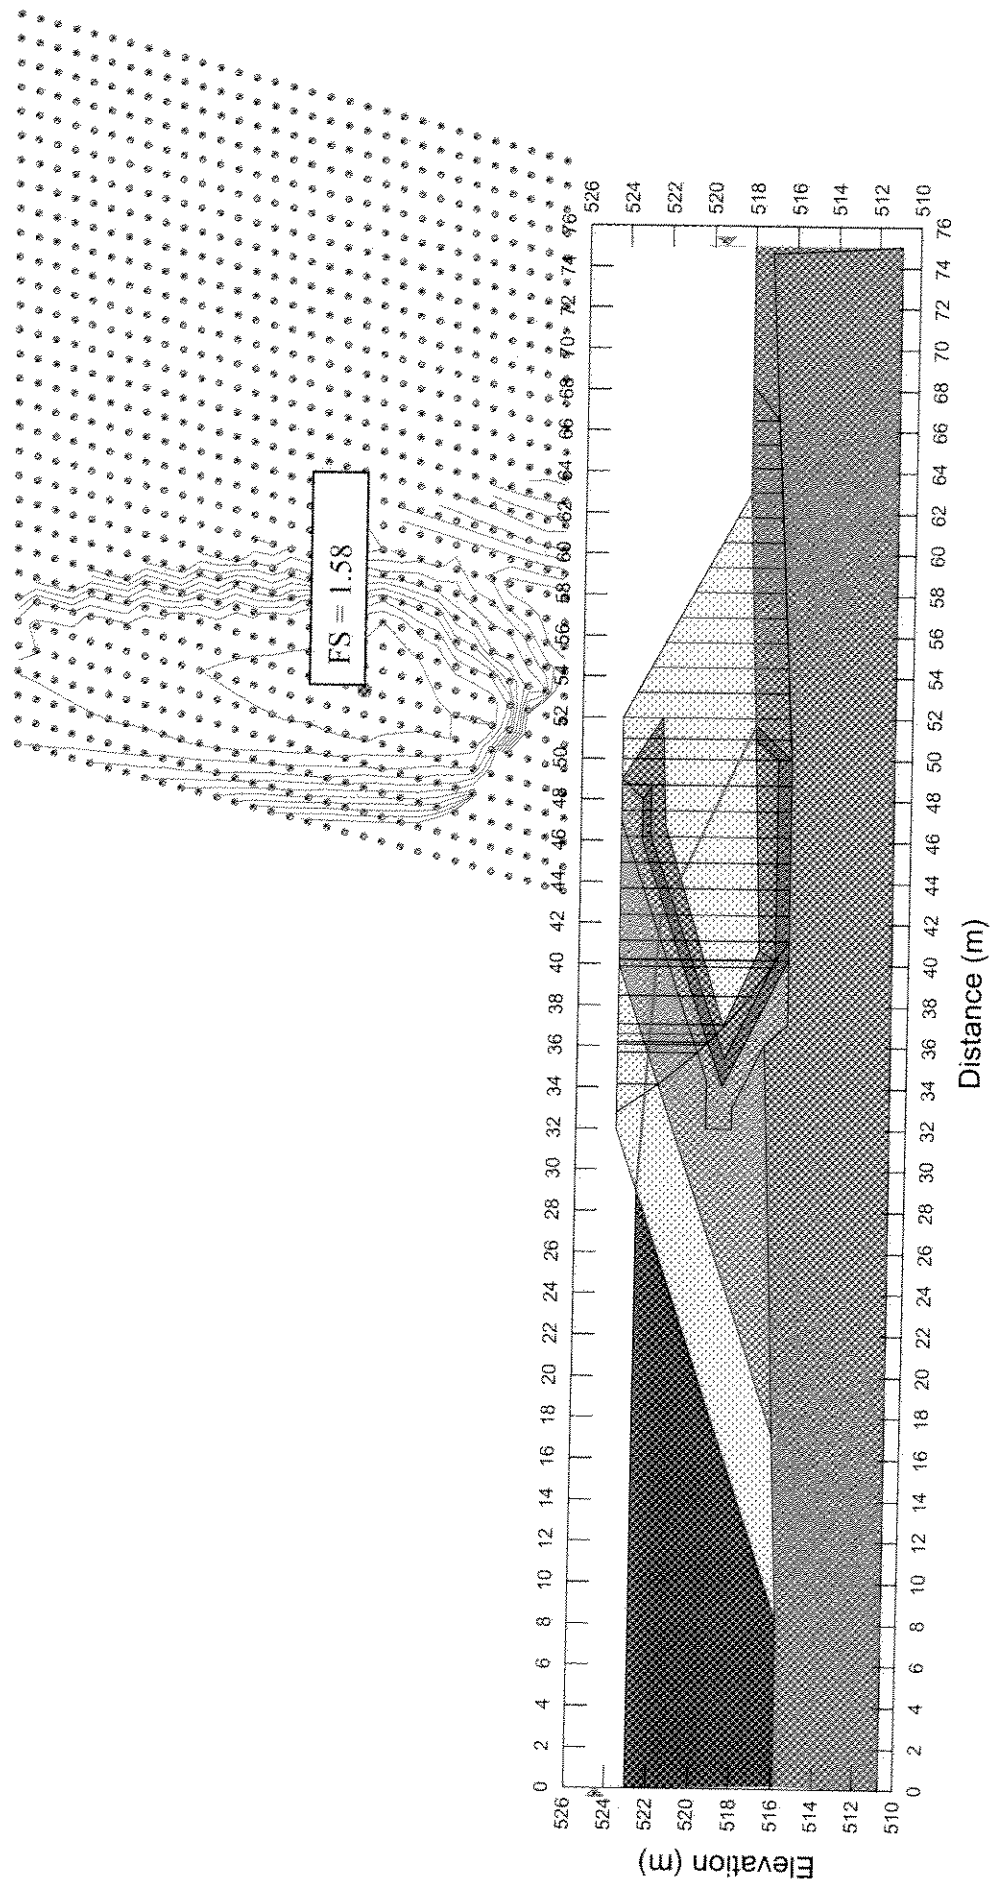
Figure A14  
Stability Analysis - Downstream, Seismic Analysis - Slip Surface along Liner

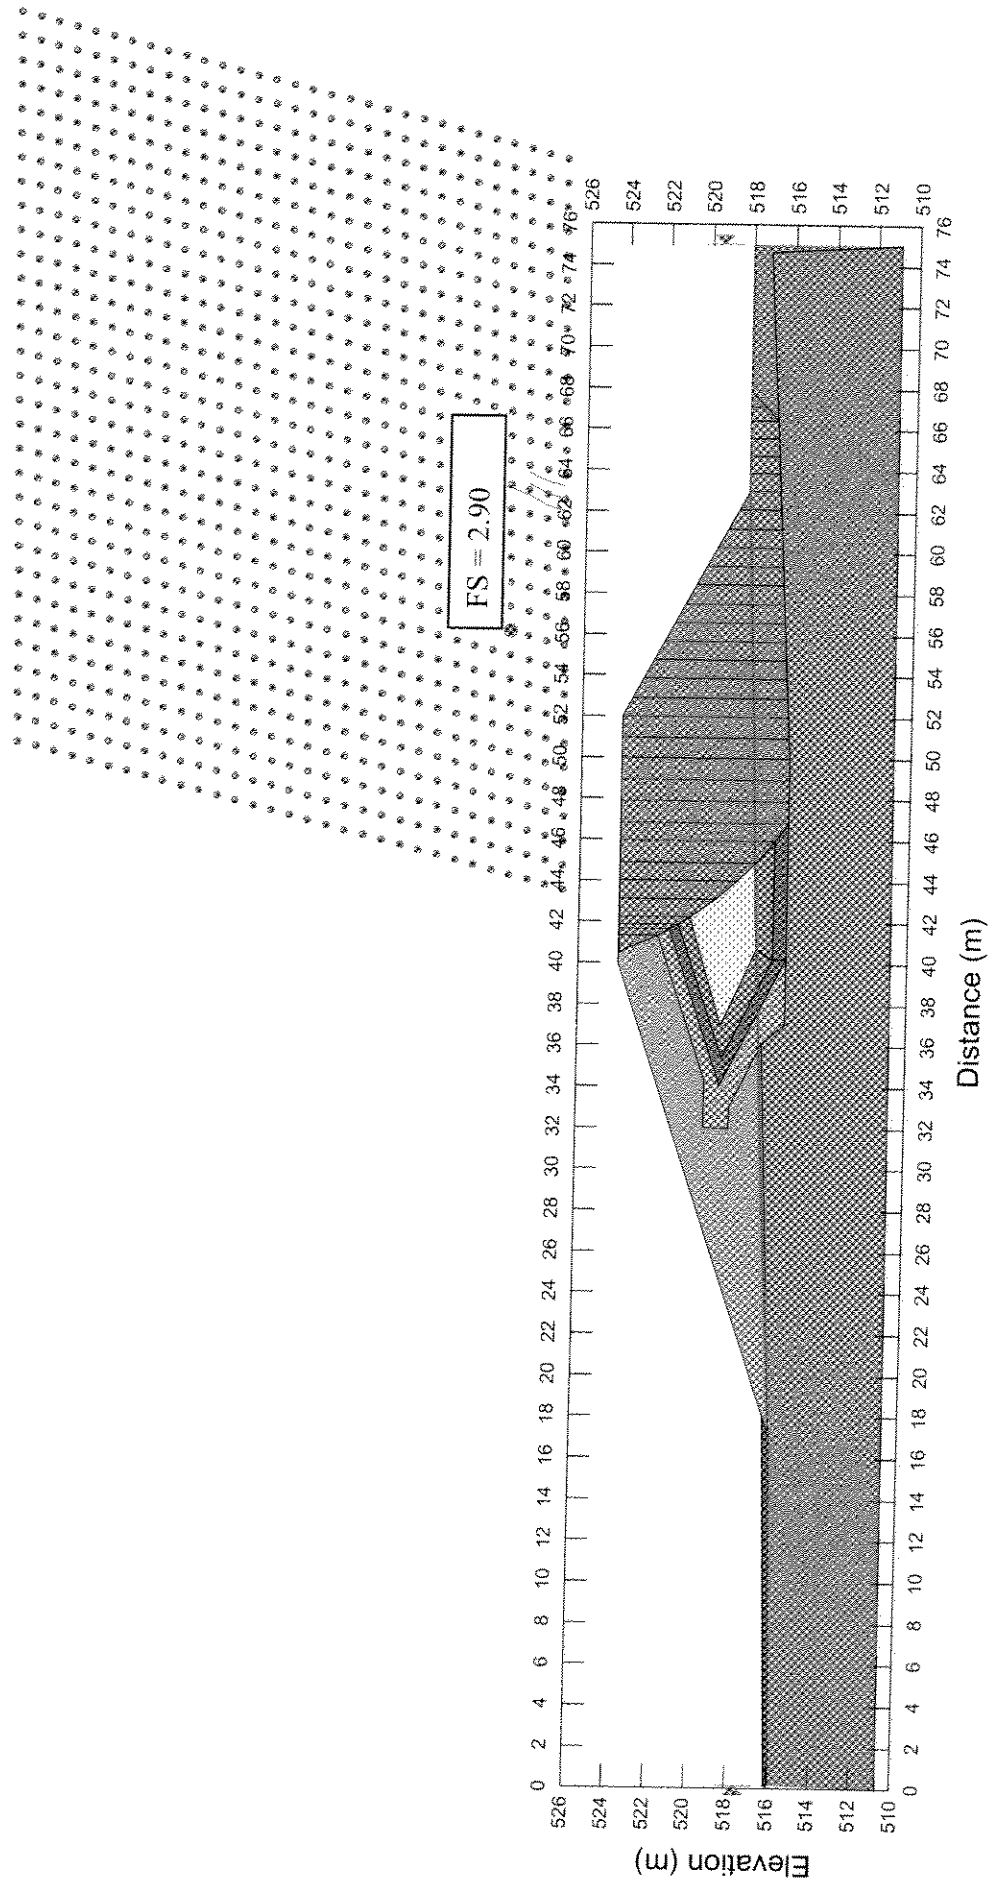
Figure A15  
Stability Analysis - Downstream, End of Construction - Slip Surface along Liner

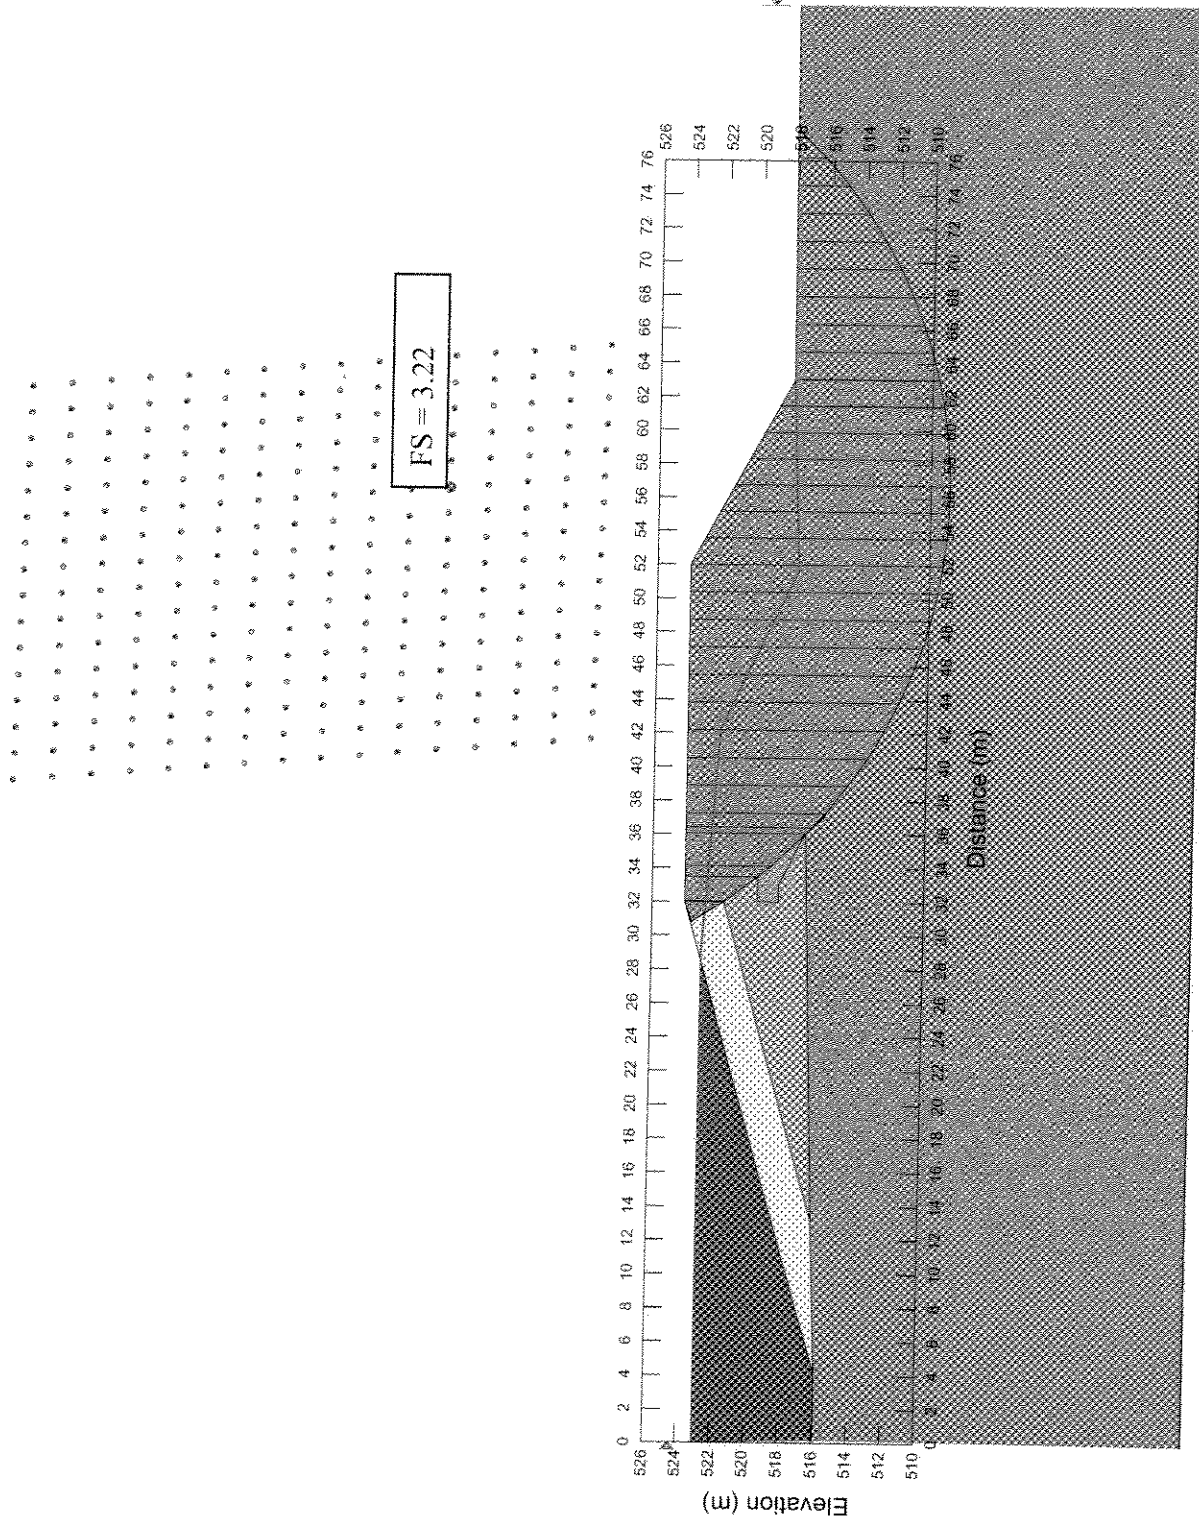
Figure A16  
Stability Analysis - Full Tailings - Overall Stability - Ice Rich Foundation

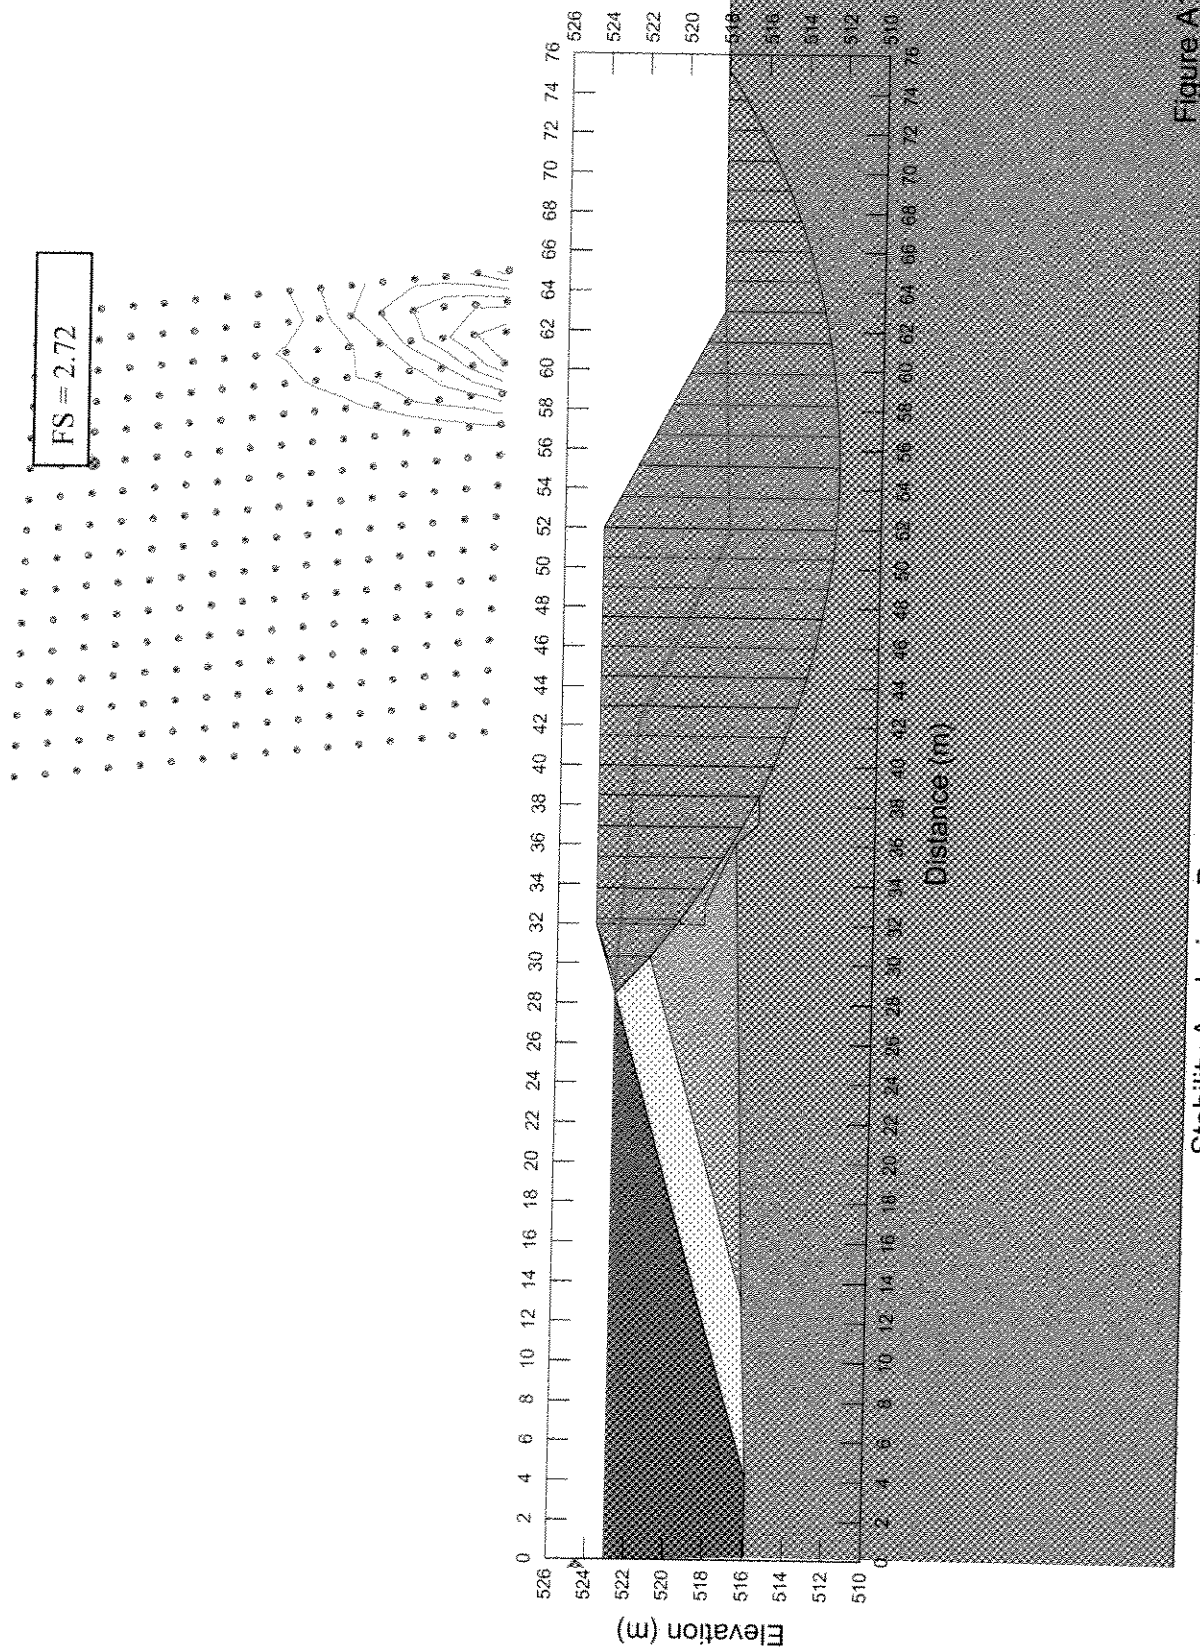
Stability Analysis - Downstream, Full Tailings -Overall Stability - Ice Poor Foundation
