GEOLOGY AND HYDROGEOLOGY BASELINE

**Kiggavik
Project**

ENVIRONMENTAL IMPACT STATEMENT
APPENDIX 5B

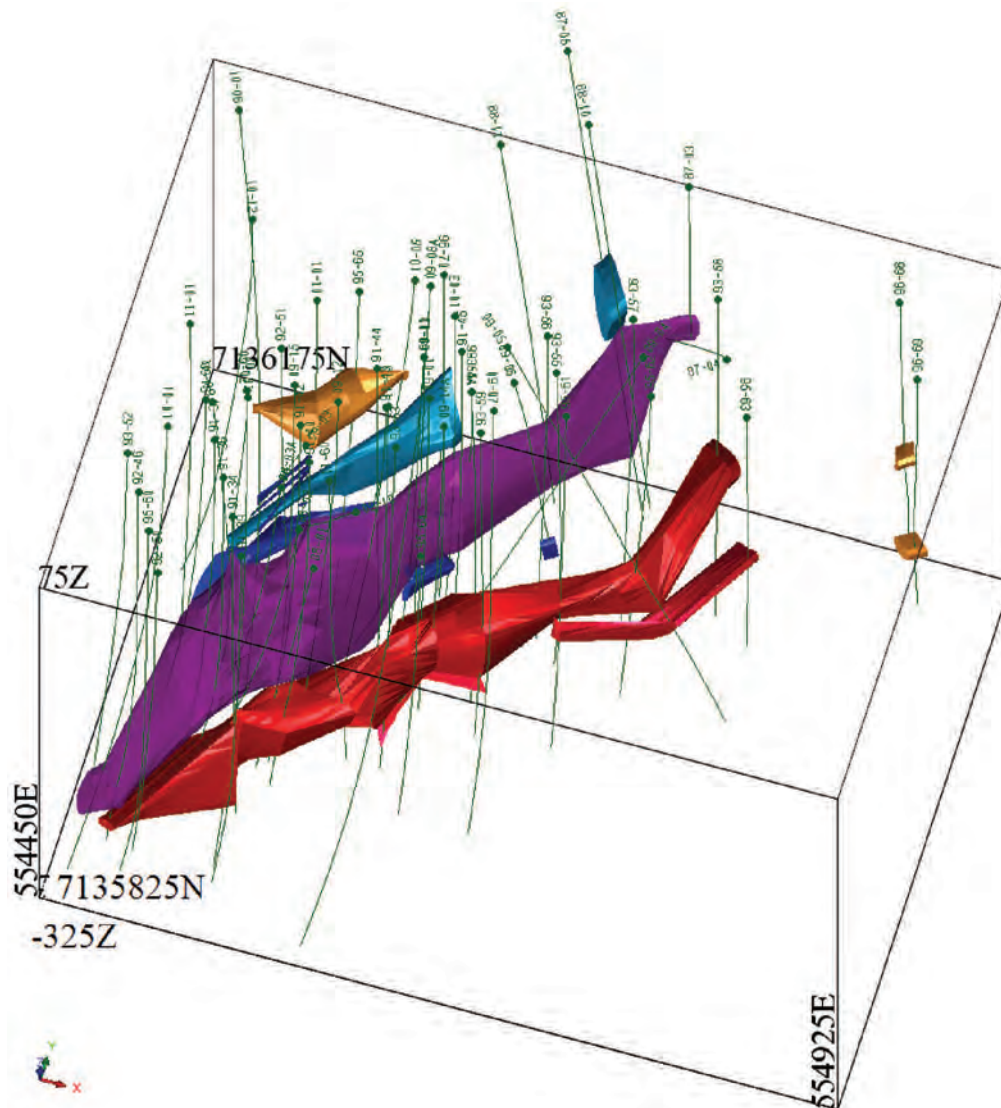
FIGURE 4.2-22
THREE DIMENSIONAL VIEW OF END GRID NORTH POD DEPOSIT

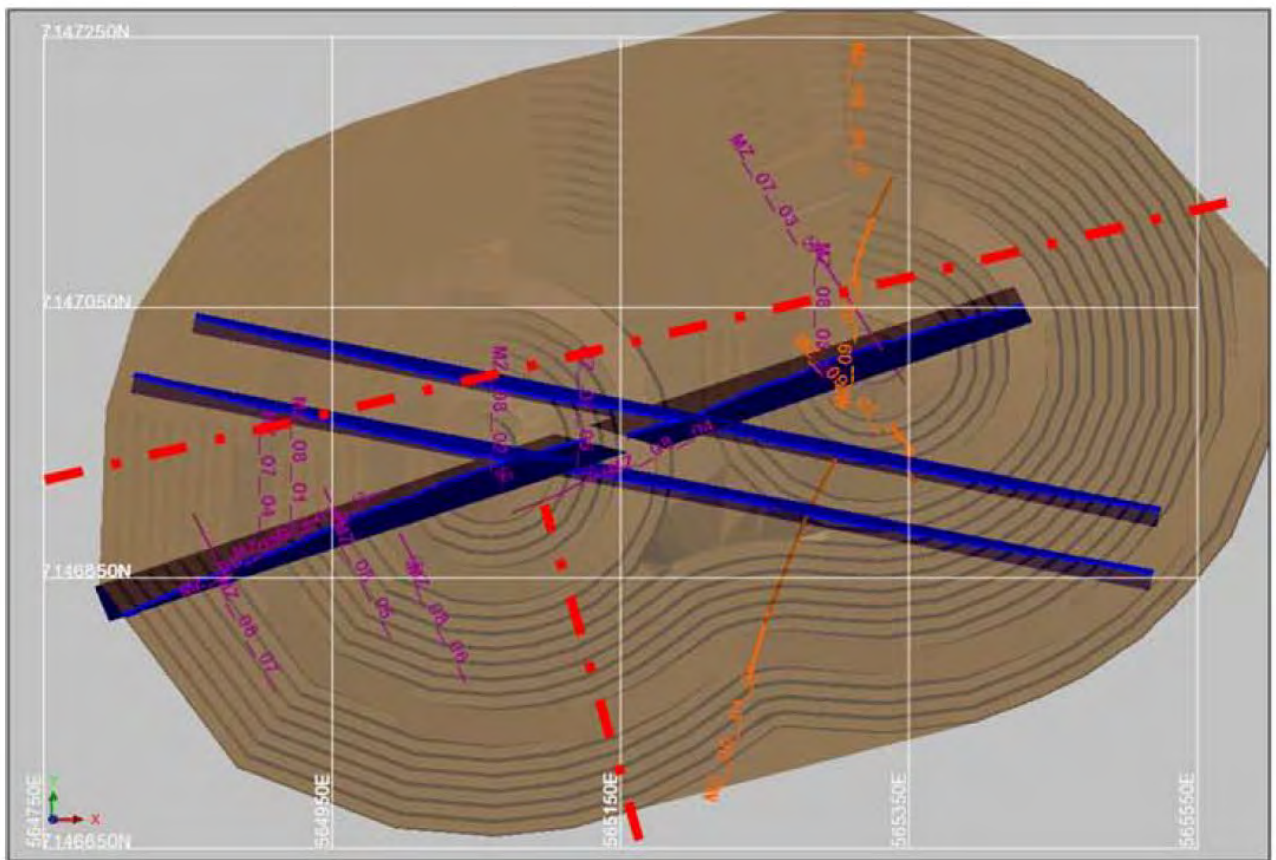
Main Zone Pit / Tailings Management Facility

— Regional Fault Trends
— Inferred Fault Trends

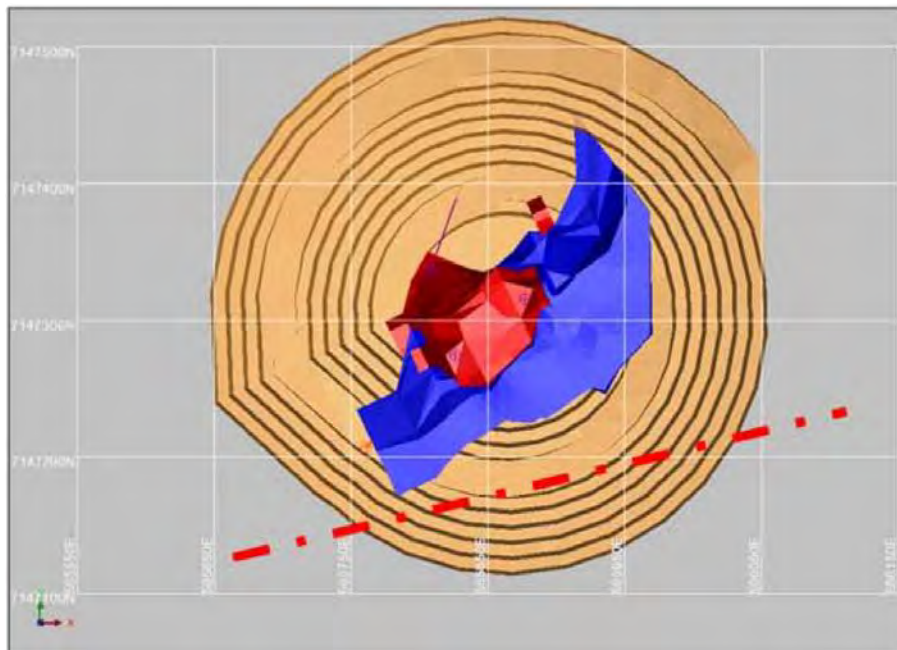
Center Zone Pit / Tailings Management Facility

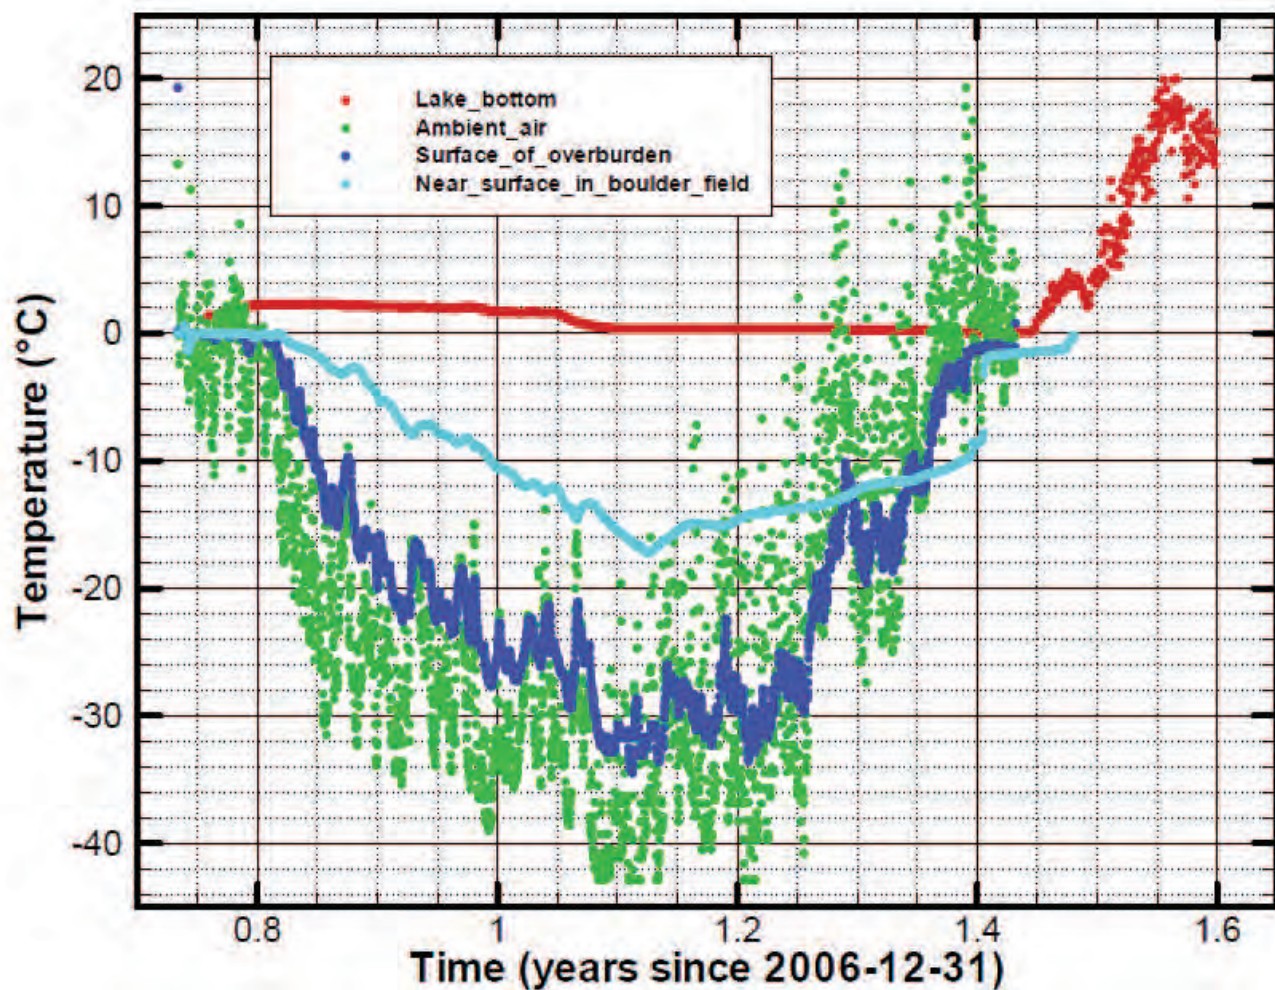
Figure 5.2-1
Temperature Data – Shallow Lake
bottom, Ambient air, Surface
overburden and Boulder field

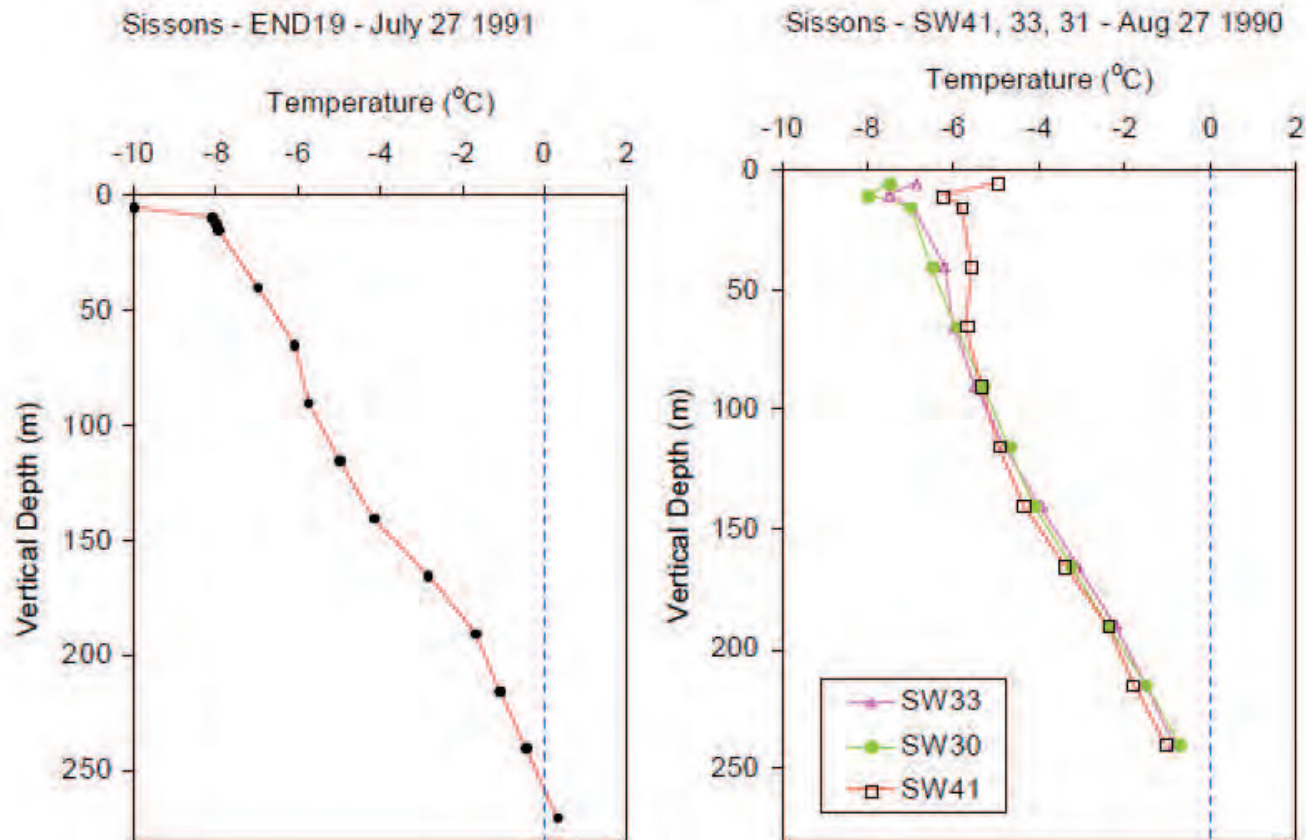
Figure 5.4-1
Permafrost temperature profiles
with depth in the Sissons area
Historical data
