Areva Kiggavik Project  
2008–2009 Subsurface GPR Survey

2008 Mill Site Data  
Profile 2008–6  
Proposed Tahn Farm Location

Figure A17

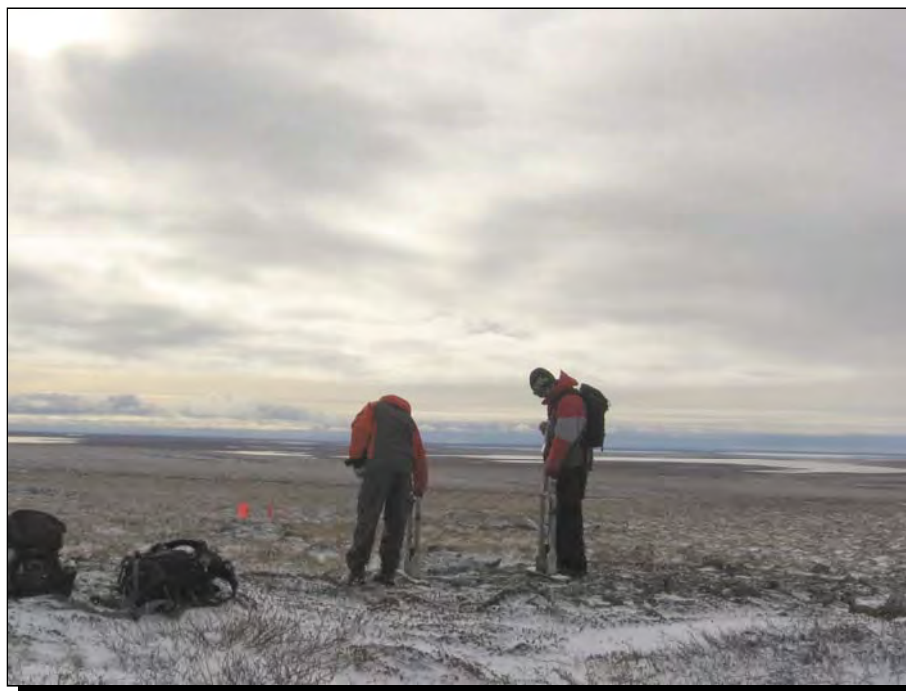
**Photo 1**

2008 GPR survey in progress. Each person would handle an antenna, which was stepped 10 cm at a time along a tape measure stretched out on the ground.

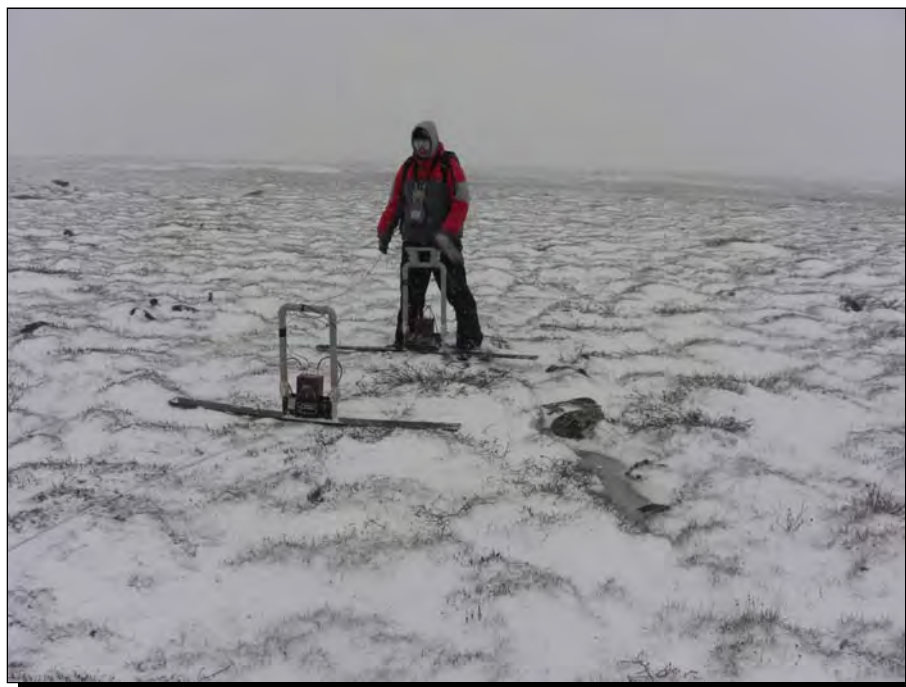
**Photo 2**

View of the pulseEKKO GPR System, with 50 MHz antennas, used in the 2008 GPR survey.

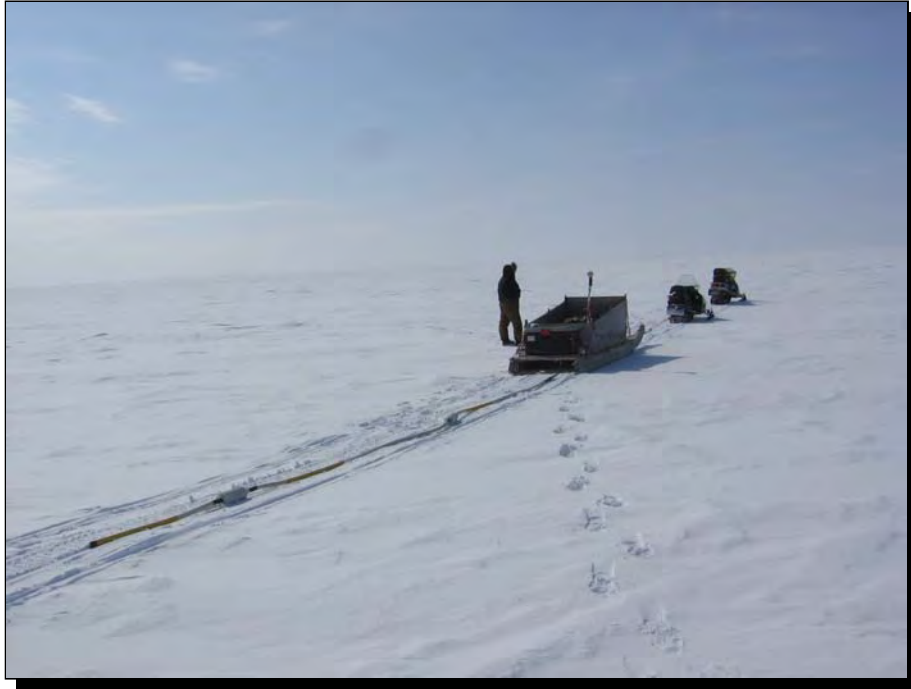
**Photo 5**

View of the Ramac GPR system used in the 2009 GPR survey.
