| PROJECT | | | | KIGGAVIK PROJECT | | | |
| TITLE | | | | HABITAT MAP<br>THELON RIVER (CROSSING 18)<br>2008 | | | |

The team focused their attention on the crossing location identified in the 2007 Pre-Feasibility study prepared by EBA which was completed with large scale mapping and satellite imagery and did not include any field investigation. During the reconnaissance the team identified an alternate crossing location. Both locations are illustrated in figure 1. The second location was identified because of potential concerns with slope stability, and uncertainty of ground conditions and bedrock depth at the first location.

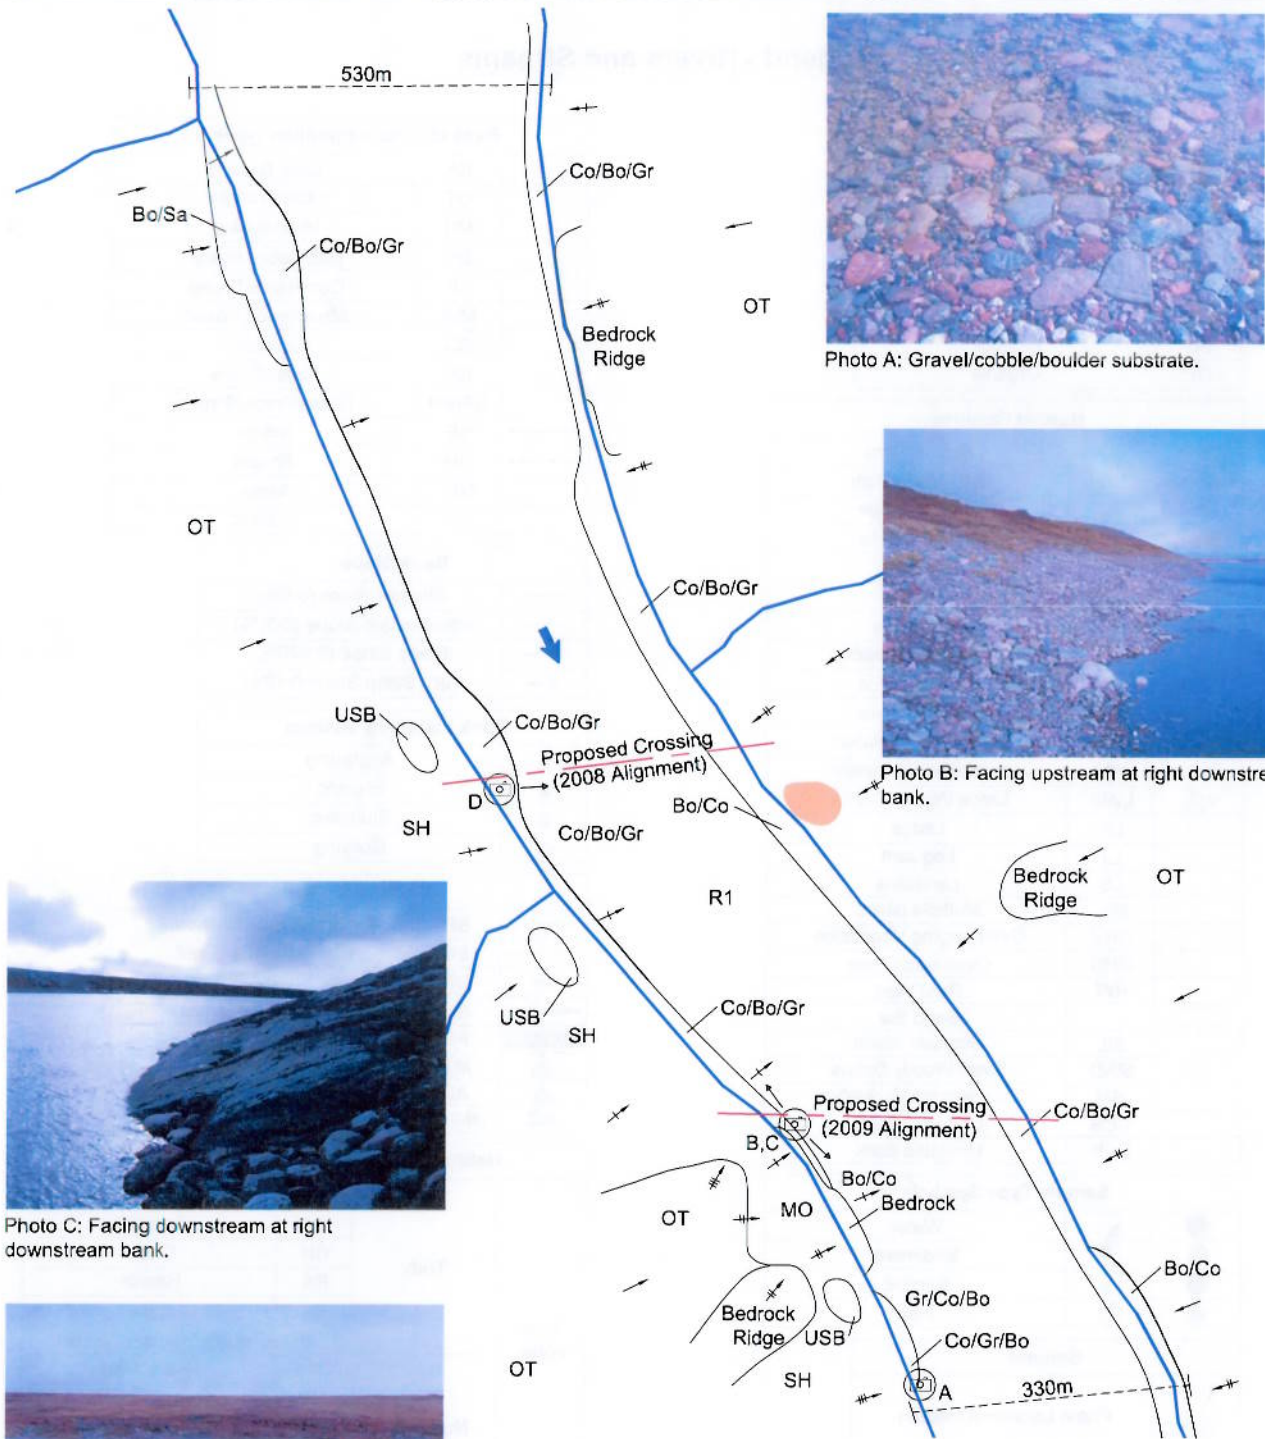
**FIGURE: 1**

- Note:
- Channel measurements include:
    - Wetted Width
    - Bankful Width
    - Maximum Depth
  - Detailed stream habitat data available in attachment.
  - Channel width not to scale.
  - See reverse for legend.

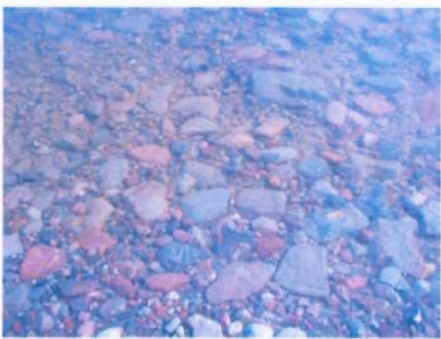
Photo A: Gravel/cobble/boulder substrate.

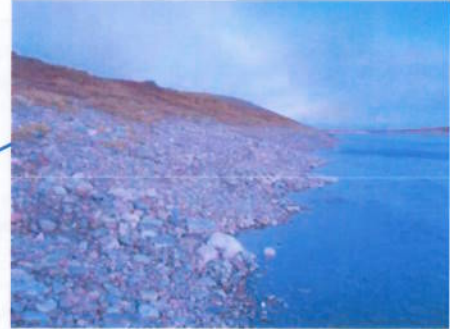
Photo B: Facing upstream at right downstream bank.

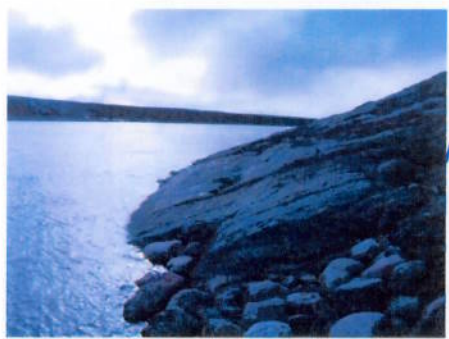
Photo C: Facing downstream at right downstream bank.

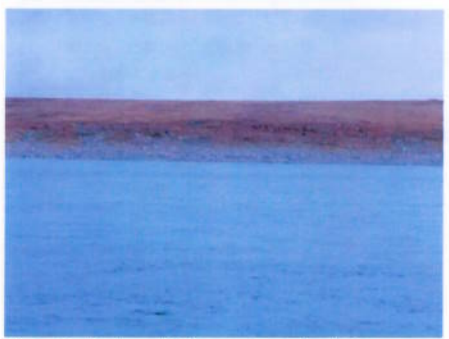
Photo D: Facing left downstream bank from proposed crossing.

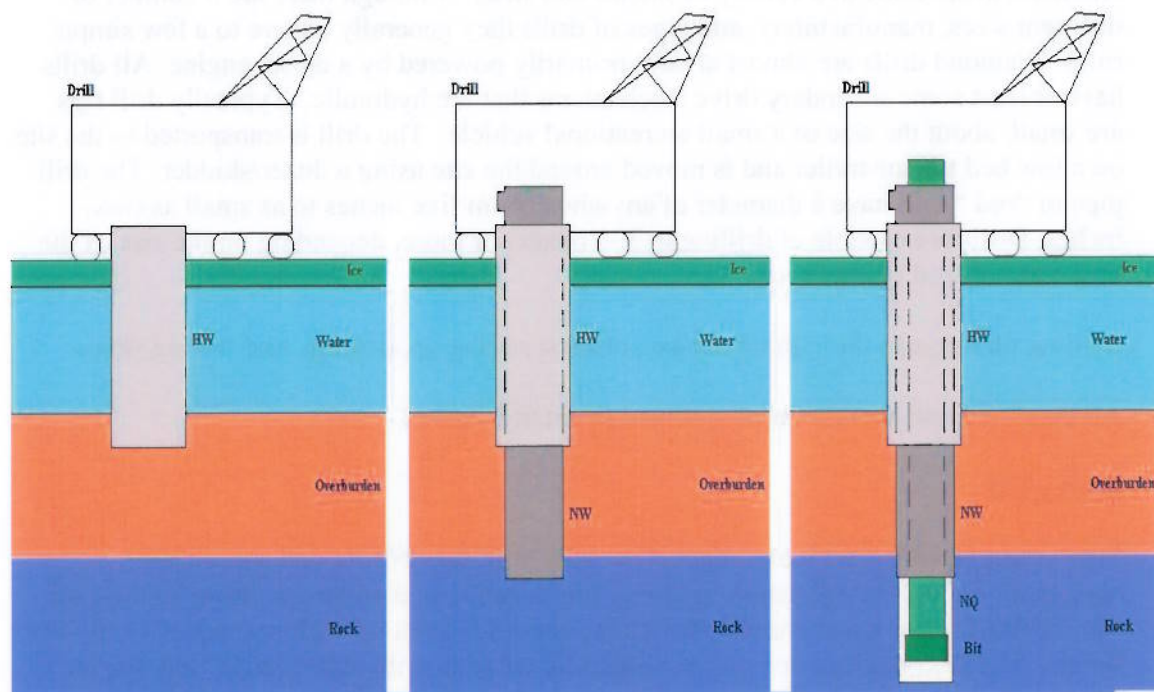
The first step in drilling is “casing” the hole. This means sealing the hole from bedrock to surface using a large diameter pipe or “rod”. This is a necessary step to ensure that the hole can be located again if any subsequent drill rods need to be removed during the operation. When casing the hole, one factor to contend with may be the depth of the water, or the distance between the drill and something solid. If the water is deep, the drillers will drop their largest rods first (rod size referred to as HW in *Figure 1*). The HW rod will be pushed and turned as far as it will go into the lake bottom manually and then anchored to the drill. Some disturbance of lake bottom sediments will result from this initial stage, however it is minimal and localized. If the lake bottom is bedrock there will be virtually no disturbance at all. If however consolidated sediments exist then some disturbance to organic matter at the bottom of the lake should be expected.

If the HW encounters bedrock then the next smallest size casing referred to as NW will be lowered inside the HW. The NW rod will be drilled into the rock to form a seal between the rock at the bottom of the lake and the drill at the surface. Once the NW rod is in place the next smaller “NQ” rods can be lowered into the hole.

*Figure 1.* Setting Casing

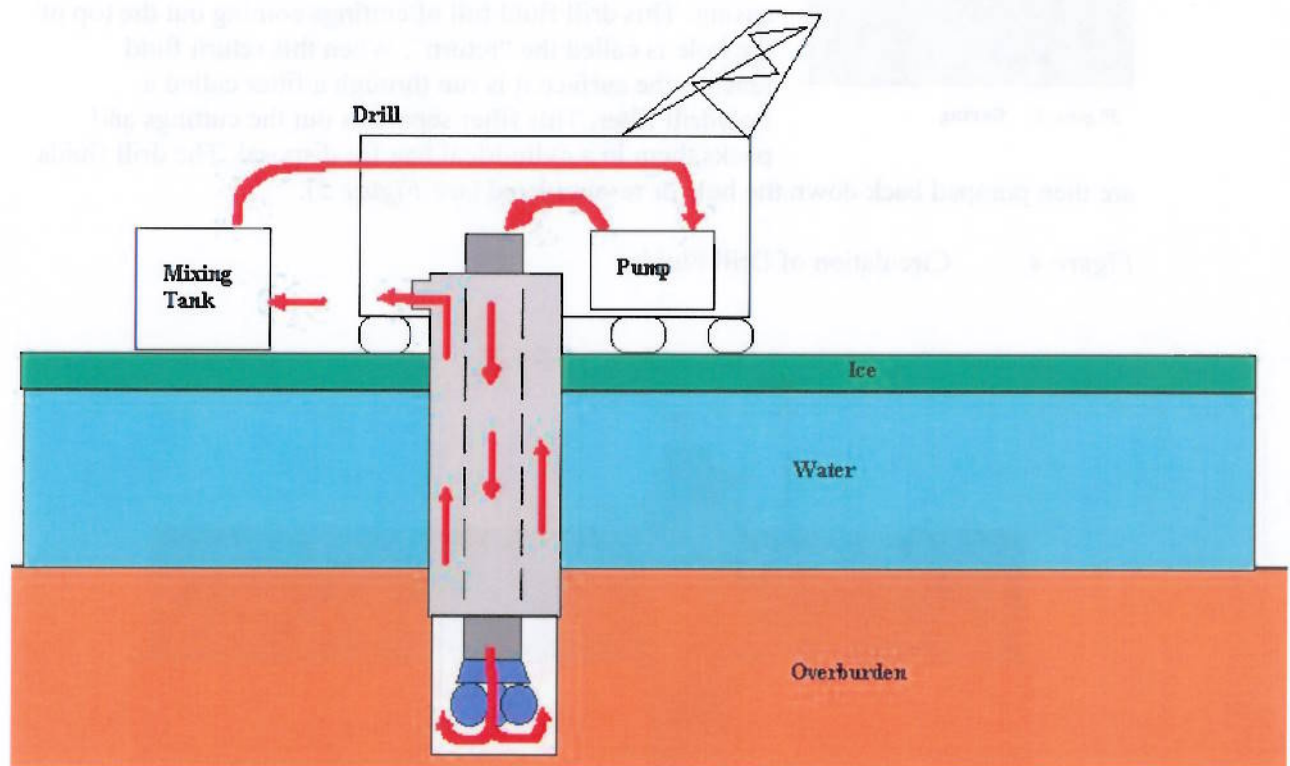
If the NW rod doesn't hit bedrock when it is initially lowered into the hole, it will commence hollow core drilling through the lake sediment or “overburden”. If the overburden is deep, or the drilling is difficult, then the drillers will probably switch to a type of drill bit called a tricone. Tricones do not hollow core drill; instead they simply grind their way through everything they encounter. Triconing produces a lot of sand and

silt and this abrasive material must be removed from the bottom of the hole or it will plug up the tricone and stop the drilling. Because this material is very coarse and heavy, drillers will commonly add a substance called bentonite to the drilling water to float the coarse sand away from the tricone and out the top of the hole. Mixing bentonite with water forms thick slurry that is able to float out the coarse sand produced by the tricone, when pumped down with enough pressure. This drilling mixture is pumped down through the rods, out through the tricone, back up the outside of the hole into the HW rod, and thus back to the surface. When the bentonite reaches the surface it is contained in a large mixing tank, likely the same tank that was used to mix it in the first place, where the coarse sand can settle. The bentonite is then reused or re-circulated back down through the hole (see Figure 2). After the NW rods are sealed with the bedrock, the hole is considered “cased”. Once the hole is cased the next step is the actual drilling. For this process, the drillers use the next smaller size rods called NQ.

Figure 2 Re-circulation During Triconing

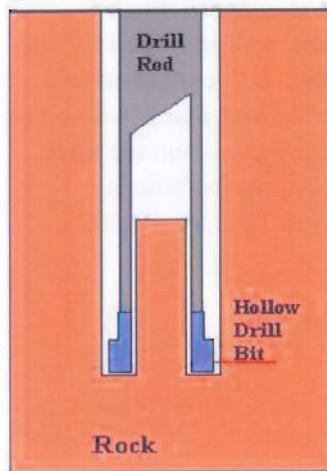
“Coring” is the process by which rock is extracted using a hollow bit drill (see Figure 3). Coring is achieved by the drill supplying a great deal of pressure and a high-speed rotation. This process generates heat so drilling fluid must be circulated through the bit to keep it from melting. In most cases water will suffice as a drill fluid, but in some cases additives must be used for additional reduction in friction and/or better cooling. If water is used it will be pumped directly from the lake down the hole.

Figure 3. Coring
