Kinross Gold Corporation

LUPIN OPERATION

**CLOSURE PLAN FOR
TAILINGS CONTAINMENT AREA**

JANUARY 2005

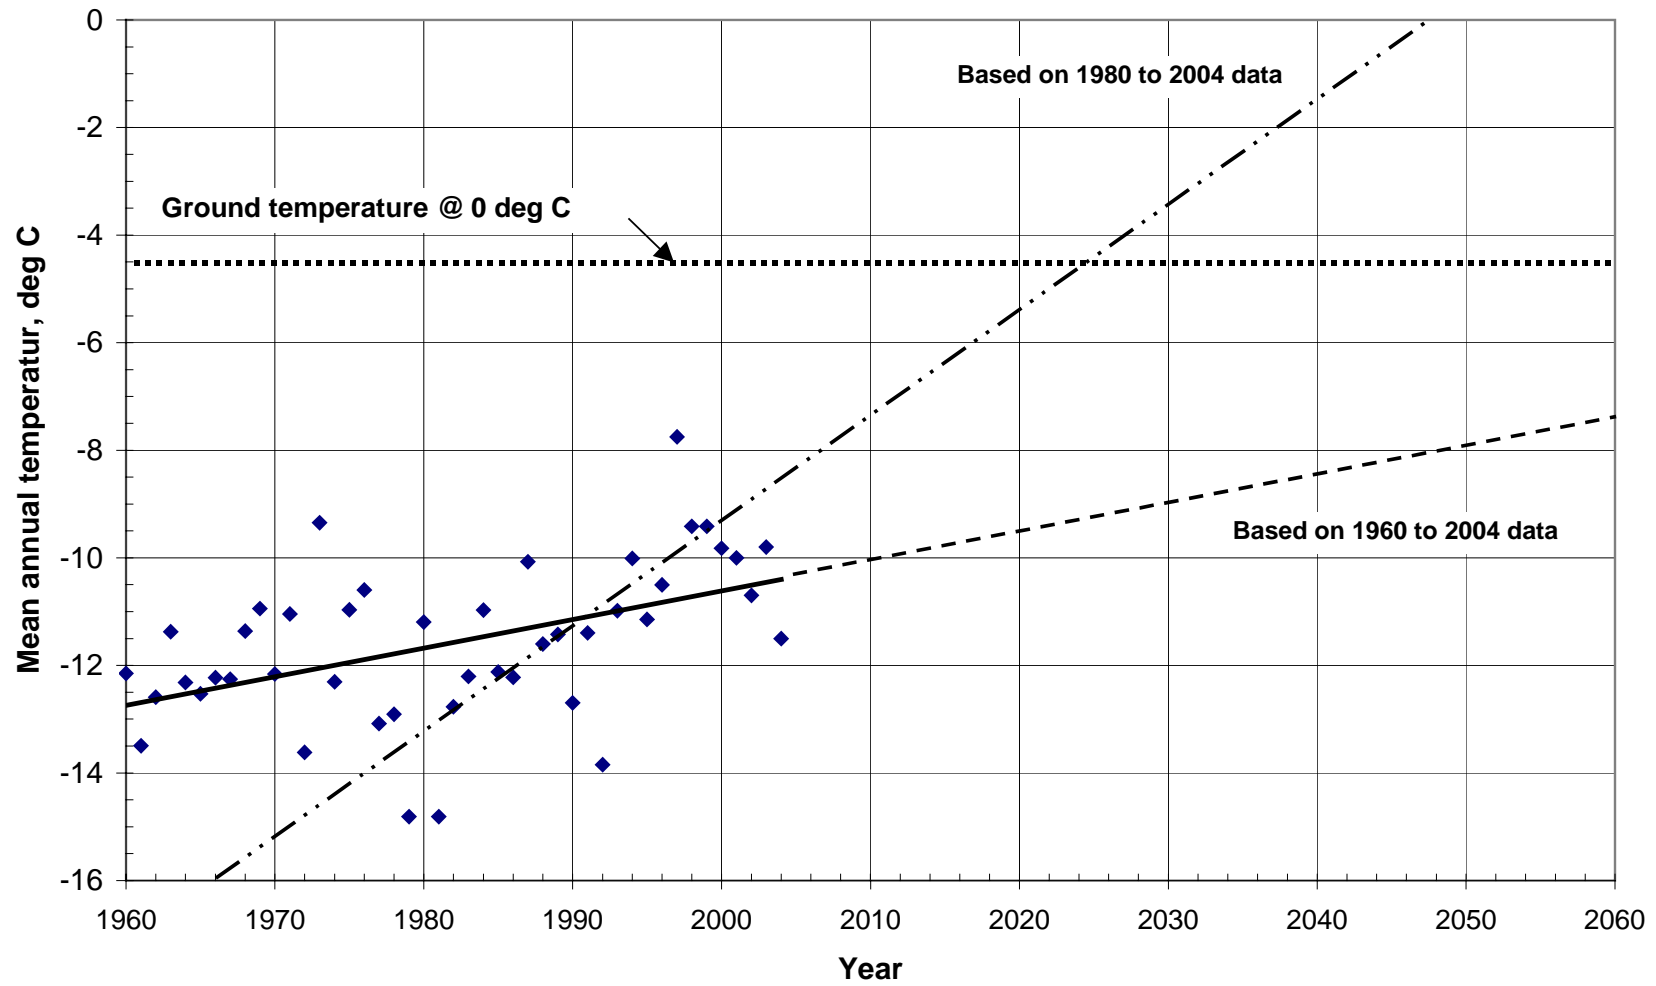
Figure 2-1. Mean annual air temperature trend at Lupin

The MAAT has been rising since the first measurements were taken in 1951 and the rate of increase has amplified since 1980 as has been observed in Alaska and the Northern Global hemisphere (Anisimov & Fitzharris 2001). The combined MAAT measurements from the Contwoyto Lake and Lupin climate stations are shown in Figure 2-1. Based on a general relationship observed between ground temperature and MAAT (Smith & Burgess 2000), a ground temperature of 0°C is observed at a MAAT of -4.4°C . Based on the two trend lines, one for 1960 to 2004 data and the second for the 1980 to 2004 data, the MAAT of -10.3°C at 2004 will warm to -4.4°C in about 110 years based on the long-term temperature records but only about 30 years based on the MAAT trend since 1980.

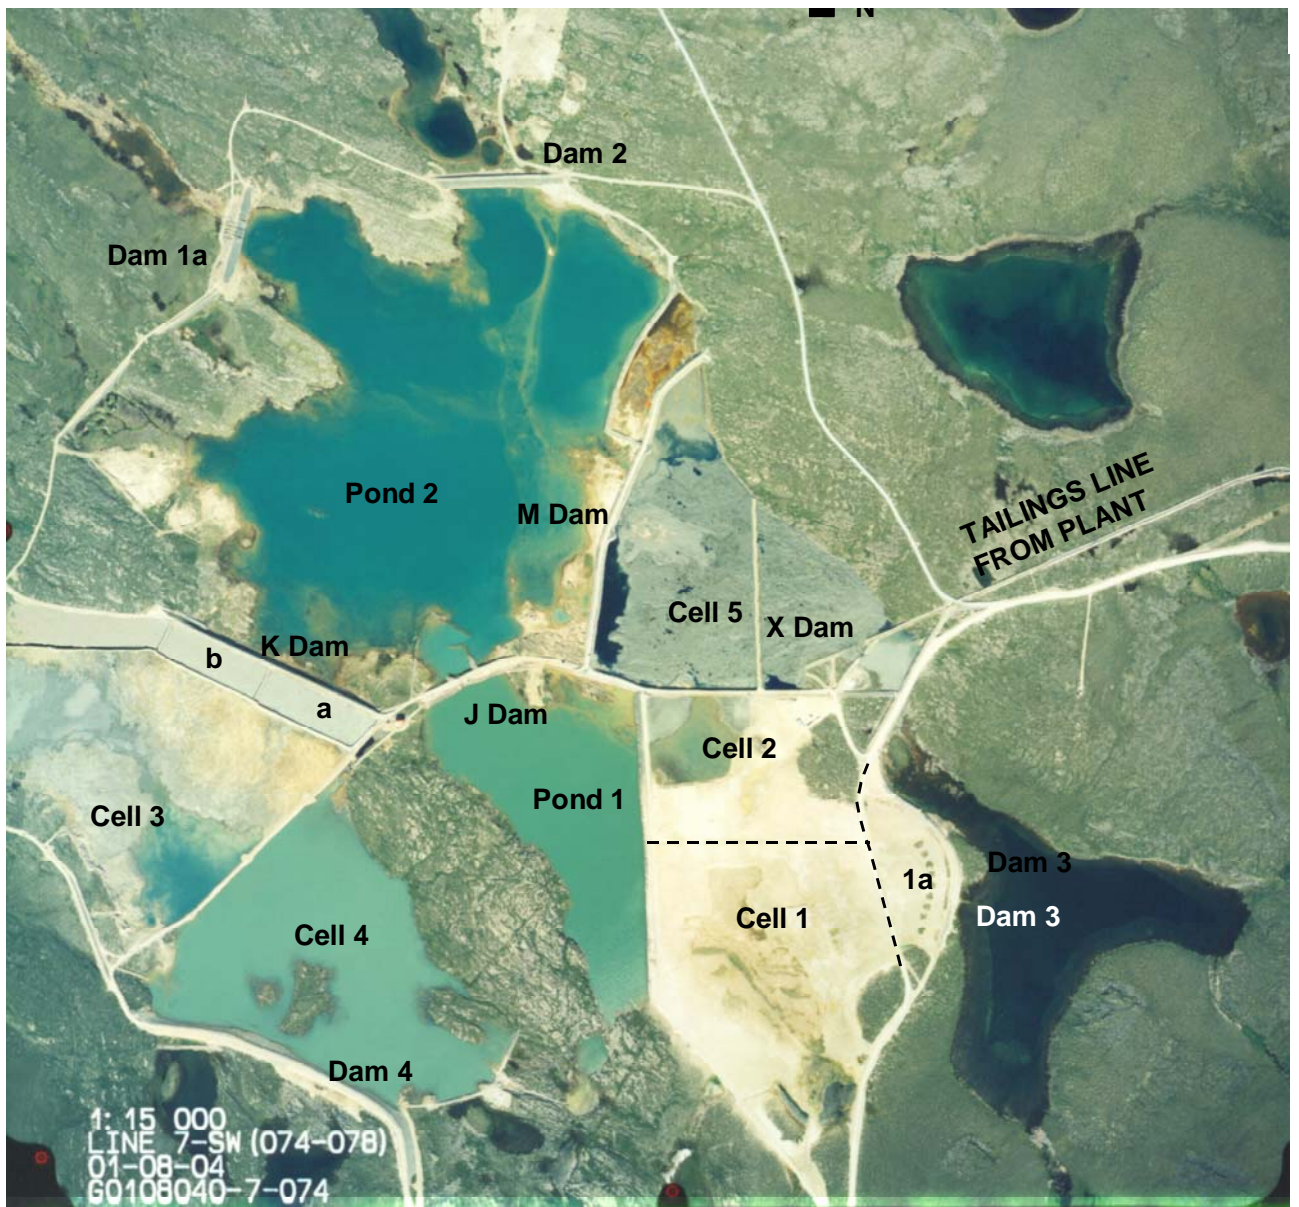
Figure 6-3. Aerial view of TCA in 2001

Construction of Dams 1a, 2 and 4 changed the water management of TCA. During the initial 5 years, all water inputs into the TCA, precipitation and slurry water were retained within the TCA. This resulted in forming a large pond against Dams 1a and 2 as illustrated in Figure 2-5. From 1985, Lupin began storing the tailings in cells and managing excess water by passing it through a series of ponds to improve the water to meet discharge quality before siphoning the water over Dam 1a annually. Layout of the TCA during 2000 is portrayed in an aerial photo taken in 2000 in Figure 6-3.

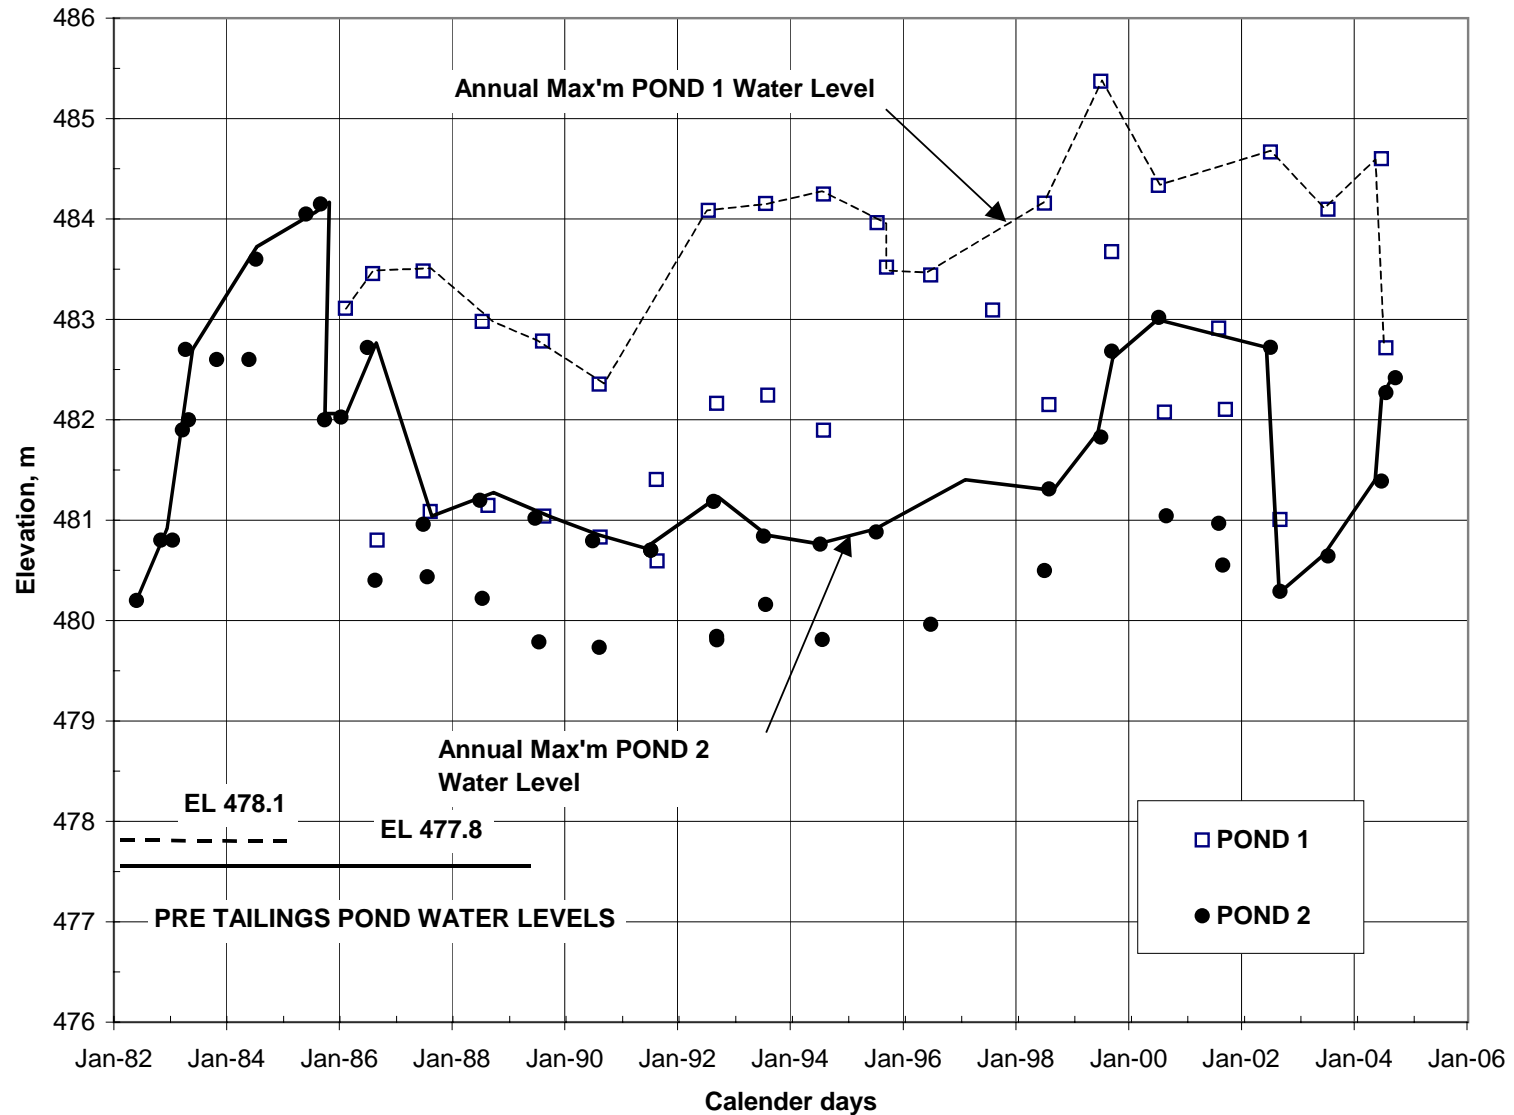
Figure 6-4. Water level fluctuations in Ponds 1 and 2

Excess water within the TCA was stored temporarily within Ponds 1 and 2. When water levels became high in these ponds and water quality within Pond 2 met the discharge quality criteria, some of the excess water within Pond 2 was siphoned out. The changes in the water levels in Ponds 1 and 2 are given in Figure 6-4.

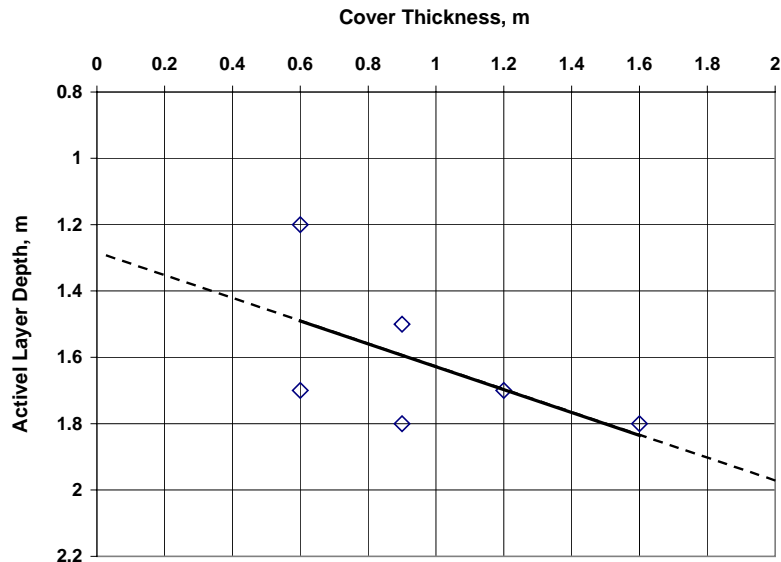
Figure 8-2. Thaw depth related to Lupin esker cover thickness

Relating the active layer (thaw depth) to the thickness of esker cover in Figure 8-2 shows that by increasing the cover thickness, the active layer or depth thaw becomes greater.

In the absence of knowing the groundwater depth at each of these thermistors, water content of the saturated zone and the moisture content of the surface unsaturated zone, it is difficult to make definite comments on the Figure 8-2 relationship. Generalized conclusions that can be made are from the observations that: 1) the groundwater surface was at or is near the bottom of the esker cover and 2) tailings beneath the cover are completely or nearly fully saturated. Based on these assumptions, the relationship in Figure 8-2 indicates the following for the Lupin site:

- a) Saturated tailings without a cover would experience a thaw depth of 1.3m.
- b) To encapsulate the tailings completely with sand and gravel would require a minimum 2m cover plus additional thickness for warm years and other uncertainties.

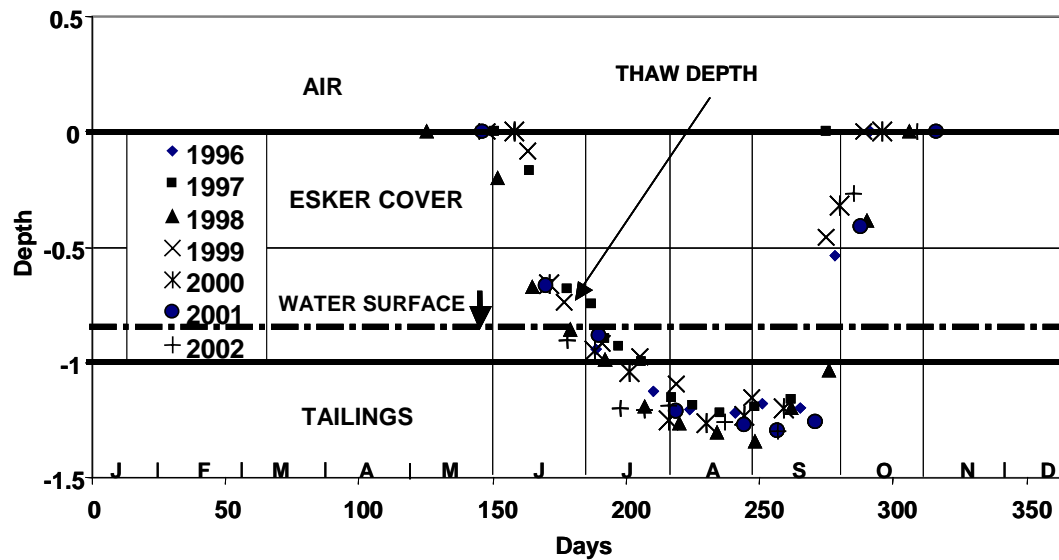
Figure 8-3 also illustrates that: a) thaw depth penetrated into the tailings by about 0.4m, b) unfrozen conditions lasted for less than 3 months and c) during this period the temperature within the thawed tailings reached a maximum of 5°C. This temperature was interpreted from individual thermistor bead locations and likely due to the variation of snow cover.

Figure 8-3. Thaw depth changes in esker covered tailings over a 7 year period, TC1-3

The progression of the active layer in and out of the cover and its changes over the years can be seen in the data of thermistor string TC1-3, which has been providing data since November 1995. The thaw depth progression for the 7 years between 1996 and 2002 is shown on Figure 8-3. At this location the thaw depth varied from 1.15 to 1.35 m during this period of monitoring. The cover at this location is 1.2m.

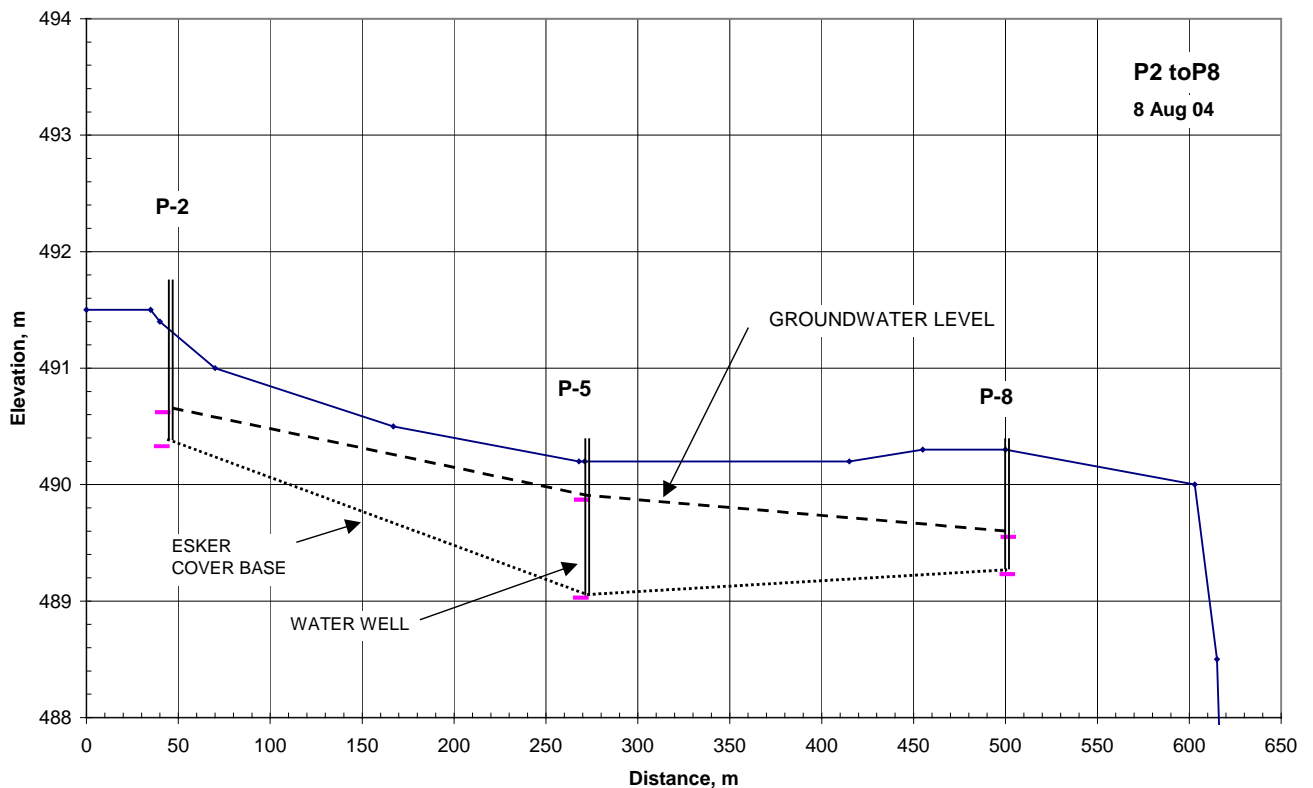
Figure 8-7 illustrates that groundwater levels drop from a high at the northern edge of Cell 1 to a low near 3D Dam. The greatest depth of saturation is located at the center of Cell 1 at pipes P5 and P6. The reason for the greatest thickness of saturation is that this area presents both the middle of Cell 1 where the finer tailings would settle and also an area that is underlain by a former lake resulting in the greatest thickness of tailings. These two factors would have caused past consolidation of the tailings and depression of the tailings surface that can be seen by the lower base of the esker cover at pipes P5 and P6. The three north-south profiles in Figures B21 to B23 illustrate that the groundwater within the esker cover, when it is thawed during the summer, slopes towards Pond-1.

Figure 8-7. Groundwater profile along pipe section P2 to P8

The groundwater profile within the esker cover in Cell 1 is illustrated on four figures (B21, B22, B23 and B24) in Appendix B and in Figure 8-7 that is a repeat of Figure B22. These figures illustrate the groundwater levels within the esker cover on the August 8, 2004.

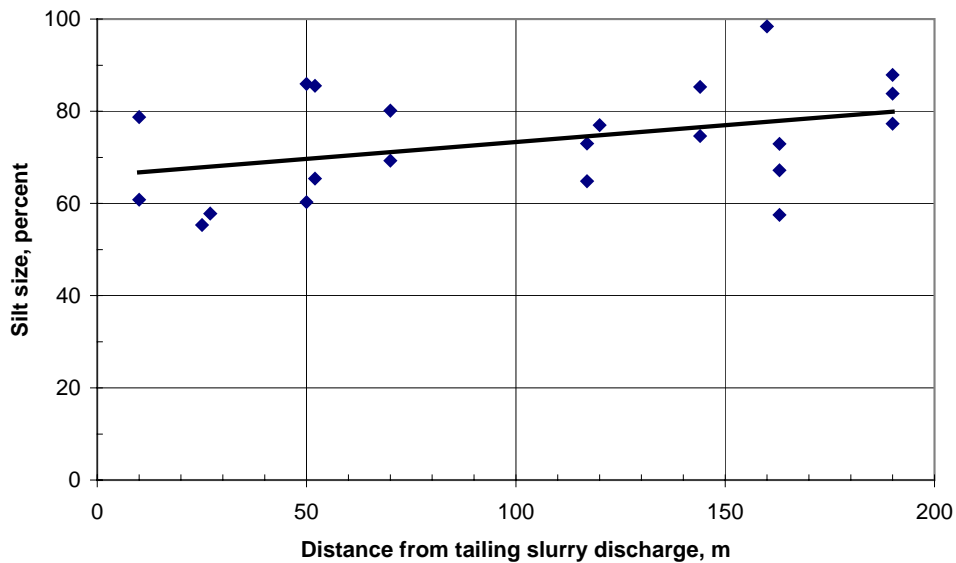
Figure 8-12. Summary of percent silt size particles in tailings (Klohn-Crippen 1995)

A summary of the silt content of these samples is provided in Figure 8-12.
