**Kinross Gold Corporation**

**LUPIN OPERATION**

**CLOSURE PLAN FOR  
TAILINGS CONTAINMENT AREA**

**I. Holubec Consulting Inc.**

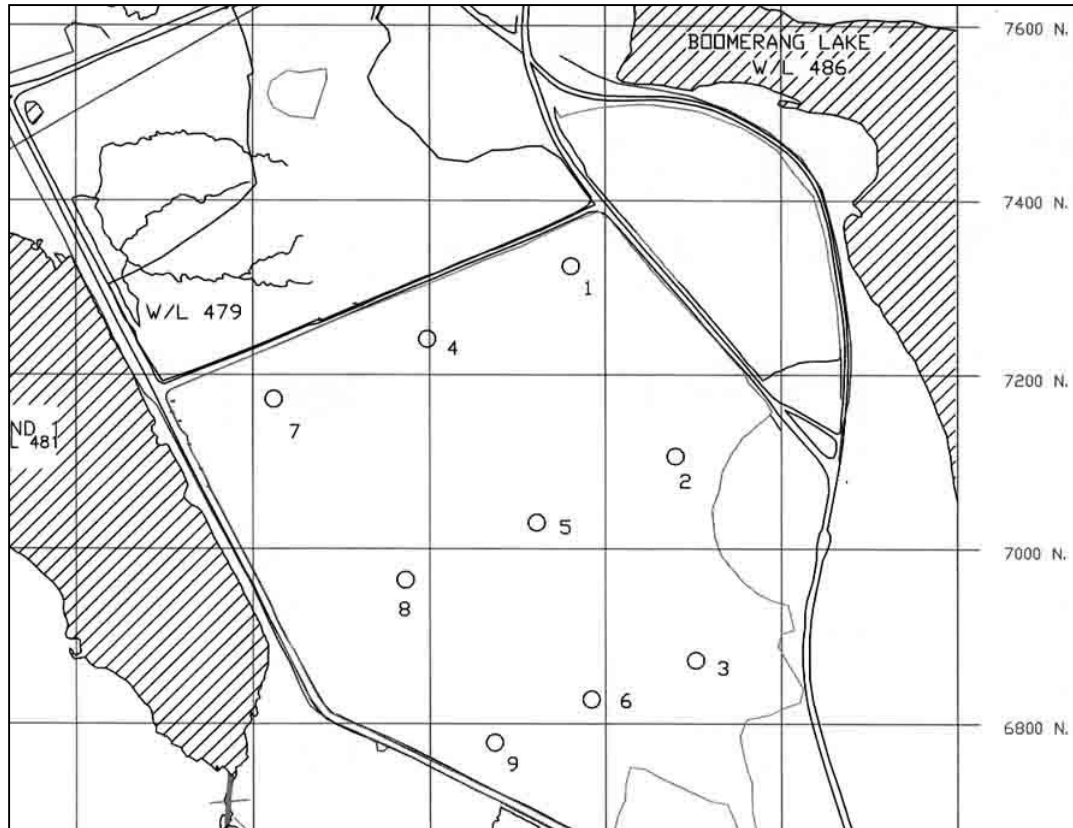
Figure 8-5. Location of pipes installed in 2002

Lupin decided to pursue the saturated zone cover concept in 2002 and oriented its field testing and monitoring to confirm the validity of this concept. Nine 1.5-metre long pipes were installed within Cell 1 (Figure 8-5) in the summer of 2002 to:

To ensure that water samples were collected from within the esker pores, the pipes bases were installed about 150mm above the tailings surface. Thickness of the esker cover at the nine pipe locations is given in Table 8-3. Measurements of the esker cover during the installation of the pipes showed that the esker cover thickness varied between 1.0 to 1.3m with an average of 1.1m.

More extensive sampling and testing of the esker pore water was started in August 2002 to obtain a better understanding of water quality within the esker cover saturated zone and how this pore water affects the water as it emerges from the ground. For this purpose 9 pipes were installed in Cell 1 as shown in Figure 8-5.

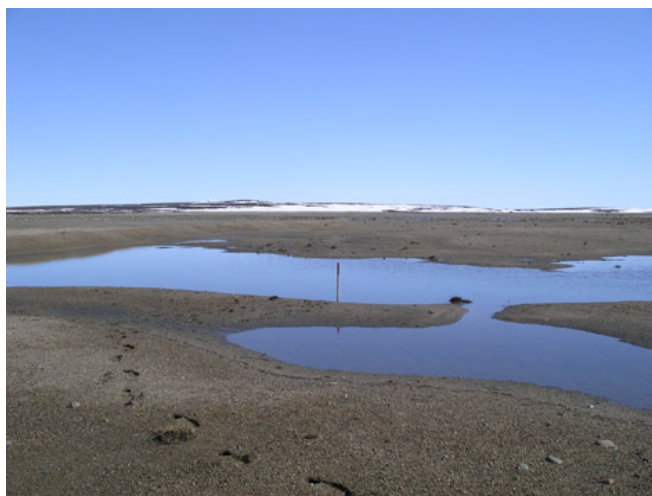
**Figure 9-2. Ponded water in Cell 1, location of water sampling**

The main impact of esker pore water on the receiving water can be determined from following the water quality from the pipes to areas where it emerges at Cell 1 ponded water surfaces and than progresses to the larger water bodies in Pond 1 and Pond 2. The ponded

water in Cell 1 is shown in Figure 9-2. Water quality measured in Cell 1 ponded water area (2004) and Ponds 1 and 2 in 2003 and 2004 are given in Table 9-5 and Table 9-6 respectively.
