TECHNICAL MEMORANDUM

DOMES DESIGN ISSUED FOR CONSTRUCTION DRAWINGS

PROJECT
WASTE ROCK DOME DESIGN
LUPIN MINE CLOSURE
NUNAVUT, CANADA

TITLE
PROPOSED WASTE ROCK DOME

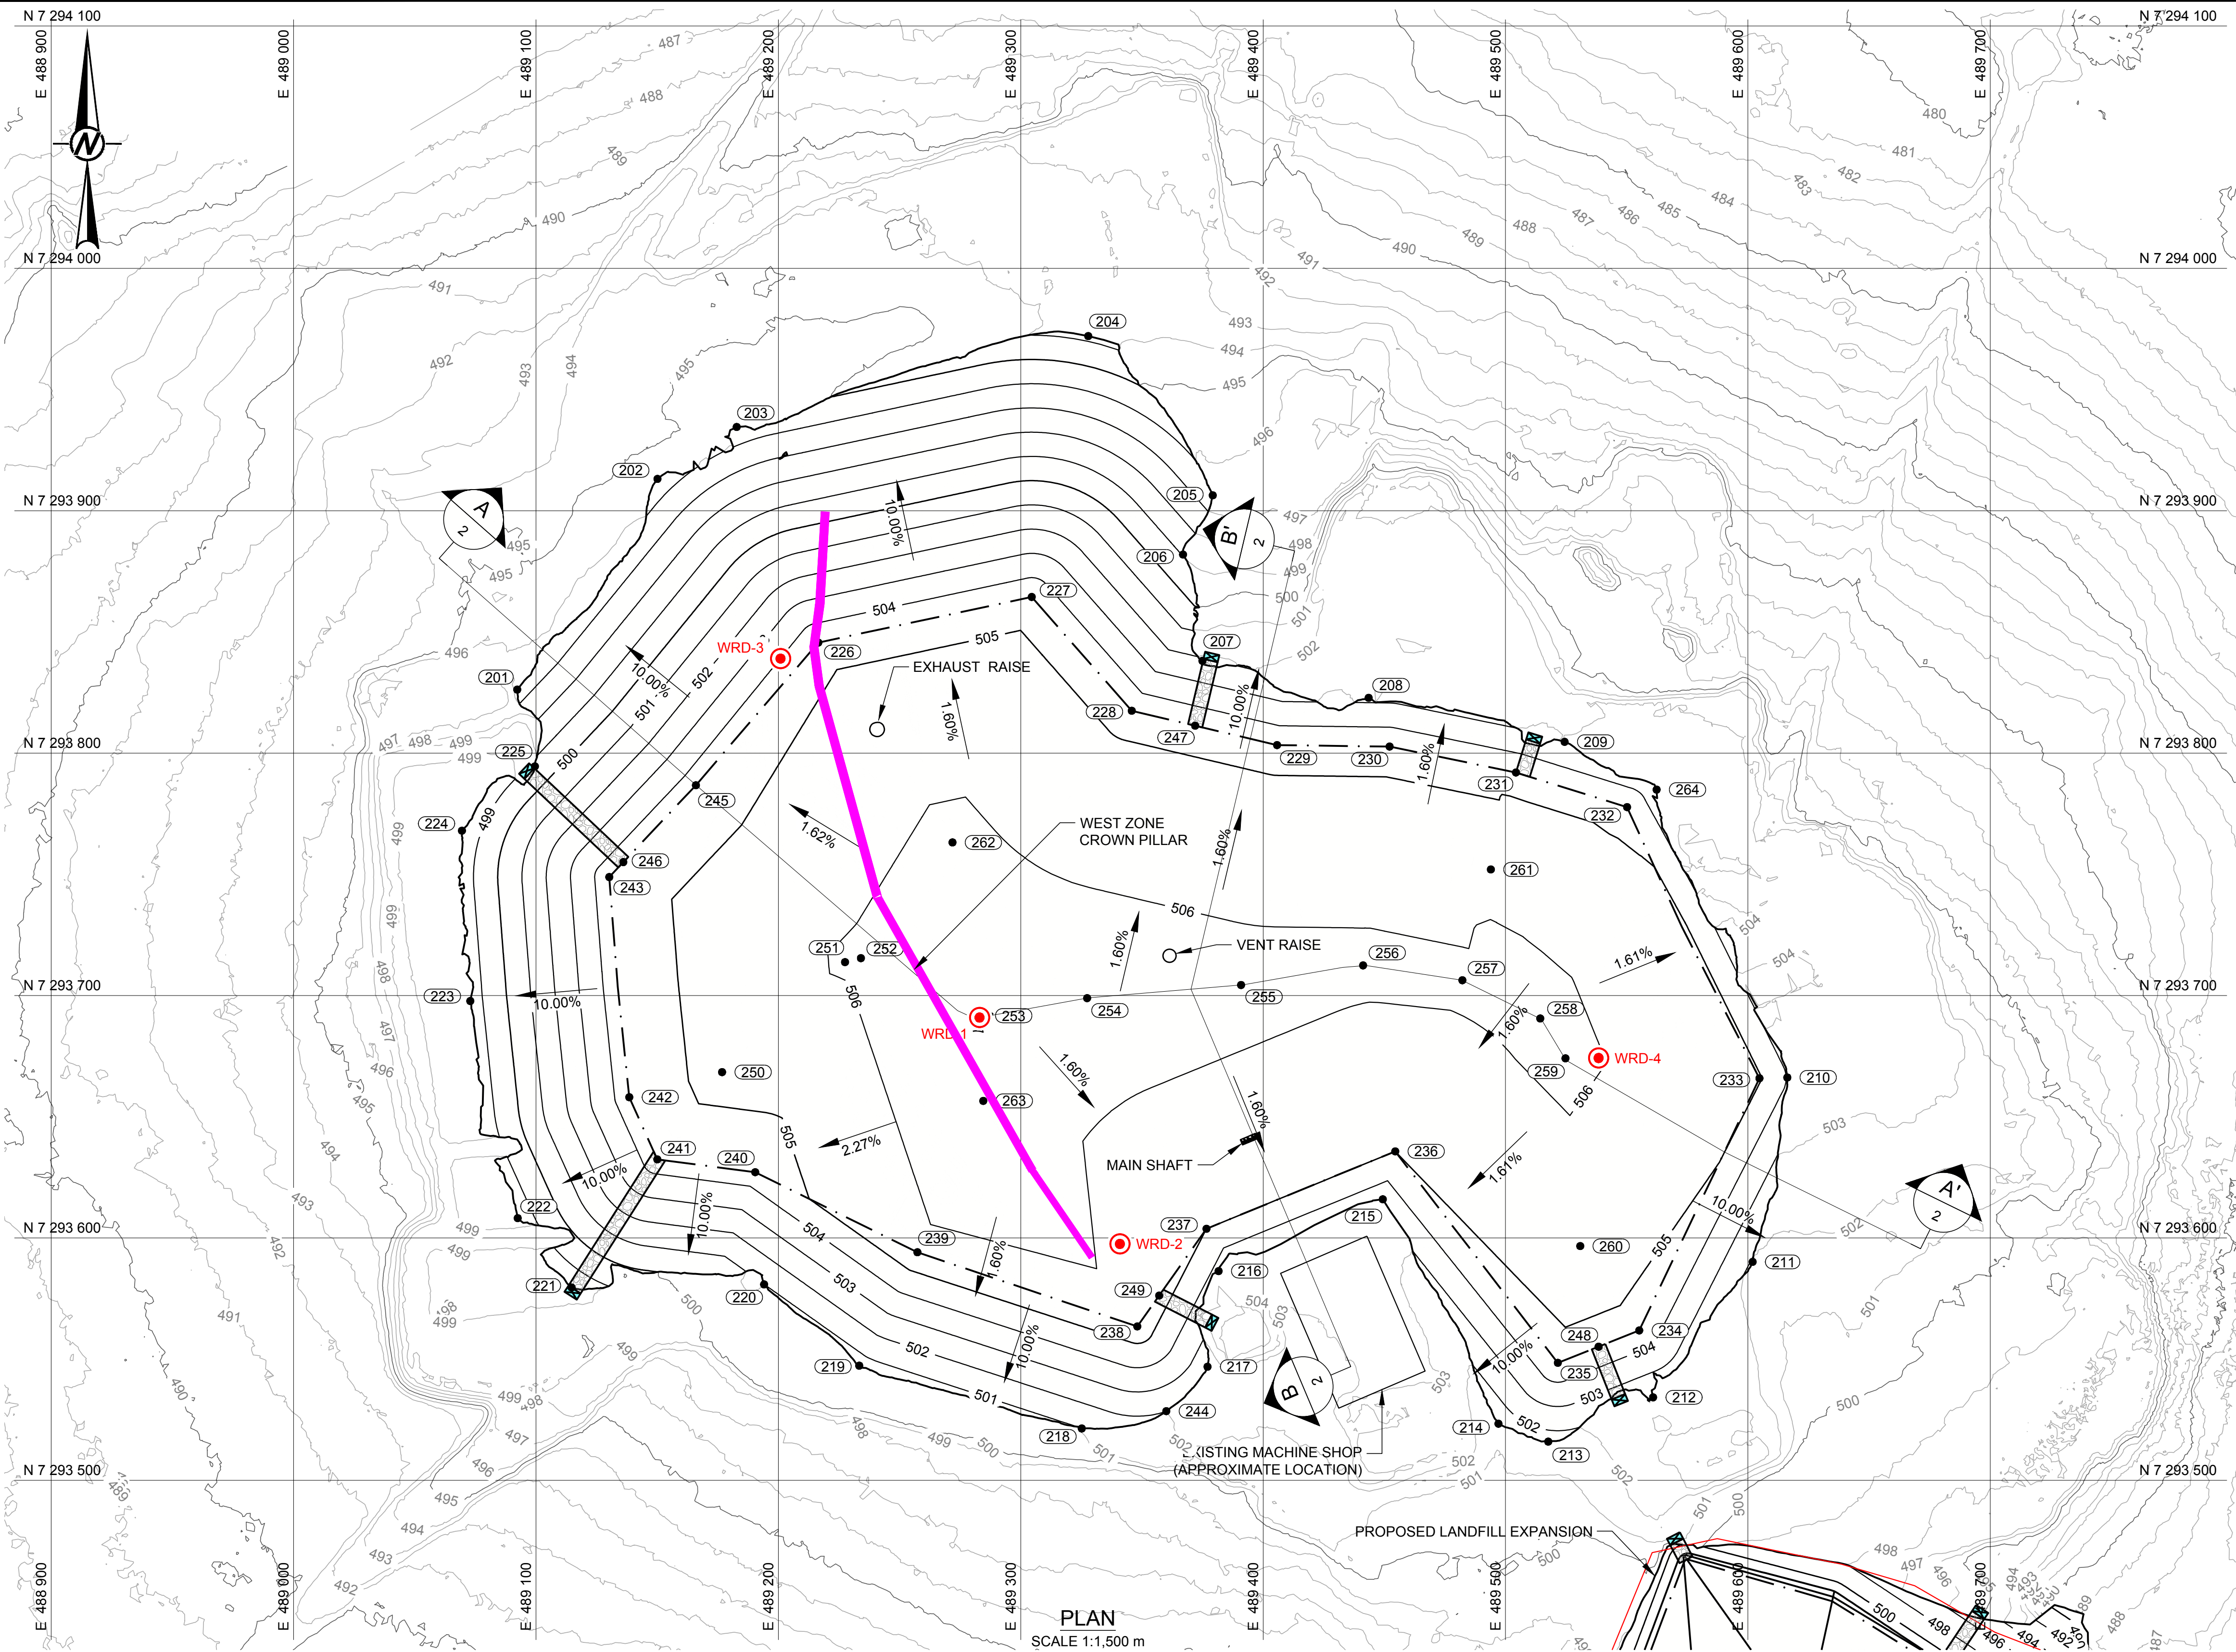
- THE DESIGN SURFACE SHOWN PROVIDES CAPACITY FOR ABOUT 269,000 m³ OF IMPORTED WASTE ROCK. IF LESS CAPACITY IS REQUIRED, A LOWER TOP SURFACE ELEVATION SHALL BE USED WHILE MAINTAINING THE GRADES AND DRAINAGE PATTERN SHOWN.

- TOPOGRAPHY BEYOND THE TOE OF WASTE ROCK DOME IS EXISTING TOPOGRAPHY BEFORE RELOCATION OF WASTE ROCK. WHERE WASTE ROCK IS PRESENT, THE COVER IS TO BE EXTENDED AT THE DESIGN SLOPE TO INTERSECT ORIGINAL GROUND.

- CONSTRUCT DITCHES OR BERMS AS NECESSARY TO DIRECT FLOW FROM DRAINAGE CHUTES AWAY FROM TOE OF DOME FILL.

Attached for Board's review in accordance with Part G, Item 1, are the final design specifications and for construction drawings, signed and stamped by an Engineer for the covered waste rock dome for closure at least sixty (60) days prior to initiating construction. The Issued for Construction drawings for the covered waste rock dome for the closure of the Lupin Mine are: Dwg. 19136158-0002-CM-0001_Rev 1 and Dwg. 19136158-0002-CM-0002_Rev 1.

Our review of the plans and sections observed that the 10% slopes, about 300m of top edge in the north portion of the “dome” is as much as 10m high and this extends out about 100m to the toe. The west and southwest side of the dome has a height of between 5m and 6m and thus extends out some 50+/- meters in these areas. Other than indicating that a berm will be constructed on the top edge of the dome to direct “dome surface” runoff to drainage chutes, no erosion control measures are included for ensure erosion protection and stability of these long 10% esker slopes. The plans and sections indicate that surface water runoff from the 1.6% surface slope, is expected to be drained off the dome, down the 10% slopes, via 6 runoff “drainage chutes”. Surface runoff is to be directed to these “chutes” by a small perimeter berm along the edge of the dome surface (0.5m high, 0.5m crest width, 2:1 slopes) constructed with the same esker material as the 1m dome cover surface. Given the importance of this berm in preventing overland sheet flow to the 10% slopes, we question the long term stability of the berm design as presented.

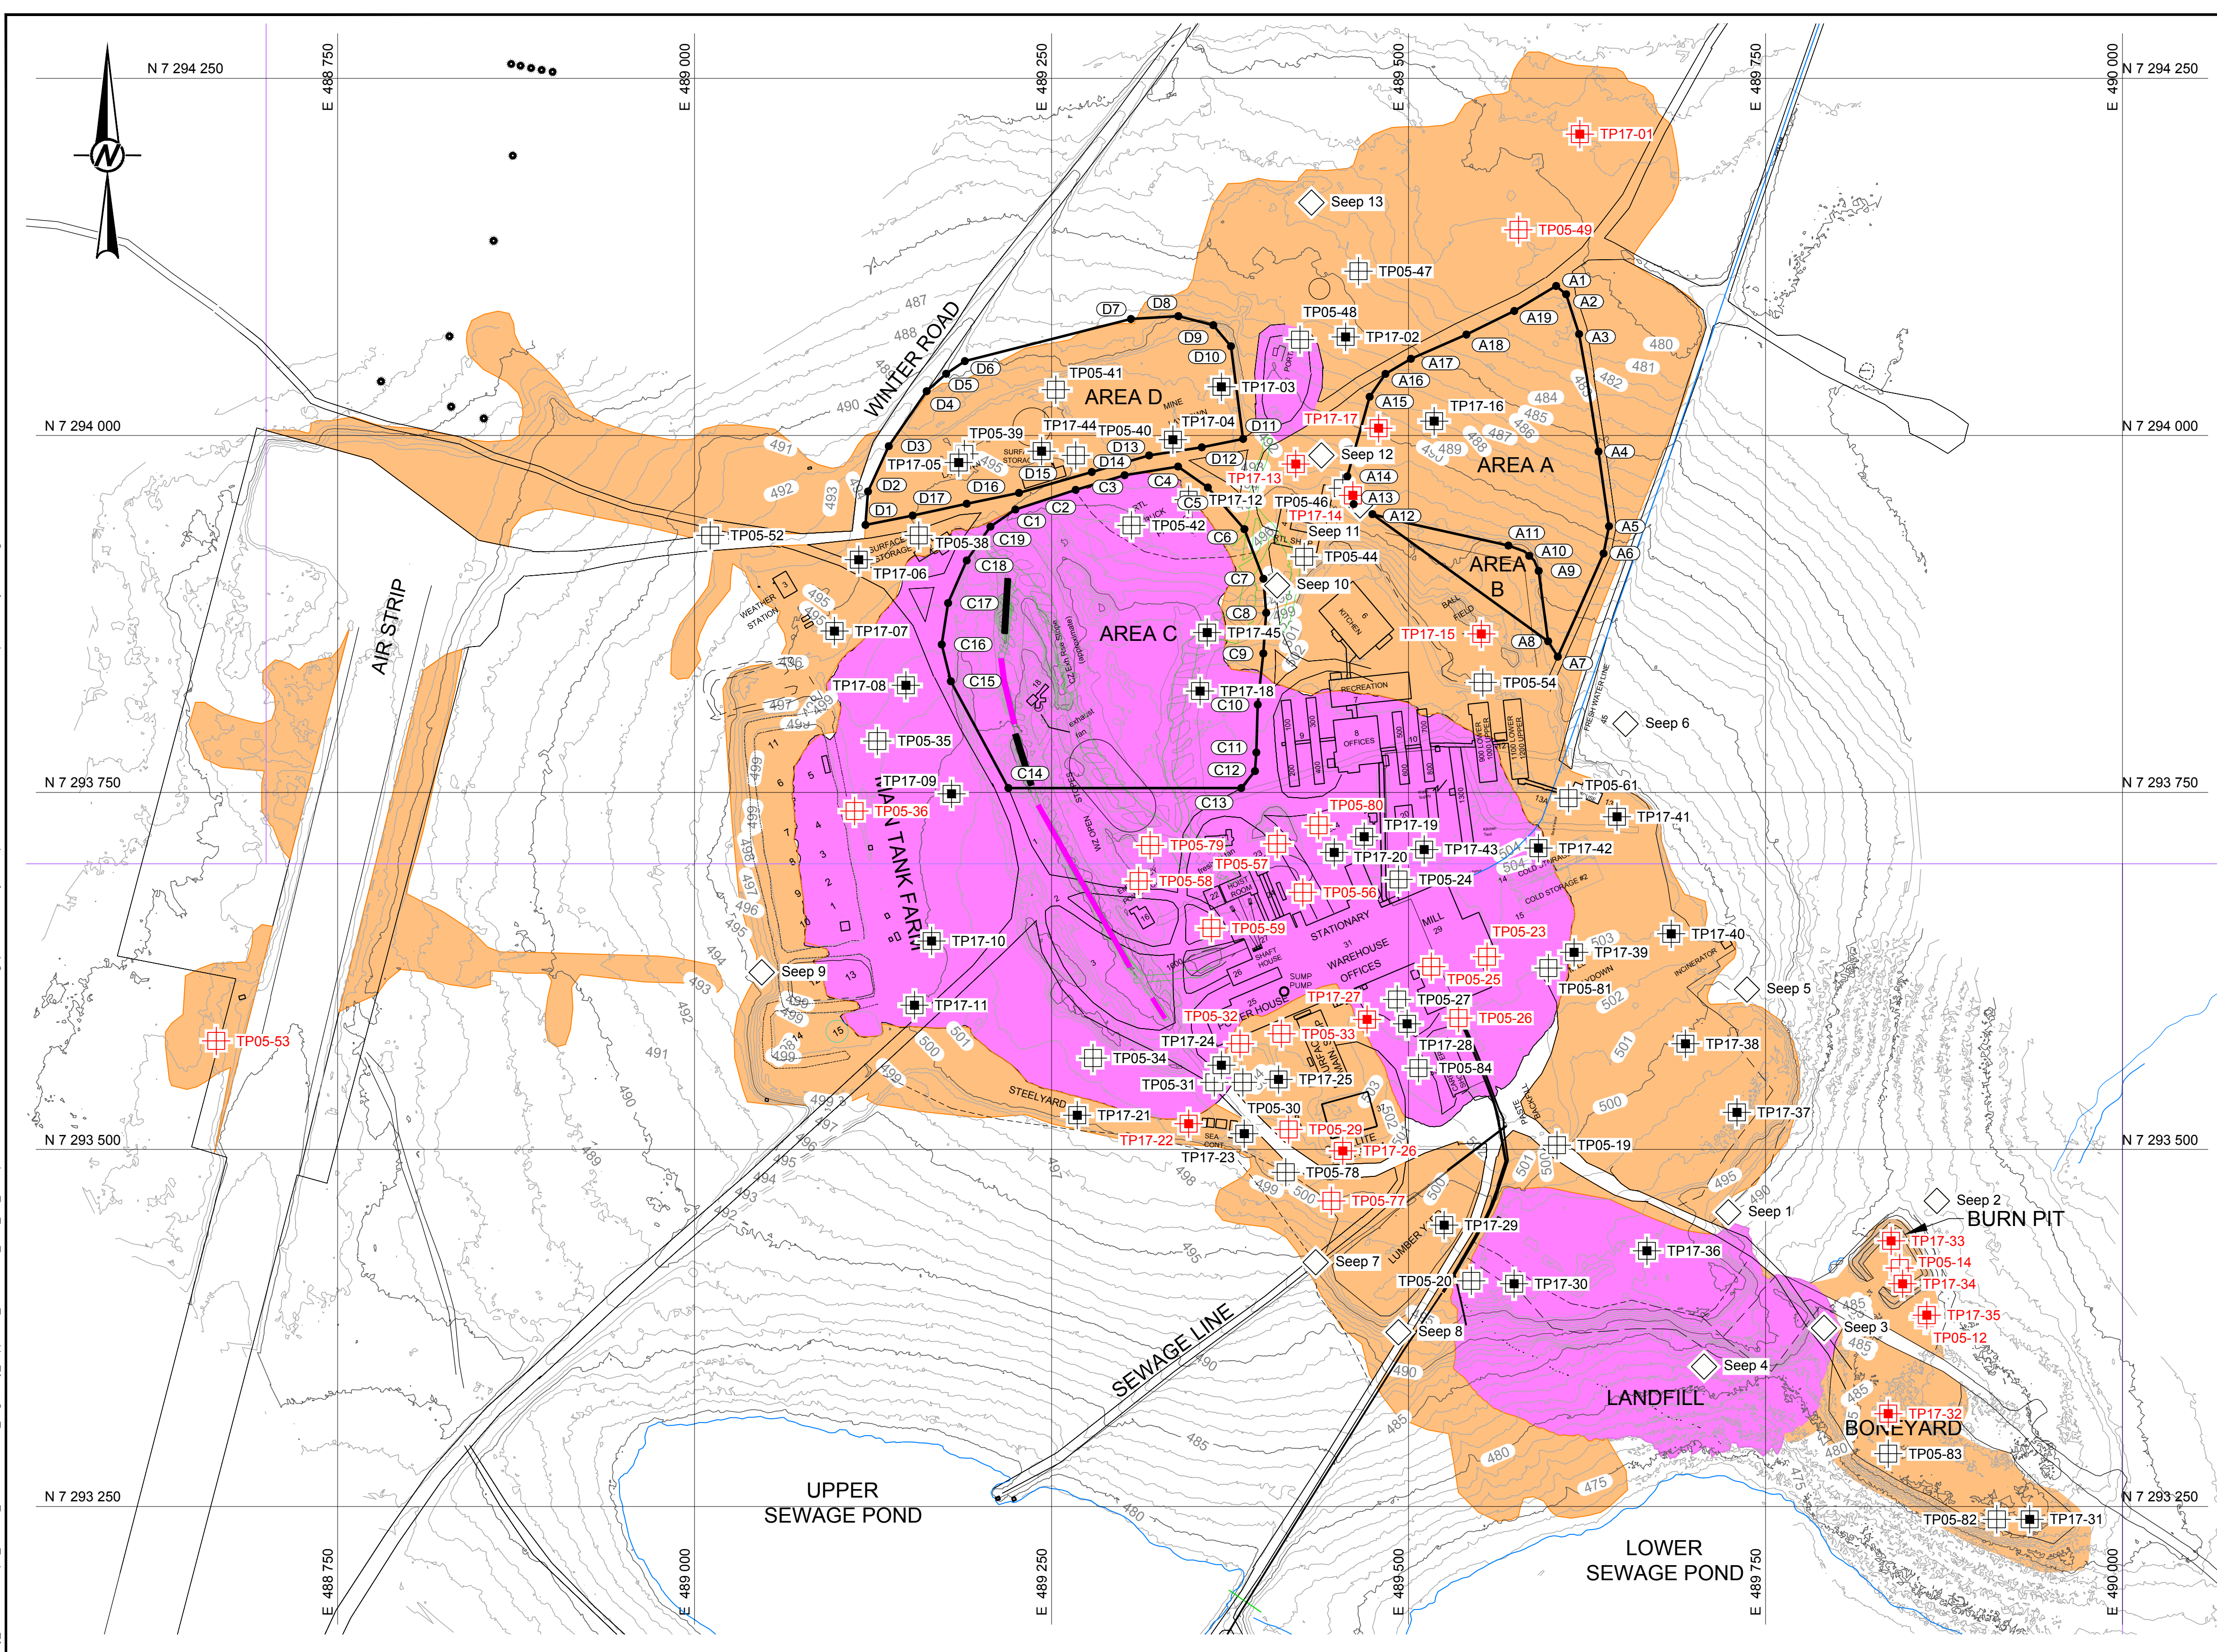
THE FOLLOWING MATERIALS SHALL BE REMOVED FROM THE EXISTING SUBGRADE AND PLACED IN THE CROWN PILLAR OR SHAFTS BEFORE THE WASTE ROCK IS RELOCATED OR COVERED: PETROLEUM HYDROCARBON CONTAMINATED SOILS, ARSENIC "HOT SPOTS", SOIL OR WASTE ROCK MATERIALS IMPACTED BY CYANIDE OR LEAD NITRATE, OR ANY HAZARDOUS WASTE. SUCH REMOVAL SHALL BE APPROVED BY THE OWNER/ENGINEER BEFORE WASTE ROCK RELOCATION OR COVERING PROCEEDS.
