**Kinross Gold Corporation**

**LUPIN OPERATION**

**CLOSURE PLAN FOR  
TAILINGS CONTAINMENT AREA**

**JANUARY 2005**

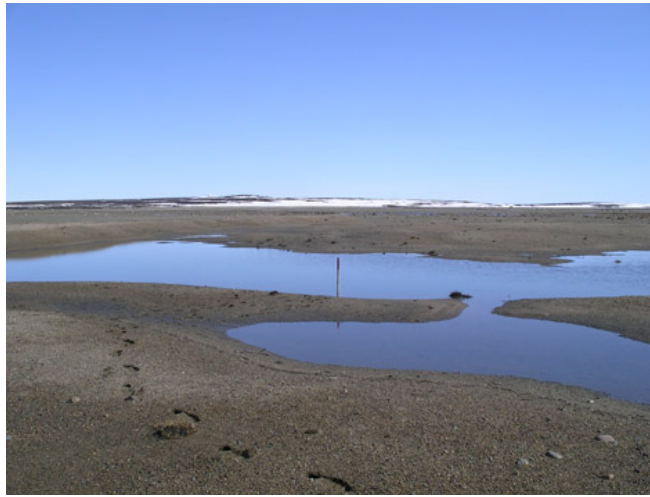
**Figure 9-2. Ponded water in Cell 1, location of water sampling**

The main impact of esker pore water on the receiving water can be determined from following the water quality from the pipes to areas where it emerges at Cell 1 ponded water surfaces and than progresses to the larger water bodies in Pond 1 and Pond 2. The ponded

water in Cell 1 is shown in Figure 9-2. Water quality measured in Cell 1 ponded water area (2004) and Ponds 1 and 2 in 2003 and 2004 are given in Table 9-5 and Table 9-6 respectively.
