**Kinross Gold Corporation**

**LUPIN OPERATION**

**CLOSURE PLAN FOR  
TAILINGS CONTAINMENT AREA**

**I. Holubec Consulting Inc.**

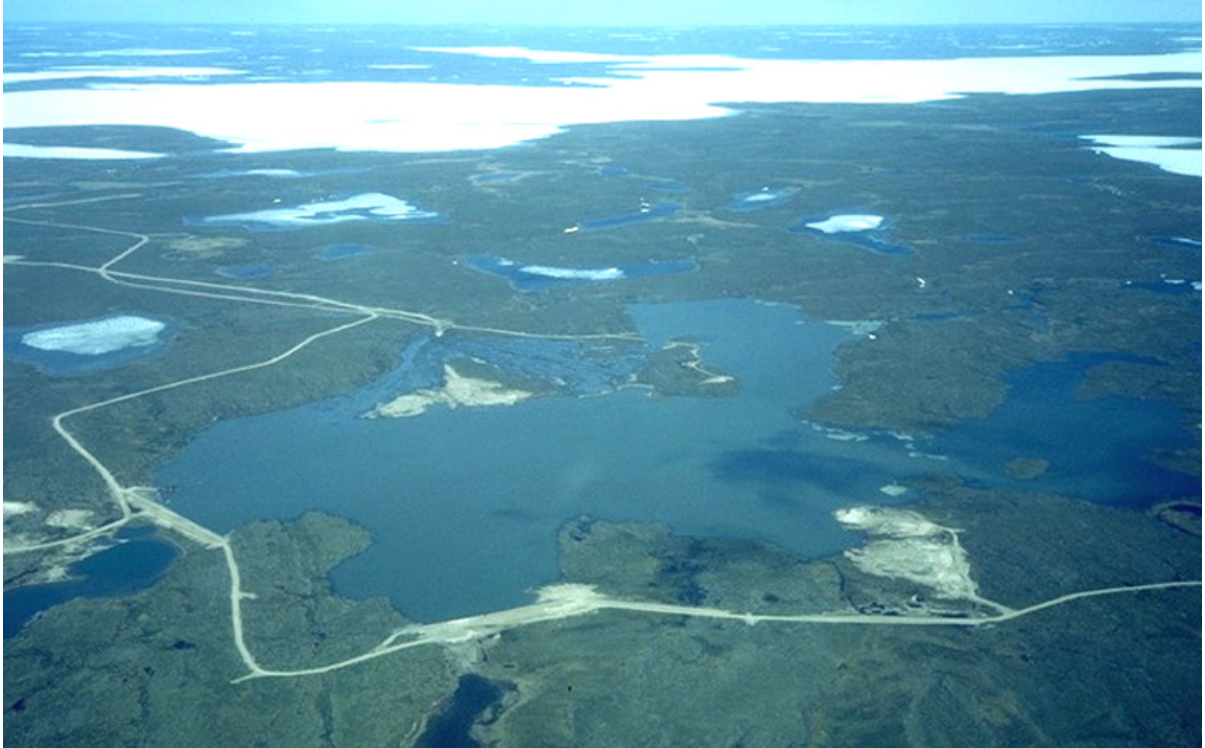
Figure 2-5. Photo of initial TCA in 1983, looking northeast

Ore milling commenced in 1982 and the tailings slurry was discharged from the northern edge of the TCA to form one large pond against Dams 1a and 2 as shown in a photograph in Figure 2-5. This operation strategy continued until 1985. Increased production of ore resulted in the adoption of a revised tailings management strategy that deposits the tailings within cells. Excess water from these cells is directed into two ponds in series within the TCA that improves the water quality before the water is discharged. Since 1985, water has been discharged from a downstream polishing pond to control the water level within ponds.

To create the two ponds, J Dam was constructed between two original Lakes 'd' and 'i' shown on Figure 2-4. The proposed route of the dam was on land that had a thin till cover over bedrock. It did cross a small stream that drained Lake 'i' into Lake 'd' shown on Figure 2-6. At this time, the original proposed alignment of Dam J was already flooded by the filling of the TCA reservoir as shown in Figure 2-5.

Construction of Dams 1a, 2 and 4 changed the water management of TCA. During the initial 5 years, all water inputs into the TCA, precipitation and slurry water were retained within the TCA. This resulted in forming a large pond against Dams 1a and 2 as illustrated in Figure 2-5. From 1985, Lupin began storing the tailings in cells and managing excess water by passing it through a series of ponds to improve the water to meet discharge quality before siphoning the water over Dam 1a annually. Layout of the TCA during 2000 is portrayed in an aerial photo taken in 2000 in Figure 6-3.

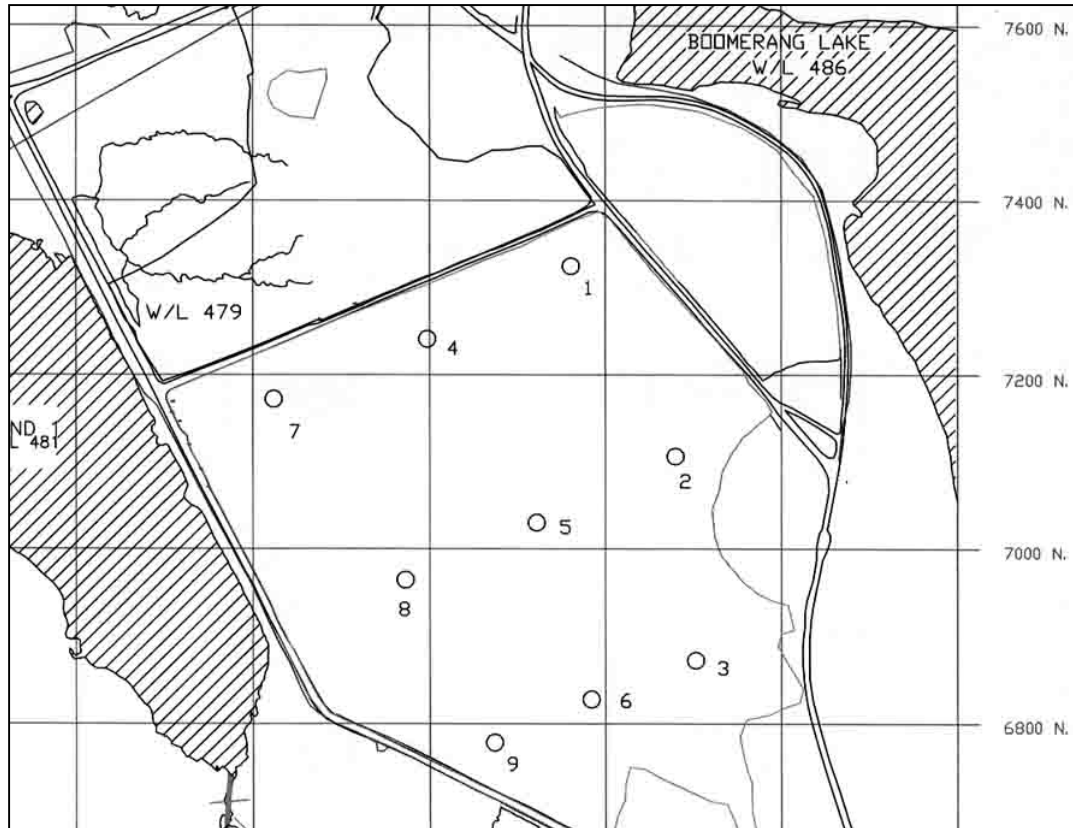
Figure 8-5. Location of pipes installed in 2002

Lupin decided to pursue the saturated zone cover concept in 2002 and oriented its field testing and monitoring to confirm the validity of this concept. Nine 1.5-metre long pipes were installed within Cell 1 (Figure 8-5) in the summer of 2002 to:

More extensive sampling and testing of the esker pore water was started in August 2002 to obtain a better understanding of water quality within the esker cover saturated zone and how this pore water affects the water as it emerges from the ground. For this purpose 9 pipes were installed in Cell 1 as shown in Figure 8-5.

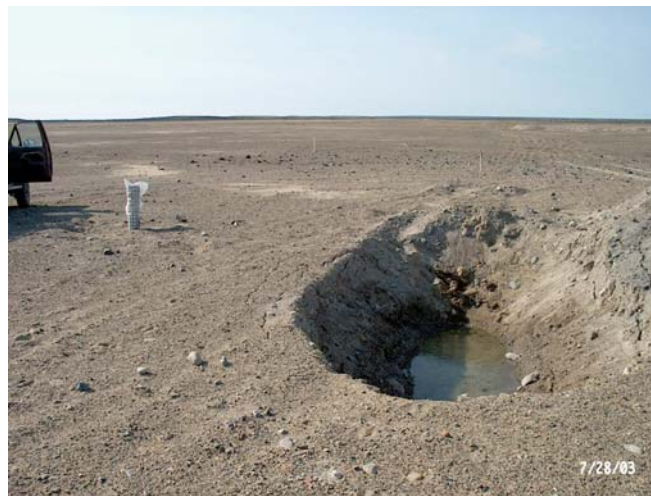
**Figure 9-1. Test Pit 2a used for water sampling beside P-2**

To study what happens to the saturated zone pore water as it emerges at the surface, a test pit was excavated beside pipe P-2 and sampled for water quality. Photo of the excavation beside P-2 is shown in Figure 9-1 and the monitored water quality results are given in Table 9-4.

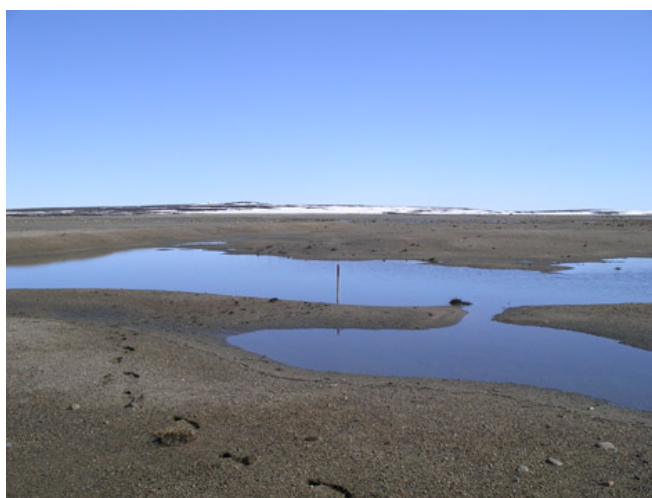
**Figure 9-2. Ponded water in Cell 1, location of water sampling**

The main impact of esker pore water on the receiving water can be determined from following the water quality from the pipes to areas where it emerges at Cell 1 ponded water surfaces and than progresses to the larger water bodies in Pond 1 and Pond 2. The ponded

water in Cell 1 is shown in Figure 9-2. Water quality measured in Cell 1 ponded water area (2004) and Ponds 1 and 2 in 2003 and 2004 are given in Table 9-5 and Table 9-6 respectively.
