**Kinross Gold Corporation**

**LUPIN OPERATION**

**CLOSURE PLAN FOR  
TAILINGS CONTAINMENT AREA**

**JANUARY 2005**

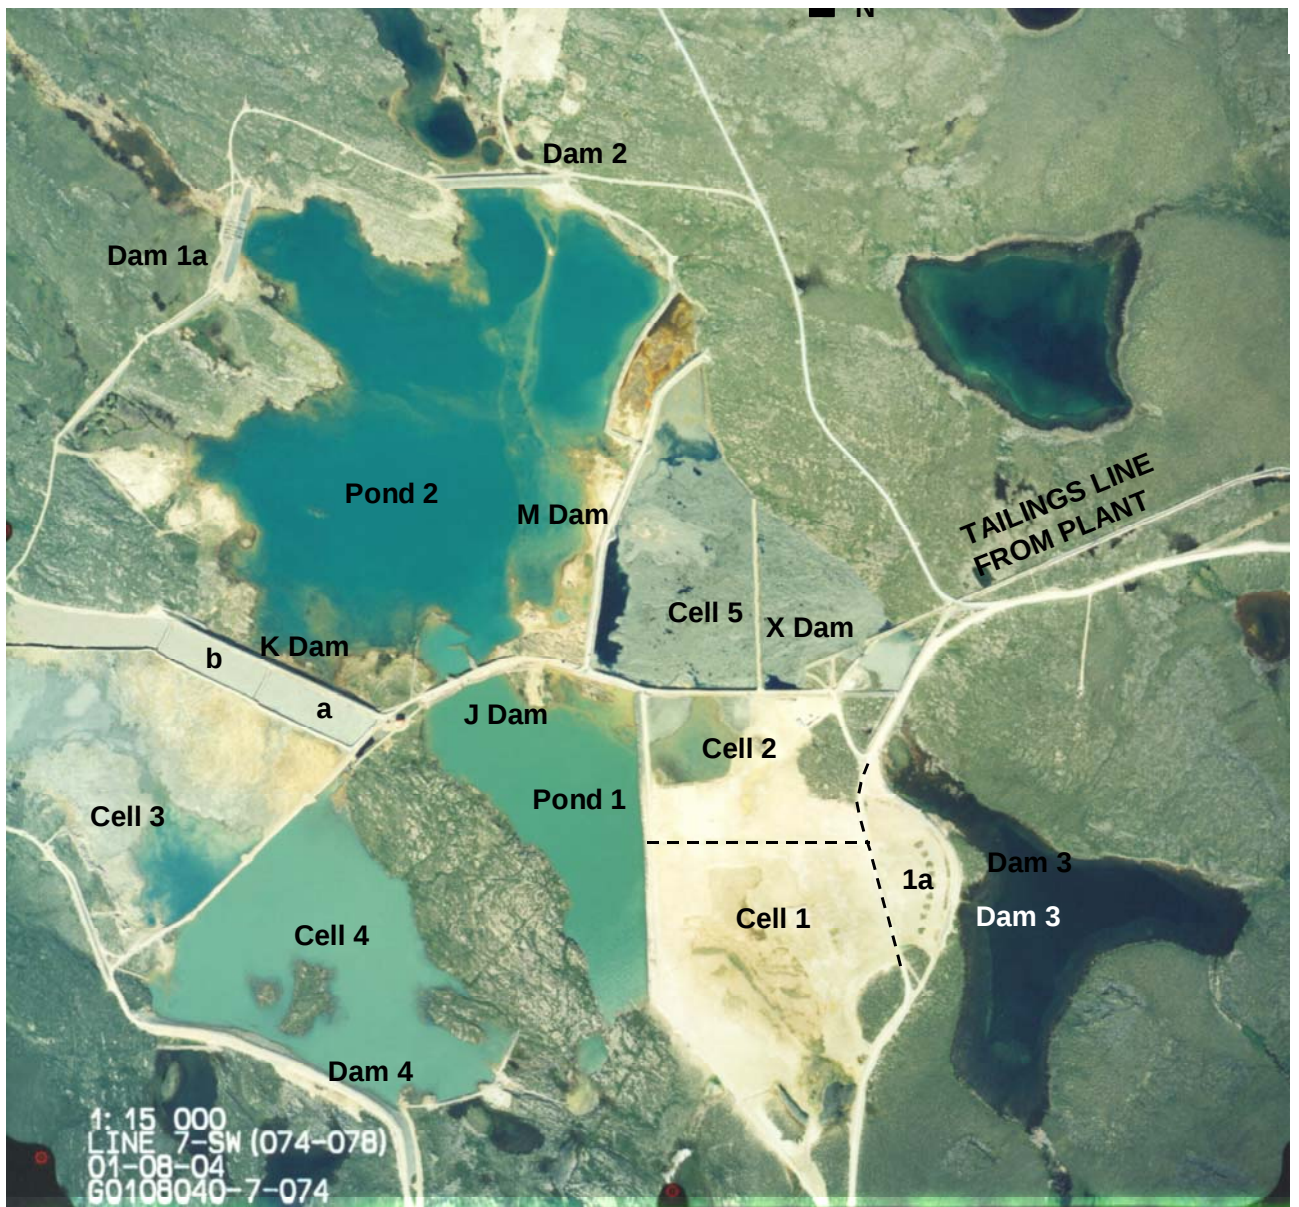
Figure 6-3. Aerial view of TCA in 2001

Construction of Dams 1a, 2 and 4 changed the water management of TCA. During the initial 5 years, all water inputs into the TCA, precipitation and slurry water were retained within the TCA. This resulted in forming a large pond against Dams 1a and 2 as illustrated in Figure 2-5. From 1985, Lupin began storing the tailings in cells and managing excess water by passing it through a series of ponds to improve the water to meet discharge quality before siphoning the water over Dam 1a annually. Layout of the TCA during 2000 is portrayed in an aerial photo taken in 2000 in Figure 6-3.

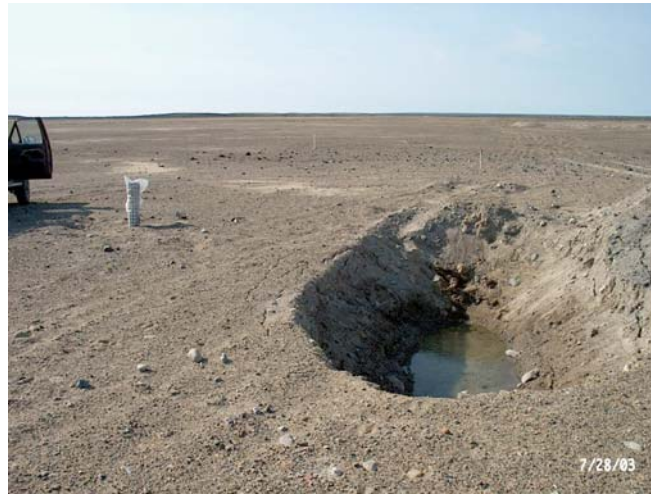
**Figure 9-1. Test Pit 2a used for water sampling beside P-2**

To study what happens to the saturated zone pore water as it emerges at the surface, a test pit was excavated beside pipe P-2 and sampled for water quality. Photo of the excavation beside P-2 is shown in Figure 9-1 and the monitored water quality results are given in Table 9-4.
