To:	Karyn Lewis Lupin Mine Incorporated	From:	Alvin Tong Stantec Consulting Ltd.
File:	Supporting information to the Contingency Contaminants Management Decision Matrix	Date:	January 9, 2020

Reference: Supporting Information to the Contingency Contaminants Management Decision Matrix

Reference: 2 AM-LUP Technical Meeting Commitment Number 13 Response – Lupin Mine Tailings Containment Area Dams Thermal Modelling Results

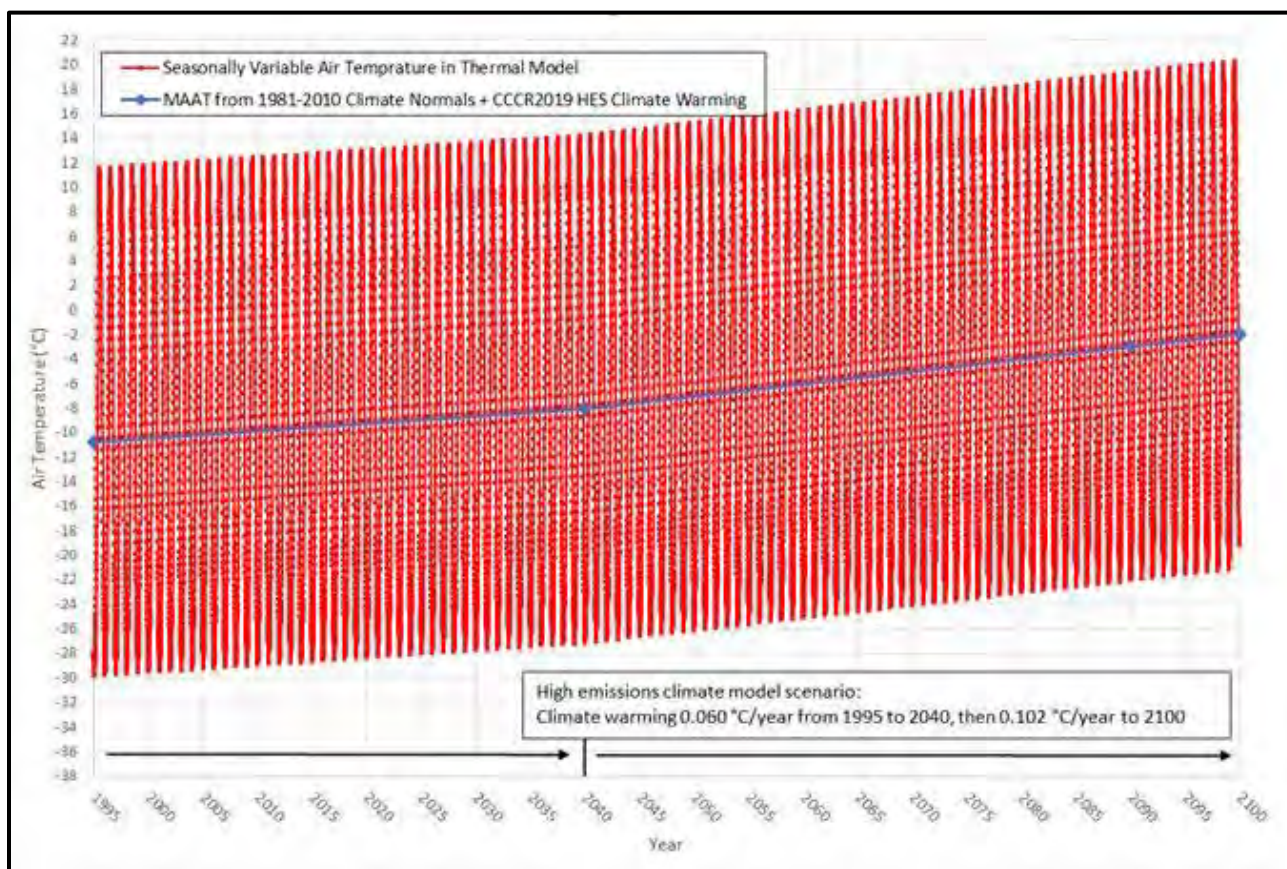
Figure 2: HES Scenario – Lupin Thermal Modelling with Climate Warming, Air Temperature Input Data

The HES model represents the worst-case emissions scenario (i.e., highest rate of climate warming) of the three climate warming scenarios considered. Figure 2 displays the seasonal variation in air temperature used in the HES thermal modelling. The air temperature data is shown at 5-day intervals represented by red symbols. The MAAT is shown by the blue symbols and is the same air temperature data that was shown for the HES scenario in Figure 1.

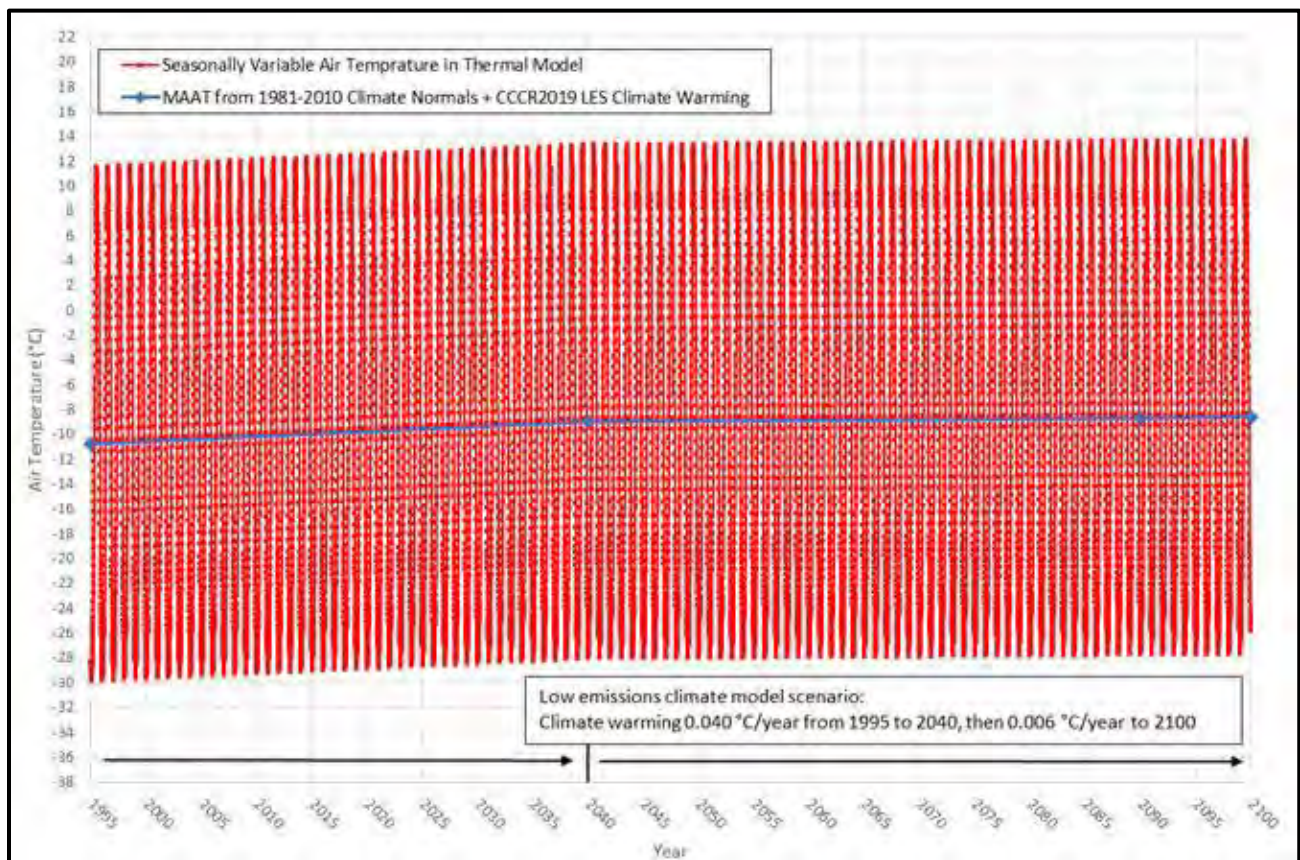
Figure 4: LES Scenario – Lupin Thermal Modelling with Climate Warming, Air Temperature Input Data

The air temperature data used in the modelling for the LES thermal modelling is shown in Figure 4. The LES scenario uses a MAAT increase of 2.2°C from 1995 to 2100. CCCR, 2019, states that the warming trend observed in Canada from 1948 to 1996 was 1.2°C, representing an average warming rate of 0.025°/yr. Accordingly, the LES is considered to be more realistic than the HES.

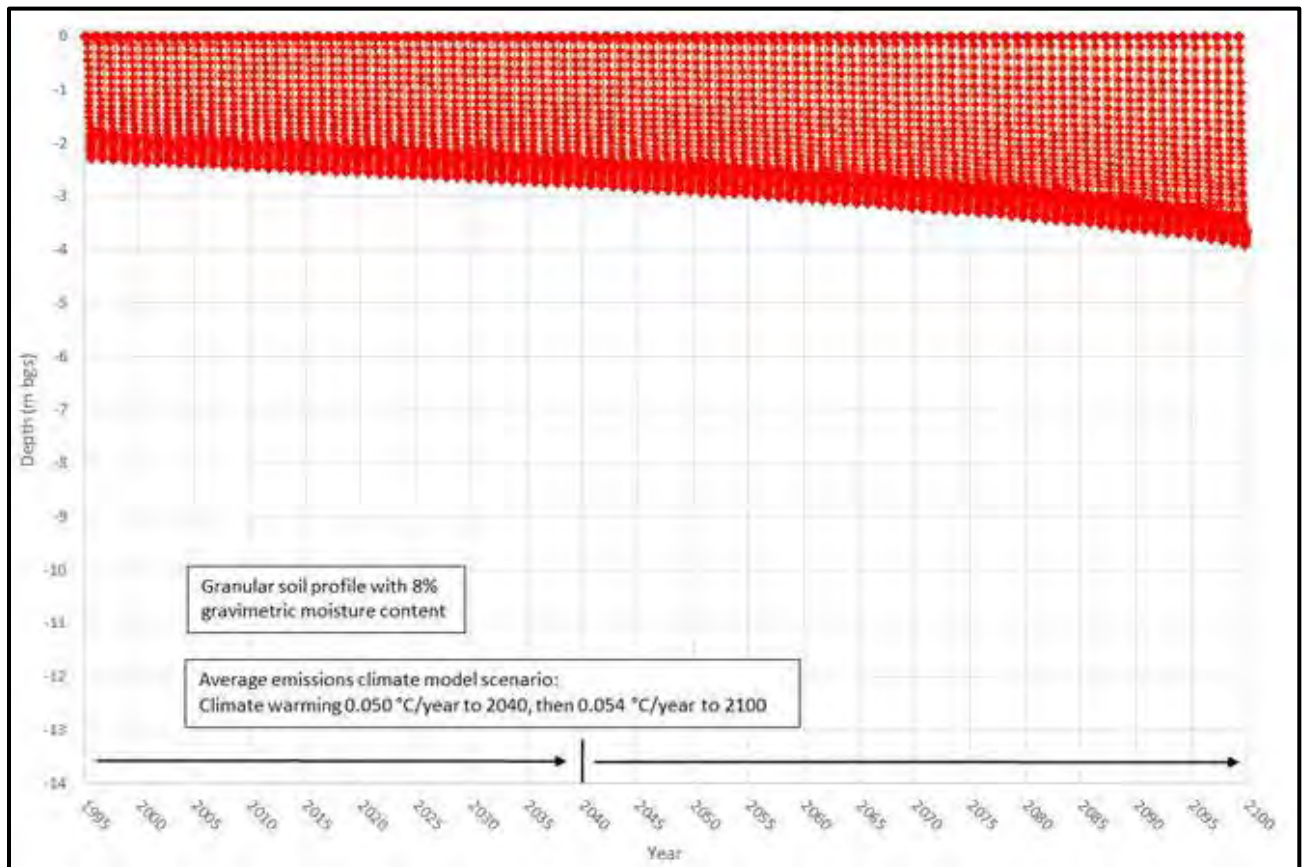
Figure 7: LES Scenario – Lupin Long-Term Thaw Depth with Climate Warming

Figure 7 shows the model-calculated thaw depth for the AES from 1995 to 2100. The model begins with an active layer thaw depth of 2.3 m in 1995, which deepens to 3.9 m by year 2100, indicating an active layer thickness increase of 1.6 m. As with the LES, there is no long-term progressive permafrost thaw.

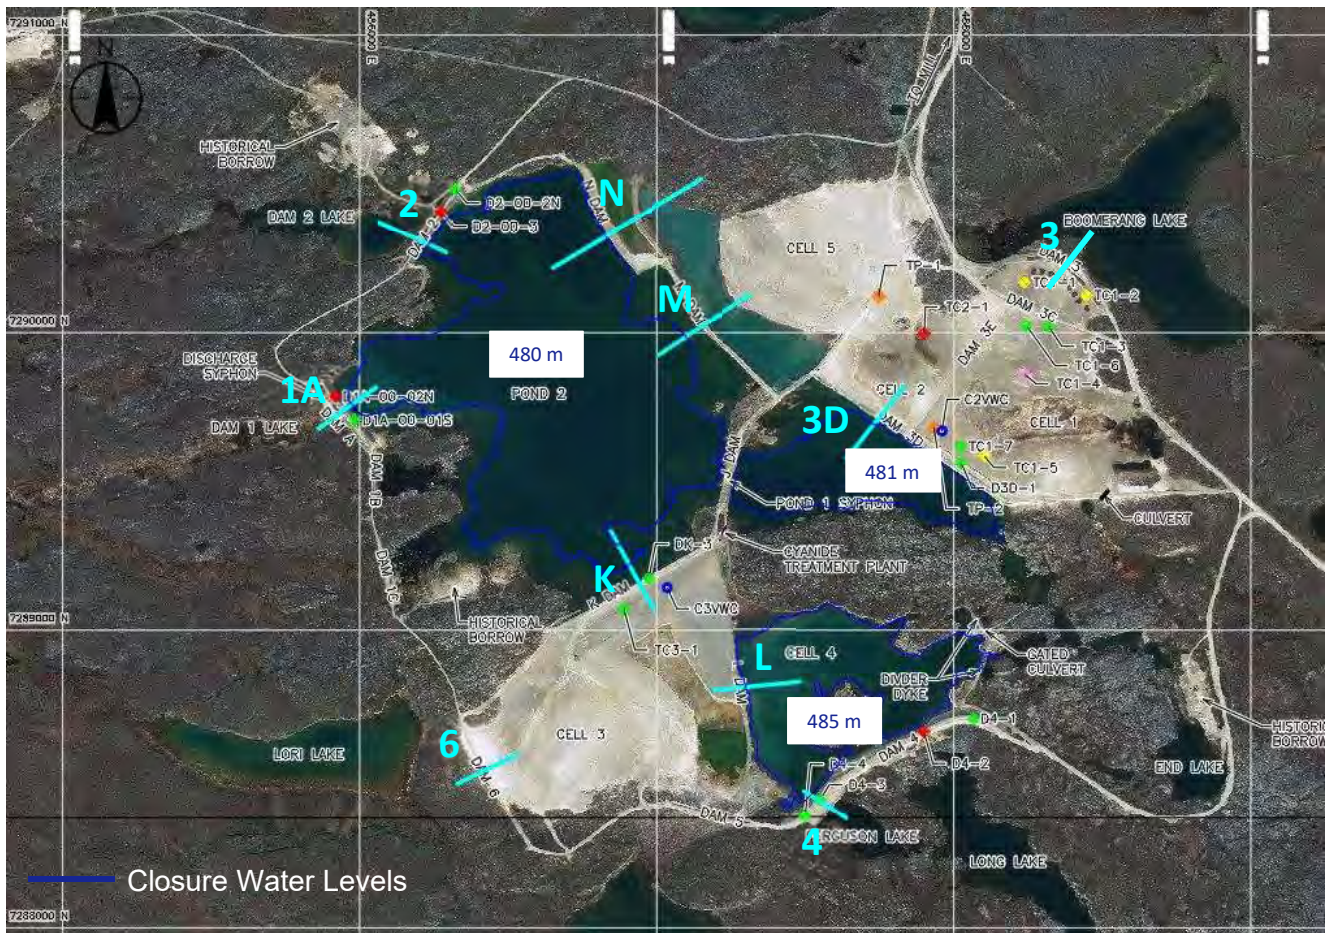
Figure 1: Tailings Containment Area Stability Section Locations

Slope stability analyses have been completed for the closure condition of the Lupin dams. The dam cross-sections are based on the historical design sections presented in the dam safety review report (SRK, 2016). A plan view with cross-section locations is shown on Figure 1. Material properties used in the analyses are based on previous work experience with similar materials and are presented in Table 2. The analyses have been completed using the limit equilibrium software, SLOPE-W, from GeoStudio 2018 (Version 9.0.4). The FOS values were calculated using the Spencer method in SLOPE/W.

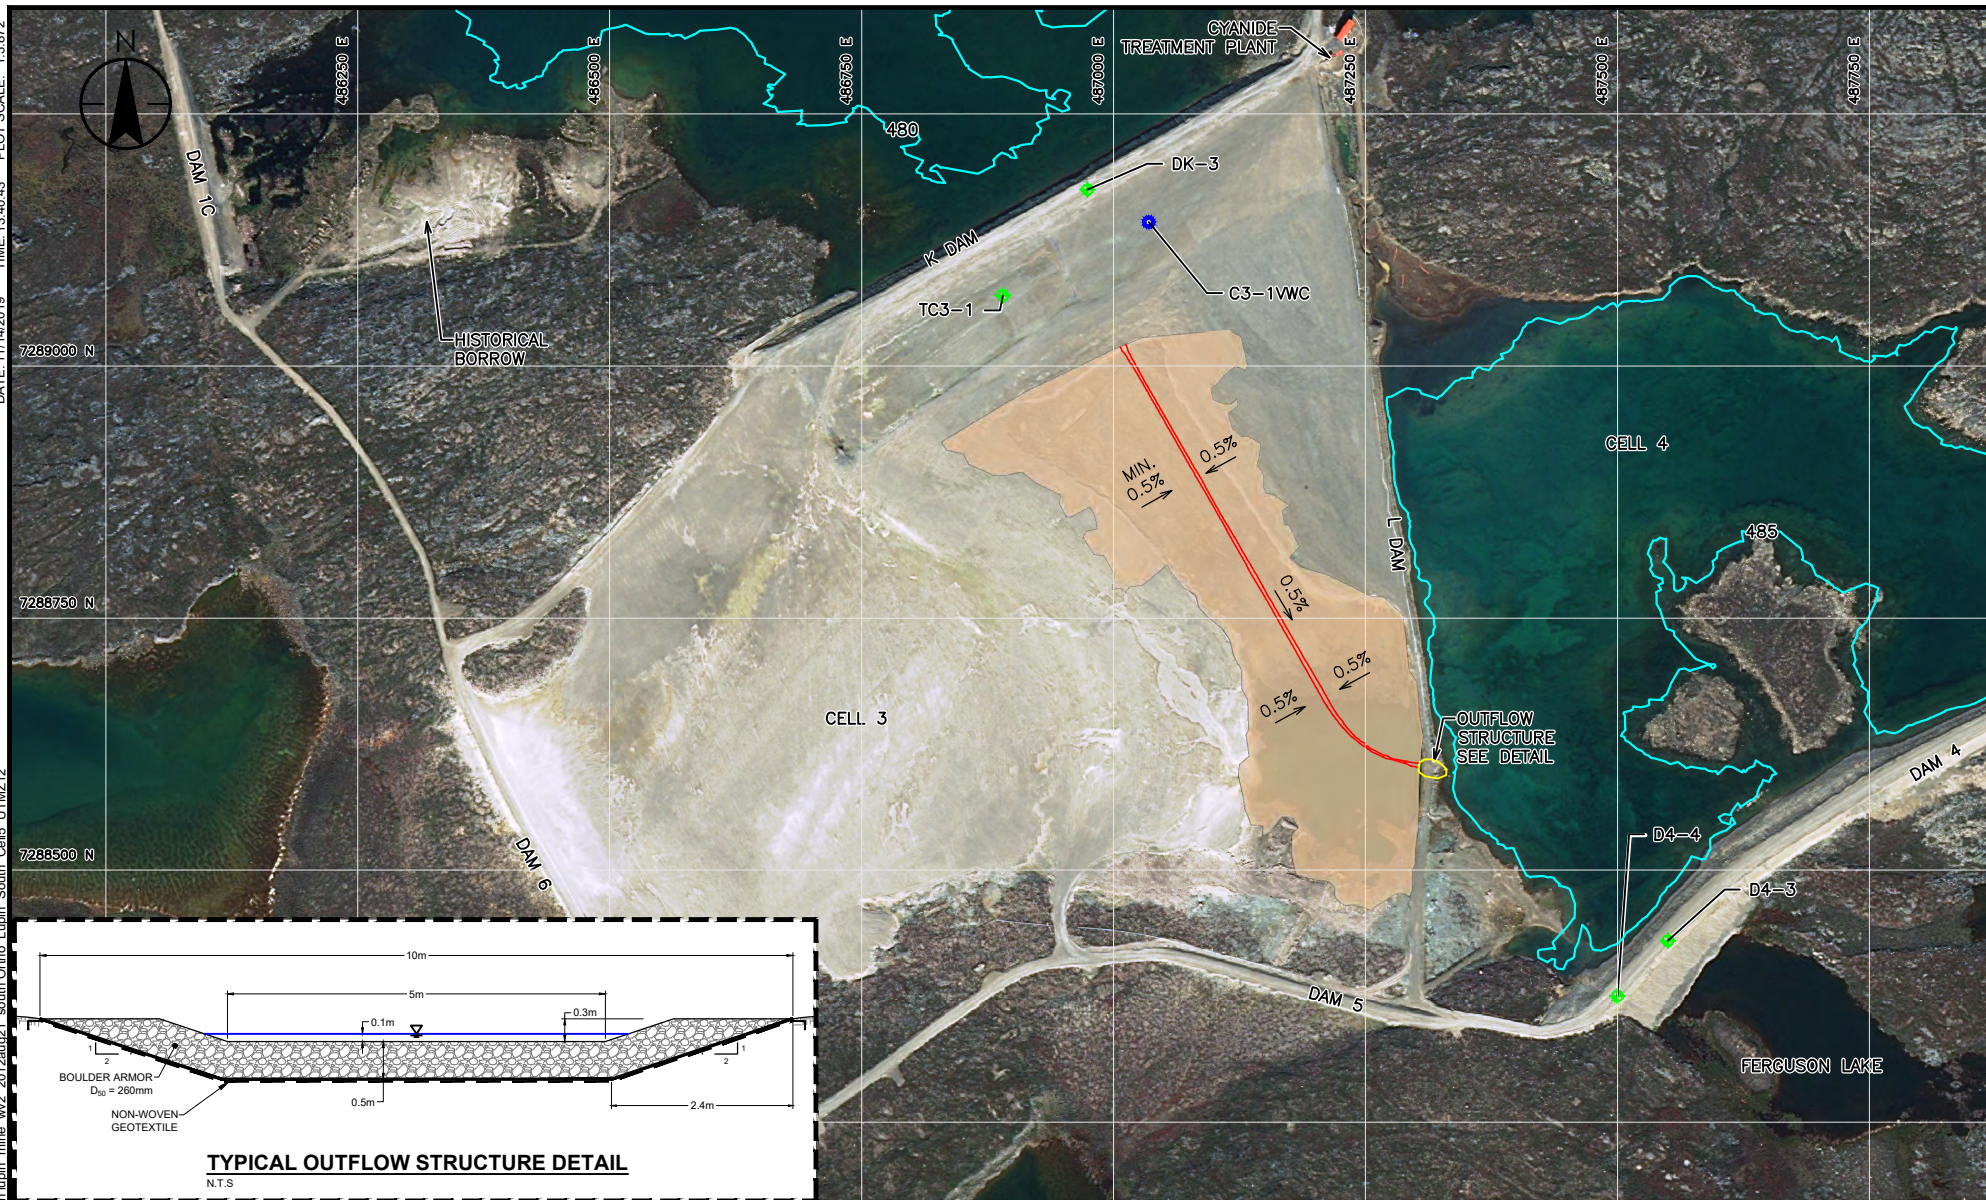
The Cell 3 engineered cover design is shown on Figure 2 and Cell 5 engineered cover design is shown on Figure 3. These should mitigate long term erosion potential over the dam face.

Attachment: Figure 2 – Cell 3 Engineered Cover Design
Figure 3 – Cell 5 Engineered Cover Design
Appendix A – Stability Analyses Results

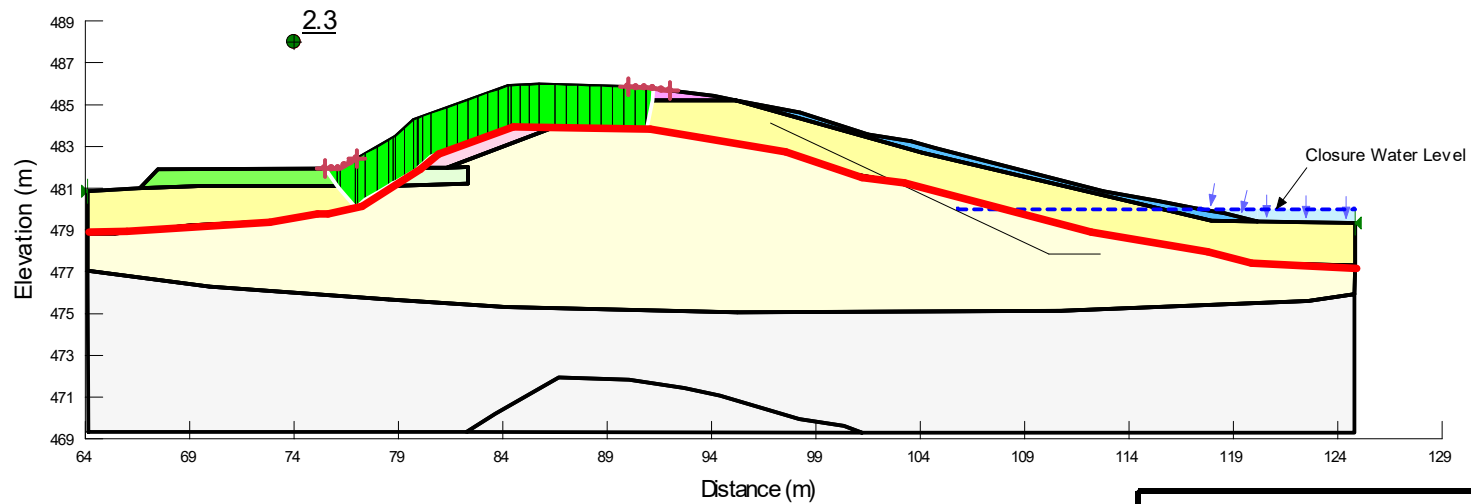
SLOPE STABILITY ANALYSIS
SECTION 2 – PERMAFROST CONDITIONS
PSEUDO-STATIC CASE – GLOBAL FAILURE

Current Permafrost Conditions: permafrost is present at depth 2m below ground surface

1. FOS is for global failure that breaches the dam using Spencer method in SLOPE/W (GeoStudio 2018, version 9.0.4).

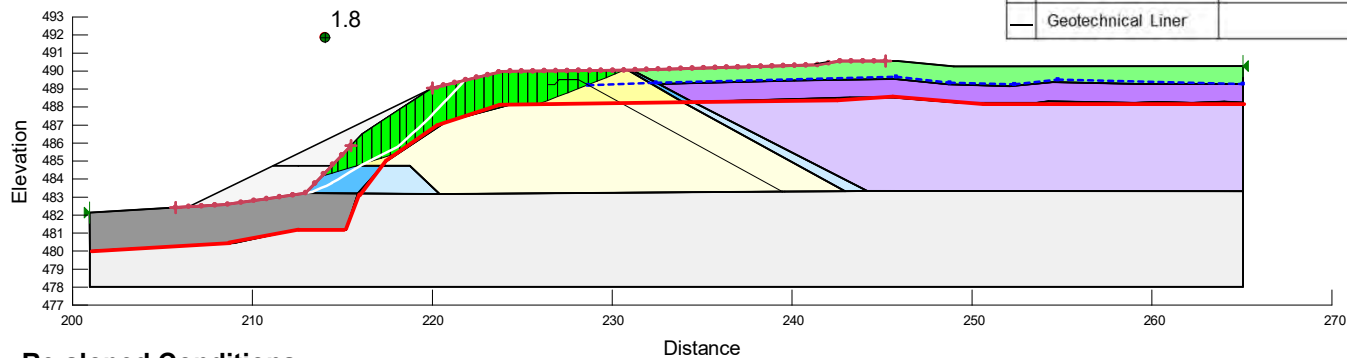
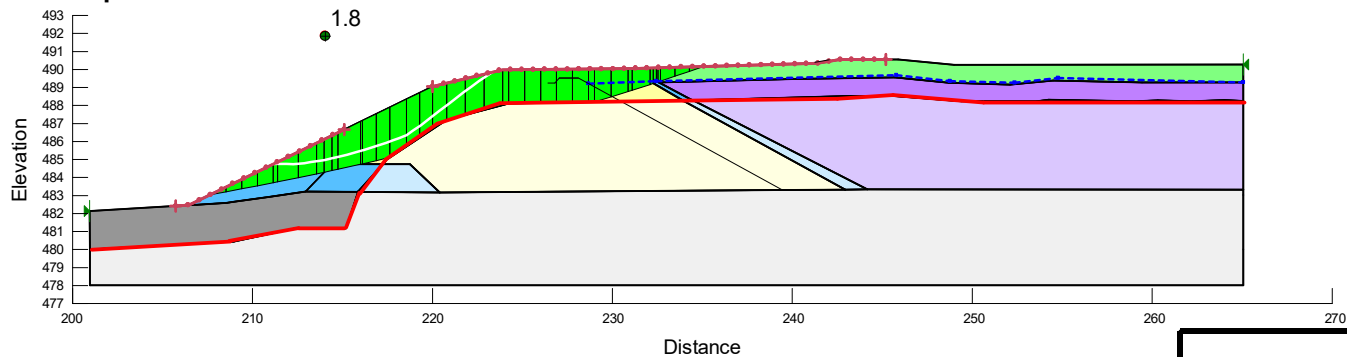
SLOPE STABILITY ANALYSIS
SECTION K – PERMAFROST CONDITIONS
STATIC CASE – LOCAL FAILURE

Details:**Current Permafrost Conditions:** permafrost is present at depth 2m below ground surface**Re-sloped Conditions:** regraded to 2H:1V to reach minimum FOS criteria

As Built Conditions

**Re-sloped Conditions**

1. FOS is for global failure that breaches the dam using Spencer method in SLOPE/W (GeoStudio 2018, version 9.0.4).

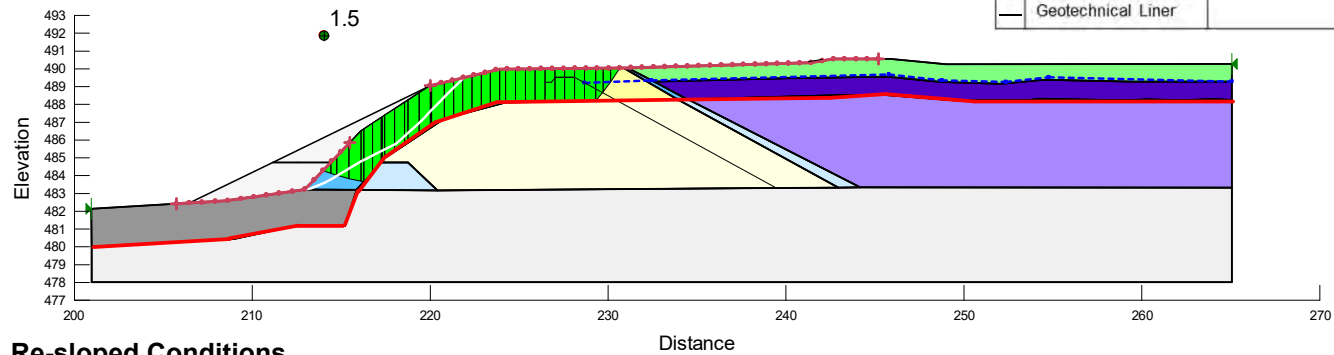
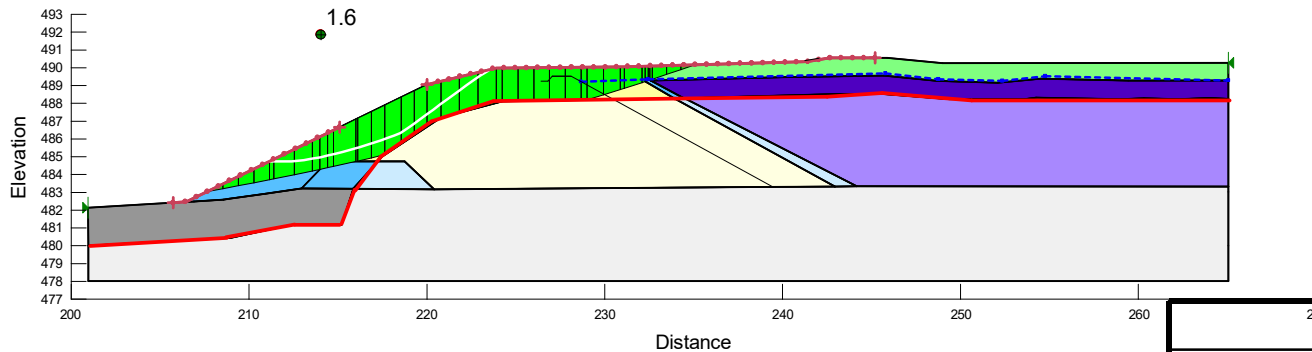
SLOPE STABILITY ANALYSIS
SECTION K – PERMAFROST CONDITIONS
STATIC CASE - GLOBAL FAILURE

Current Permafrost Conditions: permafrost is present at depth 2m below ground surface

Re-sloped Conditions: regraded to 2H:1V to reach minimum FOS criteria

As Built Conditions

Re-sloped Conditions

1. FOS is for global failure that breaches the dam using Spencer method in SLOPE/W (GeoStudio 2018, version 9.0.4).

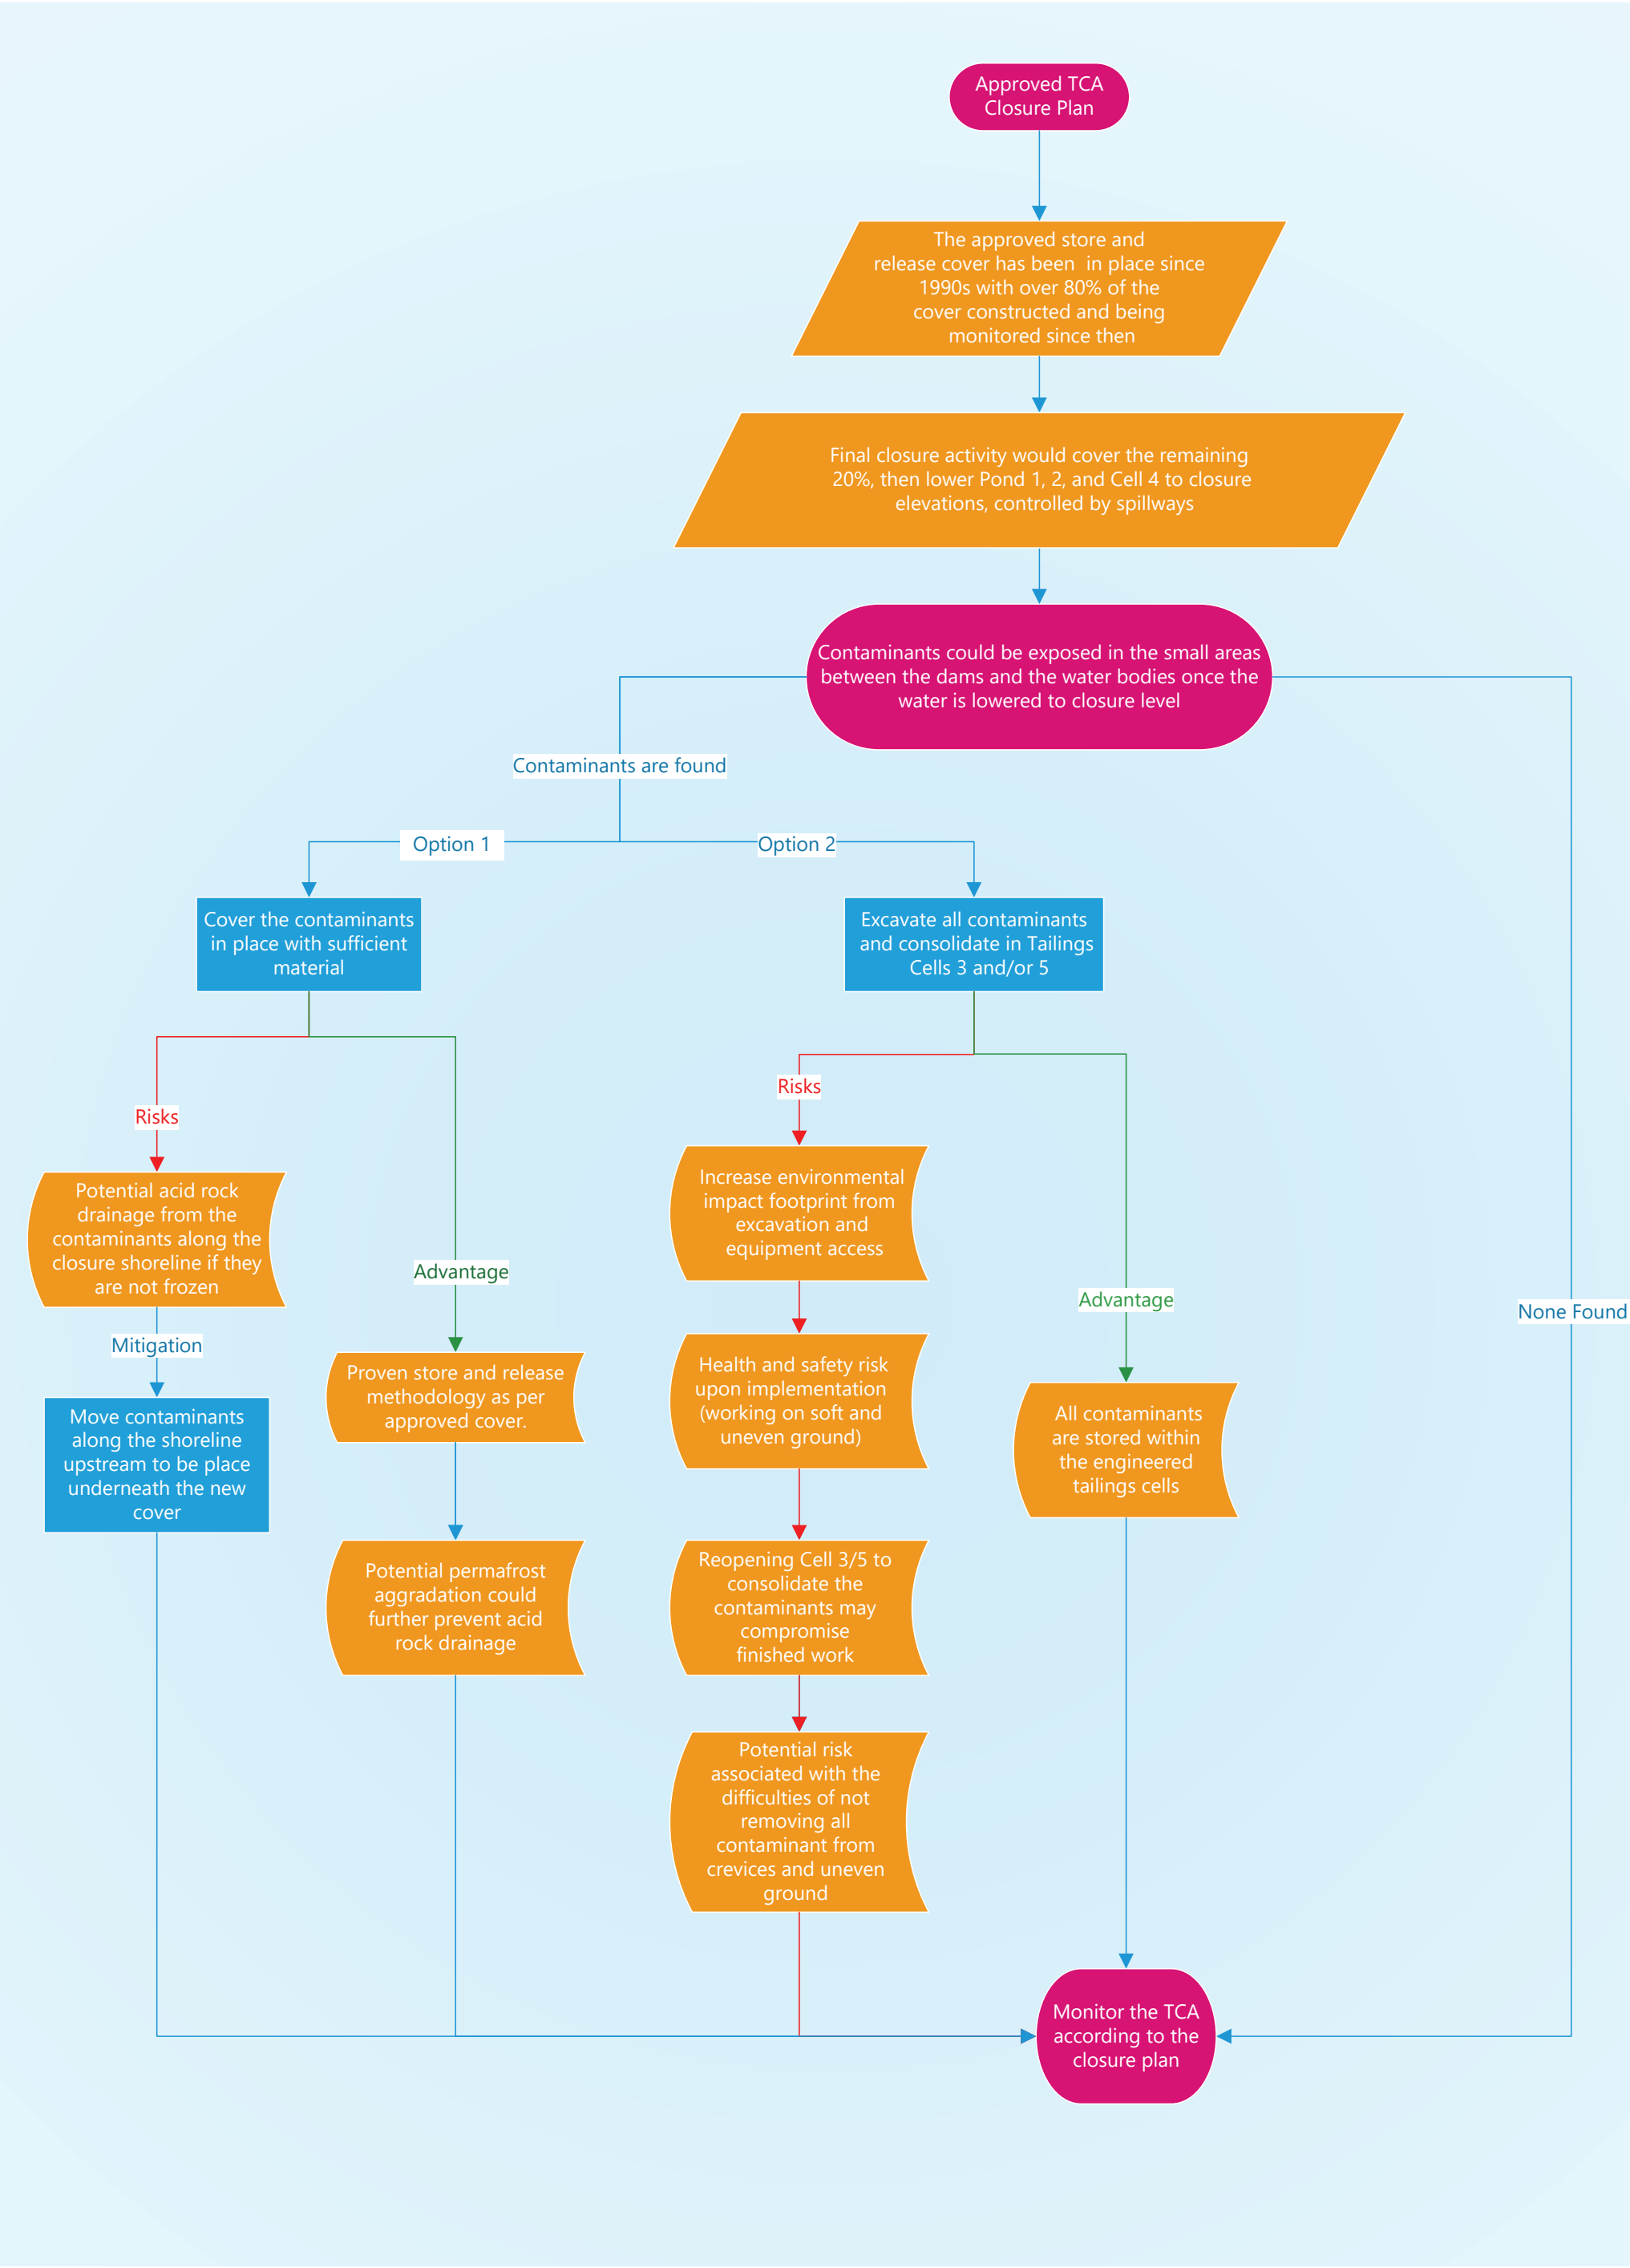
Figure 1: Decision Matrix for Contaminants Exposed above Lupin Mine Tailings Containment Area Closure Water Levels

Commitment No. 8 was fulfilled by preparing the attached Figure 1 Decision Matrix for Contaminants Exposed above Lupin Mine Tailings Containment Area Closure Water Levels. The options, risks and advantages supporting each decision item in the matrix are detailed within.
