### **Meadowbank Tailings Storage Facility OMS Version 11**

**TAILINGS MANAGEMENT**

**Operation, Maintenance and  
Surveillance Manual**

Prepared by  
Agnico Eagle Mines Limited

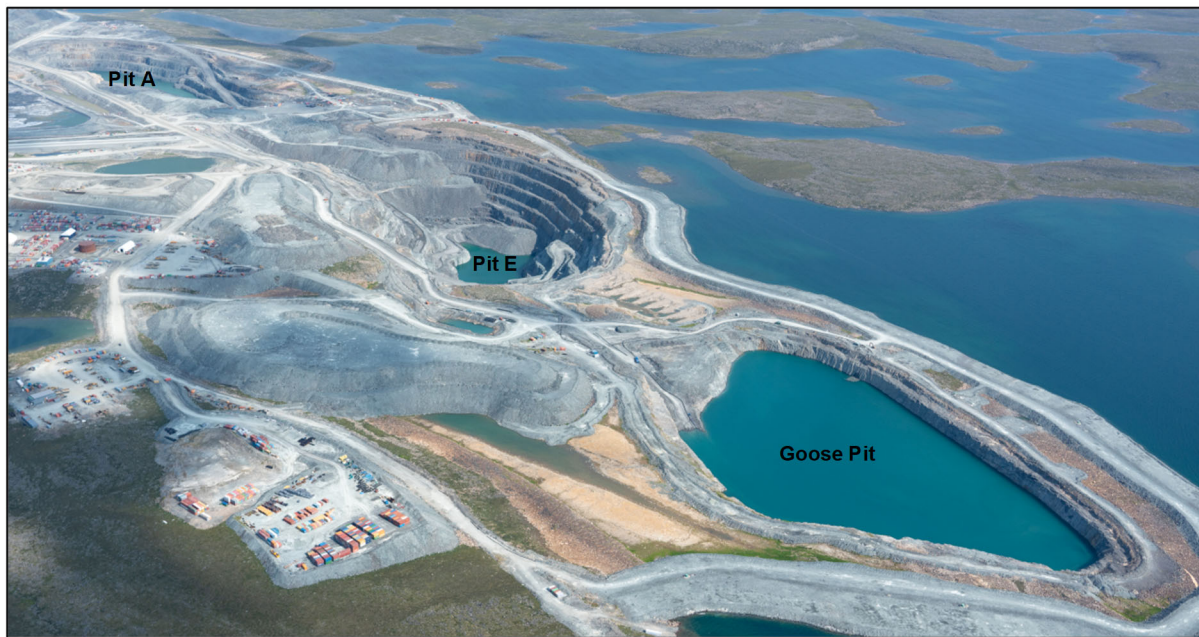
Figure 3-18: In-Pit Area for Tailings Management (Summer 2020)

In-Pit tailings deposition started in the summer of 2019 with the deposition of tailings in Goose Pit. Deposition of tailings switched to Portage Pit E in the fall of 2020. Water is reclaimed to the mill from Pit A or Pit E. Water is transferred from Goose Pit to Pit A and from Pit E to Pit A as required.
